In-flight fire involving Boeing 737, VH-YFY

56 km north-north-east of Hobart Airport, Tasmania, on 21 July 2025

ATSB Transport Safety Report

AO-2025-043

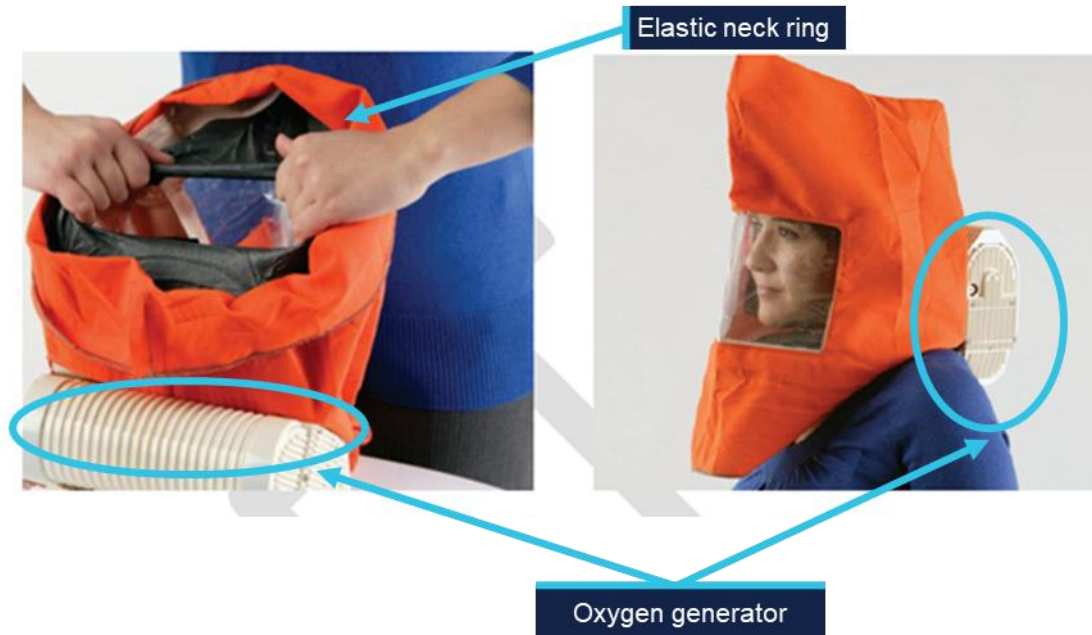
Figure 4: Exemplar PBE, showing how to open the neck ring (left) and when donned (right)

The 2 cabin crew who attempted to use the PBE stated that the equipment provided in training was much easier to don as the neck ring was stretched from repeated usage.

Protective breathing equipment (PBE) was available for cabin crew to use if deemed necessary in preparation to fight a fire, and all crew were trained in their use. Two of the cabin crew attempted to use the PBE, but did not find it effective due to fitment and communication/visibility issues. As the cabin crew were unable to use the PBE, they had no protection from the smoke and were placed at an increased risk of smoke inhalation. While these cabin crew did not experience any residual effects from the smoke, any protective equipment provided should be efficient to don and wear continuously while managing an emergency situation.

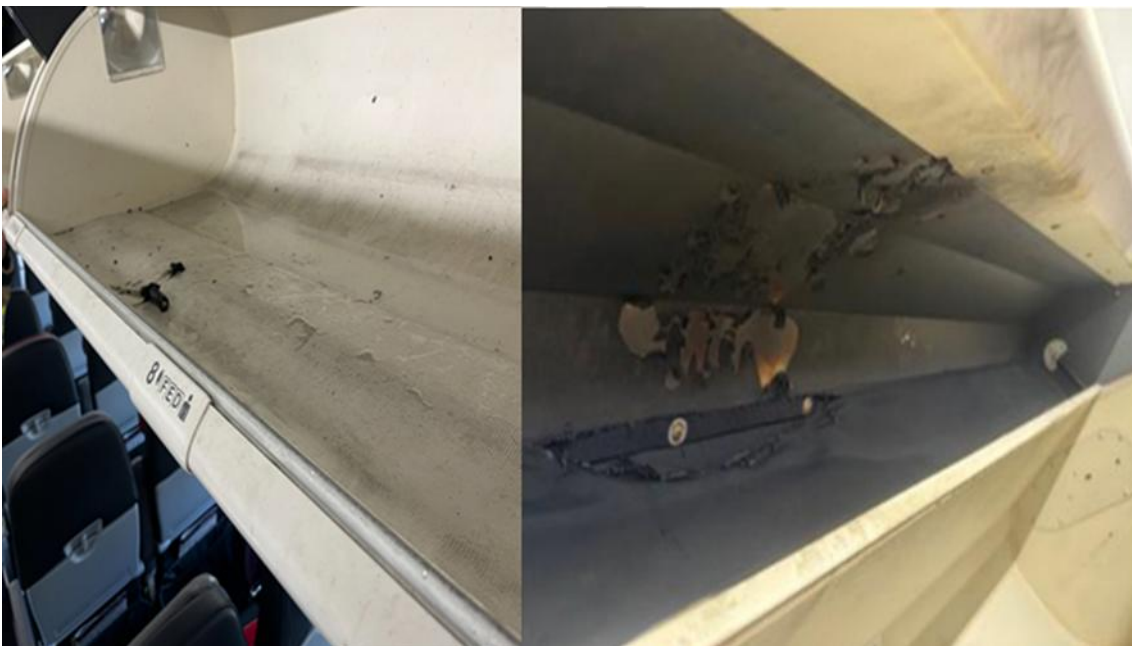
Figure 7: Overhead locker above row 7DEF where the smoke and flames were observed (left) and area behind the overhead locker showing fire damage (right)

An inspection of the aircraft found fire damage in the panels above and behind the overhead locker above row 7 and 8 DEF. The passenger service unit containing the reading lights, call bell and information signals under this locker also sustained fire and water damage. The overhead locker needed to be replaced post-fire (Figure 7).
