Loss of power and forced landing involving Piper PA-28, VH-BUN

32 km north-north-east of Sydney Airport, New South Wales, on 17 August 2025

ATSB Transport Safety Report

AO-2025-049

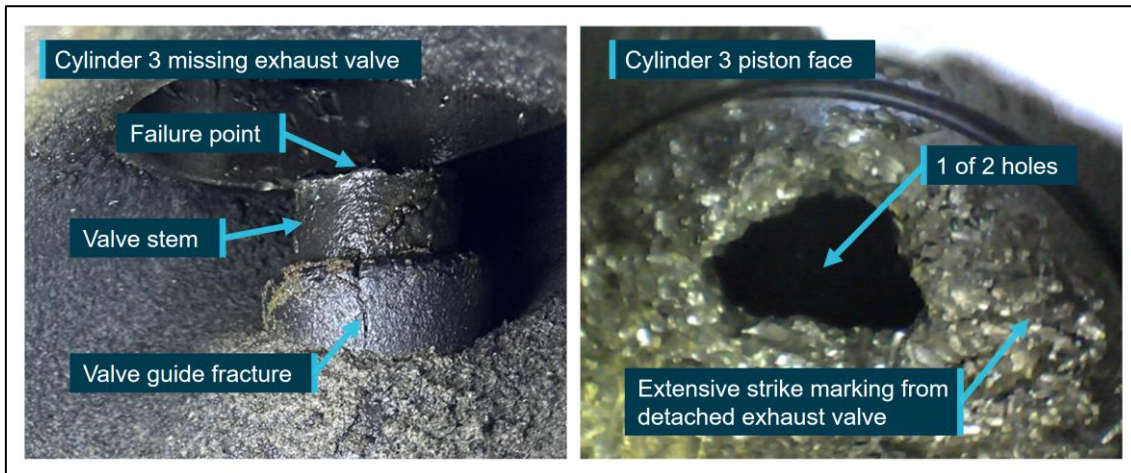
Figure 2: Borescope images of cylinder 3 showing the missing exhaust valve and damage to the piston face

The ATSB undertook a detailed engineering inspection of the aircraft's engine following the occurrence. Each of the engine's 4 cylinders was subject to a compression check, external visual inspection, and internal borescope inspection. Cylinders 1, 2 and 4 exhibited no major defects. However, cylinder 3 showed signs of significant damage.

The exhaust manifold of cylinder 3 was heavily soaked with oil and its valve train components showed signs of exposure to combustion gases. Cylinder 3 provided no compression, and an internal inspection showed its upper surface and piston face to be heavily damaged with multiple strike marks and 2 large holes (Figure 2). The exhaust valve had broken off at its stem and was missing, while the valve guide exhibited a small fracture line. Both of the cylinder's spark plugs had sustained impact damage to their electrodes.

The ATSB determined that the exhaust valve of cylinder 3 impacted the piston surface multiple times, causing damage to the piston, cylinder and spark plugs. This resulted in a sudden loss of compression and subsequent loss of engine power. It could not be determined if the valve had stuck open, resulting in the piston impact and valve fracture, or if the valve fractured prior to impacting the piston.
