Fuel starvation event involving Cessna T210M, VH-LLM

near Darwin Airport, Northern Territory, on 8 September 2025

Aviation Occurrence Investigation (Short)

AO-2025-054

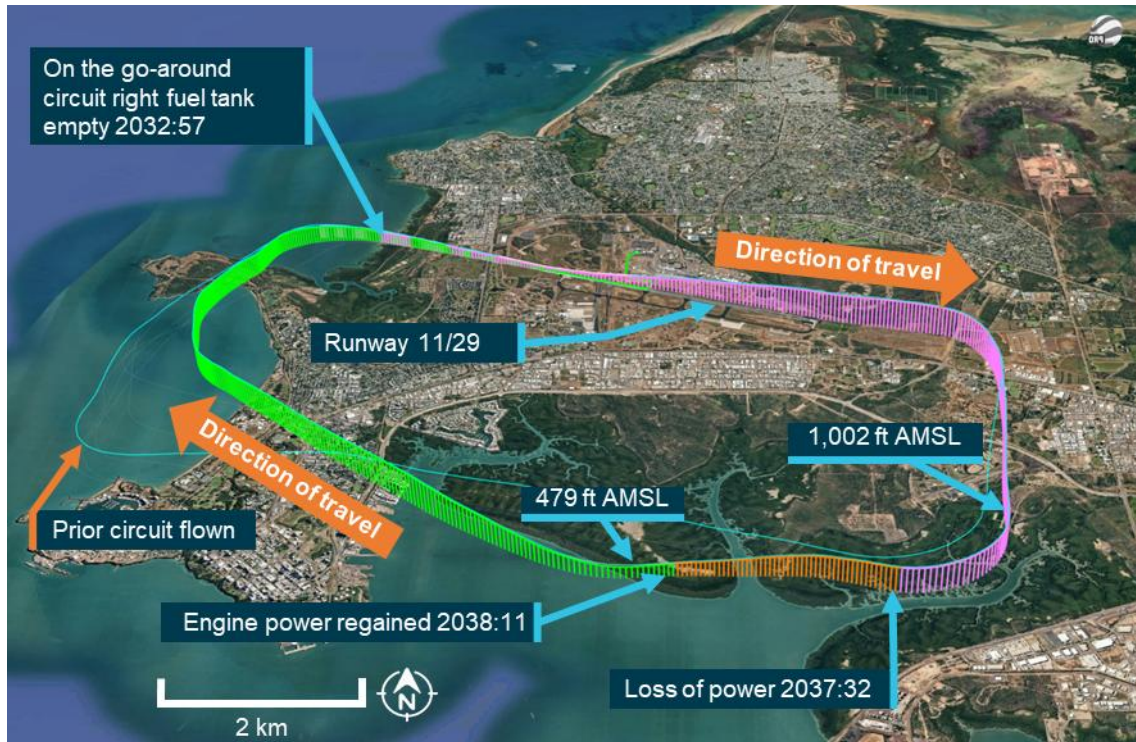
Figure 1: Graphical depiction of the occurrence circuit

At about 2030, during the student's fourth circuit, the instructor directed the student to conduct a go-around⁴ while on the final approach due to an aircraft behind them. The instructor recalled that the go-around was not completed proficiently and mentally noted to brief the student at the next opportunity to change the fuel selector to the left tank.

At 2032:57, recorded data showed that the right fuel tank indicated zero fuel before conducting the go-around, but the aircraft engine continued running using fuel in the lines and header tank.

At 2037:32, after turning onto the downwind circuit leg, the engine began to lose power and, realising that a return to the airport was not achievable, the student handed control to the instructor. The instructor conducted troubleshooting while the student declared an emergency to air traffic control (ATC).

The instructor identified that the aircraft fuel selector was positioned on the right fuel tank and realised that the tank, which had not been changed since beginning the circuits, was likely empty. They followed the POH procedure to change tanks, activated the auxiliary fuel pump and changed the fuel selector to the left tank. This restored engine power and they initiated a climb. The aircraft was at 600 ft above ground level at this time, and the

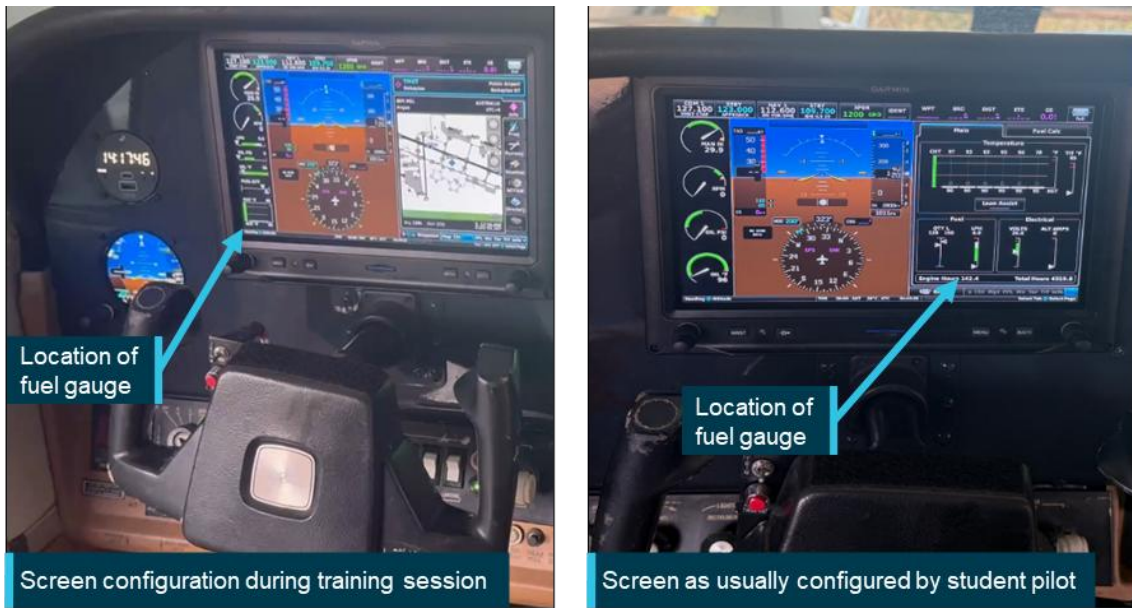
Figure 2: Photograph of VH-LLM Garmin G3X screen configuration changes

The cockpit of VH-LLM had been retrofitted with a customisable Garmin G3X suite (GI 275) glass cockpit.⁵ The student reported that on the night of the training session the instructor had changed the screen from the configuration that the student was previously used to. This included a change to the location of the fuel gauge which was positioned at the far left of the screen rather than on the right (Figure 2).

The instructor reported that there were no audio or visual fuel-related alerts associated with low fuel quantities or reminders to switch the fuel tank selection in the display. The instructor reported that the location of the fuel gauge was difficult to see from their seat position on the right-side of the aircraft.

Both the student and instructor reported that the fuel gauge was less visually prominent in the new screen configuration and more difficult to monitor.

The student reported not monitoring the fuel gauge (which had been relocated on the primary flight display) due to the screen configuration change from the display that they normally used. Although the student used a mnemonic for pre-landing checks which included the fuel, the check was not completed with the required response that the fuel selector was set to the fullest tank in accordance with the pilot operating handbook.

The instructor reported that their ability to monitor the fuel status was influenced by their restricted view of the fuel gauge which was not clearly visible during a normal visual scan.

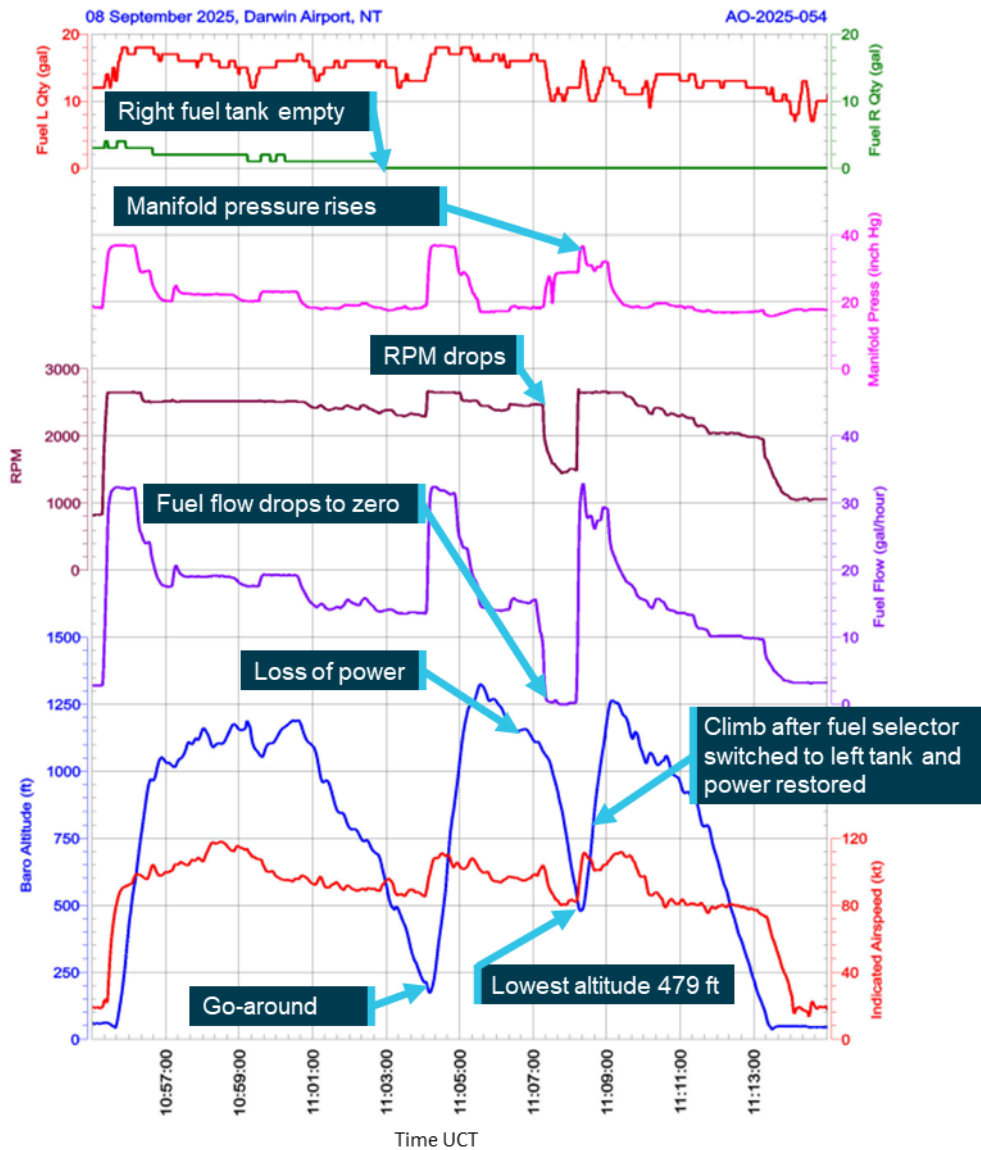
Figure 4: Data obtained from the VH-LLM Garmin G3X SD card

The Garmin G3X avionics suite recorded to a secure digital (SD) card which was analysed by the ATSB (Figure 4).

Recorded data indicated that during the last circuit, the aircraft had descended from about 1,200 ft to 479 ft AMSL before then climbing.

The recorded fuel data identified that fuel from the right tank had been fully used at 2032:57, prior to commencement of the go-around. Due to the residual fuel in the system and header tanks, the engine power loss occurred about 5 minutes later at 2037:32. After conducting engine troubleshooting, the power was restored at 2038:11.
