Australian Government
Australian Transport Safety Bureau

Ground proximity alerts involving Sikorsky S-92A, VH-IPE

71 km north-north-west of Exmouth Aerodrome, Western Australia, on
1 February 2025

ATSB Transport Safety Report
Aviation Occurrence Investigation (Defined)
AO-2025-005
Final – 4 February 2026

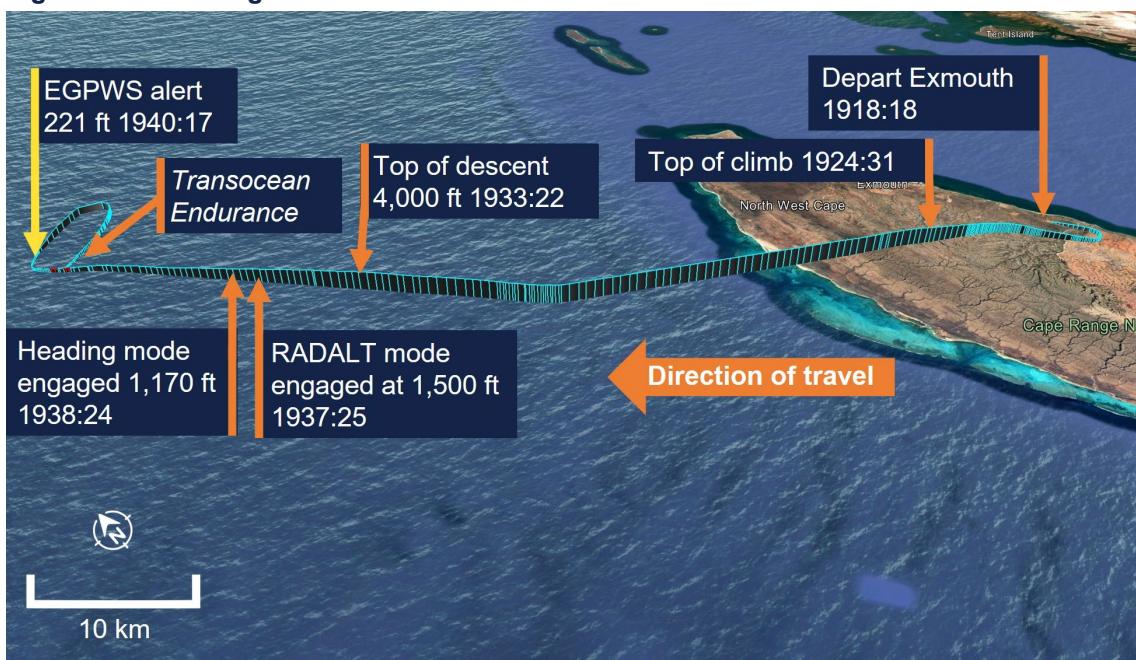
Figure 1: VH-IPE flight track

At about 1933 and 11 NM (20 km) south-east of the drill rig and now in darkness (see *Meteorological information*), the helicopter began a descent to the lowest safe altitude of 1,500 ft (Figure 1). At 1937, the PF requested the PM to engage the radar altimeter (RADALT) hold mode and lower the target altitude capture height to the 660 ft circuit height. This was confirmed by the PM and the helicopter commenced a further descent to the drill rig circuit height. Both flight crew later recalled completing the before landing checklist during the descent.

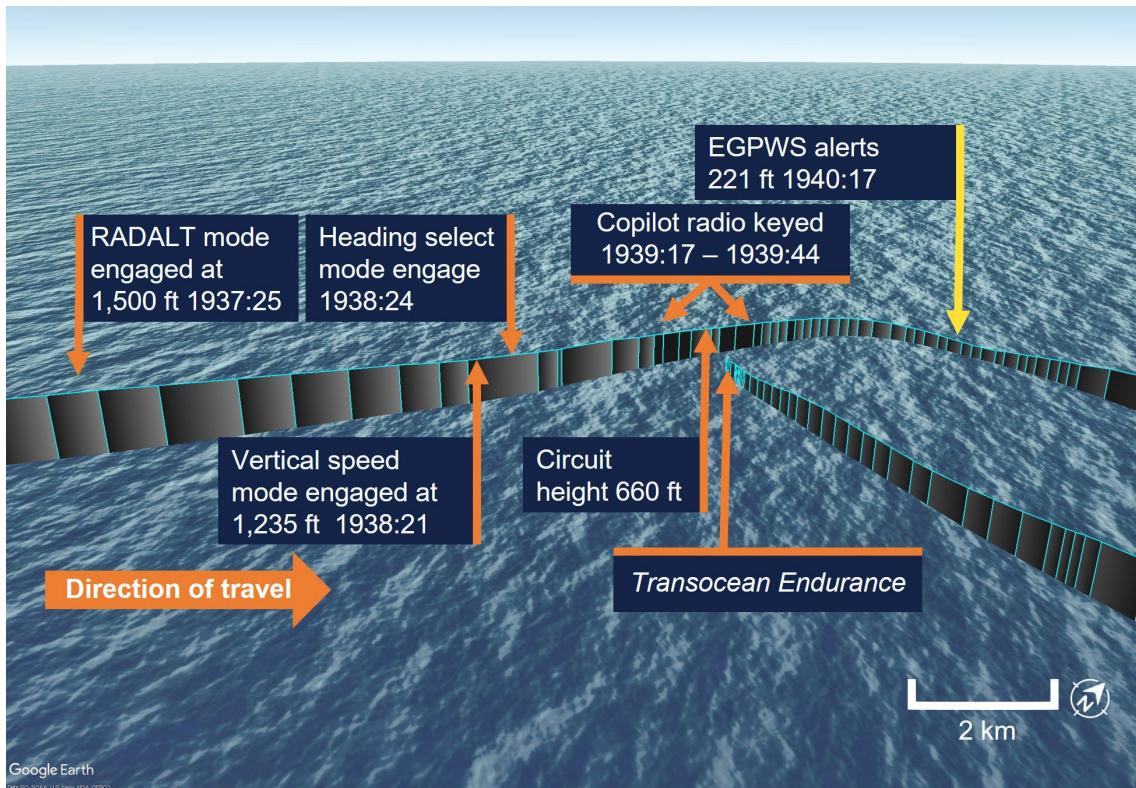
Figure 2: VH-IPE flight track from 1,500 ft

At 1938:21 and about 1,235 ft, during the descent for a visual approach to the rig (Figure 2), the PF attempted to select the heading mode on the automatic flight control system (AFCS) mode select panel to adjust the heading and avoid flying directly over the rig.

While attempting to press the heading mode button, the PF inadvertently and unknowingly selected the vertical speed button which was directly below it.

The inadvertent selection of the vertical speed hold mode captured the helicopter's 500 ft per minute rate of descent, and cancelled the RADALT hold mode that would have levelled the helicopter at a preset circuit height of 660 ft above sea level.

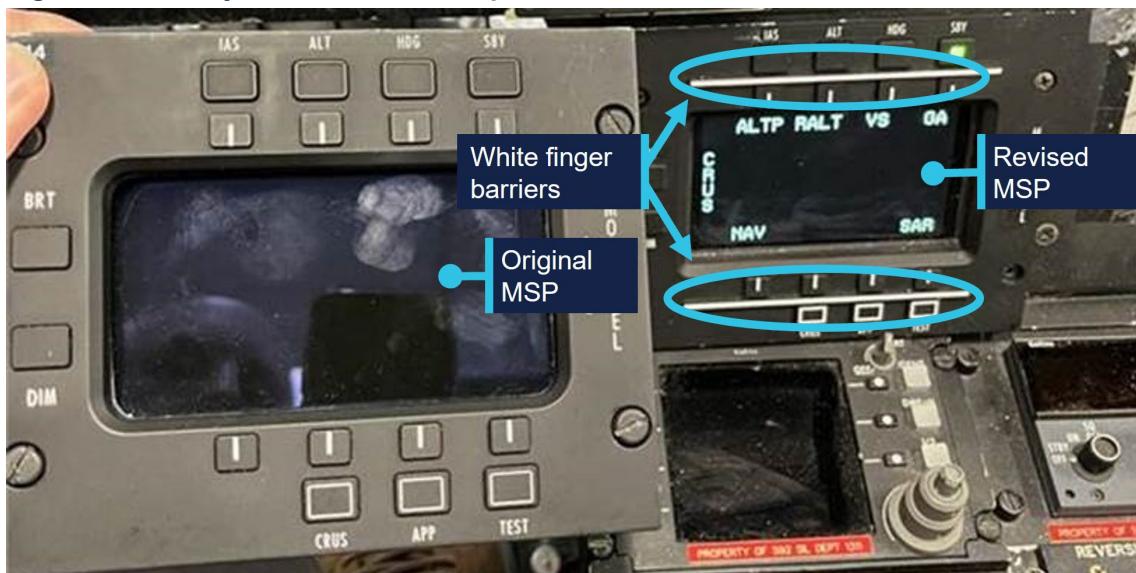
Figure 4: Sikorsky S-92A mode select panels

The manufacturer advised that from aircraft serial number 920057 (built after VH-IPE), the mode select panel was upgraded to incorporate 2 white coloured finger barriers above and below the display screen between the rows of hard and soft keys (Figure 4). The barrier protruded higher than the height of both the soft and hard keys and gave pilots tactile feedback on finger position in relation to the rows of hard and soft keys. The manufacturer advised that the design change was likely due to customer feedback regarding the panel.

VH-YPE featured an MSP without the white finger barriers on the left copilot side of the cockpit but with the revised MSP with the finger barriers on the captain's right side. In this occurrence, the mis-selection of button below the finger barrier was done by the captain as the pilot flying.

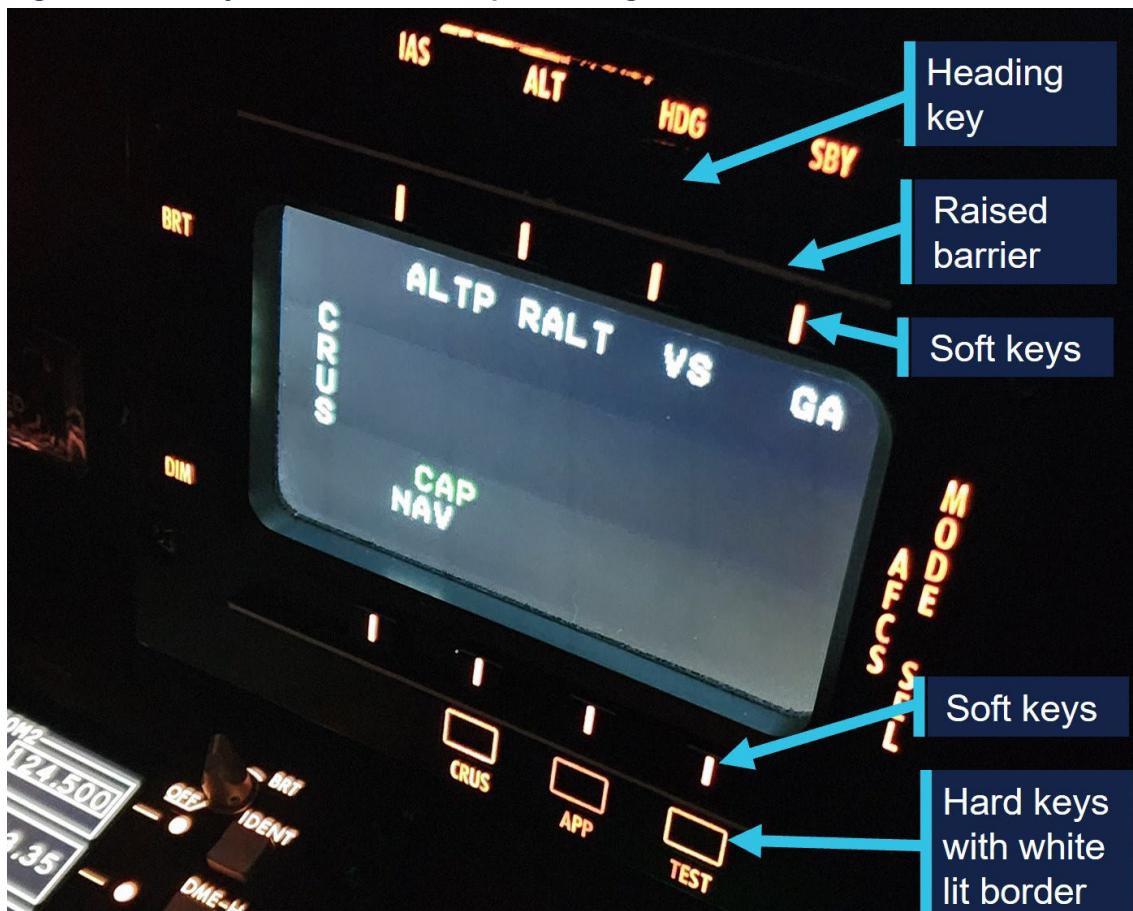
Figure 5: Sikorsky S-92A mode select panel at night

The top row of hard keys, which included the heading key, were not back lit when the relevant modes were not engaged (Figure 5). The manufacturer identified that the lower row of hard keys featured a lit border on the individual key as those keys were menu keys and changed the function of the lower row of soft keys. The white finger barrier (when installed) separating the hard and soft keys did not illuminate.

The S-92A cockpit lighting environment was reviewed by the operator with subject matter experts to consider if an engineered improvement was practicable. A procedural change was implemented by PHI International Australia that required the use of small lights that are worn on the pilot's fingers to improve visibility of the cockpit environment (such as switches, buttons, and controls) during S-92A night flights.

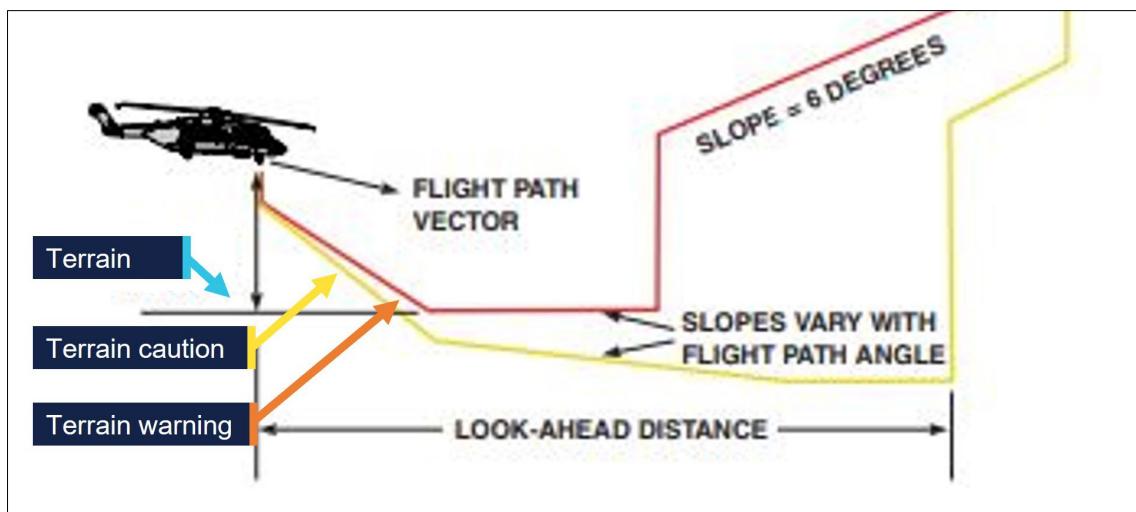
Figure 7: EGPWS look ahead mode

The flight crew received a terrain caution alert as the helicopter descended through about 220 ft followed by a terrain warning alert at about 180 ft AGL.

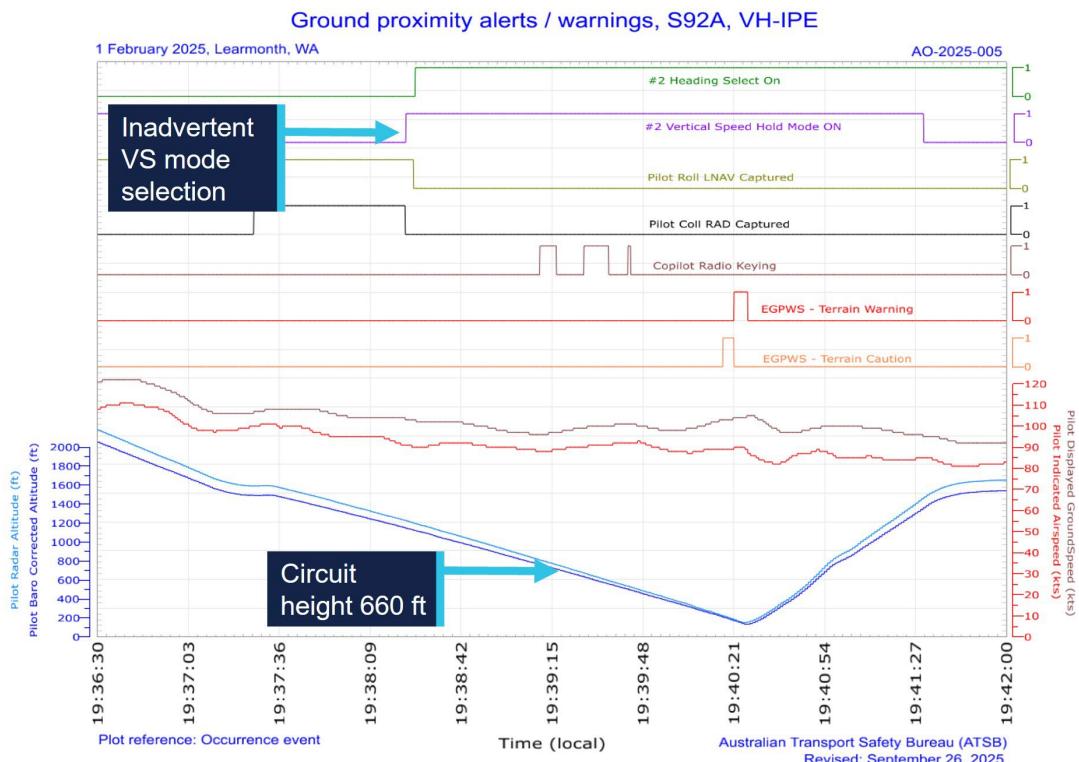
Figure 9: VH-IPE flight data

- At 1938:24, 3.3 seconds after the engagement of vertical speed mode, the heading mode was shown to be engaged at about 1,170 ft (Figure 9).
- At 1938:32, the helicopter heading was adjusted from 348° to 333°.
- The flight track was adjusted to the left and the helicopter passed to the south-west of the drilling rig.
- At 1939:46, as the helicopter descended through about 510 ft, the helicopter heading was again adjusted from 345° to 065° and the helicopter commenced a turn onto the downwind leg of a right circuit to the drilling rig helideck.
