VFR into IMC and controlled flight into terrain involving Cirrus SR20, VH-TEL

12 km east of Braidwood/Percheron aircraft landing area, New South Wales, on 18 September 2025

ATSB Transport Safety Report

AO-2025-056

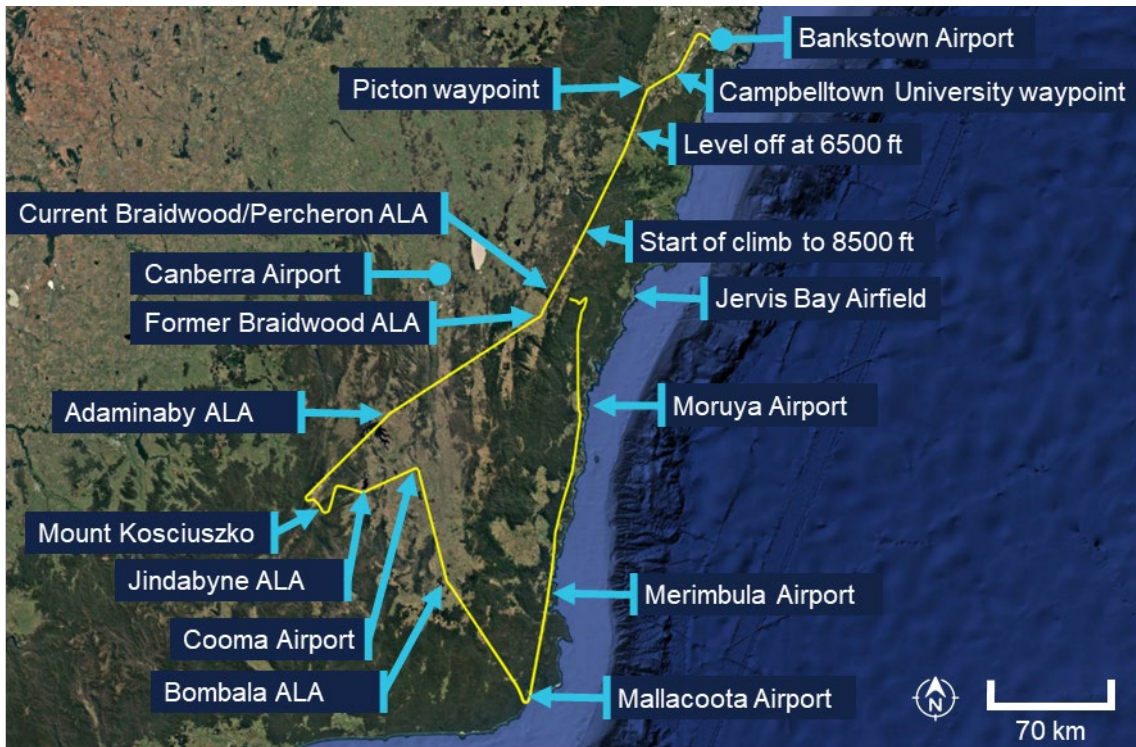
Figure 1: Flight path overview

Once passing Mallocoota Airport at 1342, aircraft flight data showed the pilot began to descend while tracking towards Merimbula Airport, New South Wales, and then continued further north.

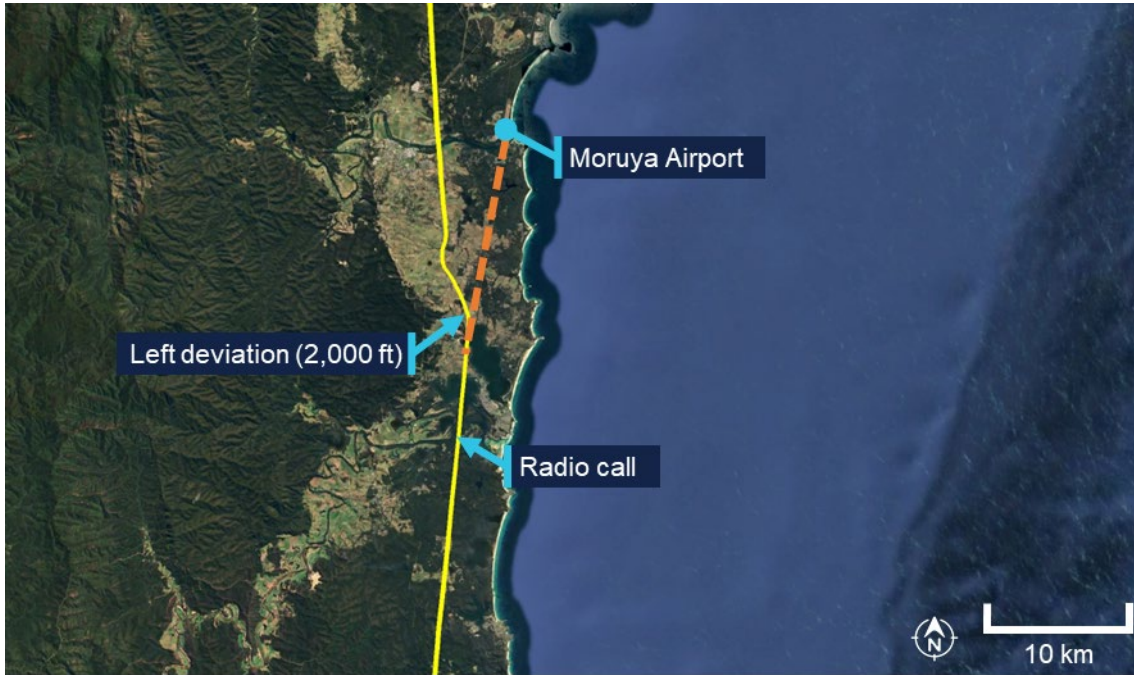
Figure 2: Diversion from Moruya Airport approach track

There were no further radio calls from the pilot. The pilot continued to track towards Moruya Airport at 2,000 ft before diverting left and climbing to 2,500 ft passing the airport to the west at 1431 (Figure 2).

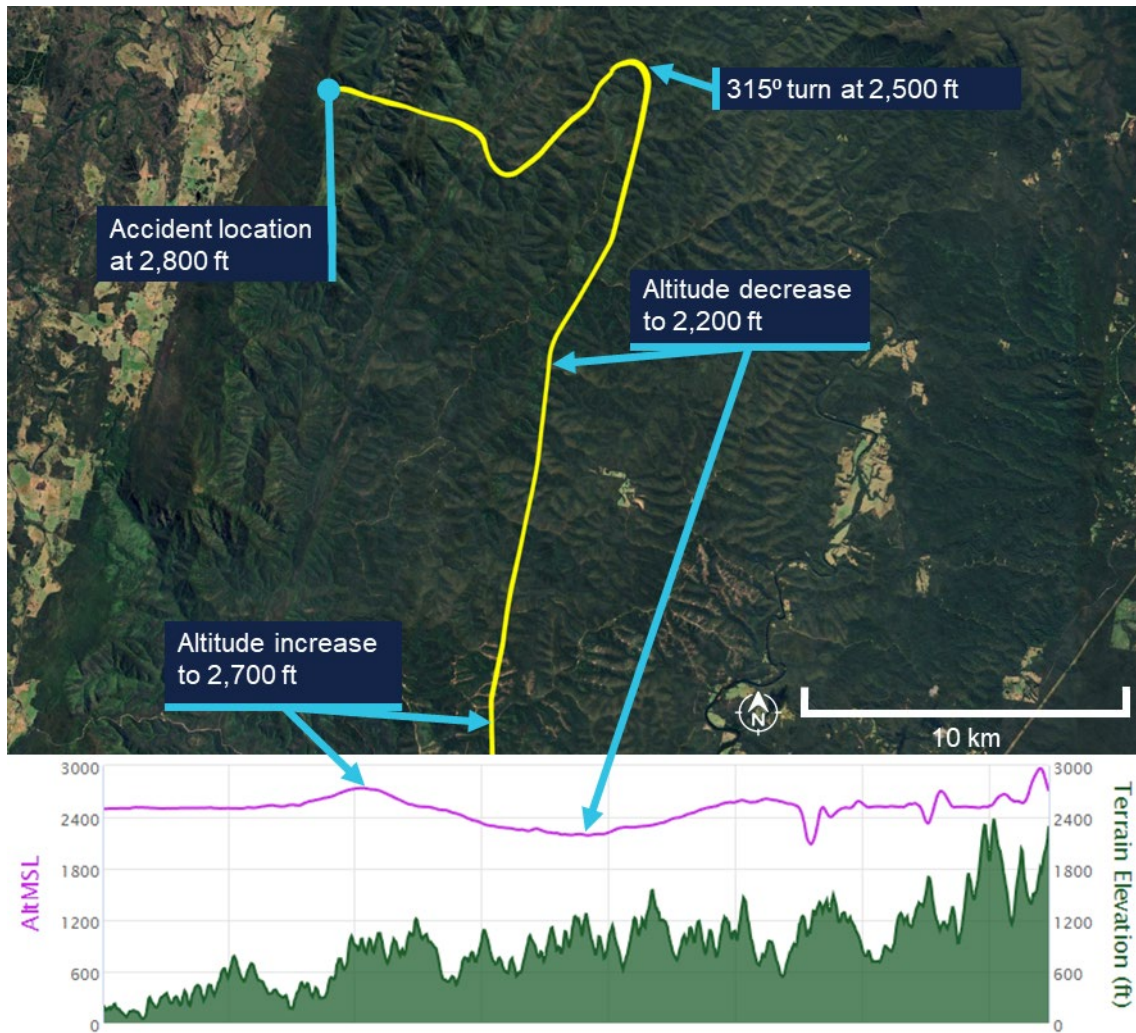
Figure 3: Flight path of the last 15 minutes of the flight

The pilot continued north-west for 13 minutes at about 2,500 ft AMSL. For the remainder of the flight, the pilot maintained an altitude between 2,000 and 2,700 feet AMSL, with intermittent climbs and descents (Figure 3). The mountainous area had fluctuating terrain heights, with a maximum terrain height in the area of about 2,900 ft.

The lower plot does not show the point of impact, because the data recording ceased prior to that point.
 Source: Google Earth, annotated by the ATSB

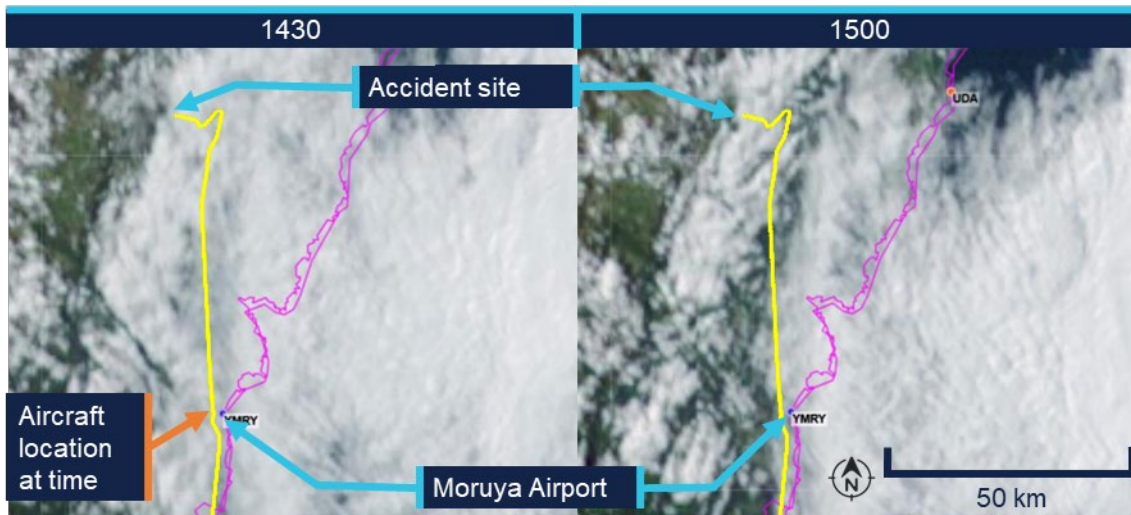
Figure 4: Satellite image showing cloud formation on 18 September at 1430 and 1500 local time

breaks observed in the cloud layer. The images provided no information on cloud height, or density at a given height.

The flight path was overlaid on the satellite image to illustrate the route relative to the weather. The actual flight occurred below the cloud base.

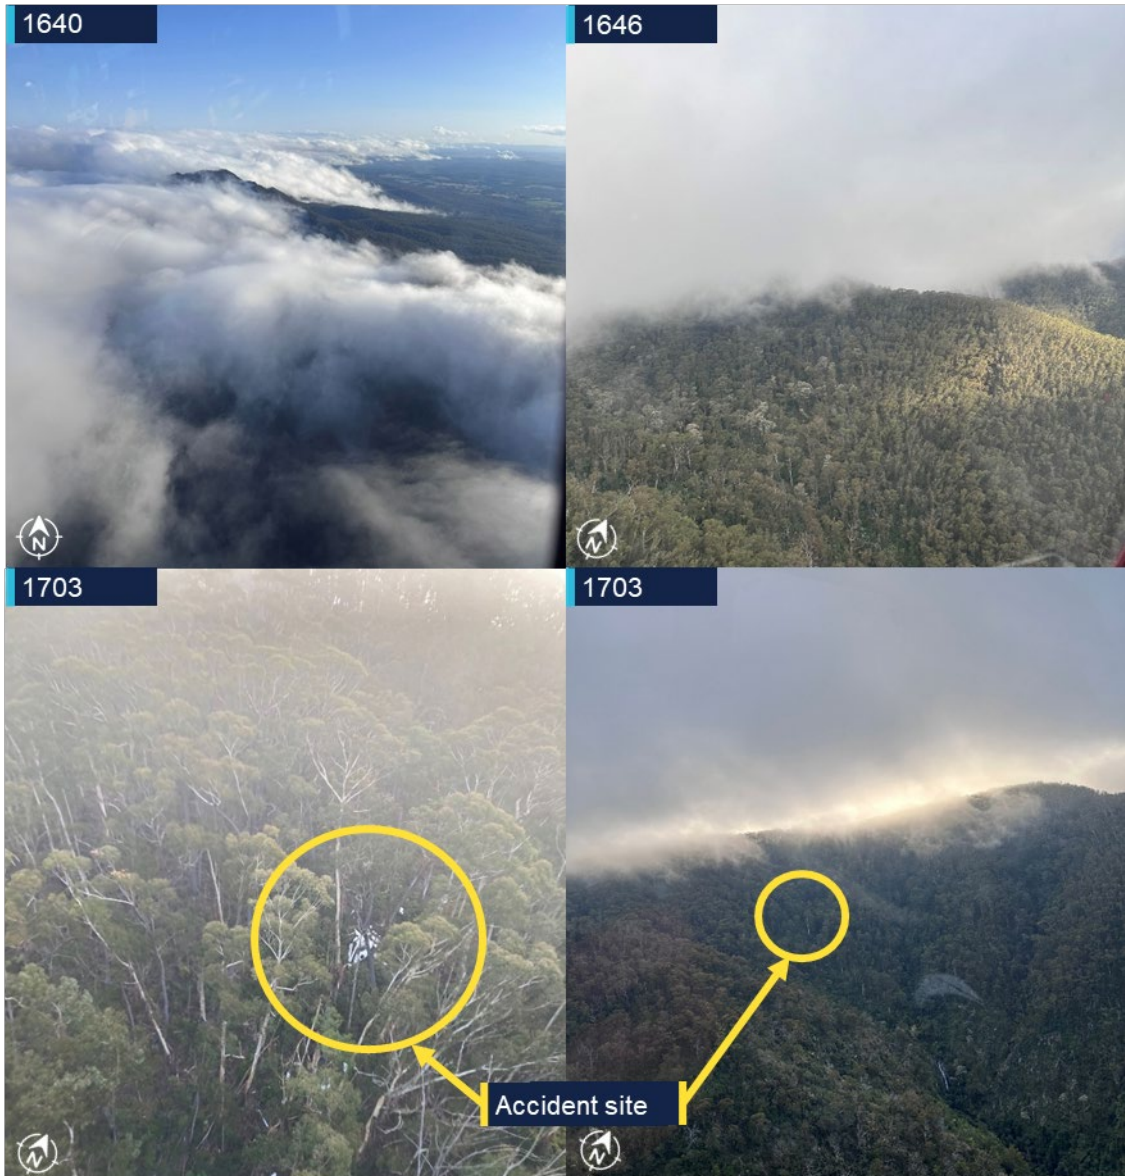
Figure 5: Cloud over the accident site between 1640 and 1703 local time

Top left and top right: cloud coverage to the north of the accident site. Bottom left: overhead the accident. Bottom right: view of the accident site and surrounding weather from the east.
Source: ACT Emergency Services Agency, annotated by the ATSB

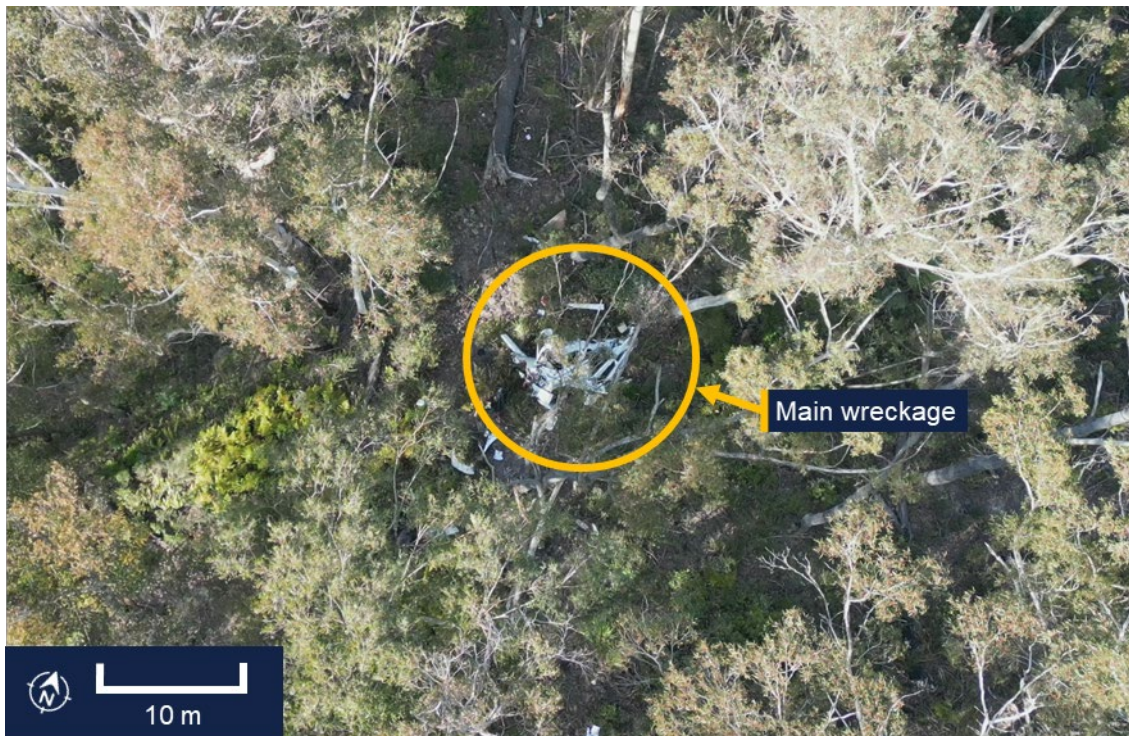
Figure 6: Overhead view of accident site

The aircraft wreckage was located in heavily vegetated, steep, mountainous terrain (Figure 6).

The ATSB conducted an examination of the accident site and wreckage on 21 September. The aircraft impacted the side of the mountain and slid backwards from the direction of travel until supported on the slope by some small trees. Ground impact marks and impact marks on the trees indicated the aircraft entered the trees with wings and fuselage almost level.

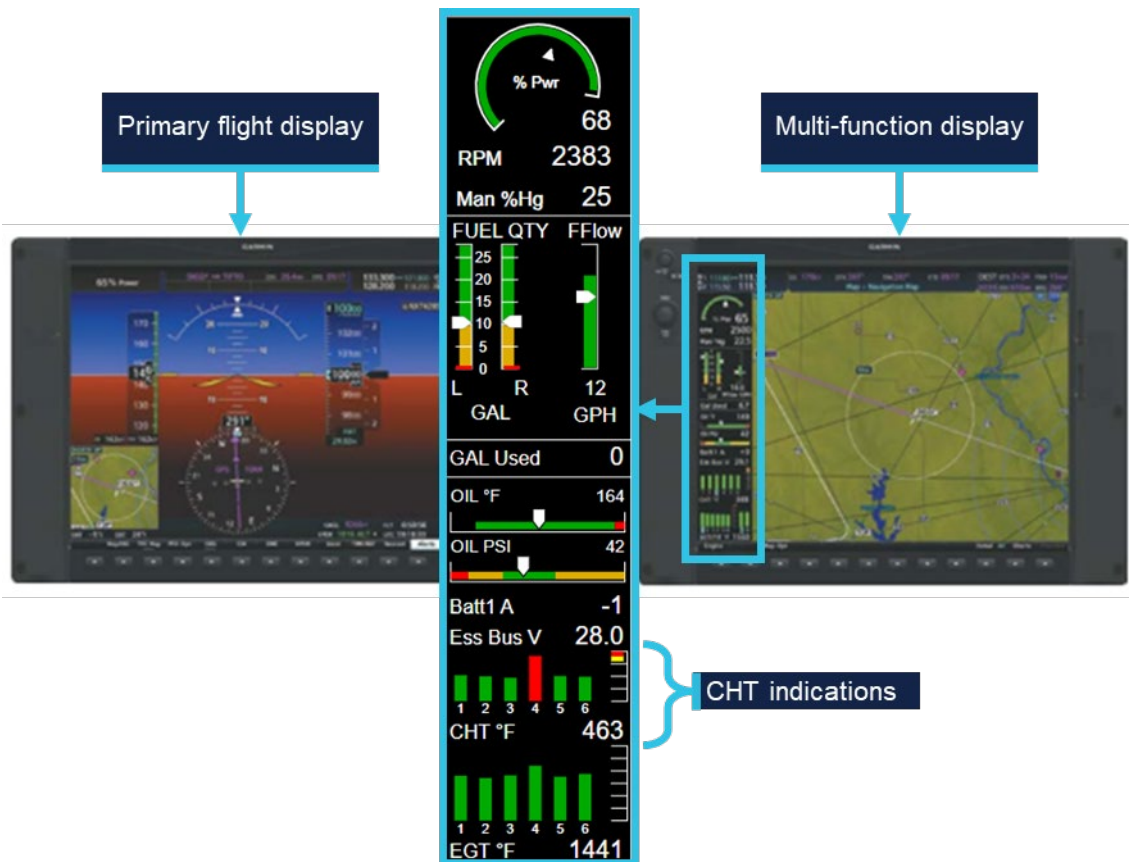
Figure 7: MFD engine indication system (EIS) panel, showing the vertical coloured bars indicating a CHT warning state for engine cylinder 4 temperature

In the event CHT exceeds 420°F, the MFD will display “Check CHT” in a yellow advisory box in the lower right corner of the MFD. In the event CHT exceeds 460°F, the MFD will display “Check CHT” in a red advisory box in the lower right corner of the MFD.

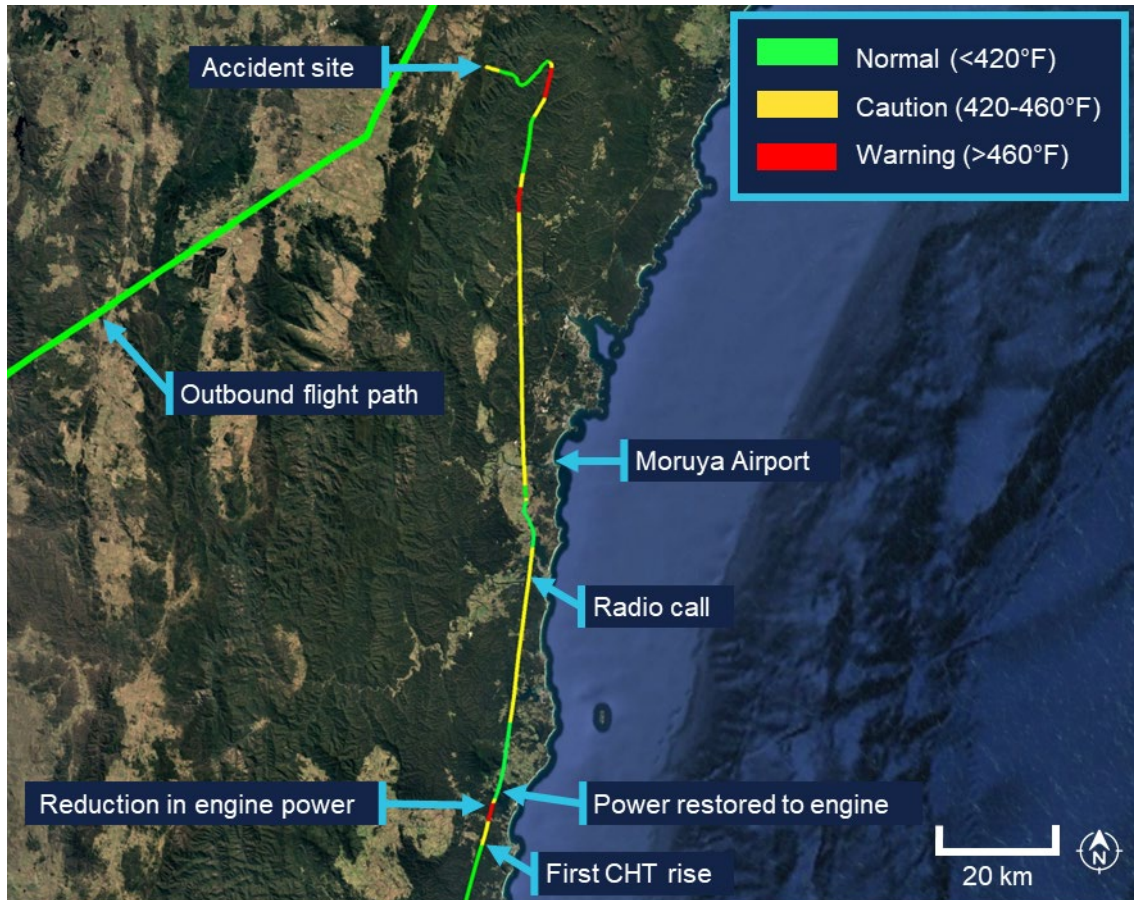
Figure 9: Number 4 cylinder head temperature readings throughout the last 1.5 hours of the flight

The ATSB compared the recorded CHT and exhaust gas temperature (EGT) data for cylinder 4 in order to determine whether the observed high CHT indications were consistent with an overheating cylinder or were more likely the result of a faulty CHT probe. In normal engine operation, a genuine rise in cylinder head temperature is typically accompanied by a corresponding rise in EGT for the affected cylinder, as both parameters respond to increased combustion temperatures and heat rejection. Conversely, a significant increase in indicated CHT with little or no corresponding change in EGT is characteristic of a failing or erratic CHT sensor.

The analysis indicated that the EGT for cylinder 4 remained relatively stable and within normal operating limits throughout the period when CHT repeatedly entered the yellow and red advisory ranges. This suggested that the anomalies were most likely caused by a faulty cylinder 4 CHT probe. The ATSB presented this information to Cirrus Aircraft which agreed that ‘the CHT sensor was giving faulty information as there were no other indications that there was an engine issue in the data.’

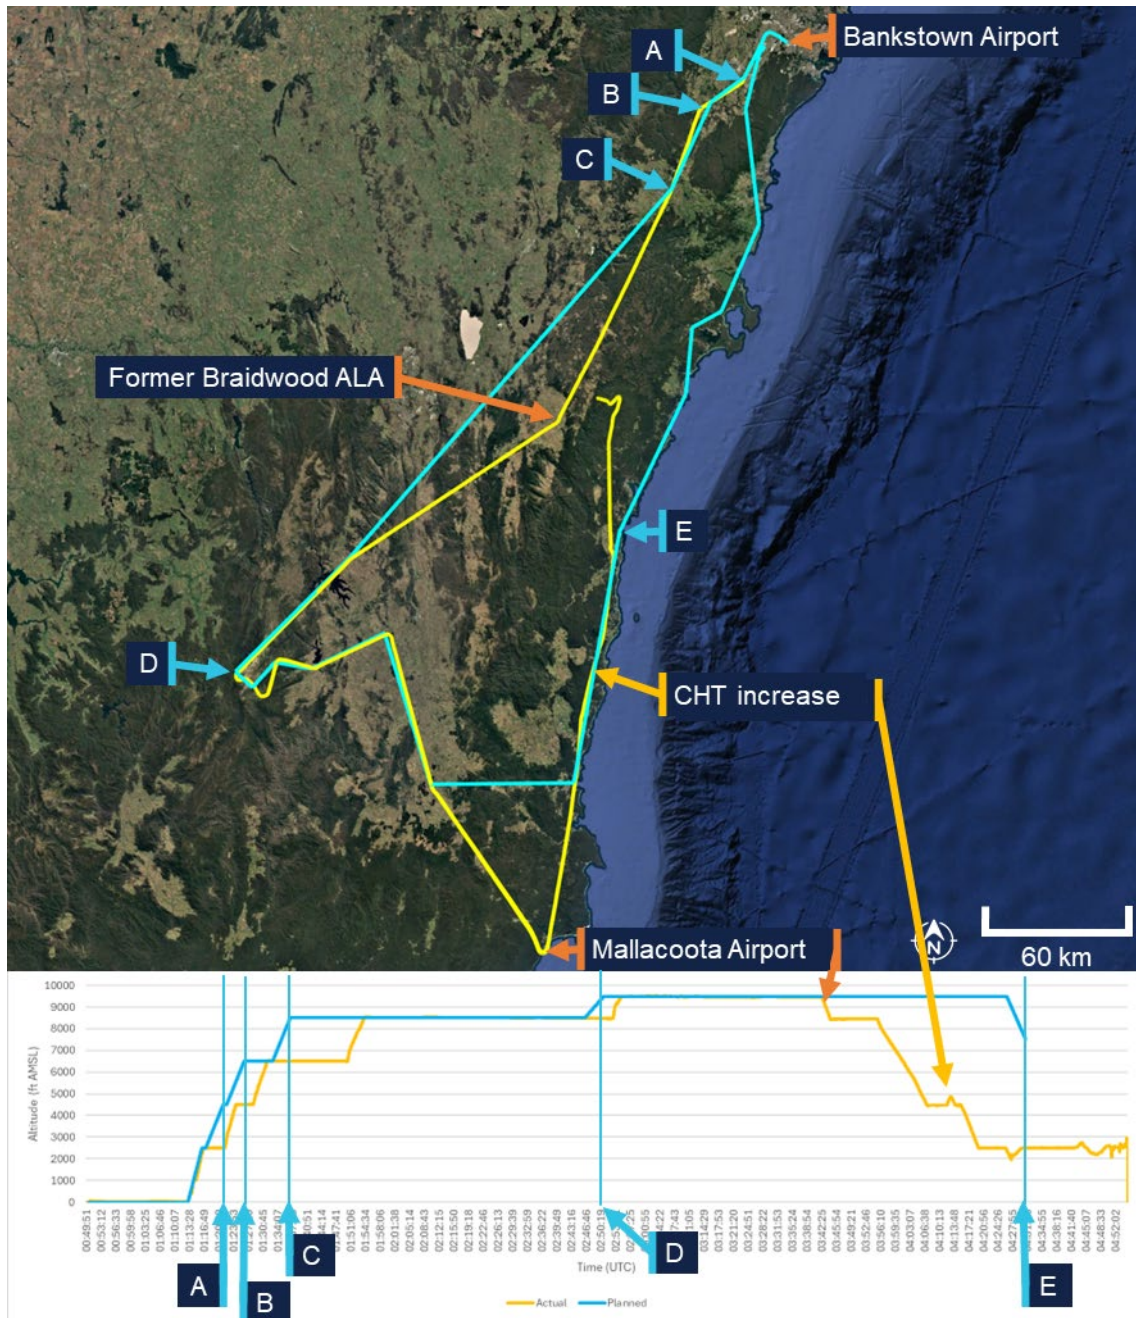
Figure 11: Planned flight (blue) comparison to actual flight (yellow)

A. Bankstown Airport; B. Campbelltown University waypoint; C. Picton waypoint; D. pilot chosen waypoint using lat/long; E. Moruya Airport.
Source: ATSB
