VFR into IMC and controlled flight into terrain involving Cirrus SR20, VH-TEL

12 km east of Braidwood/Percheron aircraft landing area, New South Wales, on 18 September 2025

ATSB Transport Safety Report

AO-2025-056

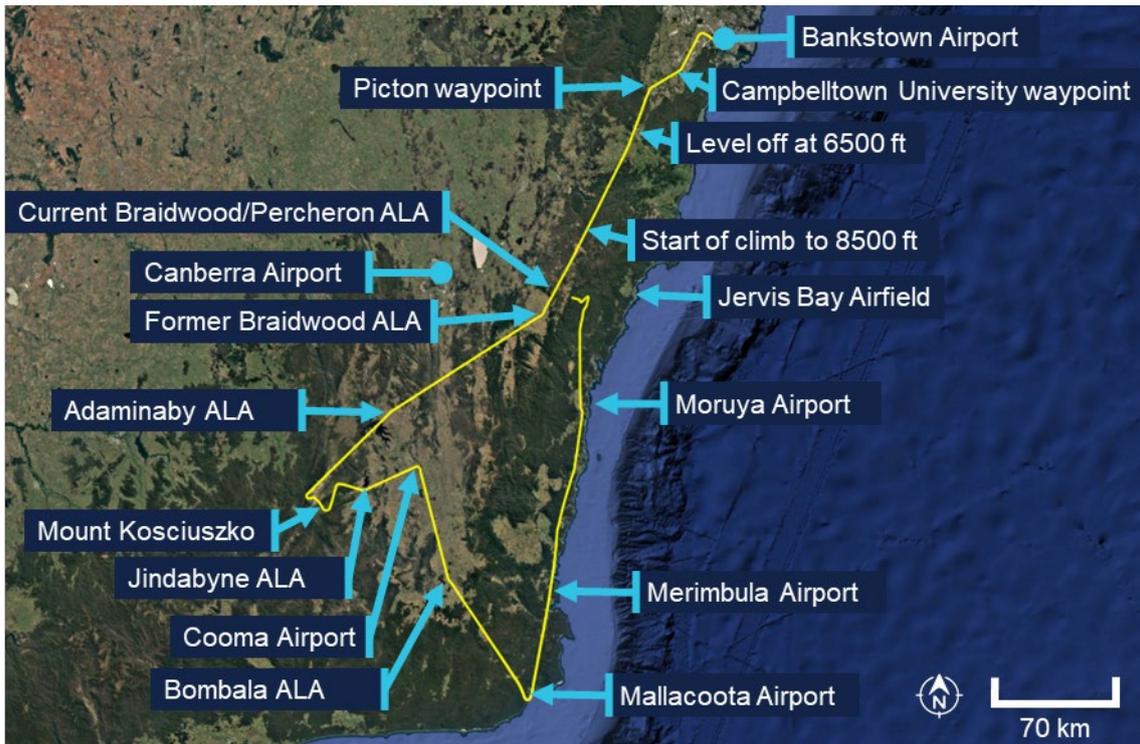
Figure 1: Flight path overview

Once passing Murrumbidgee Airport at 1342, aircraft flight data showed the pilot began to descend while tracking towards Merimbula Airport, New South Wales, and then continued further north.

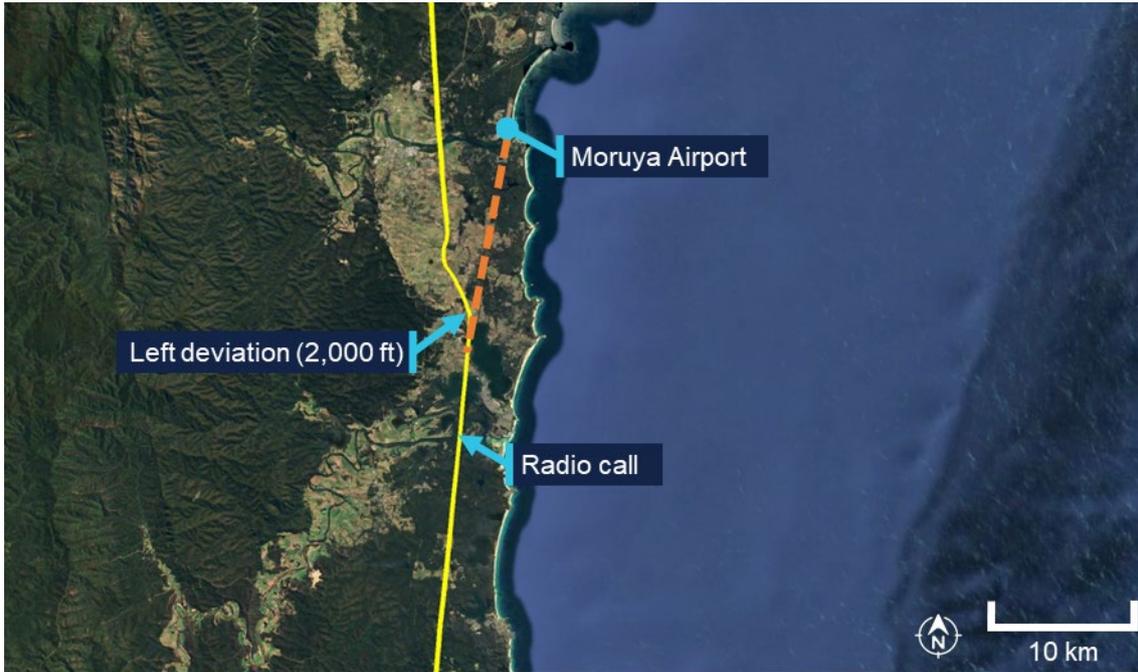
Figure 2: Diversion from Moruya Airport approach track

There were no further radio calls from the pilot. The pilot continued to track towards Moruya Airport at 2,000 ft before diverting left and climbing to 2,500 ft passing the airport to the west at 1431 (Figure 2).

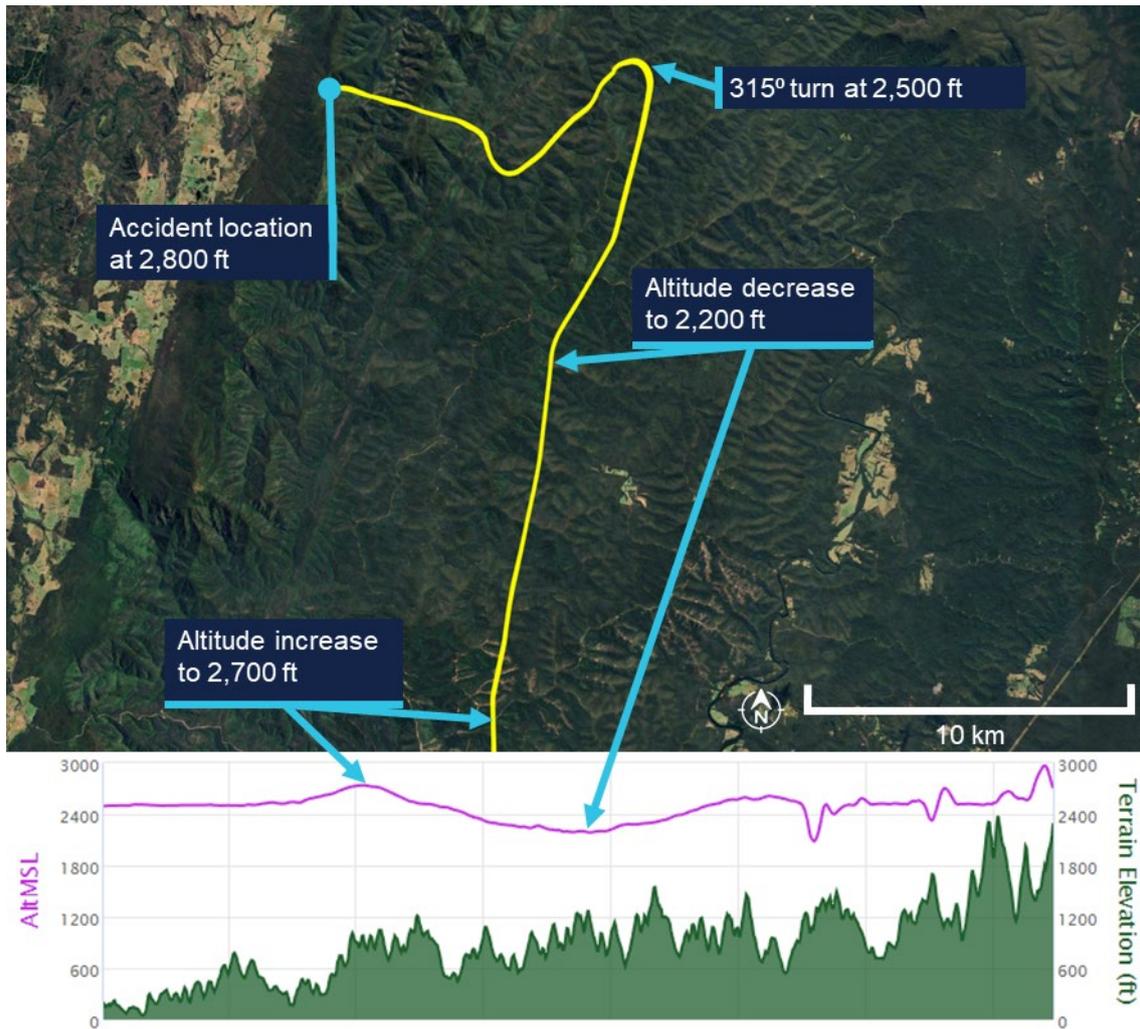
Figure 3: Flight path of the last 15 minutes of the flight

The pilot continued north-west for 13 minutes at about 2,500 ft AMSL. For the remainder of the flight, the pilot maintained an altitude between 2,000 and 2,700 feet AMSL, with intermittent climbs and descents (Figure 3). The mountainous area had fluctuating terrain heights, with a maximum terrain height in the area of about 2,900 ft.

The lower plot does not show the point of impact, because the data recording ceased prior to that point.
 Source: Google Earth, annotated by the ATSB

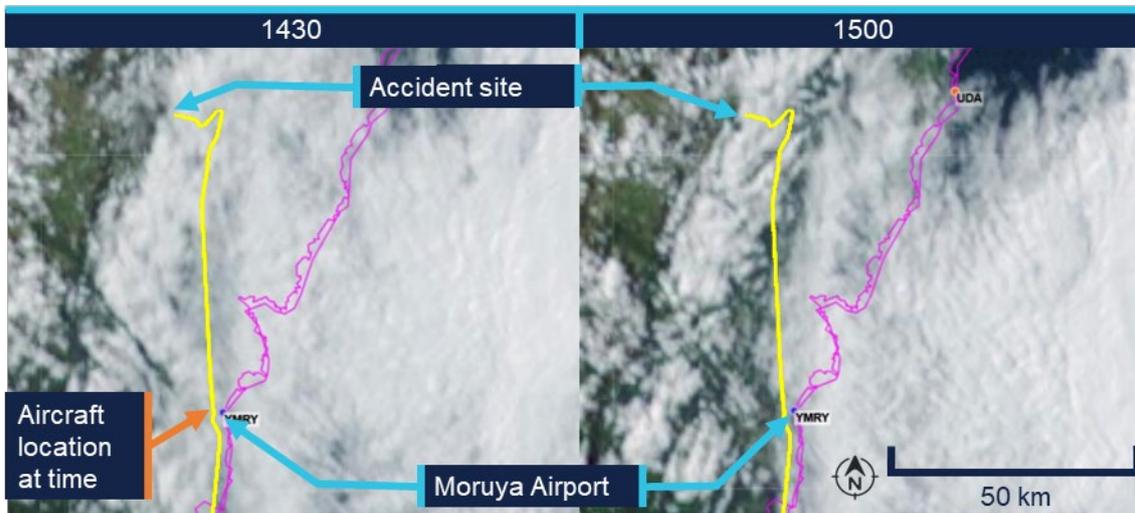
Figure 4: Satellite image showing cloud formation on 18 September at 1430 and 1500 local time

breaks observed in the cloud layer. The images provided no information on cloud height, or density at a given height.

The flight path was overlaid on the satellite image to illustrate the route relative to the weather. The actual flight occurred below the cloud base.

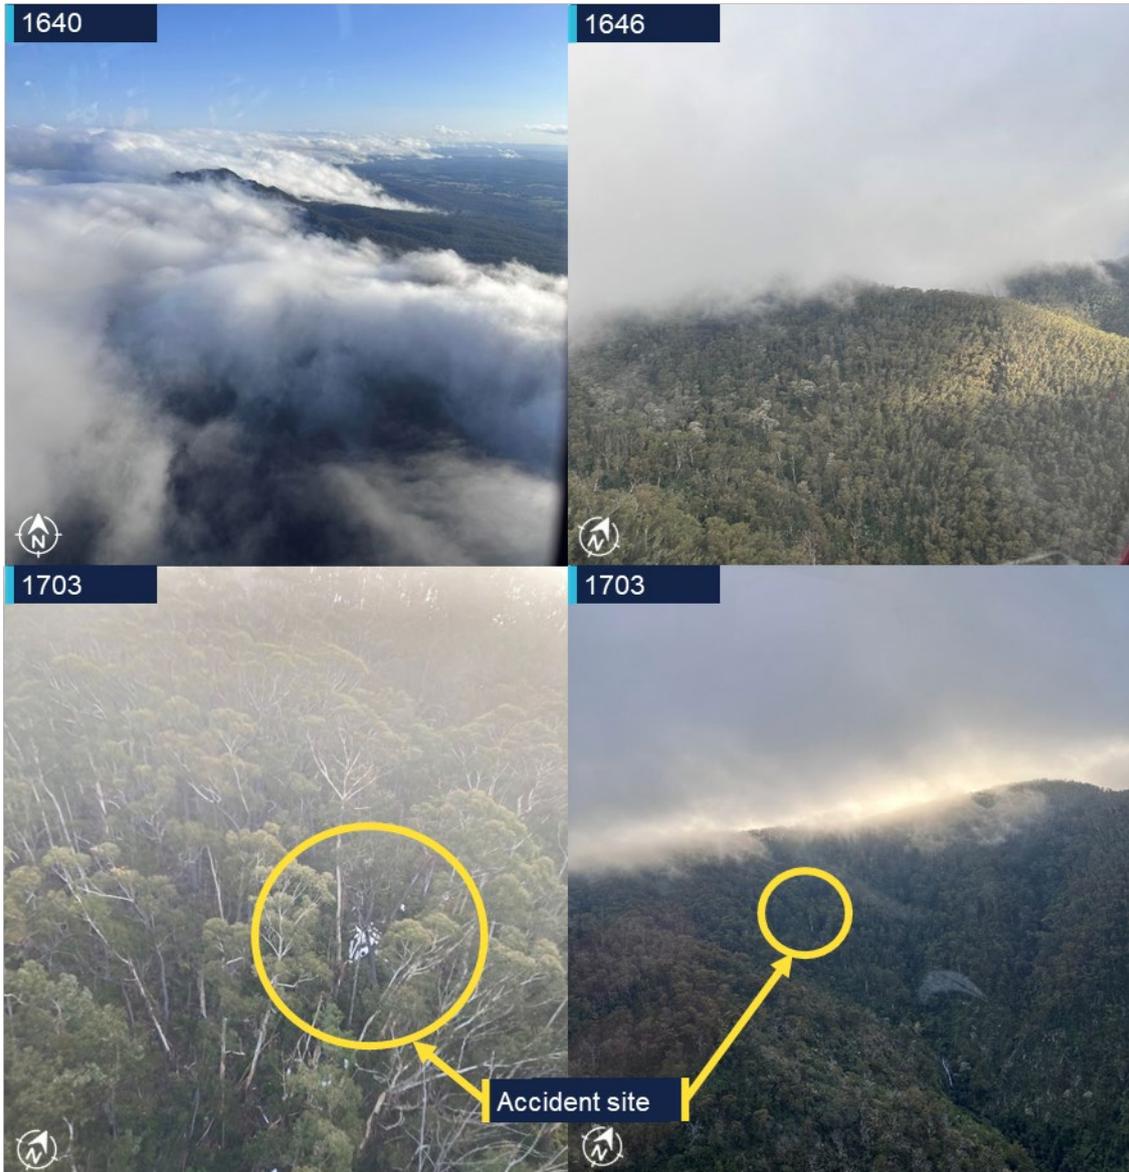
Figure 5: Cloud over the accident site between 1640 and 1703 local time

Top left and top right: cloud coverage to the north of the accident site. Bottom left: overhead the accident. Bottom right: view of the accident site and surrounding weather from the east.
Source: ACT Emergency Services Agency, annotated by the ATSB

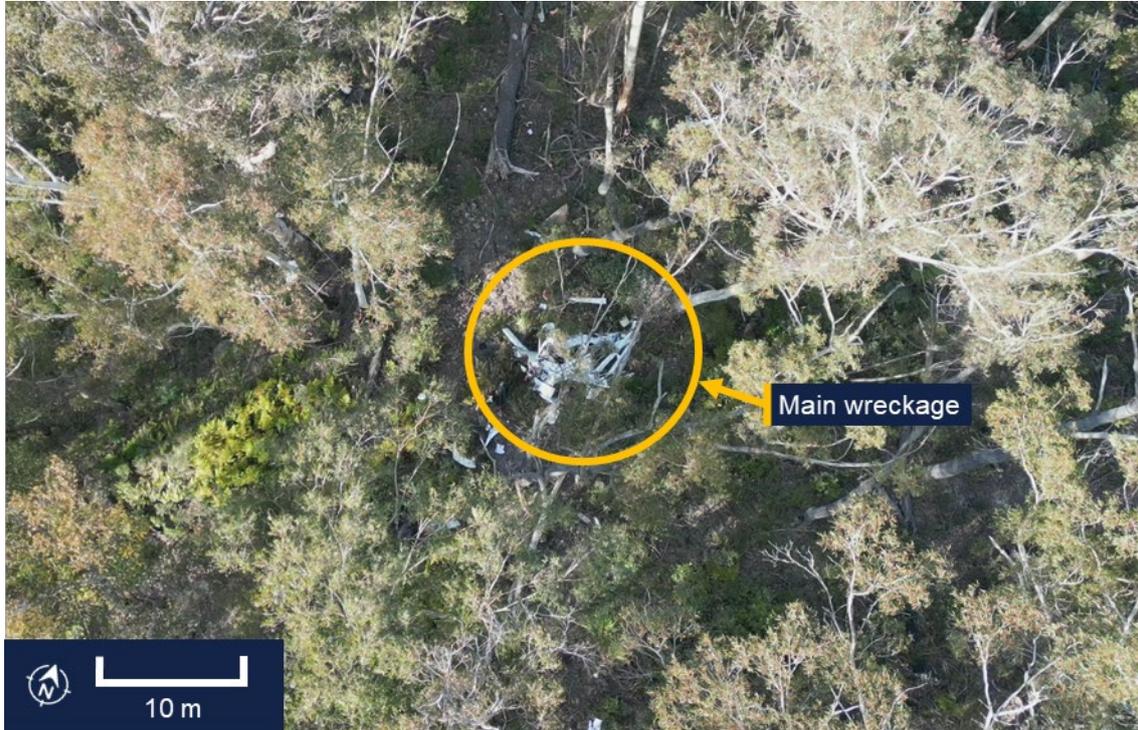
Figure 6: Overhead view of accident site

The aircraft wreckage was located in heavily vegetated, steep, mountainous terrain (Figure 6).

The ATSB conducted an examination of the accident site and wreckage on 21 September. The aircraft impacted the side of the mountain and slid backwards from the direction of travel until supported on the slope by some small trees. Ground impact marks and impact marks on the trees indicated the aircraft entered the trees with wings and fuselage almost level.

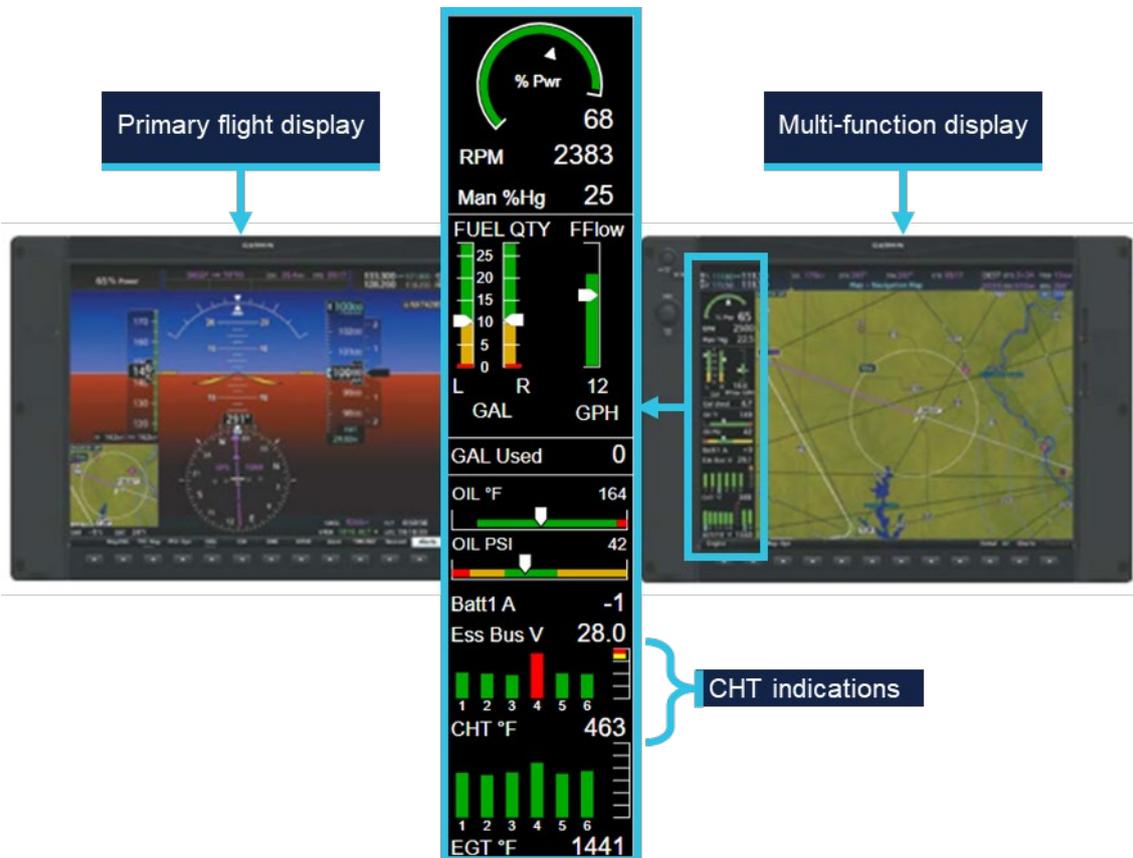
Figure 7: MFD engine indication system (EIS) panel, showing the vertical coloured bars indicating a CHT warning state for engine cylinder 4 temperature

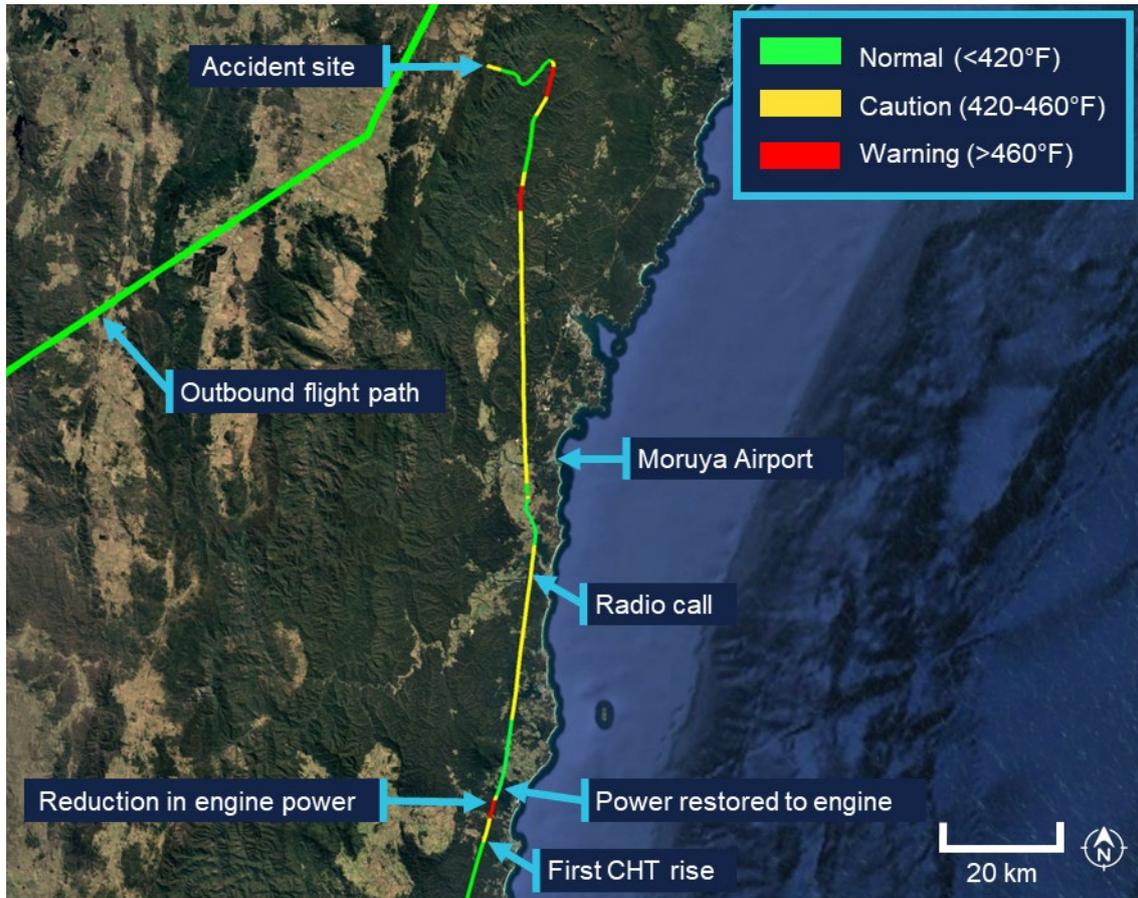
Figure 9: Number 4 cylinder head temperature readings throughout the last 1.5 hours of the flight

The ATSB compared the recorded CHT and exhaust gas temperature (EGT) data for cylinder 4 in order to determine whether the observed high CHT indications were consistent with an overheating cylinder or were more likely the result of a faulty CHT probe. In normal engine operation, a genuine rise in cylinder head temperature is typically accompanied by a corresponding rise in EGT for the affected cylinder, as both parameters respond to increased combustion temperatures and heat rejection. Conversely, a significant increase in indicated CHT with little or no corresponding change in EGT is characteristic of a failing or erratic CHT sensor.

The analysis indicated that the EGT for cylinder 4 remained relatively stable and within normal operating limits throughout the period when CHT repeatedly entered the yellow and red advisory ranges. This suggested that the anomalies were most likely caused by a faulty cylinder 4 CHT probe. The ATSB presented this information to Cirrus Aircraft which agreed that ‘the CHT sensor was giving faulty information as there were no other indications that there was an engine issue in the data.’

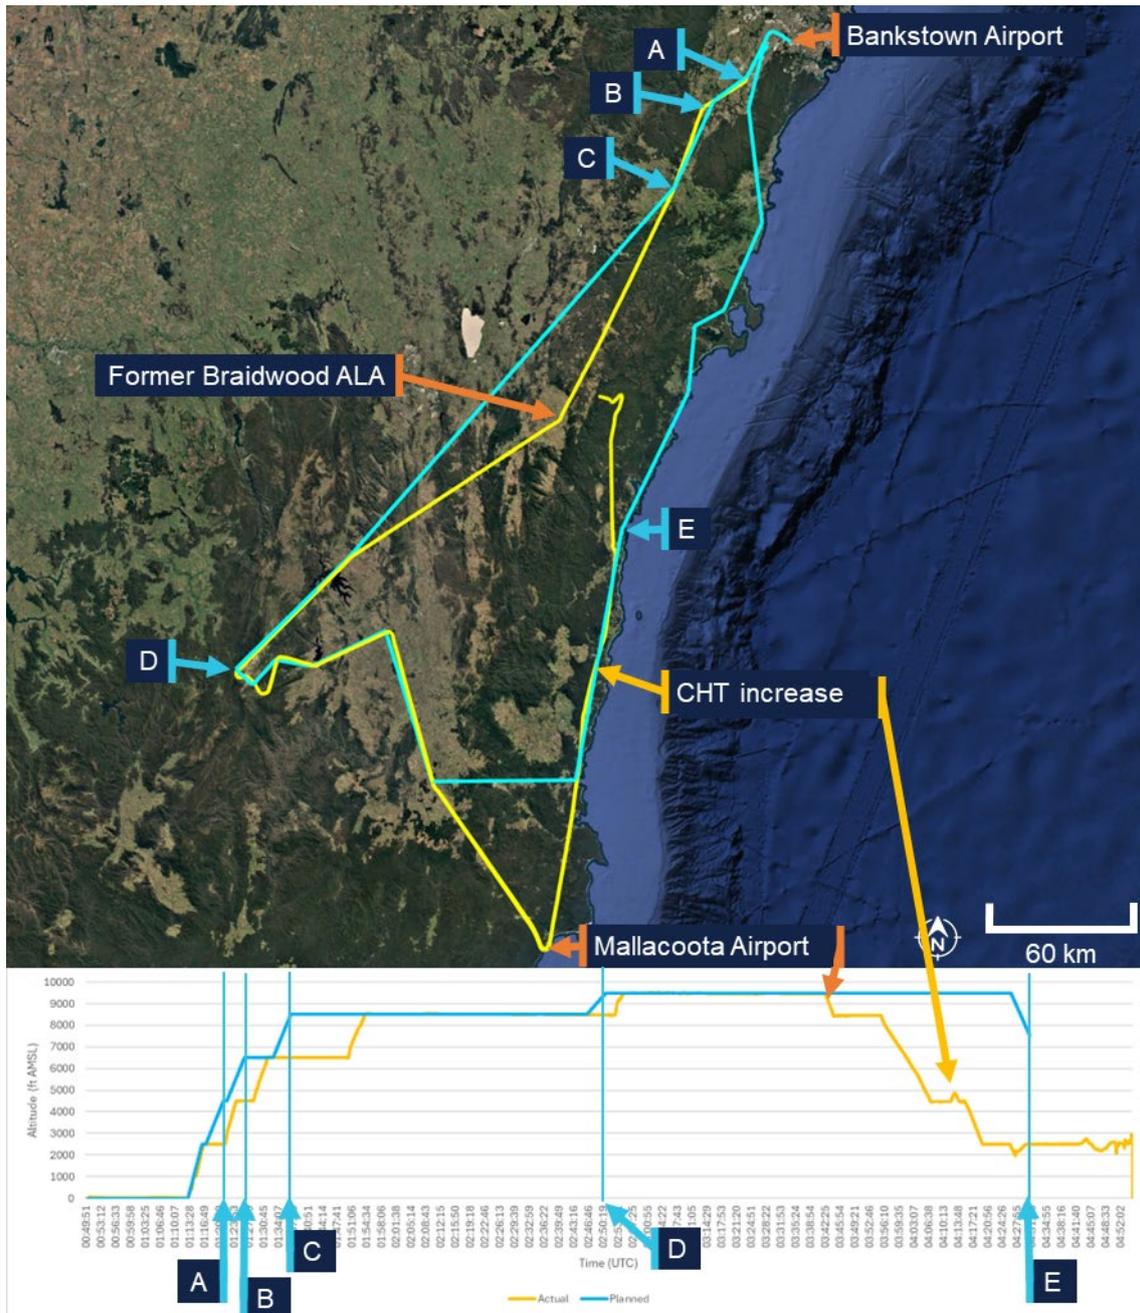
Figure 11: Planned flight (blue) comparison to actual flight (yellow)

A. Bankstown Airport; B. Campbelltown University waypoint; C. Picton waypoint; D. pilot chosen waypoint using lat/long; E. Moruya Airport.
Source: ATSB
