Collision between a truck and The Ghan passenger train

The Garden Road level crossing, 48 km north of Alice Springs, Northern Territory,
on 15 September 2024

ATSB Transport Safety Report
Rail Occurrence Investigation (Short)
RO-2024-005
Final – 12 February 2026

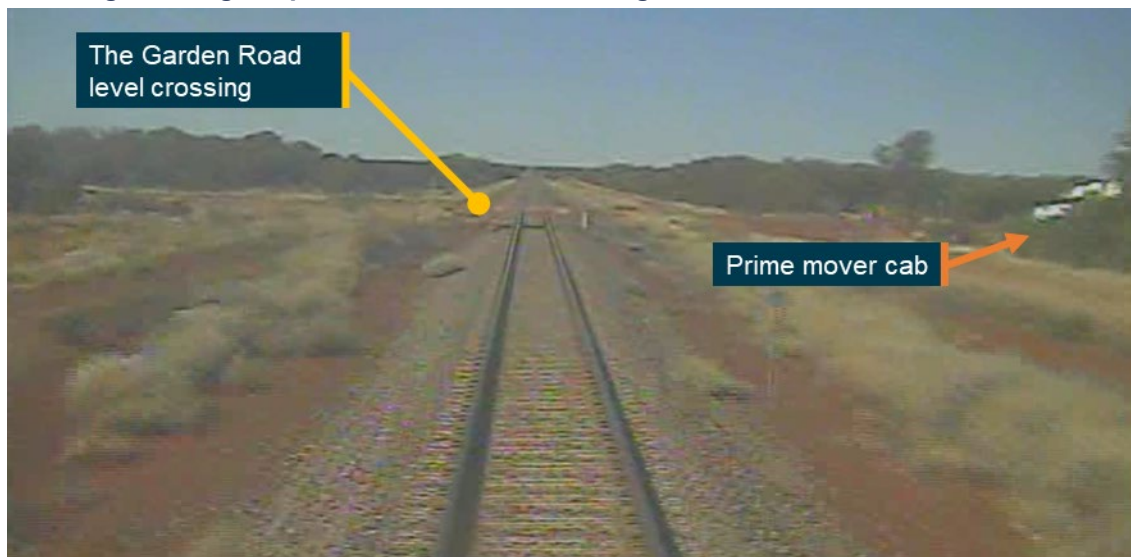
Figure 3: Field of view from the locomotive camera approximately 120 m from the level crossing showing the prime mover cab as it emerged

A video camera system fitted to the front of The Ghan's leading locomotive recorded the journey and at 0952:57 showed the truck appear from behind the vegetation. Audio from the recording identified that, at 0952:58, just prior to the level crossing, the driver briefly sounded the horn, and then at 0952:59, blasted it continuously as they travelled through. The truck did not stop and at 0953:02 the front end of the prime mover impacted the right rear bogie² of The Ghan's trailing locomotive.

*This image was obtained from the locomotive video camera as The Ghan travelled southward.
Source: Pacific National, annotated by the ATSB*

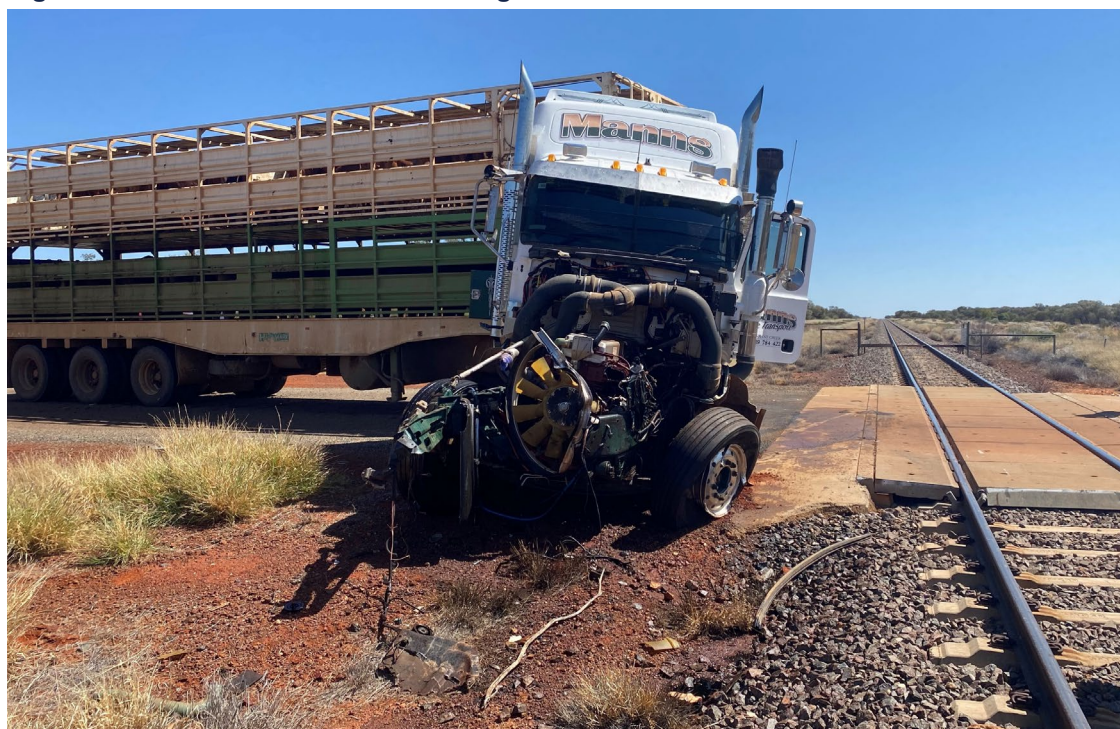
Figure 4: The truck at the level crossing after the collision

The prime mover of the truck came to rest on the field side of the track with engine bay components scattered along the rail corridor (Figure 4).

*View looking north along the Tarcoola–Darwin railway line from which The Ghan was travelling.
Source: Northern Territory Police*

The trailing locomotive sustained extensive damage to the air pipes, side ladder, and front cowling. The power van also received superficial body damage. There was no damage to the other carriages or the lead locomotive.

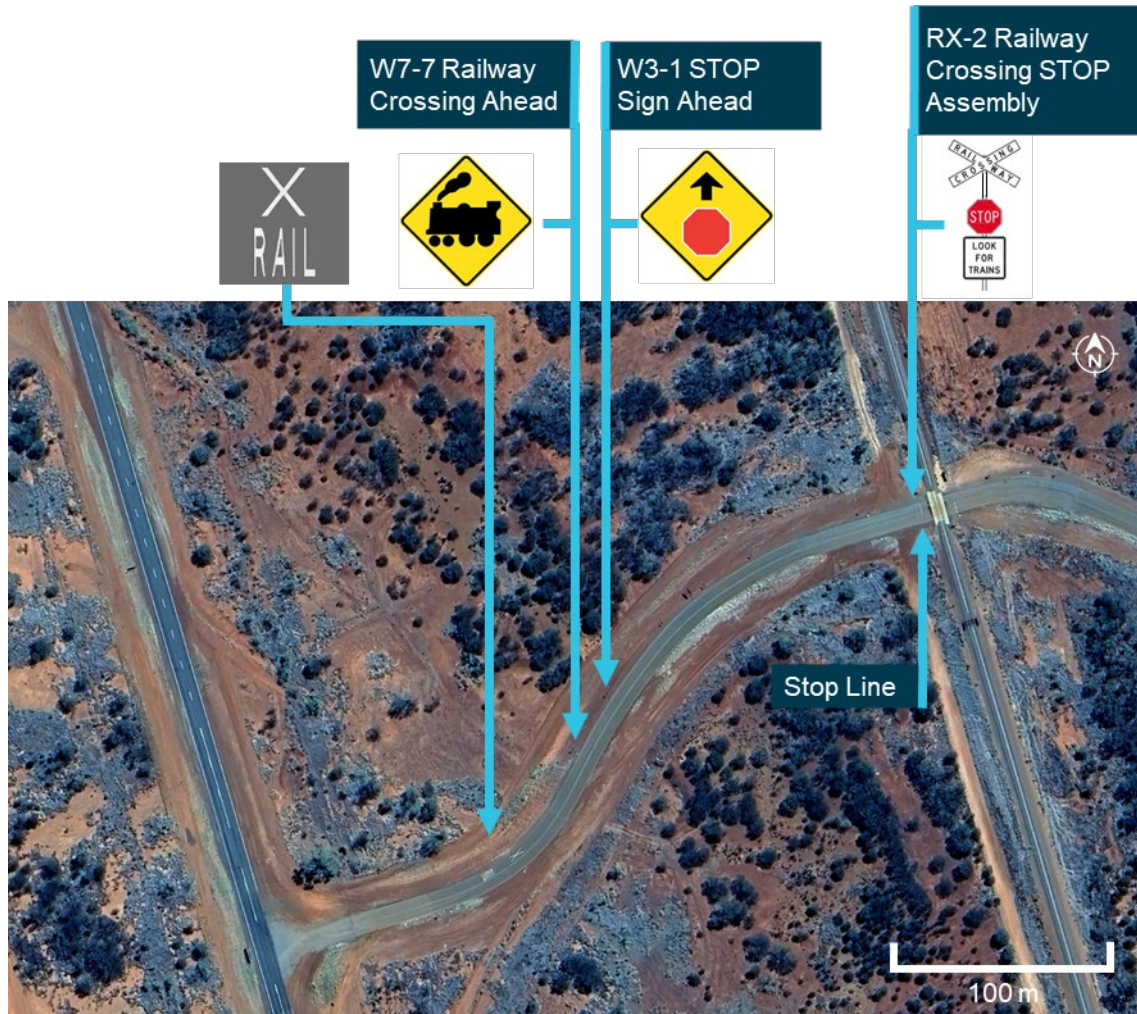
Figure 5: Location of the advance warnings and road markings near the level crossing

The 'RAIL' and 'X' painted road markings were positioned approximately 225 m from the level crossing and placed at the first curve of the S-bend. The advance warning sign 'Rail Crossing Ahead' (W7-7 L) was positioned about 190 m from the crossing, and the second sign in advance of the crossing was a 'STOP Sign Ahead' (W3-1) sign about 165 m from the crossing.

As the speed limit for The Garden Road was over 90 km/h, the Australian Standard required the W3-1 sign to be 180 m to 250 m before the stop sign at the crossing. The W7-7 'Rail Crossing Ahead' sign had to precede the W3-1 'Stop Sign Ahead' sign by a distance of 70 m due to the higher speed limit. The standard required the 'RAIL' and 'X' road marking to be placed between the W7-7 sign and W3-1 signs.

- Refreshment of the line marking and upgrading the approach signage at The Garden Road level crossing.
- Negotiation of a revised interface agreement with the rail infrastructure manager (RIM), which included a commitment from the RIM to install updated signage (R6-25 ‘Railway Crossing’) to meet current AS1742.7 standards at The Garden Road level crossing, and to progressively upgrade signage at other crossings when existing signs are due for replacement.
- Continuation of the Northern Territory Level Crossing Safety Working Group with the rail industry, infrastructure managers and local government.
- Continuation of level crossing assessments and line-of-sight improvements.

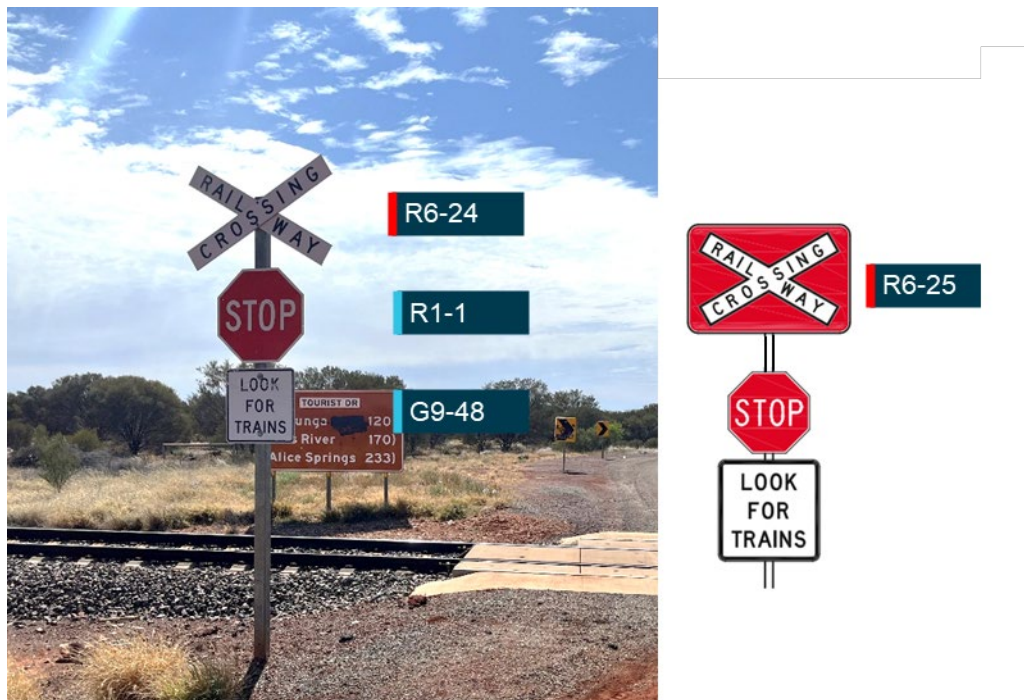
Figure 6: The railway crossing STOP (RX-2) sign assembly at the level crossing (left) when compared with the current Australian Standard requirements (right)

In 2007, the standard was changed to allow the use of either the R6-24 crossarms or the R6-25 sign (crossarms overlaid on a red background in Figure 6). It was also added that the R6-25 sign would be the preferred design on all new and refurbished RX-2 assemblies. A further update to the standard in 2016 removed the R6-24 crossarms as an approved component for new or upgraded crossings. As indicated within the

standard, the update was not intended to be retrospective and although the crossarms were outdated, they were compliant with AS1742.7 (2016).

At the time of the collision, the stop sign assemblies on both sides of The Garden Road level crossing still had the R6-24 crossarms rather than the R6-25 sign.

The interface agreement was revised and renegotiated with the rail infrastructure manager. They further advised that the rail infrastructure manager had committed to install updated signage (R6-25 'Railway Crossing') to meet the current standards at The Garden Road level crossing, and to progressively upgrade signage at other crossings when existing signs were due for replacement.

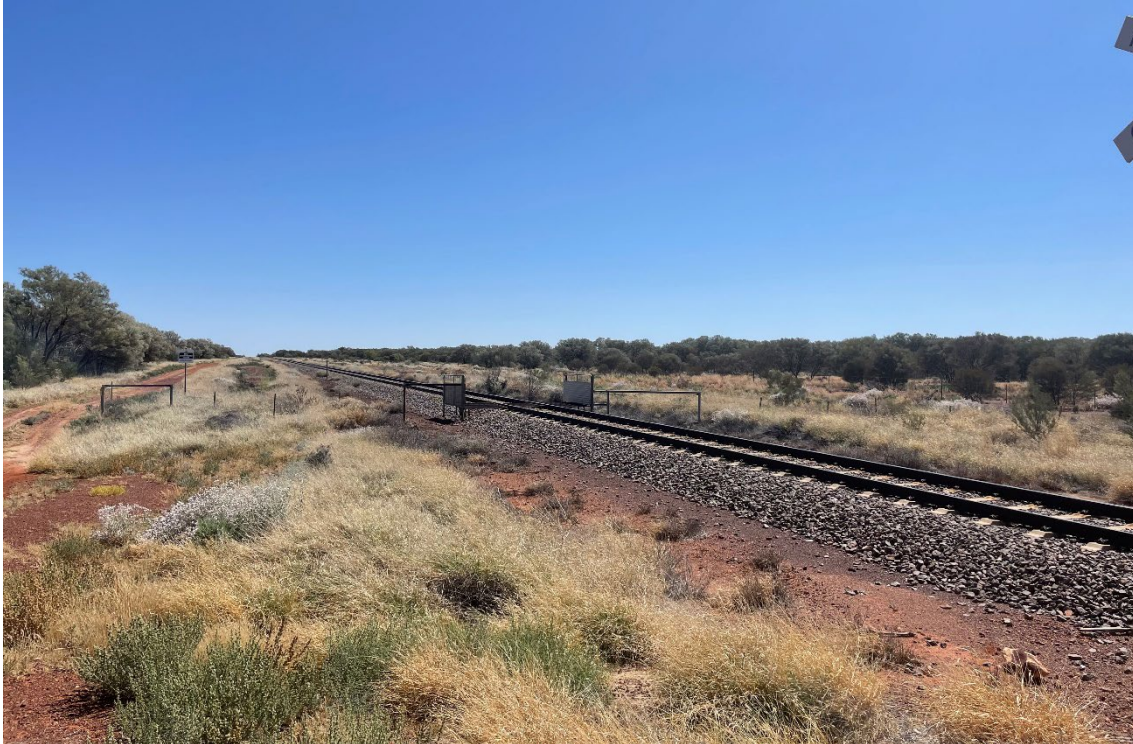
Figure 7: View looking north along the rail corridor from the stop line at the level crossing

The truck driver estimated that the sighting distance when looking north from the stop line along the track was 300–400 m. The Ghan driver also identified that vegetation obscured their view of road traffic when approaching the level crossing. However, they also added that, while the vegetation obscured sightlines in advance of the crossing, the crossing itself could be seen from a considerable distance away and that the clearance of the trees away from the track was ‘quite reasonable’.

Survey data within the Australian Level Crossing Assessment Model (ALCAM) report from May 2024 of The Garden Road level crossing identified that, when stopped at the stop line on the western side of the level crossing, the sighting distance when looking north along the rail corridor was 1,563 m. The view looking north from the level crossing stop line is shown at Figure 7. The sighting distance was 1,903 m when looking to the south. The sighting distance from the eastern side of the crossing in both directions was unlimited.

At a line speed limit of 115 km/h, the ATSB calculated that trains approaching from the north would become visible from the western stop line 49 seconds before the train reached the level crossing. This increased to 60 seconds for trains approaching from the south. For road users stopped at the stop line on the eastern side, there were no time limitations when approaching trains would become visible. Although the road speed limit for The Garden Road was 100 km/h, the ALCAM report identified that the average

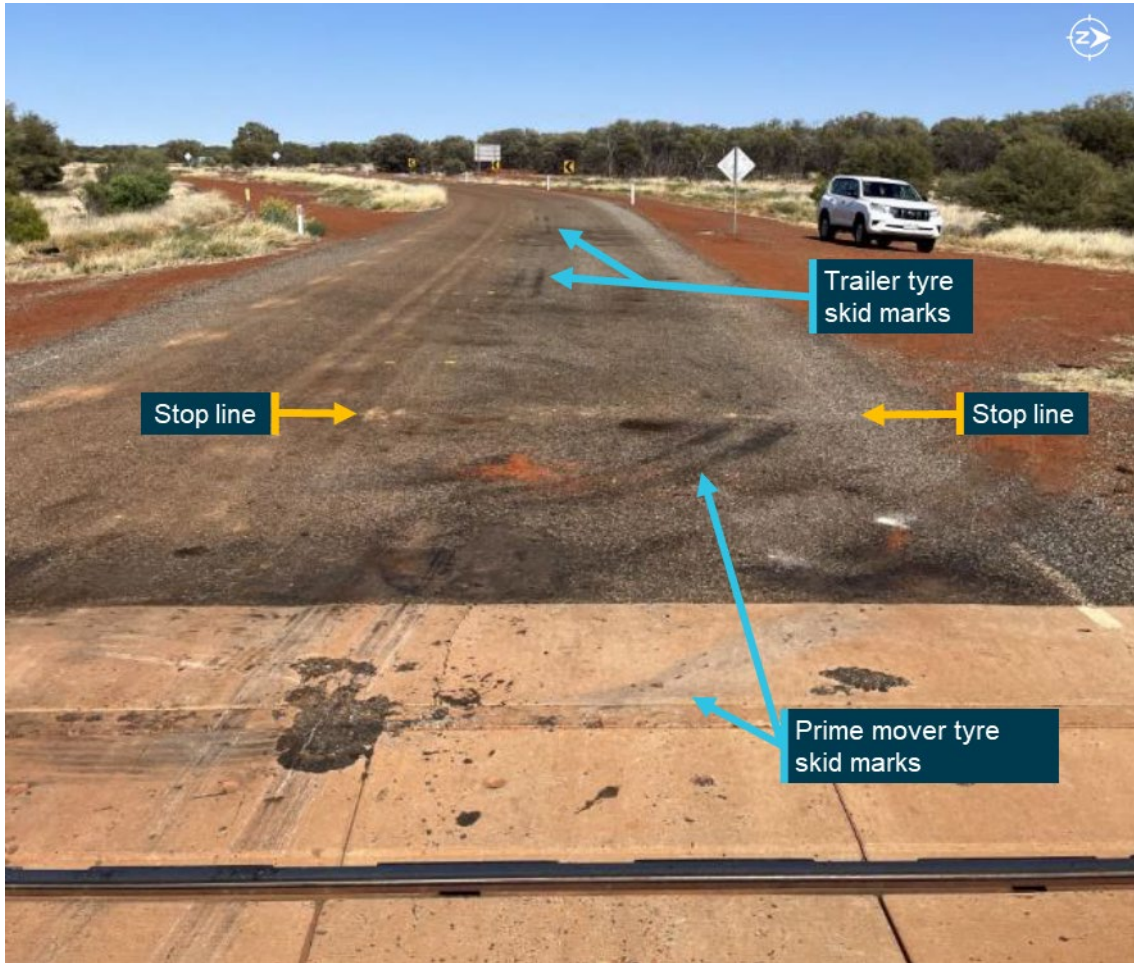
Figure 8: Faded stop line at the level crossing with skid marks evident from the emergency braking of the truck

In their examination of the truck, Northern Territory Police identified tyre skid marks from the prime mover and trailers on the road surface that each extended for approximately 2–3 m immediately leading to the crossing. Tyre defects were identified to all 3 trailers, which included several bald tyres and one shredded tyre.

The faded stop line is shown at Figure 8 and this was reportedly due to the effects of road resurfacing.
