Australian Government
Australian Transport Safety Bureau

Collision with terrain following an engine power loss involving Cessna 172M, VH-WTQ

12 NM (22 km) north-west of Agnes Water, Queensland | 10 January 2017

ATSB Transport Safety Report
Aviation Occurrence Investigation
AO-2017-005
Final – 17 October 2019

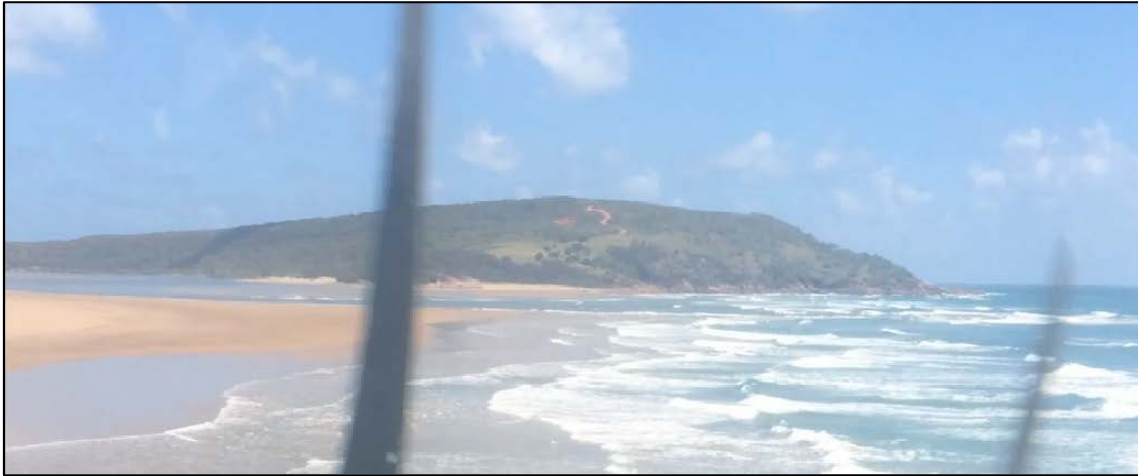
Figure 3: A still image taken from the video footage at the time of engine power loss (1037:34)

The video footage indicated that, at 1037:34, the engine sustained a sudden power loss. At the time of the power loss, the aircraft was above the water and close to the beach abeam the landing area. The aircraft was at about 60 ft (see *GPS information*) and had a groundspeed of about 124 kt (about 230 km/h). Figure 3 provides a still image from the video footage of the view outside the aircraft at the time of the engine power loss.

The image shows Bustard Head in the background (to the north). The vertical, black areas are the propeller blades captured by the video footage. Source: Queensland Police Service.

The pilot stated that, just prior to the power loss, he had pulled back the throttle slightly. He recalled that as soon as he did this the engine suddenly stopped, and he realised that there had been a total power loss. He later described the power loss as being similar to the mixture control being pulled back.

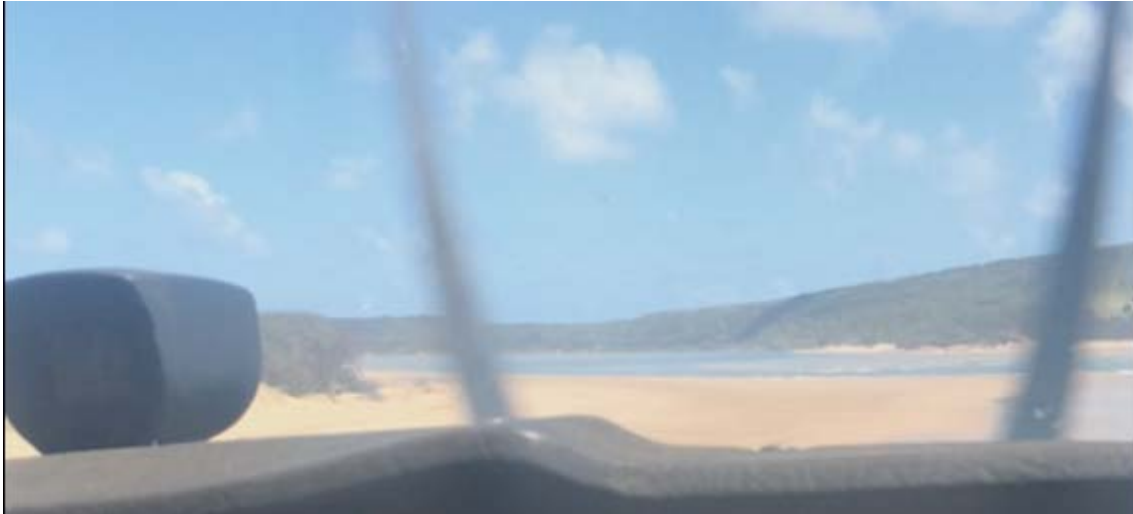
Figure 4: A still image taken from the video footage 2 seconds after engine power loss (1037:36)

Figure 4 shows the view of the remaining landing area at 1037:36, 2 seconds after the engine power loss. This shows an area of beach visible ahead, but does not show a further area of beach that was available for an emergency landing around a bend to the left (see Figure 2 and *Beach available for an emergency landing north of the landing area*).

At the time this image was taken the phone camera was oriented to the left of the aircraft's heading. The image shows an area of sand on Middle Island beach, just prior to a bend to the left with further beach beyond. Source: Queensland Police Service.

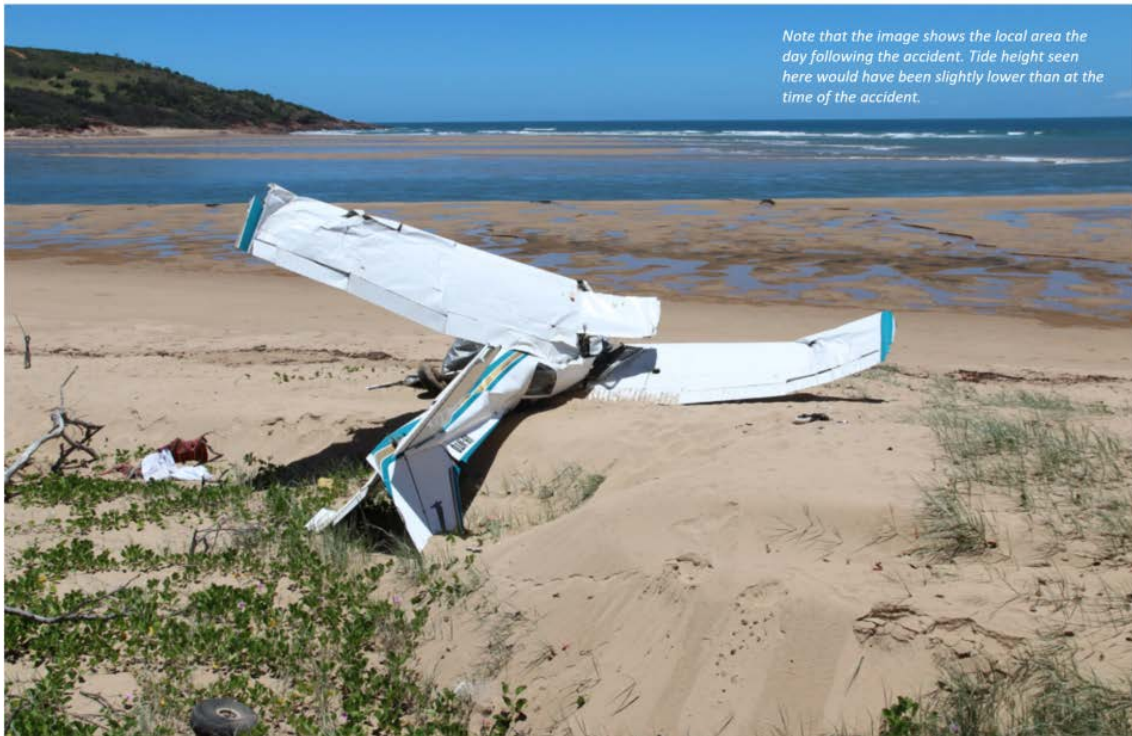
Figure 5: Accident site, facing north-east with Bustard Head in the background

One of the rear-seat passengers was fatally injured and the other three occupants sustained serious injuries during the impact. The aircraft was destroyed. Figure 5 shows the aircraft wreckage (see also *Wreckage and impact information*).

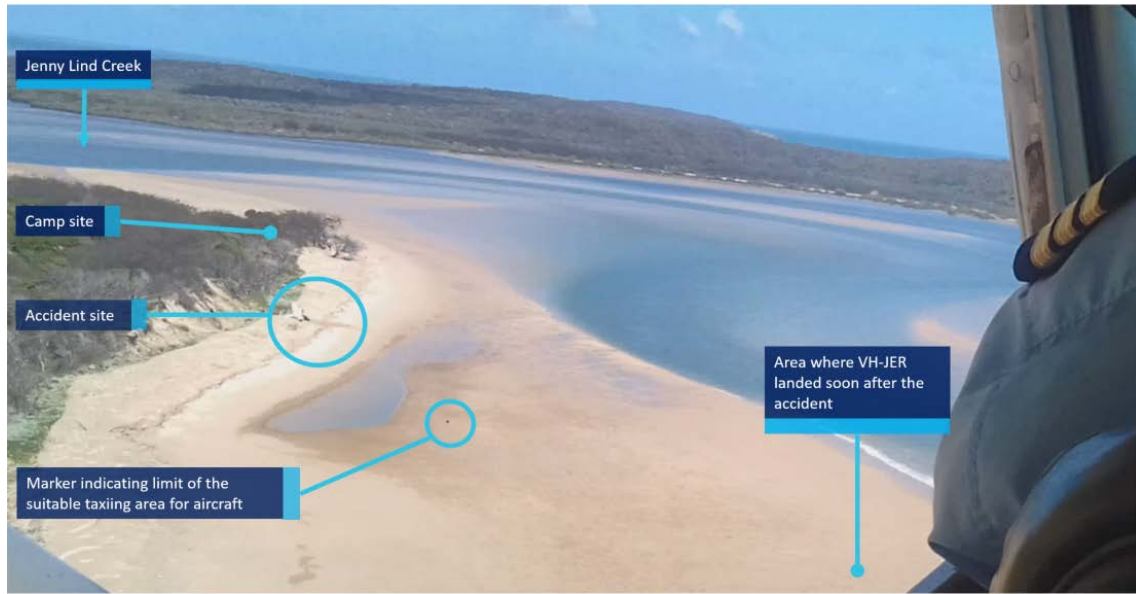
Figure 6: Accident site, as viewed from VH-JER

Following the impact, the aircraft cabin was inverted and the occupants were all held in place by their restraints. A significant amount of fuel was observed to be leaking from the aircraft's fuel tanks. The camp site employee, the chief pilot and other first responders extracted the occupants and moved them away from the wreckage to provide first aid. One of the rear-seat passengers was unresponsive, so the first responders provided cardiopulmonary resuscitation (CPR) but she could not be revived. A subsequent post-mortem examination determined that her injuries were not survivable (see also *Occupant injuries*).

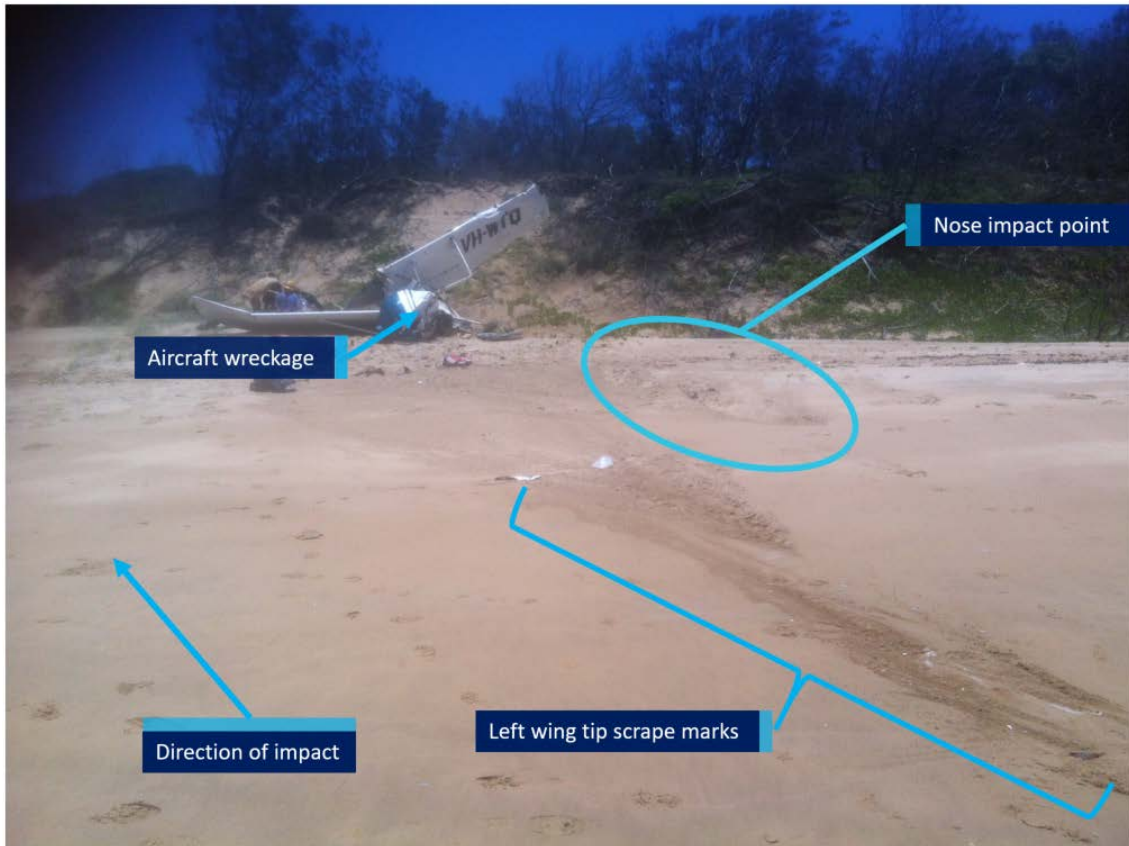
Figure 8: VH-WTQ accident site showing impact marks

The distance between the nose impact point and the main wreckage was about 5 m on a magnetic bearing of 210°. The wreckage distribution and distance from the impact point indicated that the aircraft impacted terrain in a significant nose-down and left-wing low attitude. The aircraft came to rest facing in the opposite direction to flight.

This image also shows the sand dunes behind the beach, in the direction where the aircraft was headed prior to impact.
 Source: Wyndham Aviation chief pilot.

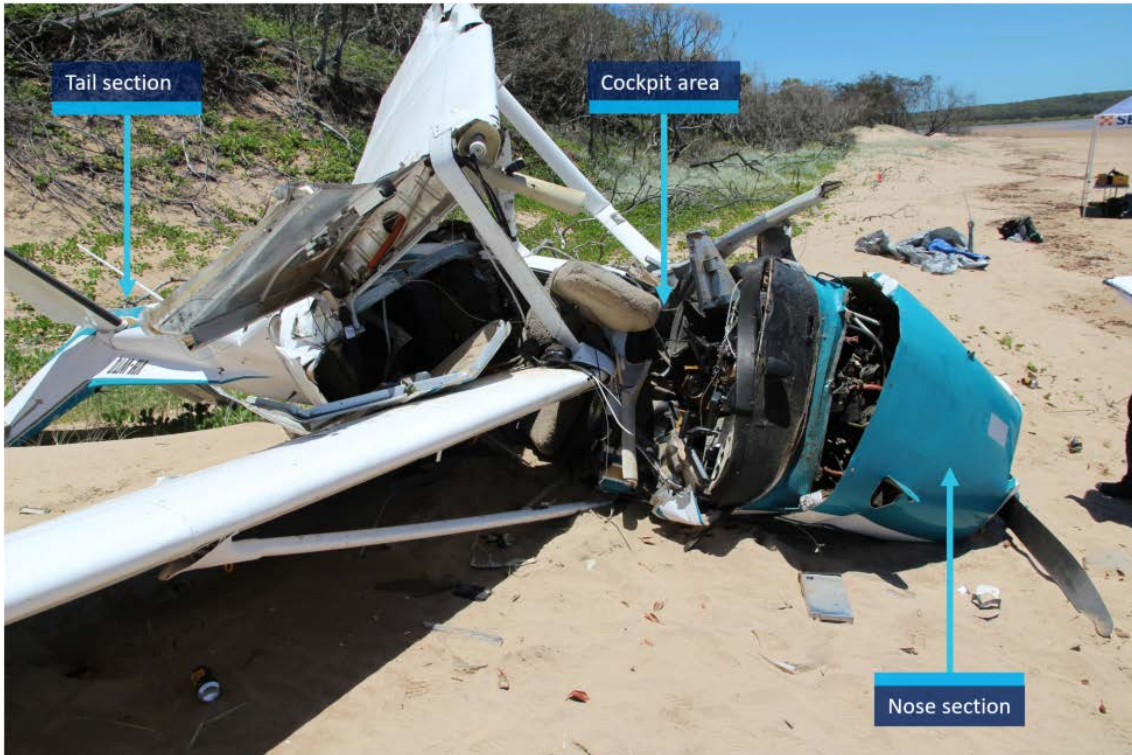
Figure 9: VH-WTQ aircraft wreckage viewed from the right

The aircraft was significantly disrupted by ground impact forces. The main fuselage structure had fractured at the rear of the engine firewall and just aft of the rear passenger seats. The cabin area was twisted and compressed and both wings had separated from the fuselage structure at the wing root (Figure 9).

The aircraft structure was examined for pre-impact defects, with none identified. All of the aircraft and its components were accounted for at the accident site. There was no indication of any fire.

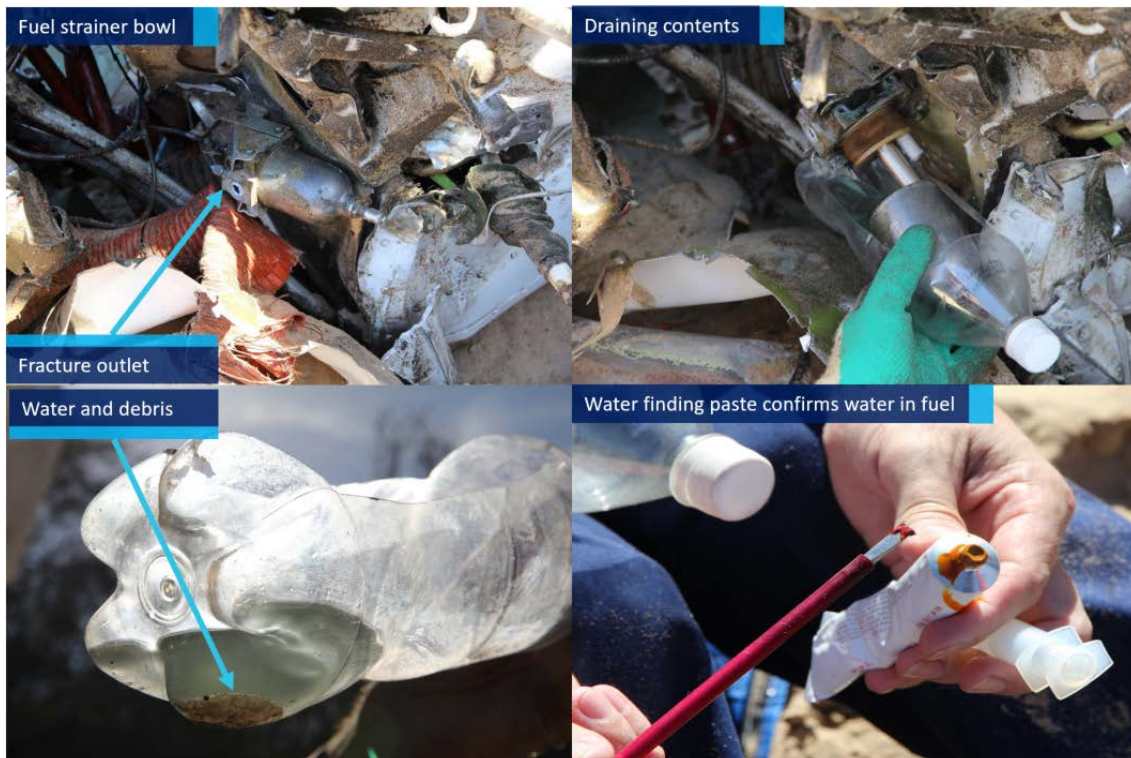
Figure 10: Fuel strainer bowl and contents showing signs of water and debris

- The fuel strainer filter was removed and examined. A small amount of debris was found in the inlet side of the filter. The amount and type of debris was not considered to be excessive or abnormal.

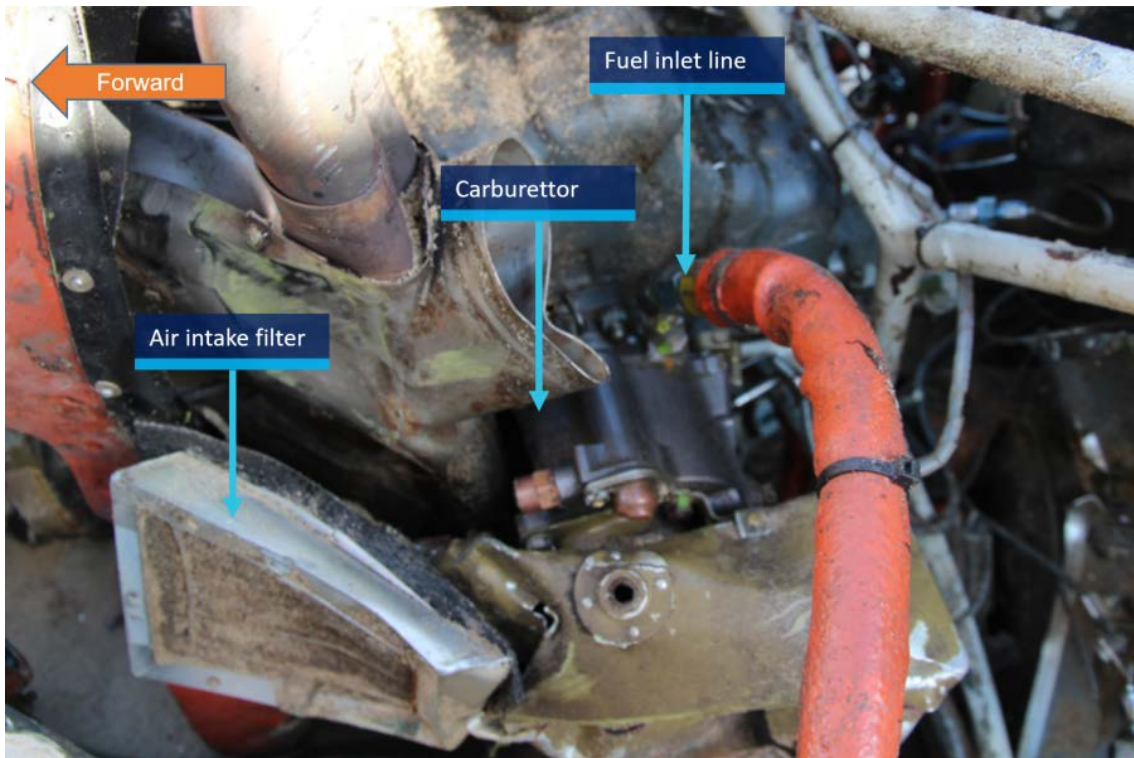
Figure 11: Carburettor and air intake assembly

The carburettor was oriented about 80° on its right side with the fuel inlet facing upwards. It was removed from the engine and inspected, with no defects noted.

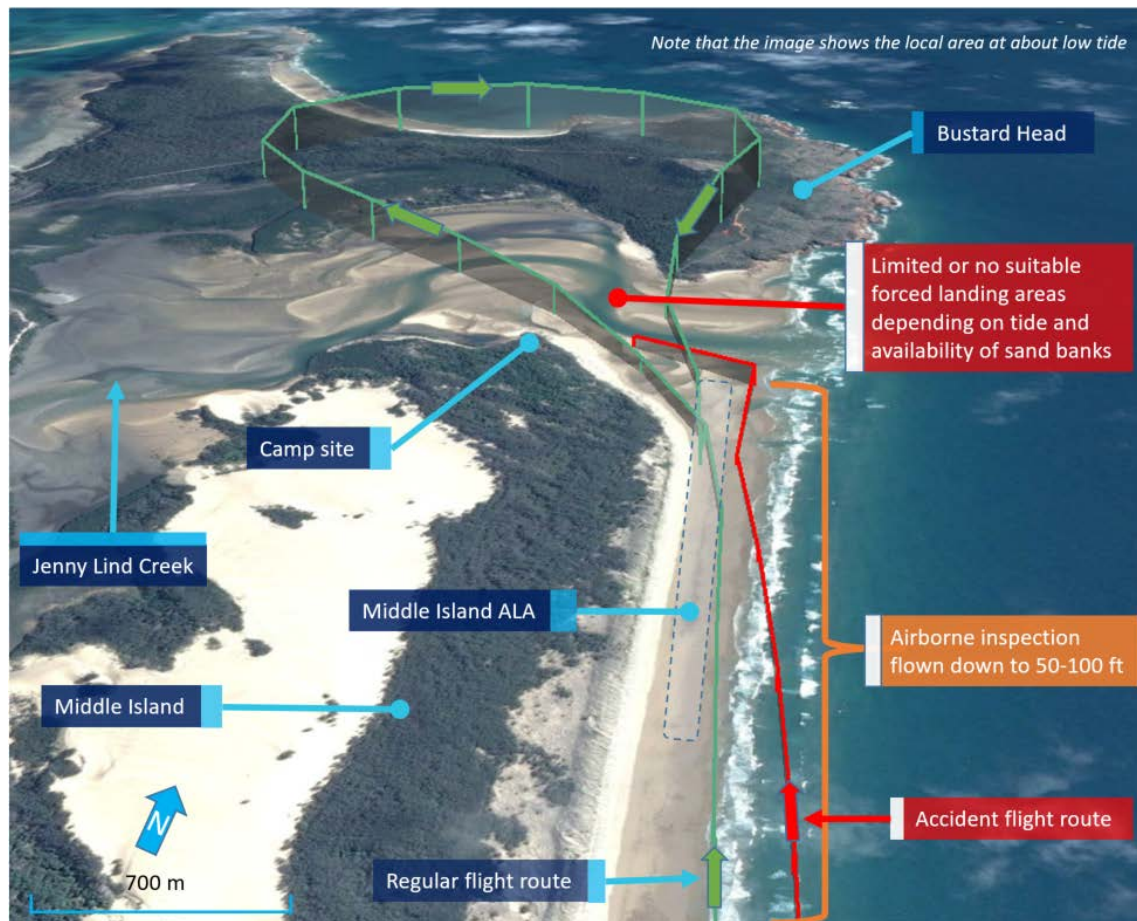
Figure 21: VH-WTQ GPS-derived regular flight path for an airborne inspection on the southerly beach landing area (green line)

In general, the aircraft passed within 300 m to the east of the lighthouse (which had a focal height of 336 ft) on Bustard Head during the approach to landing, often at an altitude of about 450–500 ft AMSL, passing directly over terrain which was up to 280 ft AMSL. In a small number of cases, the right turn over Jenny Lind Creek was completed to the west of Bustard Head, with the aircraft reaching an altitude of 350–600 ft prior to the approach.

In all cases, there was a significant segment of the airborne inspection and climb out that had no suitable forced landing areas in the event of an aircraft emergency such as an engine power loss (Figure 21 and Figure 22). In none of the cases was a standard (four-leg) circuit pattern flown after the inspection.

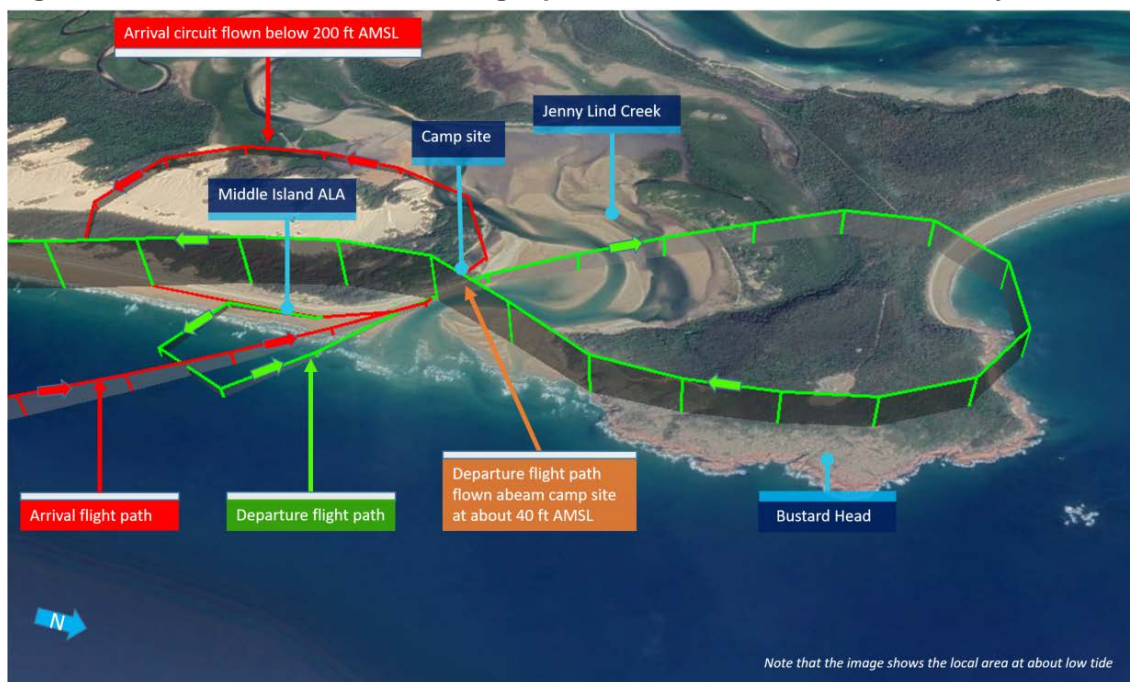
Figure 26: Additional observed GPS flight paths flown in VH-WTQ on 1 January 2017

In summary, there were several flights in VH-WTQ during the period from 12 November 2016 to 4 January 2017 at Middle Island where turns were conducted at less than 200 ft after take-off, including some flights over water. In addition, a number of flights involved segments where, if there was an engine failure, a forced landing on to water or hazardous terrain could not have been avoided. It was also relatively common practice to conduct manoeuvring below 500 ft AGL prior to being established on final approach.

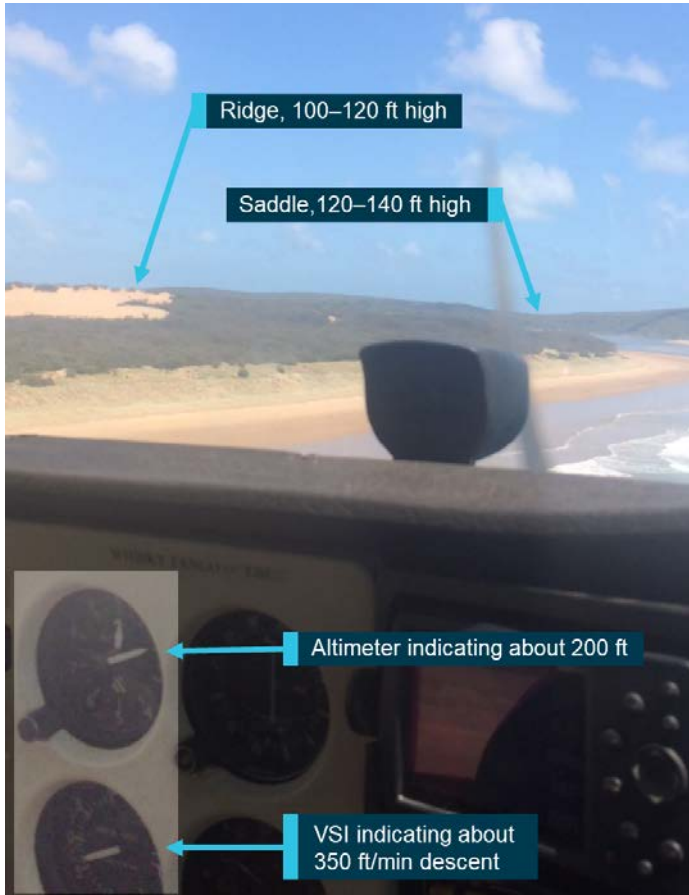
Figure B3: Still image from mobile phone video at 1037:26 (altimeter enhanced)

The image shows nearby terrain features: a ridge 100–120 ft high on nearby Middle Island, and a distant saddle 120–140 ft high. An enhanced section of the image shows the altimeter indication at that point, which is about 200 ft and the vertical speed indicator (VSI) showing a 350 ft/min descent.

With regard to the altimeter indications in the video footage, the last view of the altimeter prior to the engine power loss occurred at 1037:26, when the altimeter indicated about 200 ft (Figure B3). This was significantly higher than the recorded GPS data at the same time (120 ft), and also higher than the transponder altitude and the altitude indicated by an analysis of terrain features in the video footage at the same time.

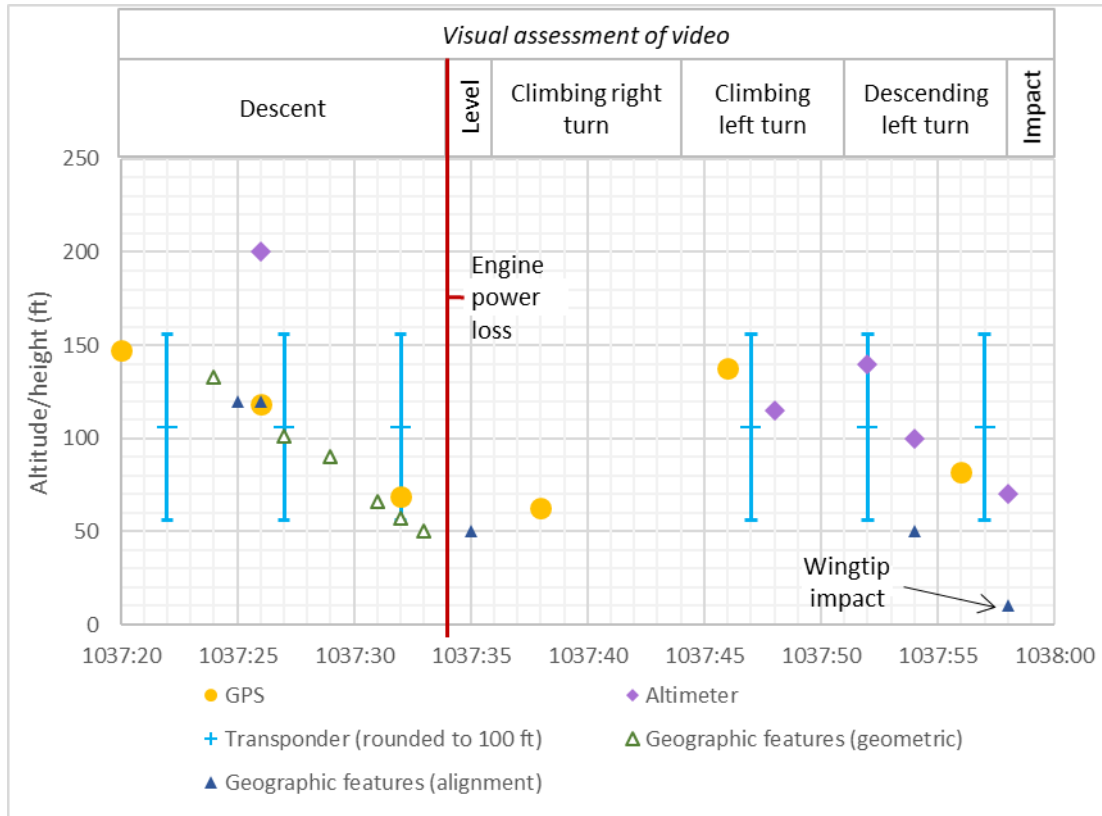
Figure B5: Summary of information about the aircraft’s altitude from 1037:20 until impact

The GPS altitude and the altimeter both appeared to be higher than the aircraft’s actual altitude in the last 10 seconds of flight (after the engine power loss). This is consistent with the GPS’s reduced accuracy in manoeuvring flight, and possibly with the altimeter being affected by sideslip during that period.
