Australian Government  
Australian Transport Safety Bureau

# Aviation Short Investigations Bulletin

Issue 40

**ATSB Transport Safety Report**  
Aviation Short Investigations  
AB-2015-034  
Final – 22 April 2015

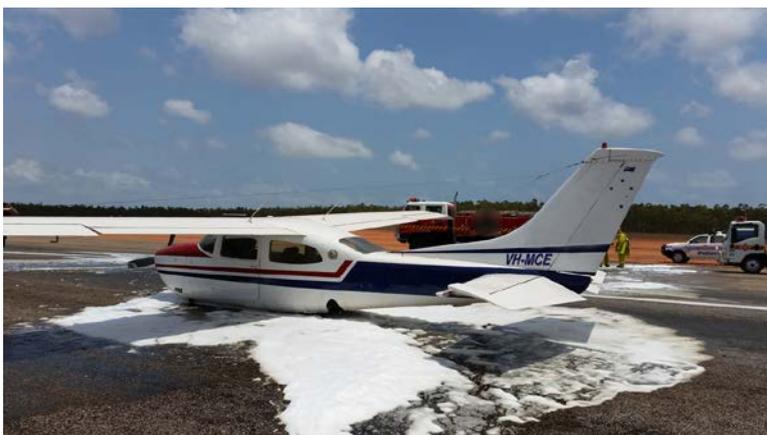
**Figure 1: Wheels-up landing**

The aircraft landed just beyond the threshold and on the centreline of runway 31 with the wheels retracted. When the pilot realised the wheels were retracted, he immediately selected the fuel to OFF. The aircraft sustained substantial damage and the pilot and passengers were uninjured (Figure 1).

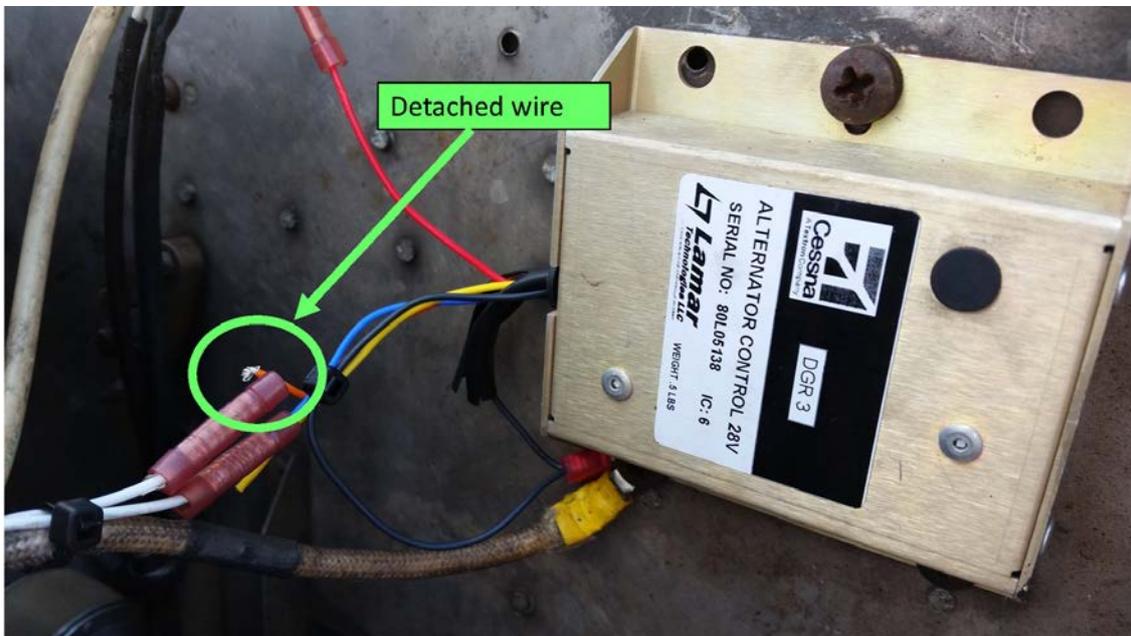
Figure 2: Detached alternator wire

A detached electrical cable was found to have caused the alternator to stop charging the battery (Figure 2). The engine had not been inspected before the completion of the ATSB report and the cause of the engine issues were unknown.

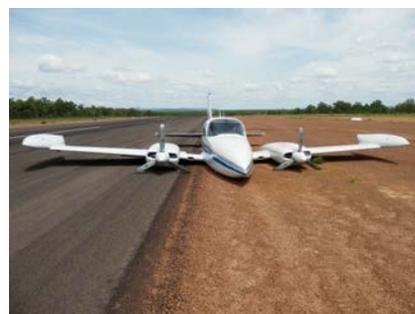
VH-TBE on side of runway

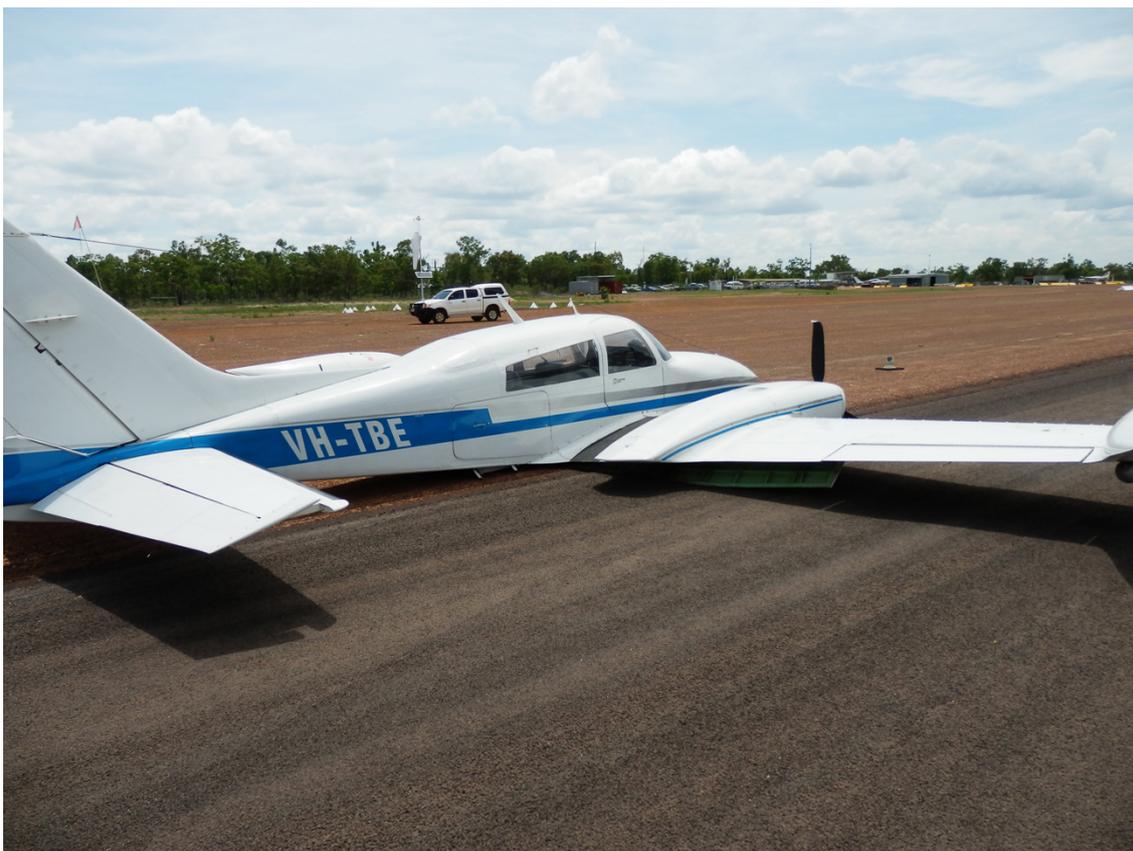
**Figure 1: VH-TBE damage**

The pilot flared the aircraft in preparation for landing. He became aware that the undercarriage remained retracted when TBE touched down on the runway centreline and he heard the propellers contacting the ground.

Mindful there was an aircraft in the circuit behind him, he used the remaining rudder effectiveness to move the aircraft slightly to the left of the runway. When the aircraft came to a stop, he checked on the welfare of his passengers and opened the door for them to exit, directing them to assemble in a safe area. After completing shutting down, he also exited the aircraft. There were no injuries to either the pilot or passengers; however, the aircraft was substantially damaged.

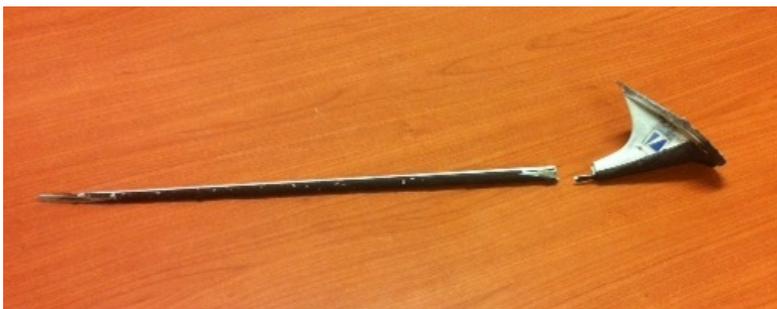
**Figure 1: Broken antenna**

As the pilot ICUS commenced the go-around, a VHF antenna fitted to the underside of the aircraft fuselage contacted the runway and both pilots heard a scraping sound. The pilots broadcast 'going around' and did not receive a response. After a second call to ATC also did not elicit a response, the supervising pilot selected the second VHF radio (COMM2) and was then able to communicate with ATC. When at about 50 ft above ground level (AGL), the pilot ICUS observed the landing gear lever in the UP position, and was then unsure whether he had omitted to select the landing gear DOWN during the pre-landing checks, or whether a technical fault had occurred.

The VHF antenna was found on the runway, having broken off from the underside of the aircraft after striking the runway (Figures 1 and 2). Two aerodynamic fins also sustained minor scrapes from the runway. The pilots and passengers were uninjured in the occurrence and a subsequent engineering inspection found that the landing gear warning horn was serviceable.

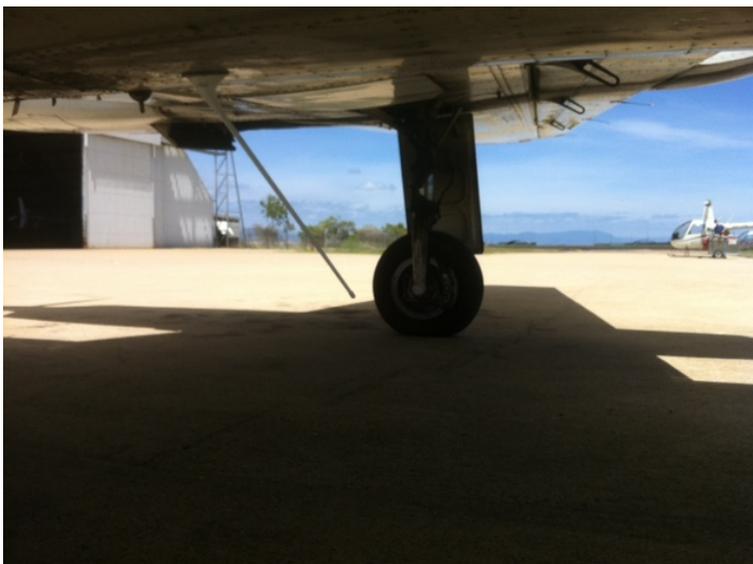
**Figure 2: Photo of new antenna fitted to VH-TXK**

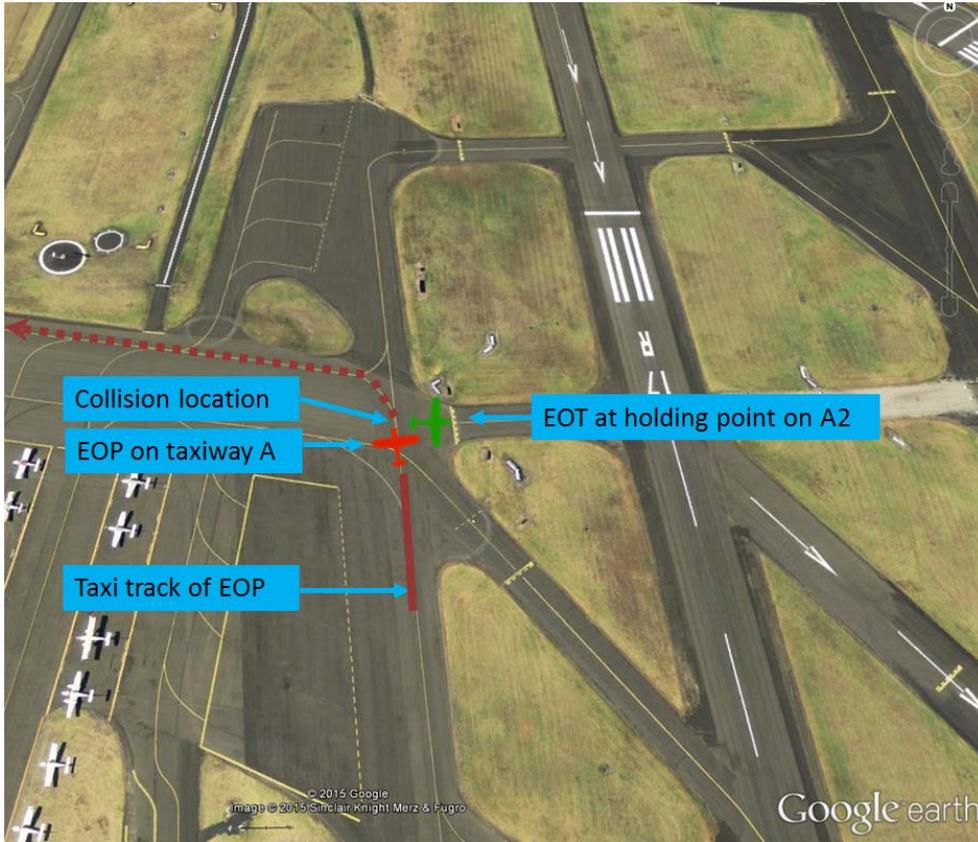
**Figure 2: Moorabbin Airport, EOP taxi route and location of EOT**

As EOP passed the 'A2' taxiway, the right wingtip struck the rudder of another Cessna 172S aircraft, registered VH-EOT, which was stationary at the holding point for runway 13 Right (13R) on the 'A2' taxiway, and less than half a metre behind the marked holding line (Figure 2). The student pilot of EOP was unaware of the collision and continued to taxi to the holding point for runway 13L. A flight instructor on board EOT advised ATC of the collision and the controller directed the pilot of EOP to taxi back to the run-up bay. He was then advised of the collision and the instructor of EOT inspected both aircraft for damage. EOP was undamaged and EOT sustained minor damage to the rudder.

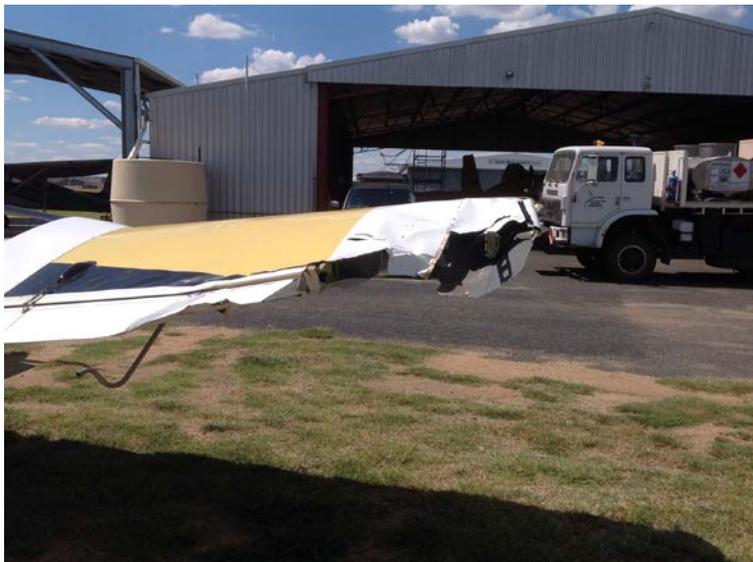
**Figure 2: Damage to VH-AGZ**

As KXT landed, the pilot observed the loader truck near the fence, which was not the normal loading position. He was momentarily distracted, as he became concerned that the truck had broken down. The loader driver had observed both aircraft approaching on different runways and had moved to a position from which he could load whichever aircraft arrived first. AGZ was in the landing roll on runway 24, and about 50 m from the loader truck when the pilot sighted KXT about 10 m from his right wing. KXT was then in the landing roll on runway 19 and the pilot of KXT returned his gaze from the loader to the front of the aircraft, just as the propeller collided with the right wingtip and then the tail of AGZ (Figure 2).

Both aircraft sustained substantial damage and the pilots were not injured.

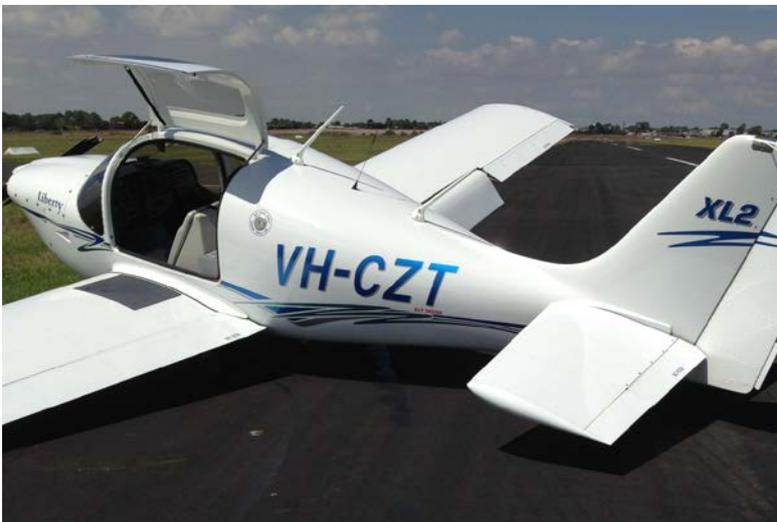
**Figure 1: Damage to VH-CZT**

During the accident sequence, the main landing gear collapsed and the propeller and left wingtip struck the runway, resulting in substantial damage (Figure 1). The pilot was not injured.

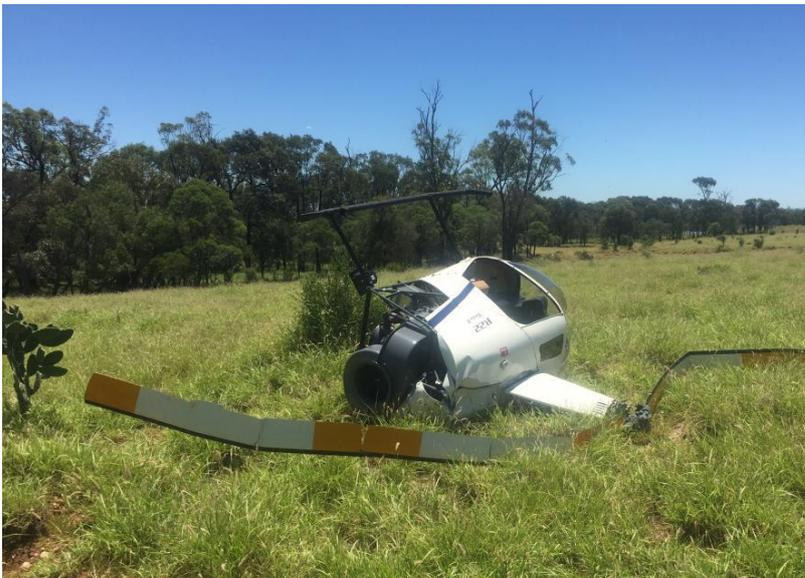
**Figure 1: Damage to VH-SSD**

The pilot then ensured the skids were level and the helicopter collided with the ground. Due to the rough surface, the helicopter bounced into the air. The pilot pulled back on the cyclic<sup>2</sup> control, which resulted in the tail of the helicopter being chopped off by the main rotor. The helicopter then spun around and came to rest on its side (Figure 1). The helicopter was substantially damaged and the pilot was uninjured.

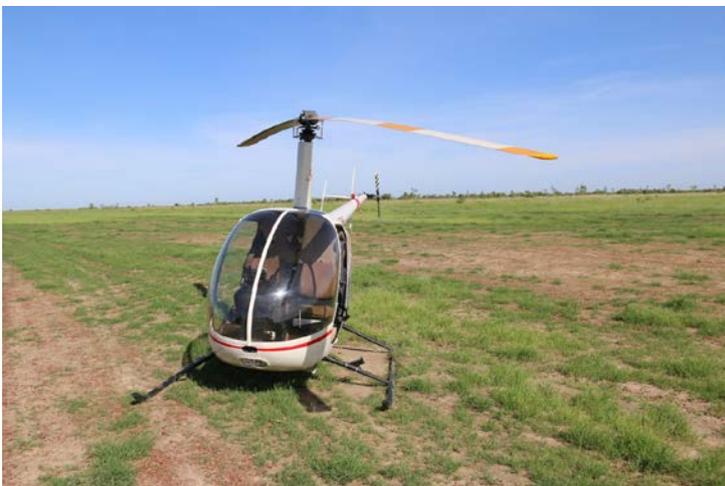
**Figure 1: Damage to VH-ZBH**

The helicopter was substantially damaged due to the impact on the skids, and the pilot and passenger were uninjured.

A post-accident engineering inspection did not reveal any cause of the engine loss of power.

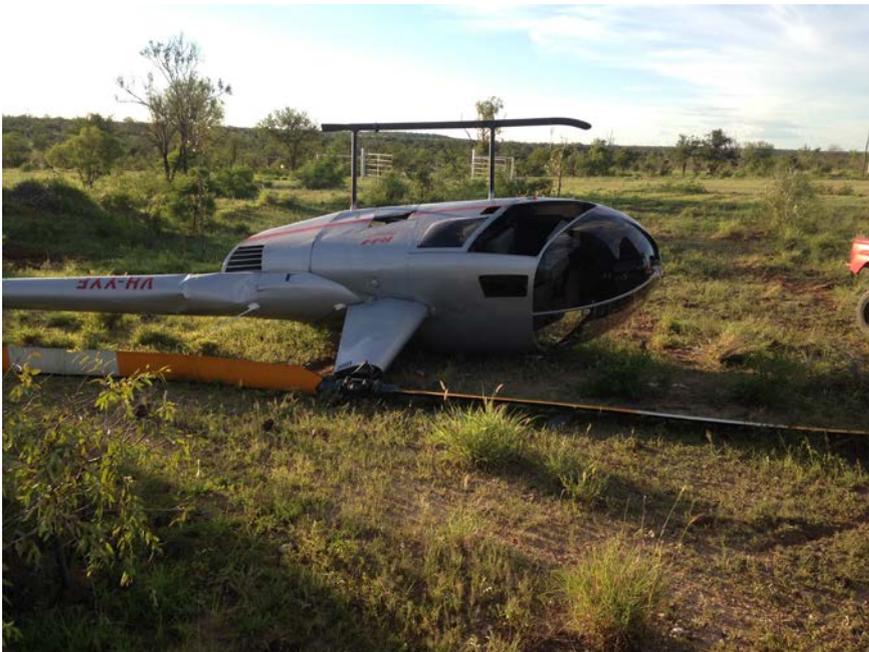
**Figure 1: Damage to VH-YYF**

At about 0800 Eastern Standard Time (EST), the helicopter lifted off normally. At about 20 ft above ground level, the pilot lowered the nose of the helicopter in attempt to gain forward speed and transition from hover to forward flight. The helicopter then sank quickly and the rotor rpm decayed. The pilot pulled back on the cyclic<sup>1</sup> control in an attempt to flare and reduce the rate of descent, prior to contacting the ground. The left skid contacted the ground first and then the helicopter spun to the right. The rear of the right skid dug into the ground and the helicopter rolled onto the right side. The pilot selected the master switch off before exiting the helicopter uninjured. The helicopter sustained substantial damage (Figure 1).
