Aviation Short Investigations Bulletin

Issue 45

ATSB Transport Safety Report
Aviation Short Investigations
AB-2015-135
Final – 22 December 2015

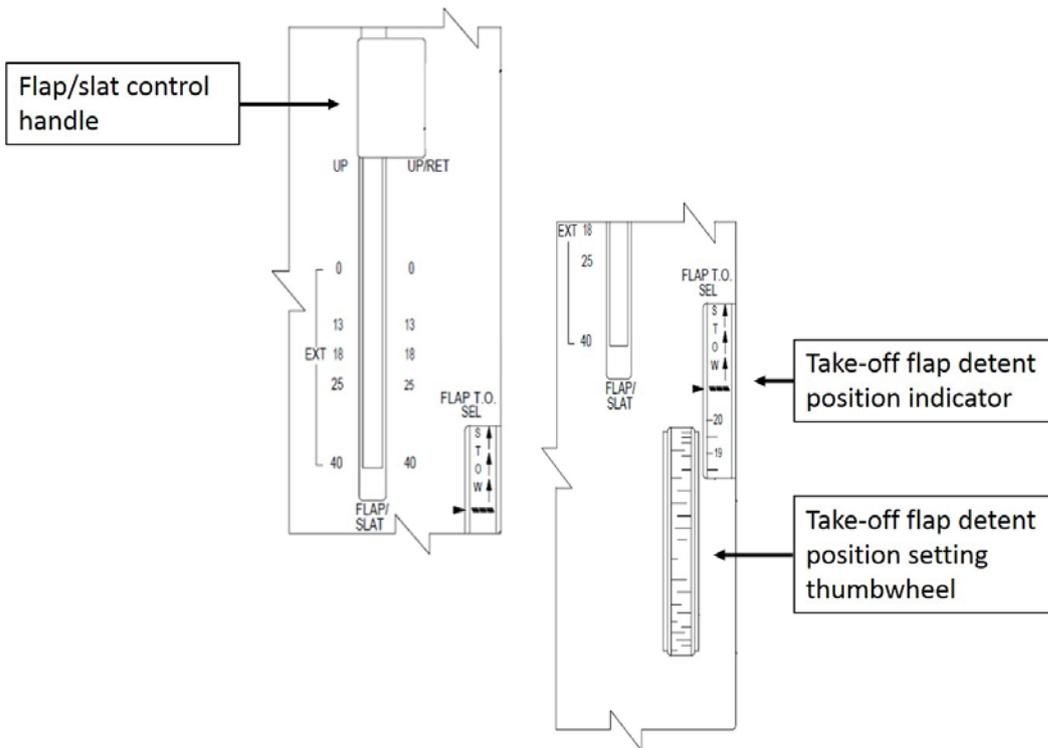
Figure 2: Flap and slat control

Within moments of stickshaker activation, the PM noticed that the flap/slat control handle was set to the UP/RET position (flaps up/slats retract). Upon noticing the position of the handle, the PM immediately called 'flaps', and moved the flap/slat control handle to the previously determined take-off setting position.

Following the incident, the crew deduced that the PM must have selected the flap/slat control handle to the UP/RET position soon after take-off, rather than raising the landing gear handle. The crew's deduction was based upon the configuration of the aircraft before, and immediately after, stickshaker activation. The crew were confident that before take-off procedures had been completed correctly, and that the flaps and slats had been correctly set. The crew also noted that had they commenced the take-off without the flaps and slats set, they would have received an aural warning alerting them accordingly – there was no such aural warning on this occasion.

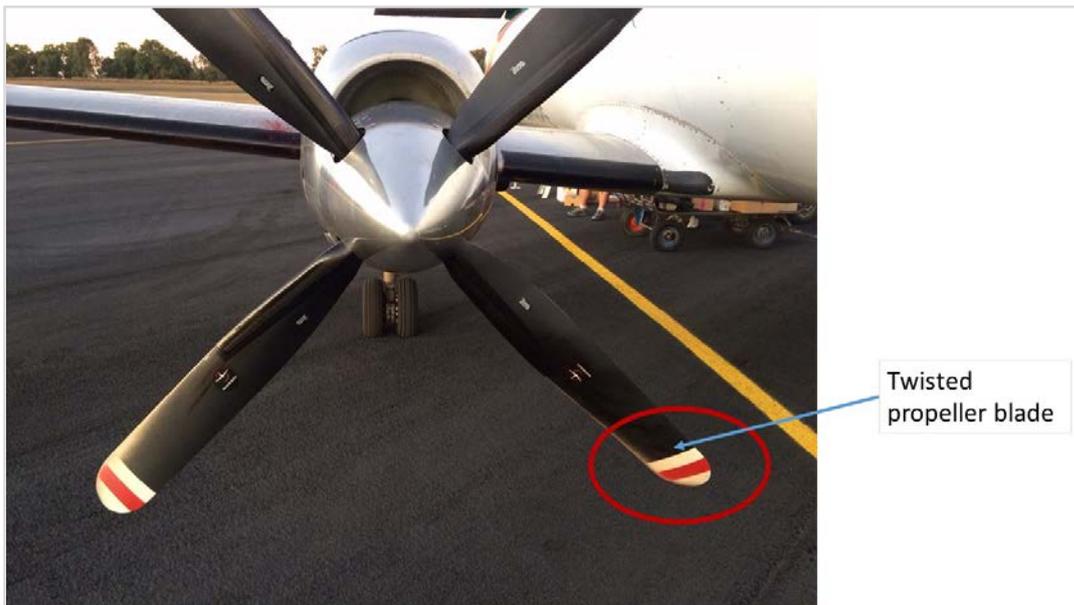
The pilot taxied the aircraft to the parking bay, shut down the engines, then carried out an external inspection and found that one of the propeller blades attached to the right engine was twisted (Figure 1). The pilot was not injured.

Figure 1: Damage to propeller blade on VH-HPE

Following the incident, the operator replaced the right engine and propeller and arranged for the original engine to be further assessed by engineering staff.

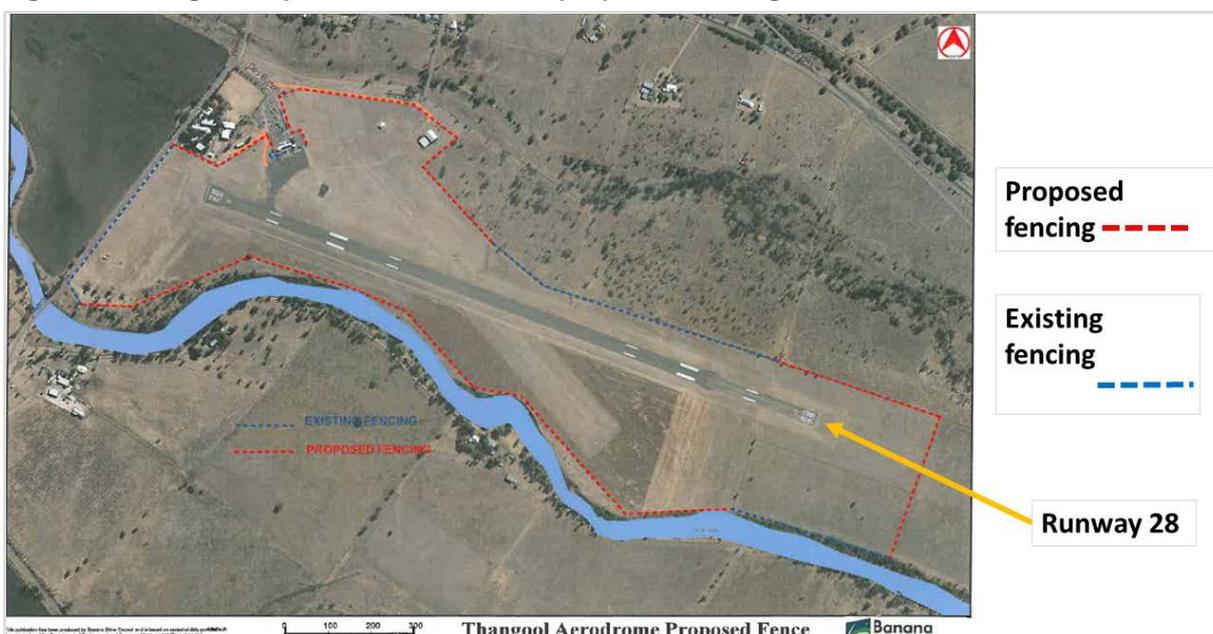
Sections of the Thangool Airport had wildlife protective fencing however, it is not fully fenced. At the time of publication, the Banana Shire Council, who own and operate the airport, had a funding application lodged with the Australian Government’s Regional Aviation Access Programme to enable the remainder of the airport fencing to be completed (Figure 2).

Figure 2: Thangool airport with current and proposed fencing marked

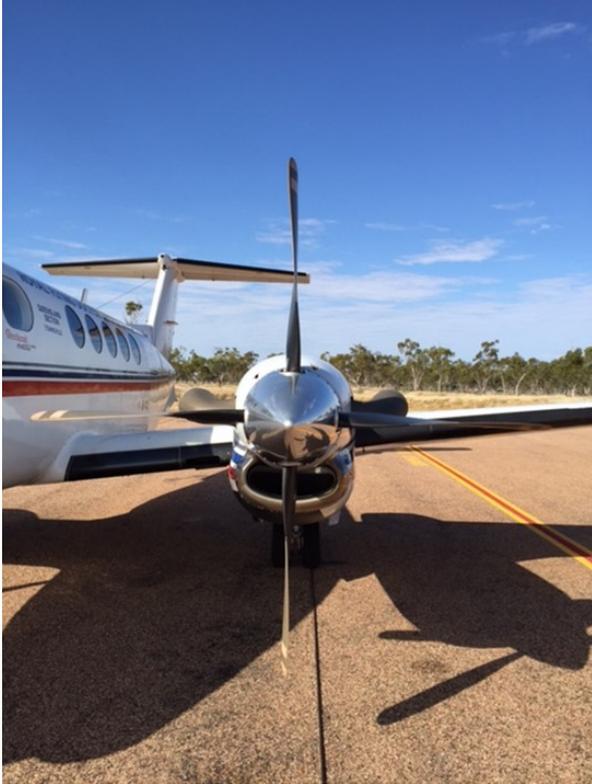
The operator/crew had not requested a “roo inspection” prior to the landing. They have also advised the ATSB that apart from the propeller damage, the left engine power module may also need replacing.

Figure 3: VH-FDB showing twisted propeller blades

The operator is amending their internal procedures, to automatically request a strip inspection for animals at any airport in the ERSA where an animal hazard is listed. This new procedure will also extend to requesting a strip inspection at any aeroplane landing area (ALA) when deemed appropriate.

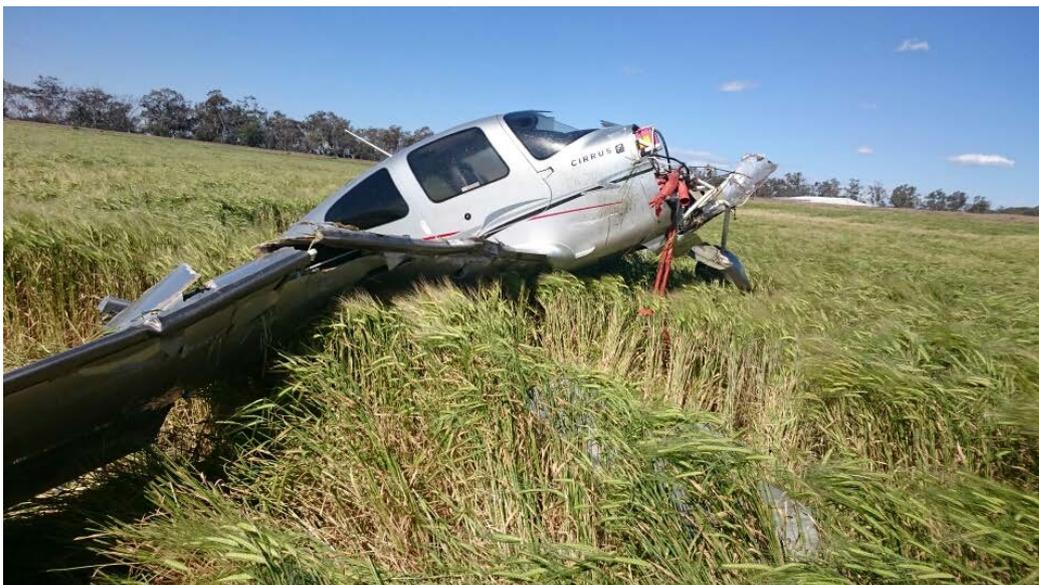
The right main landing gear touched down first, and the aircraft bounced back into the air. The pilot immediately applied full power to initiate a go-around. However, the left wing dropped and the aircraft yawed to the left. The aircraft's left wing and propeller then collided with a dam wall (Figure 1). The aircraft stopped abruptly and spun around. The engine separated from the aircraft and came to rest about 20 m away, the tail broke off and the nose landing gear collapsed. The pilot suffered minor injuries, and the aircraft sustained substantial damage (Figure 2).

Figure 2: Damage to VH-OPX

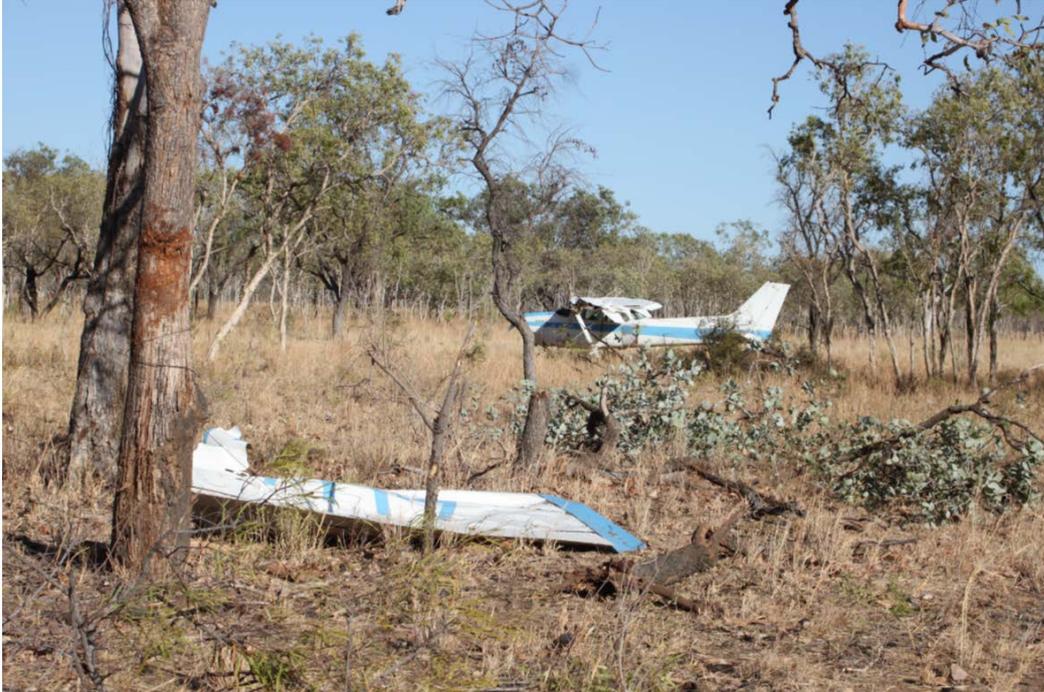
The aircraft travelled a further 20 m, before coming to rest (Figure 2). The pilot, who was not injured, was able to exit via the passenger door. The aircraft was substantially damaged (Figure 3).

Figure 2: VH-FPZ after the forced landing with part of the left wing in the foreground

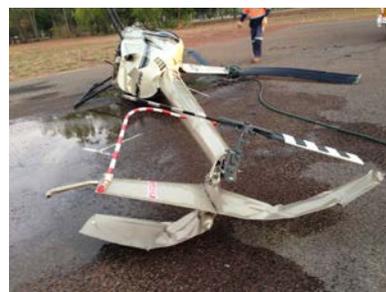
VH-ZWA on right side

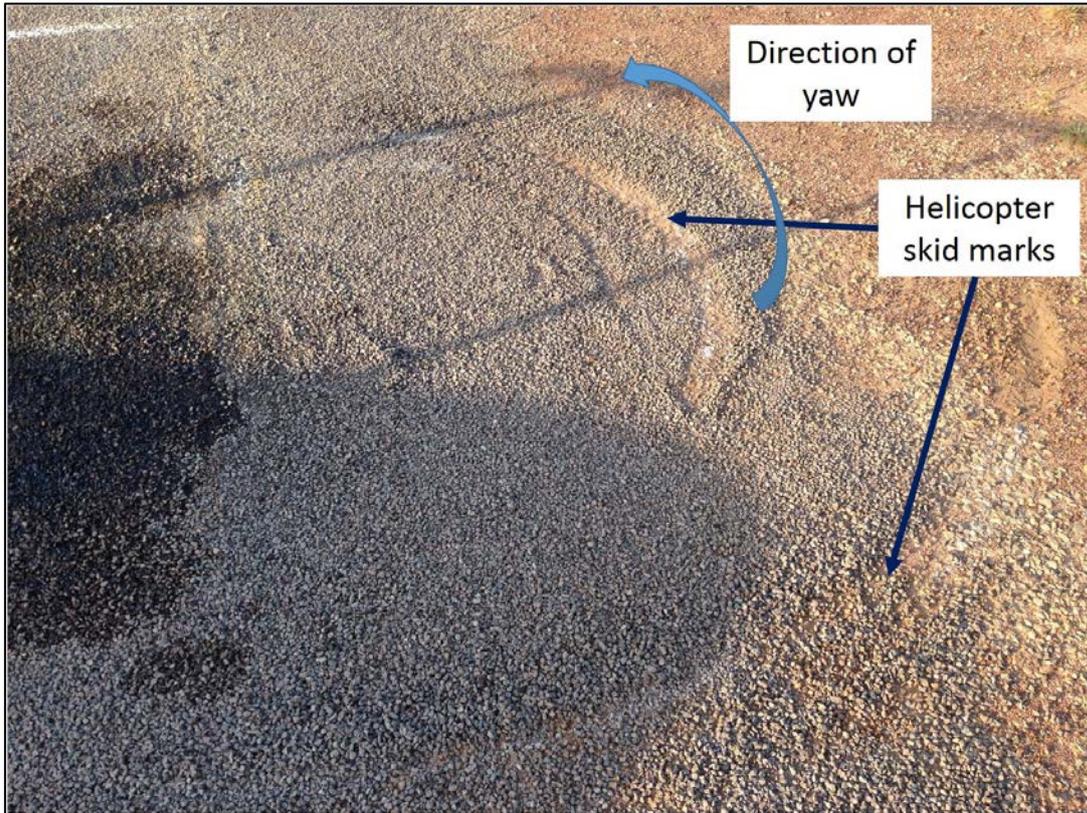
Figure 1: Skid marks made by VH-ZWA yawing to the left

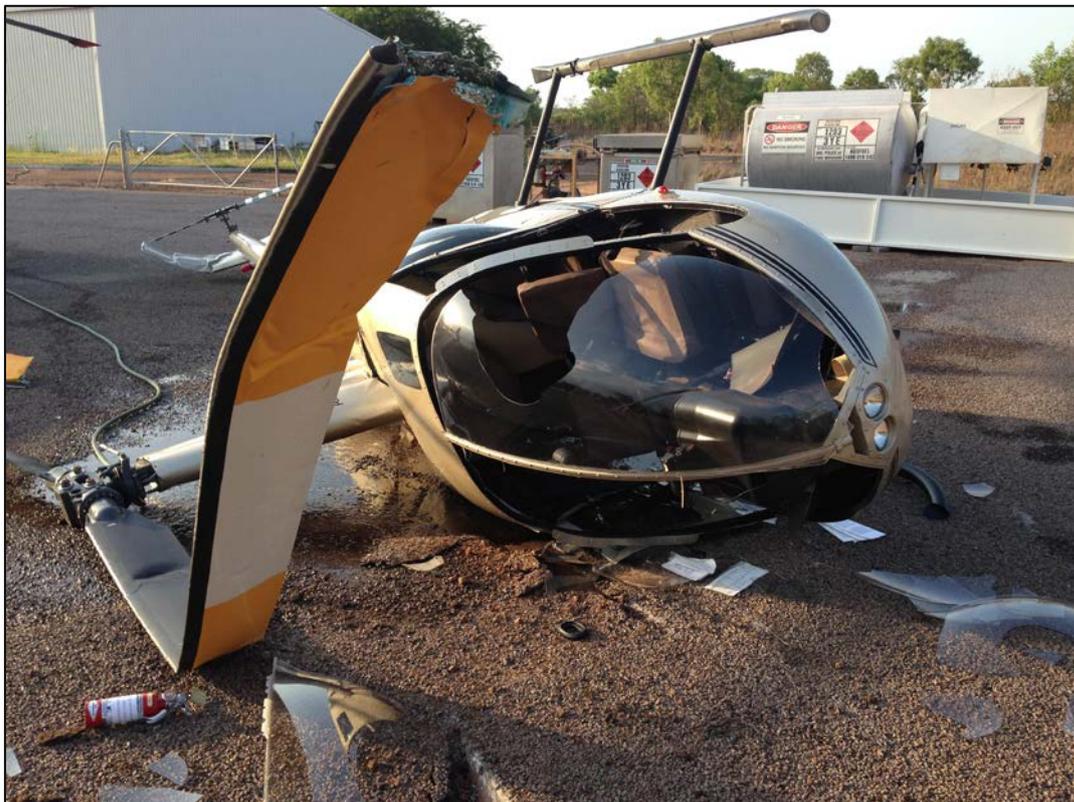
Figure 2: VH-ZWA on right side showing damage to main rotor and cabin

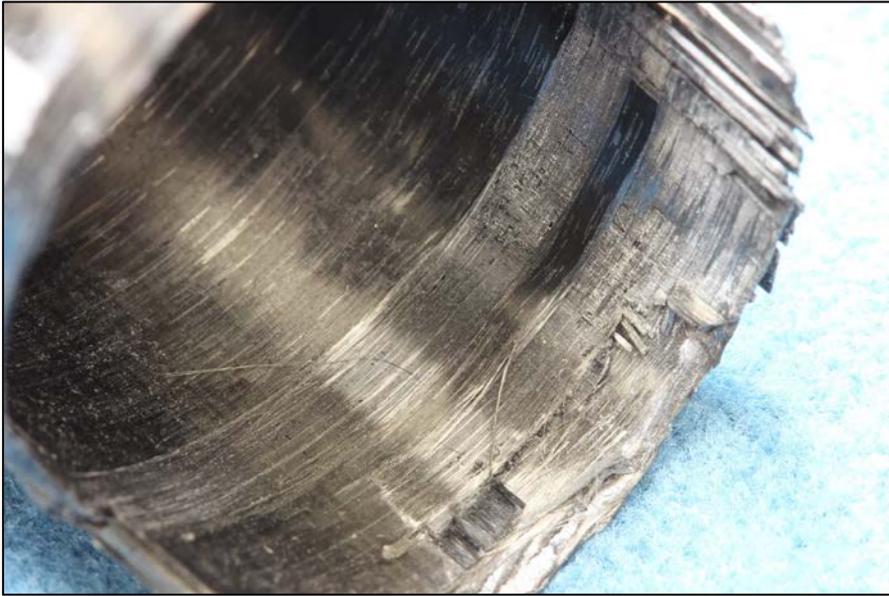
Figure 1: Innermost layer showing loose filaments
