# Safety Advisory Notice

To King Air series aircraft operators and pilots

Number: AO-2021-034-SAN-01

## Power lever friction lock adjustment

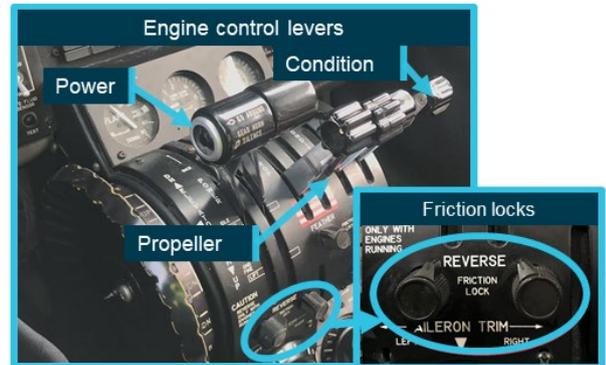
The left engine power lever had migrated rearwards as the friction lock had not been sufficiently adjusted during pre-flight checks.

A characteristic of the King Air friction locks was that they required careful adjustment as some aircraft had a narrow range between no friction and too much friction. In addition, the desired resistance could be inconsistent between power levers in the same aircraft and other aircraft, and this could change over time due to wear. This characteristic has been experienced among different King Air operators and pilots, and has also been considered as a potential factor in several fatal accidents.

Power levers and friction locks  
(Source: Operator, modified by the ATSB)

The Australian Transport Safety Bureau advises pilots and operators of the King Air series aircraft (c90, 200, and 300) that the power lever friction locks require careful adjustment to prevent power lever migration towards the idle position, particularly during take-off. Inadvertent migration of one power lever towards idle can result in power reduction and yaw that, when occurring at low height, can result in catastrophic outcomes. Operators should ensure pre-flight checks provide opportunities to confirm friction lock settings before the take-off run, and ensure pilots have adequate knowledge of friction lock sensitivity to help prevent and recover from inadvertent power lever migration.
