Loss of control and equipment contact with water involving Bell 412EP, VH-VJF

57 km north-east of Strahan Airport, Tasmania, on 10 March 2025

ATSB Transport Safety Report
Aviation Occurrence Investigation
AO-2025-013
Interim – 17 March 2026

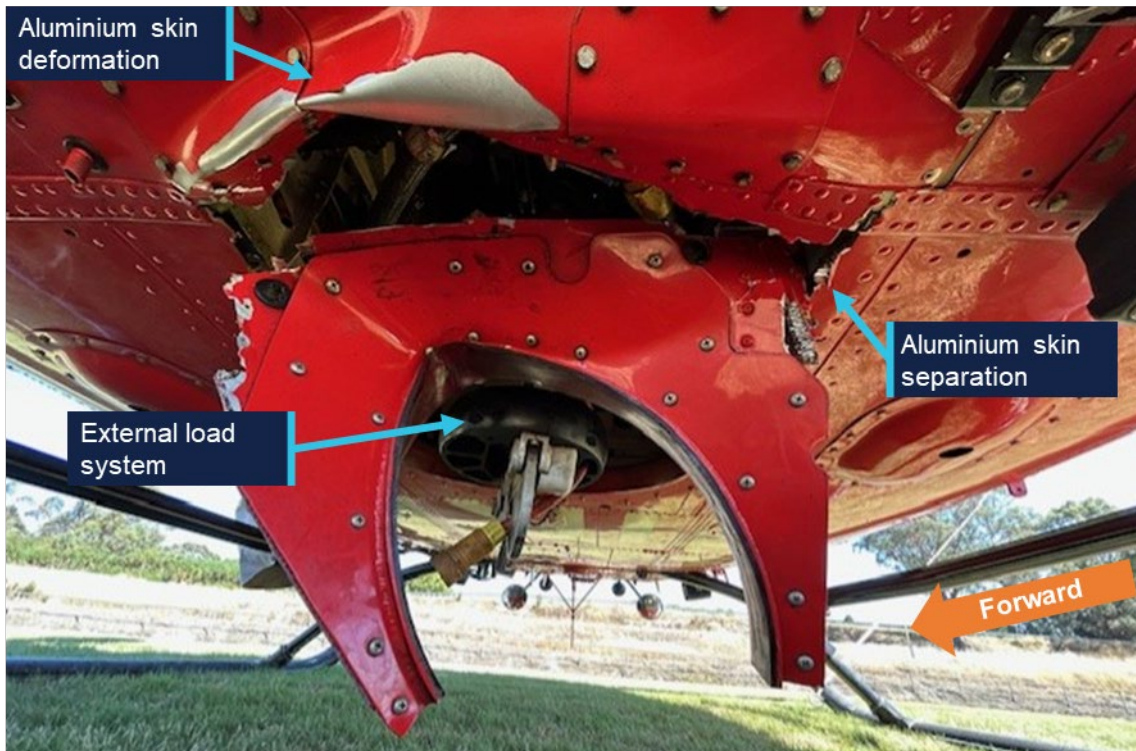
Figure 8: Helicopter aluminium skin damage

- The #1 engine control tube had sheared at the lower tube end bell crank, resulting in a complete loss of pilot input to the engine.
- The #2 engine control tube bell crank attachment bracket had detached from the helicopter structure's securing rib, restricting pilot control of the engine.
- The tail rotor control rod on the right-hand side of the external hook's bell crank airframe attachment had broken away, with the primary structure also separated.
- The main transmission oil cooler pressure line exhibited significant contact damage, however, no splits or leaks were identified.
- The fuel tank interconnect braided hoses sustained minor contact damage.
- Multiple aft fuselage drain lines were damaged.

Images of the helicopter indicated that the structural fuselage honeycomb aluminium skin, adjacent to and aft of the external hook, was deformed and had separated from the primary structure (Figure 8).

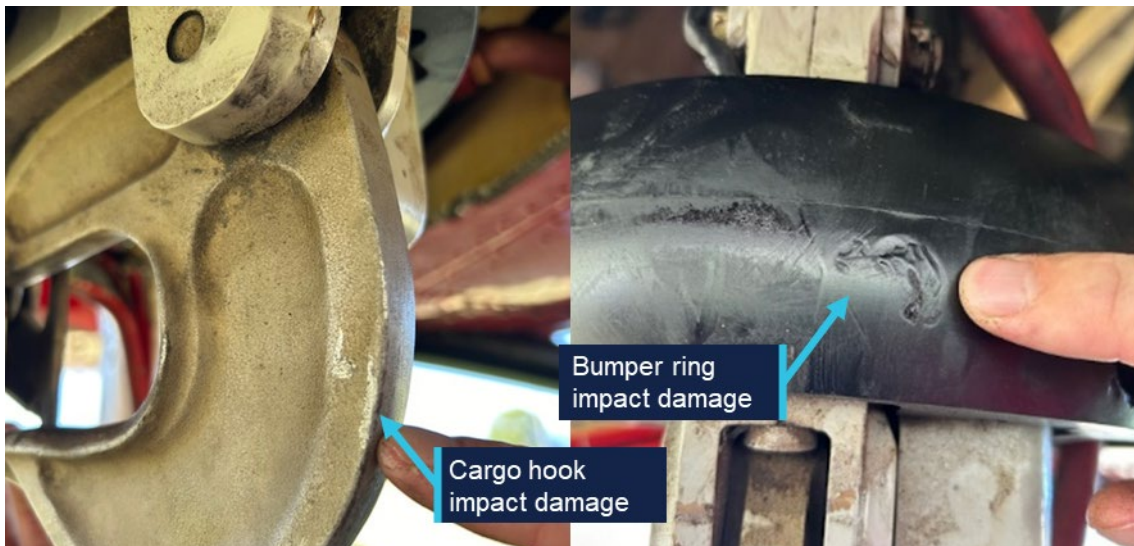
Figure 9: External load system damage

Images revealed indications consistent with contact between the longline and the rear cross tubes of the helicopter. In addition, inspection of the cargo hook and associated bumper stop components identified visible signs of impact damage (Figure 9).

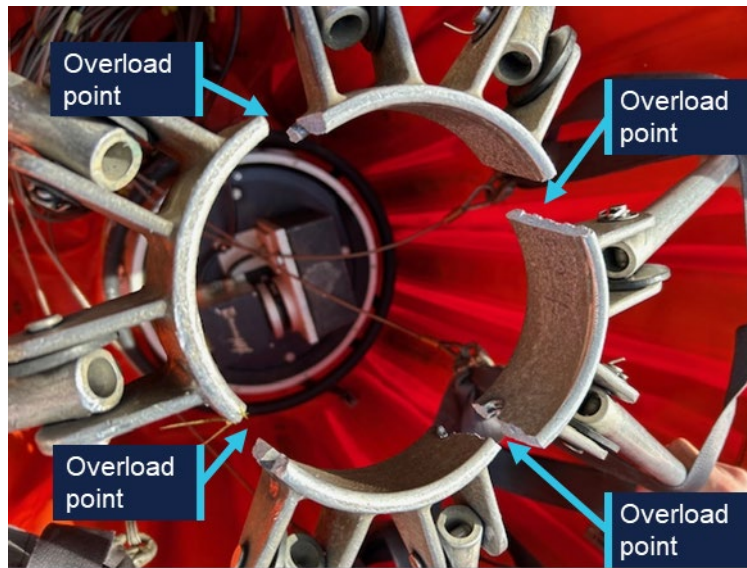
Figure 10: Bambi Max damage to spoke assembly

In addition, the ring in the middle of the Bambi bucket spoke assembly was fractured in 4 places (Figure 10).
