Collision with water involving Cessna 210N, VH-RDH

14 km south-east of Goolwa Airport, South Australia, on 6 February 2026

ATSB Transport Safety Report
Aviation Occurrence Investigation
AO-2026-010
Preliminary – 4 March 2026

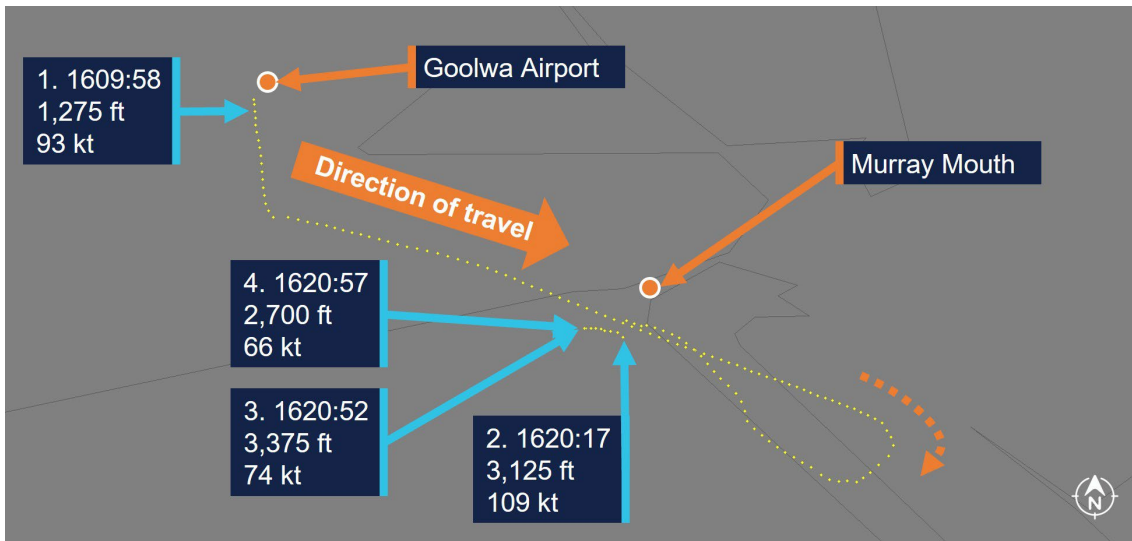
Figure 1: Air traffic control generated track with data points annotated

ATC radar tracked the aircraft as it followed the coast to the east at about 2,350 ft for about 5 minutes at about 130 kt. The aircraft then commenced a right turn through south to track west along the coast back towards the mouth of the Murray River (Murray Mouth) at about 136 kt. As the aircraft approached Murray Mouth, the altitude increased and reached 3,375 ft at 1620:52. As the aircraft climbed above 3,000 ft the tracking data shifted slightly south (at 1620:17) and the speed reduced to 74 kt while maintaining a westerly track.

At 1620:57 the aircraft was recorded at an uncorrected altitude of 2,700 ft, still on a westerly track, and the speed had reduced to 66 kt. The ATC system then ceased tracking the aircraft, but it was captured a final time on radar at 1621:05, at an uncorrected altitude of 1,200 ft. Figure 1 depicts the accident flight with 4 data points annotated.

Airservices Australia generated tracking data for the accident flight with ATSB numbered data points – at data point 2 the aircraft has climbed above 3,000 ft and the track has shifted to the south.
Source: Airservices Australia, annotated by the ATSB
