Grounding of RSV *Nuyina*

Off Heard Island, Territory of Heard Island and McDonald Islands, on
13 October 2025

ATSB Transport Safety Report
Marine Occurrence Investigation
MO-2025-011
Preliminary – 17 March 2026

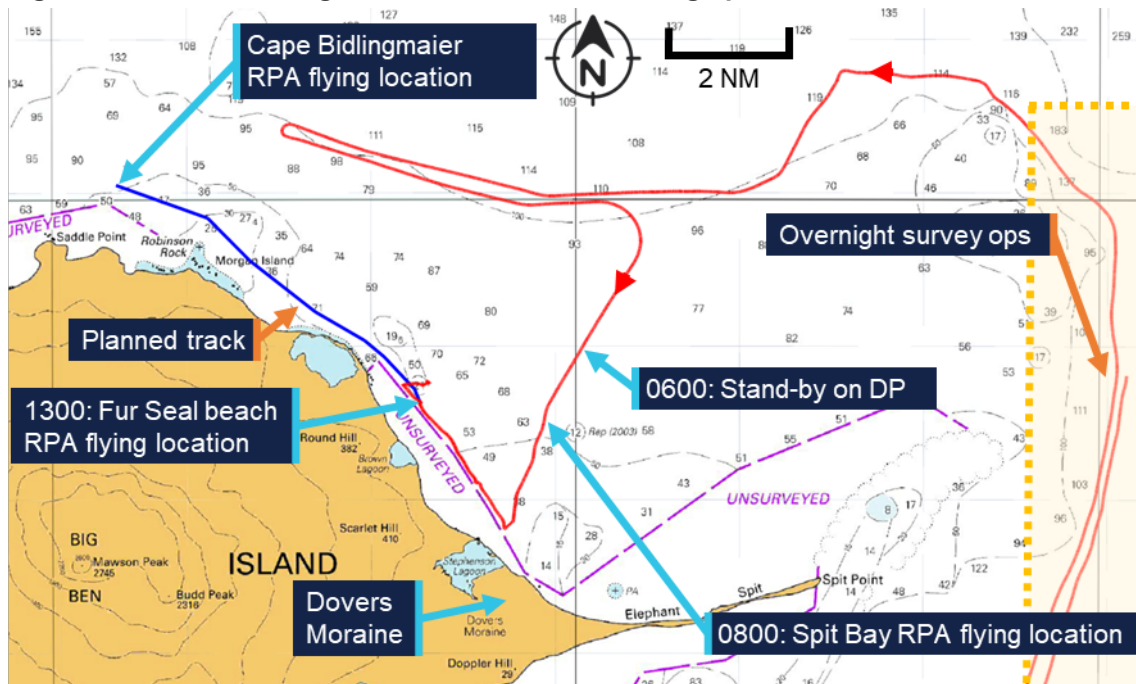
Figure 2: Section of navigation chart AUS 605 showing operations on 13 October 2025

By about 0800, the weather had improved and *Nuyina* was moved closer inshore to a position in Spit Bay (Figure 1), in water depths of about 30 m (Figure 2). The position was close enough to shore to allow for effective RPA operations while remaining clear of the 'unsurveyed' area marked on the chart.

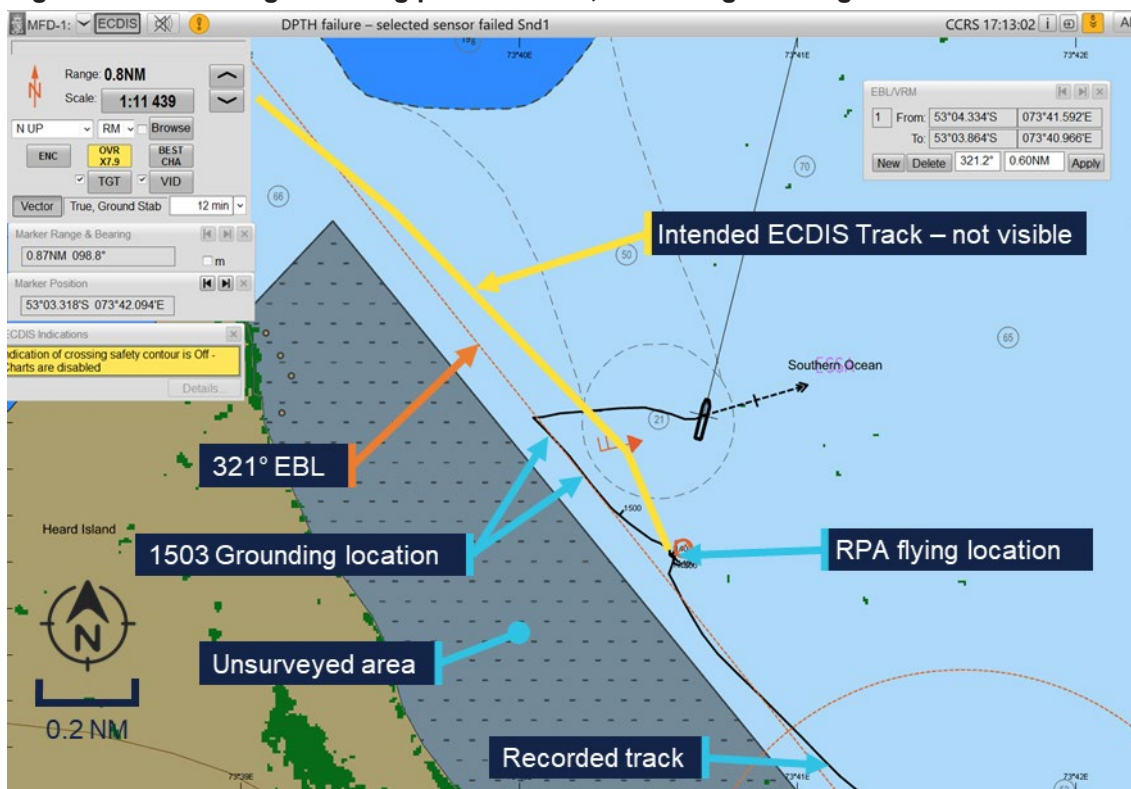
Figure 3: ECDIS image showing planned track, EBL and grounding

The second officer switched over to manual control and moved from the DP console to the helm controls forward. However, the planned route was not visible on the forward ECDIS. The master tried to correct this, while the second officer continued to track along the EBL which was still displayed on the ECDIS from the earlier manoeuvring and was set in a similar direction to the planned route. This track took the ship between the unsurveyed area to the west and a charted bank with an indicated depth of 21 m to the east (Figure 3).

At 1500, the acoustics operator contacted the bridge by phone to confirm that the bridge MBES displays were showing the correct information. The master discussed the setup of the screens and asked for some changes. At that stage, the MBES display was showing a depth⁷ of 15 m. At 1502, the master ended the call and ordered the engines dead slow ahead, immediately followed by 'stop', which was acknowledged and executed by the second officer. This was followed at 1503 by the order to go 'dead slow astern'.

At about the same time, the acoustics operator noted the water depth was now indicating 13 m and that this only left 3.25 m between the MBES transducer in the deployed drop keel and the seabed. The operator called the bridge to warn of shallow water and this was acknowledged by the master who stated they were already 'going astern'.

Nuyina then briefly grounded with the retractable drop keel initially impacting the seabed, followed by the ship's hull.

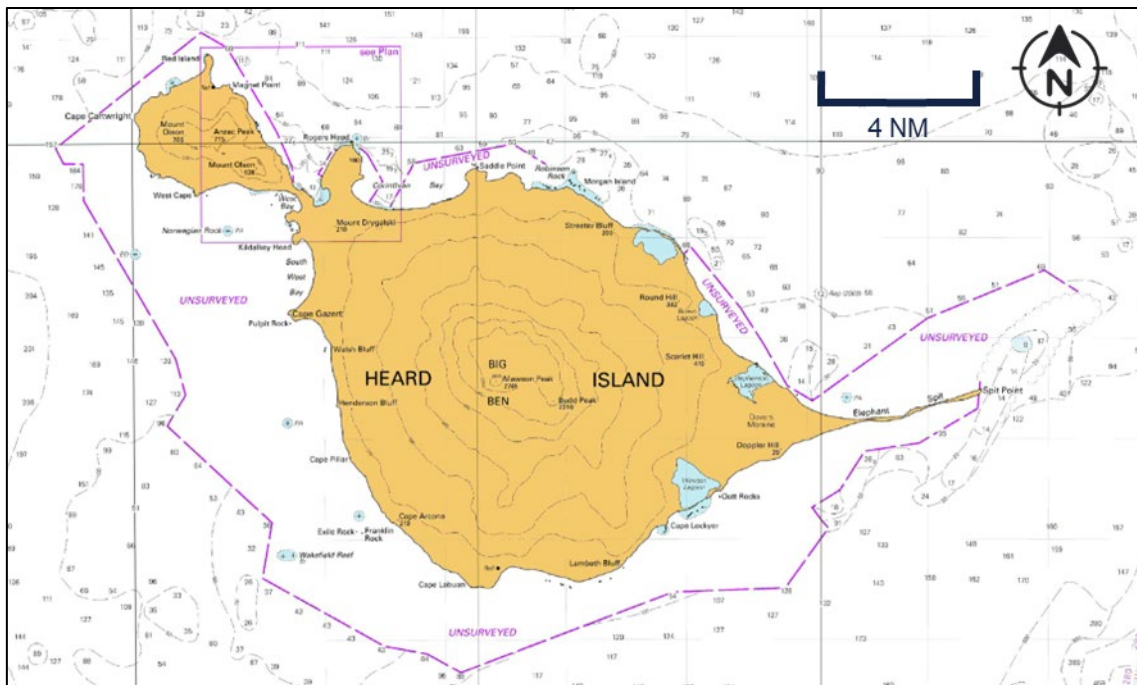
Figure 5: Section of navigation chart AUS 605 showing Heard Island

Due to the island’s remote location and low volumes of shipping traffic, the waters around Heard Island have not been systematically surveyed. Instead, charts are based on limited data available from passage soundings, mostly obtained by earlier expeditions by

the AAP and its predecessors. The charted soundings for the area around Spit Bay were based on data from passage soundings obtained in 1948 and 1990 as well as from a more comprehensive 1999 survey.

In electronic navigational charts, information to evaluate the relative accuracy of the chart data is provided by assigning a 'category of zone of confidence in data' (CATZOC). Areas of the chart are assigned to one of 6 categories and allocated a CATZOC value (A1, A2, B, C, D and U). The area around Heard Island (including the location of the ship's grounding) was assessed in the lowest assessed category (CATZOC D), indicating poor seafloor coverage and accuracy where large depth anomalies may be expected. Additionally, extensive coastal areas were marked as 'unsurveyed' with no depth information presented.

- New measures addressing the hazards of operations in low CATZOC areas were introduced including the development of a detailed risk assessment, revision of the master's standing orders to prioritise use of the navigational echo sounders and the use of the science tender to support mapping operations.
- A review of passage planning processes in the SMS, including the navigation manual, procedures and supporting forms. This also included instructions on ECDIS management and troubleshooting as a specific procedure.
- The development of a Heard and McDonald Islands navigation decision support guide and the acquisition of sufficient multi beam data to identify safe transit corridors around Heard Island.
