Grounding of *Coral Adventurer*

Nussing Island (100 km east of Lae), Papua New Guinea, on 27 December 2025

Marine Occurrence Investigation

MO-2025-013

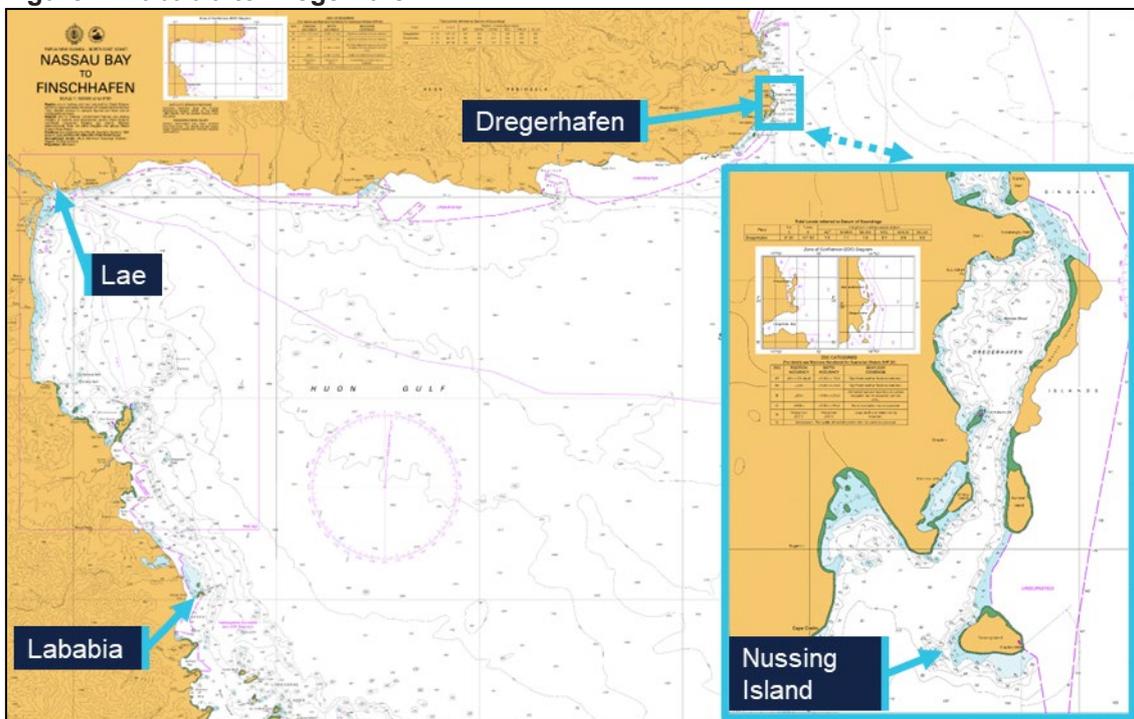
Figure 2: Lababia to Dregerhafen

On 26 December, the ship was at anchor off Lababia, approximately 60 km south-south-east of Lae. During the evening, the chief mate completed the departure checklist and, at 1918, the ship commenced its 63 mile¹ passage to Dregerhafen (Figure 2).

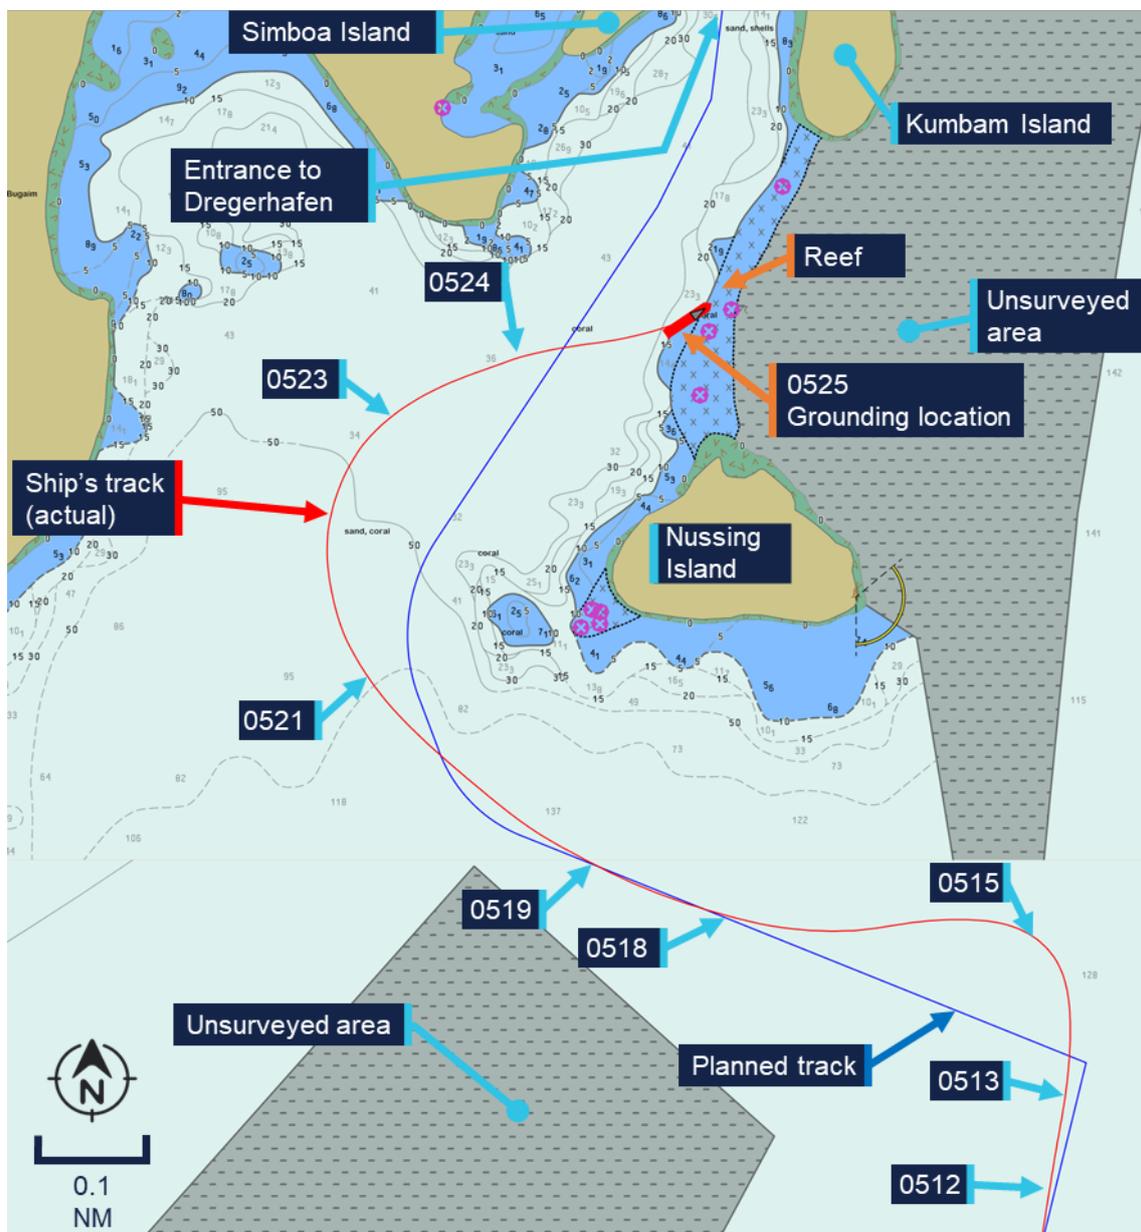
Figure 3: Route 2 – entrance to Dregerhafen

At 0512, the ship was in autopilot mode steering a heading of 357°. The ship was making good a course of 009° at a speed over ground of 5.6 knots while approaching the final waypoint of the route (Figure 3).

The chief mate then attempted switching the ECDIS monitored route to Route 2 – the track into Dregerhafen. However, as Route 2 had been modified, it failed to load as the active route. This caused a delay as the chief mate completed the required ECDIS ‘route check’ for Route 2, to allow it to be monitored as the active route.

Planned track (blue) and actual track (red) overlaid on vector chart in use on board Coral Adventurer at the time of the grounding. Source: Australian Hydrographic Office, modified and annotated by the ATSB

While the chief mate was conducting the ‘route check’, the ship passed the wheel over point⁵ for the turn to the next course (293°). At 0512:26, with the ship heading towards unsurveyed waters to the north, the chief mate switched to manual steering in common mode⁶ to facilitate a quicker turn and return to the planned track.

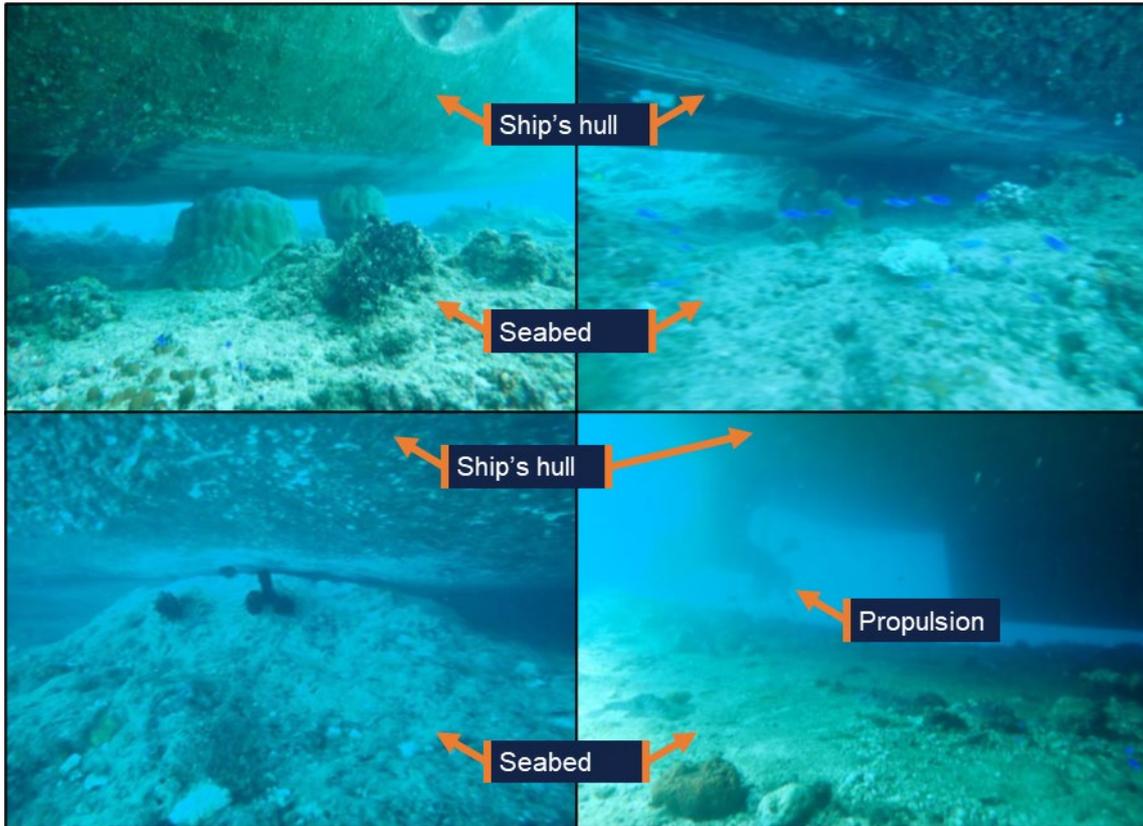
Figure 4: Underwater images taken during the dive inspection

Expedition staff later completed dive inspections, which confirmed that the ship was resting on the seabed along its starboard side (Figure 4). The propulsion and steering were unaffected.

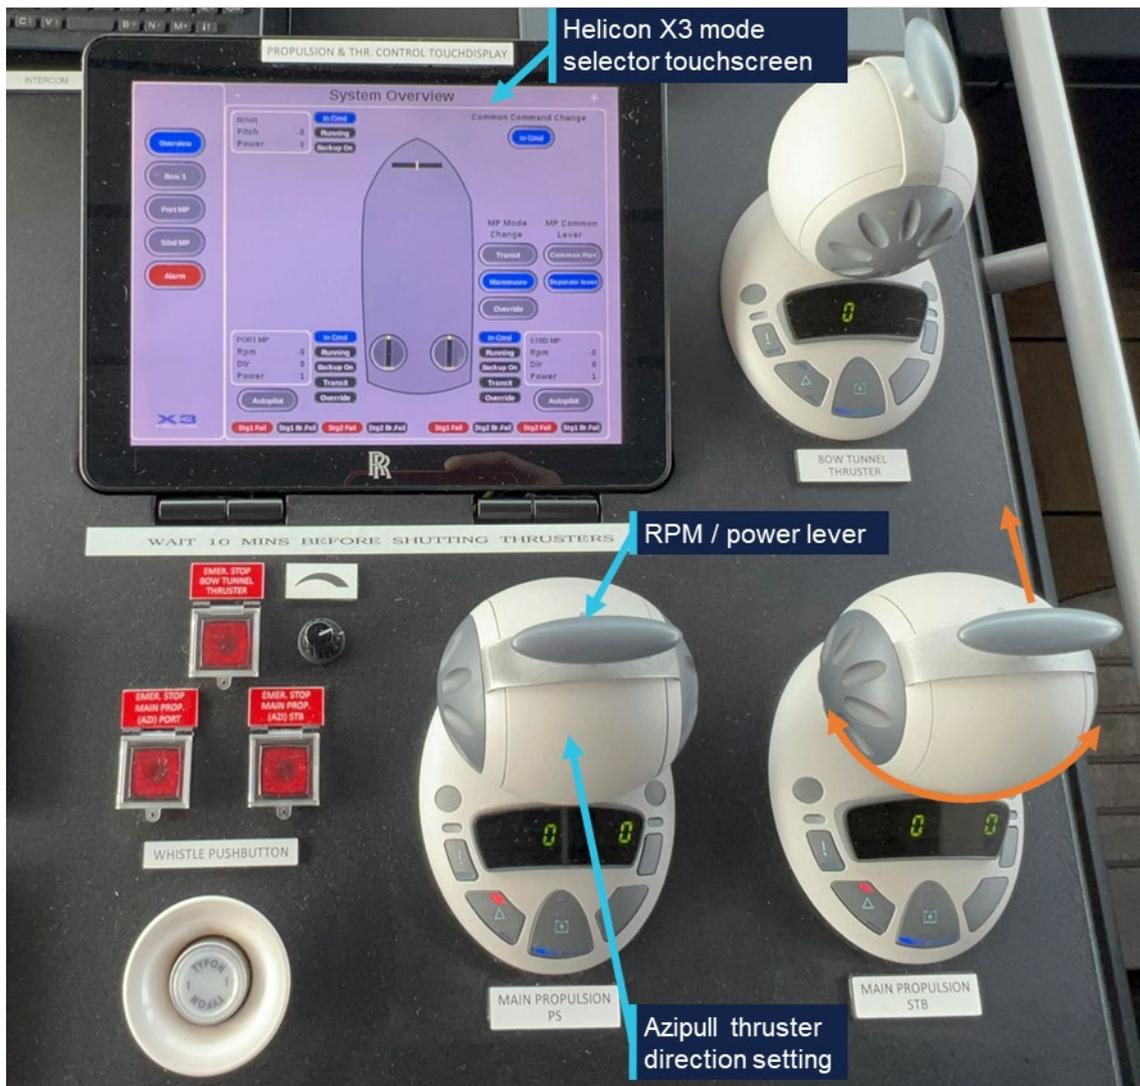
Figure 6: Azipull thruster controls

The Azipull units consisted of an electric drive motor fitted inside the hull with a gearbox driving a vertical shaft connected to the underwater thruster unit. The thruster units were fitted with fixed pitch pulling propellers and could be rotated through 360°. This allowed the thrust vector of the main propulsion to be rotated through 360°, improving slow speed manoeuvring capabilities. The Azipull thrusters were controlled by a Helicon X3 remote control system. Normal control was through sets of ball-shaped controllers (Figure 6). One set was mounted in the centre of the bridge console and one set on each bridge wing control station.

While approaching Nussing Island, the chief mate was steering the ship on autopilot before switching to manual steering in common mode, controlling both Azipull thrusters with a single controller. This offered better steering control capability than autopilot mode but limited slow speed steering capability when compared to using separate controllers for individual thruster operation.

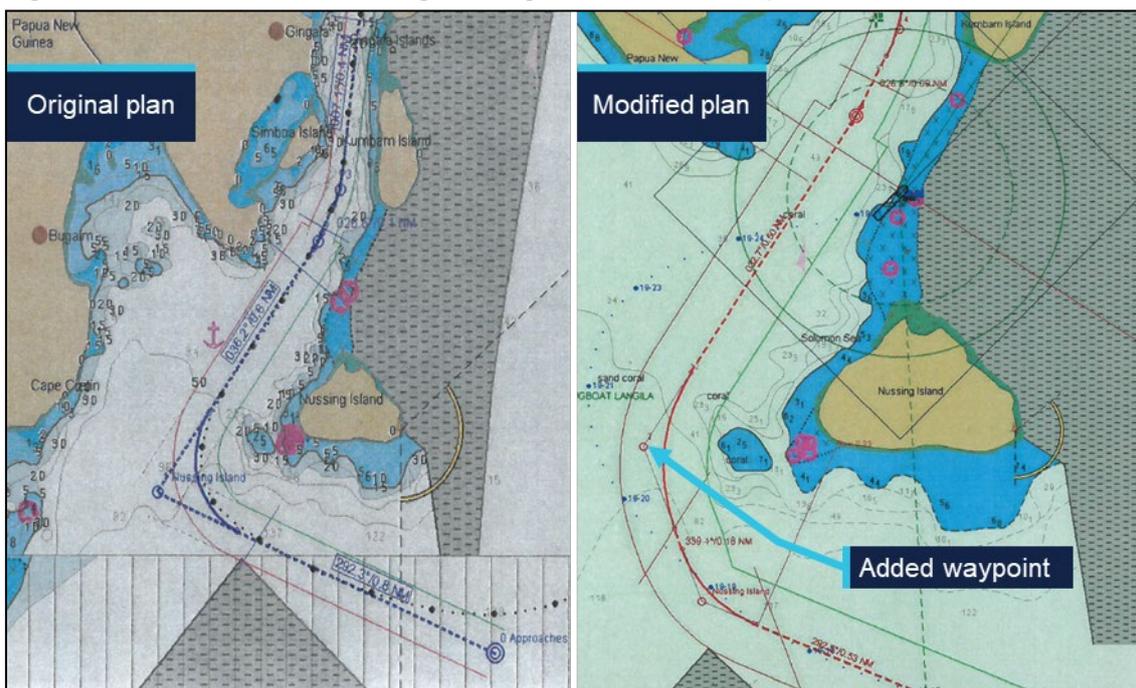
Figure 7: ECDIS courses showing the original and modified plan

On the incident voyage, both routes had been checked prior to departure. However, while transiting Route 1, the chief mate made changes to Route 2, adding an additional waypoint to the starboard turn around Nussing Island (Figure 7). This change invalidated the route check and meant that Route 2 could not be activated for monitoring without entering the route editor and conducting a new route check.

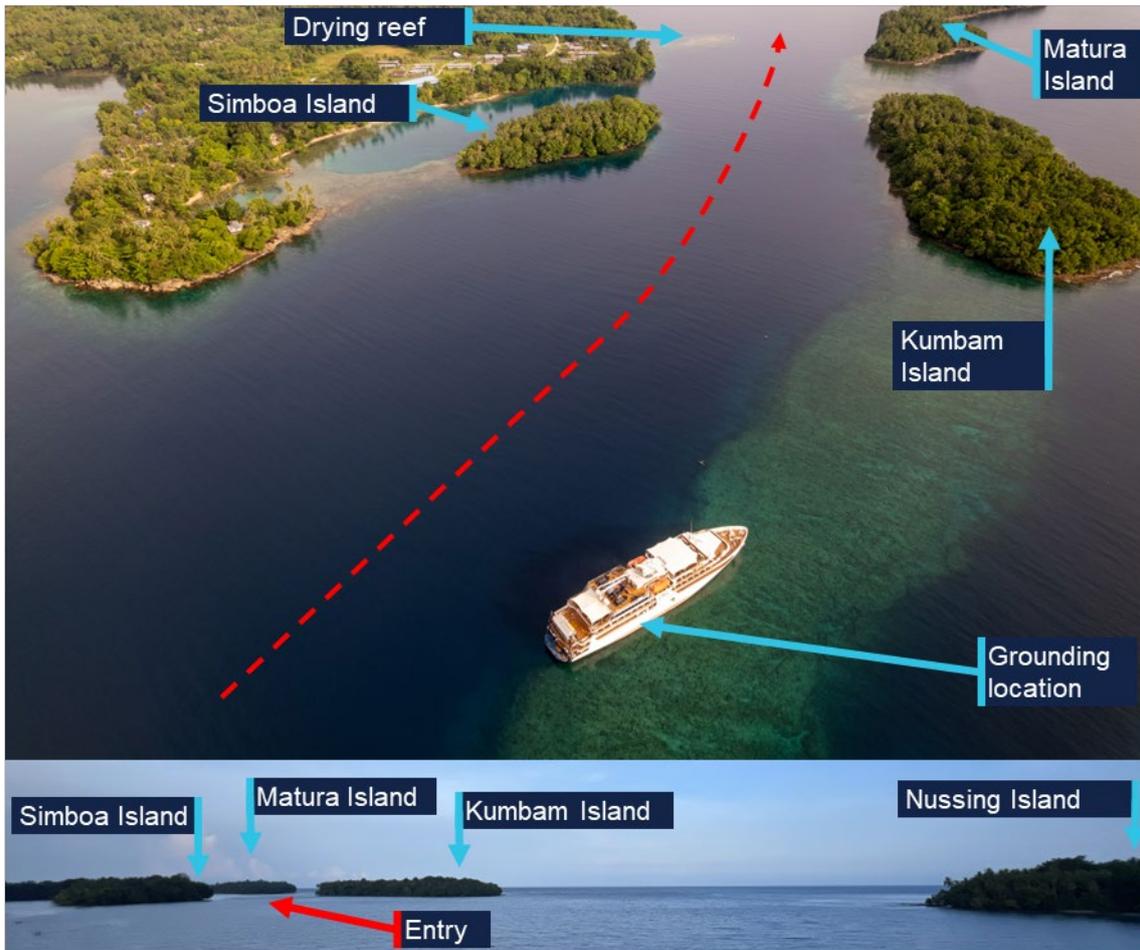
Figure 8: Entry channel views

The only entry into Dregerhafen is deep but narrow, with a maximum navigable width of 120 m (Figure 8). It requires passing west of Nussing Island and entering the passage between Simboa Island and Kumbam Island, before passing between Matura Island and a drying reef off the town of Gingala. The reef was marked with a lighted beacon, though this was not visible from the location of the ship during the turn.

Aerial view of the entry to Dregerhafen. Insert below shows the view from the approximate ship's position 3 minutes before grounding, taken from the height of the bridge in daylight.
Source: Sebastian Bang, annotated by the ATSB. Insert view, the ATSB.
