Australian Government
Australian Transport Safety Bureau

Train overspeed by run 805K

through BN 318 turnout, Blacktown, New South Wales, on 21 April 2024

ATSB Transport Safety Report
Rail Occurrence Investigation (Defined)
RO-2024-003
Final – 24 March 2026

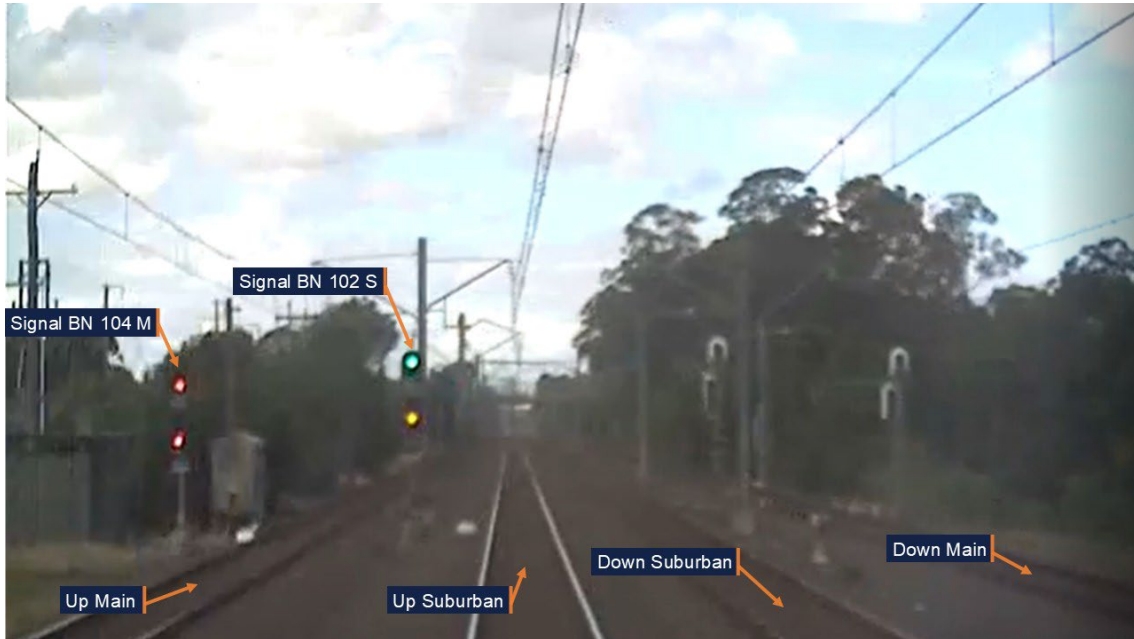
Figure 7: Signal BN 102 S

The train's speed dropped back to 106 km/h by 1421:21 as the train reached Blacktown West, which was marked by a yard limit⁷ sign and controlled Accept signal BN 102 S (Figure 7). This signal was displaying a Medium indication, which warned the driver that the next signal would be displaying a Caution⁸, Caution Turnout⁹ or Medium Turnout¹⁰ indication. However, the driver continued to coast at 106 km/h with no braking action applied.

*Image from Front of Train CCTV Car D6432 on incident run, approaching signal BN 102 S.
Source: Sydney Trains, annotated by OTSI*

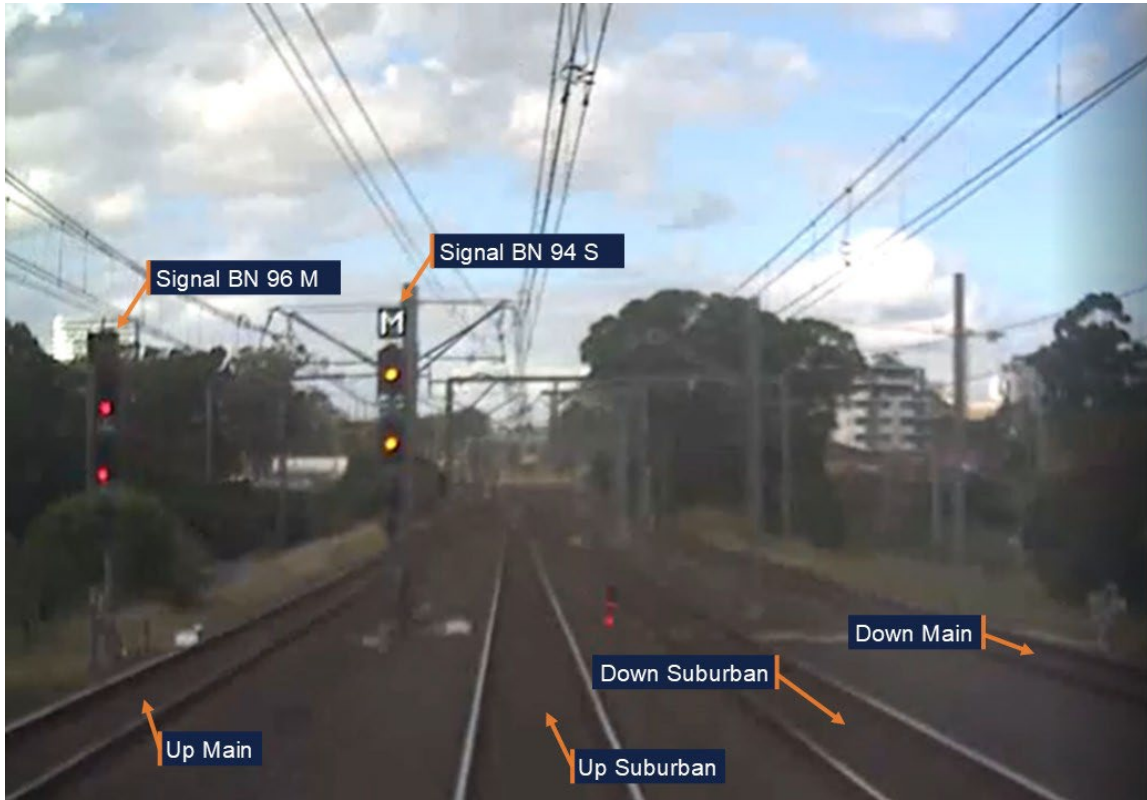
Figure 8: Signal BN 94 S

At 1421:42, around 21 seconds and 635 m after passing signal BN 102 S, the train reached controlled Home signal¹¹ BN 94 S at a speed of 106 km/h. This signal was displaying a Medium Turnout indication with a corresponding route indication of 'M'. This warned the driver that the points beyond the signal were set for the route from the Up Suburban to the Up Main, which had a posted speed limit of 25 km/h (Figure 8).

*Image from Front of Train CCTV Car D6432 on incident run, approaching signal BN 94 S.
Source: Sydney Trains, annotated by OTSI*

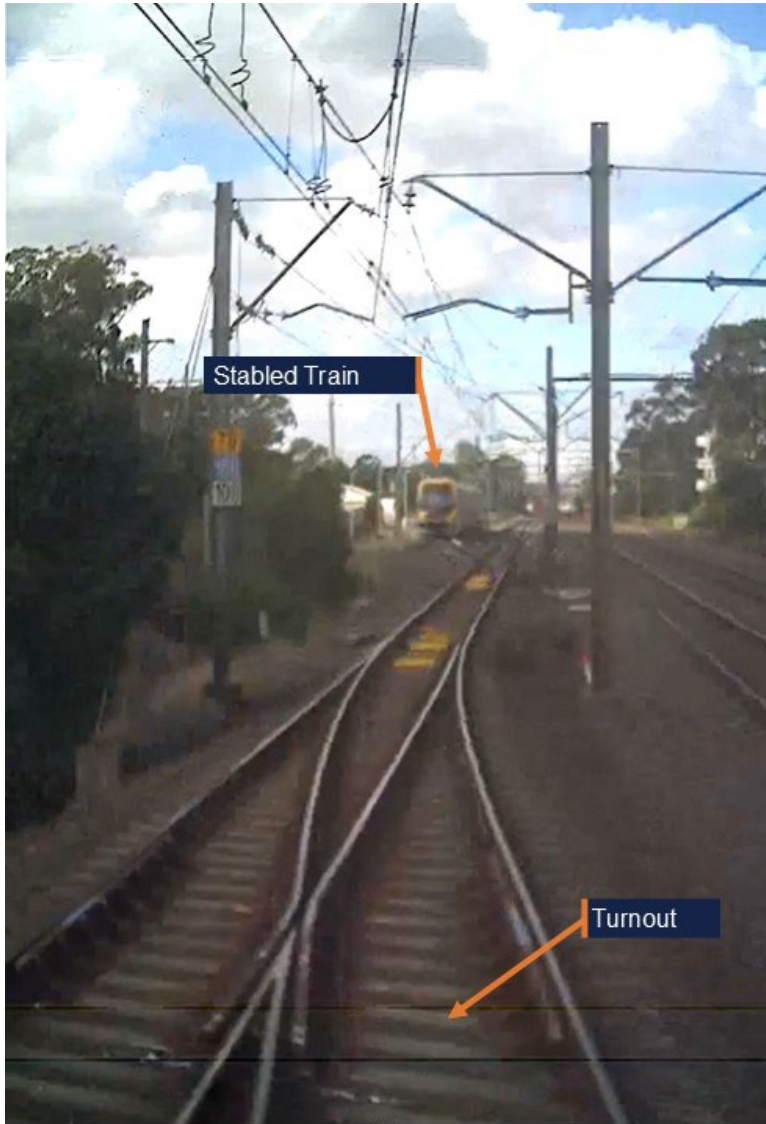
Figure 9: Dashcam of train mid turnout

The train decelerated to 103 km/h before the lead car entered BN 318 turnout at 1421:49 and at a speed of 101 km/h. Although the train went through the leading points at more than 4 times the posted speed limit, the train remained upright and did not derail. A 4-car Millennium set was stabled at the country end of Blacktown Up Loop, which was adjacent to the Up Main, but it was not impacted as run 805K stayed on the tracks (Figure 9).

*Image from Front of Train CCTV Car D6432 on incident run, mid turnout with stabled train ahead.
Source: Sydney Trains, annotated by OTSI*

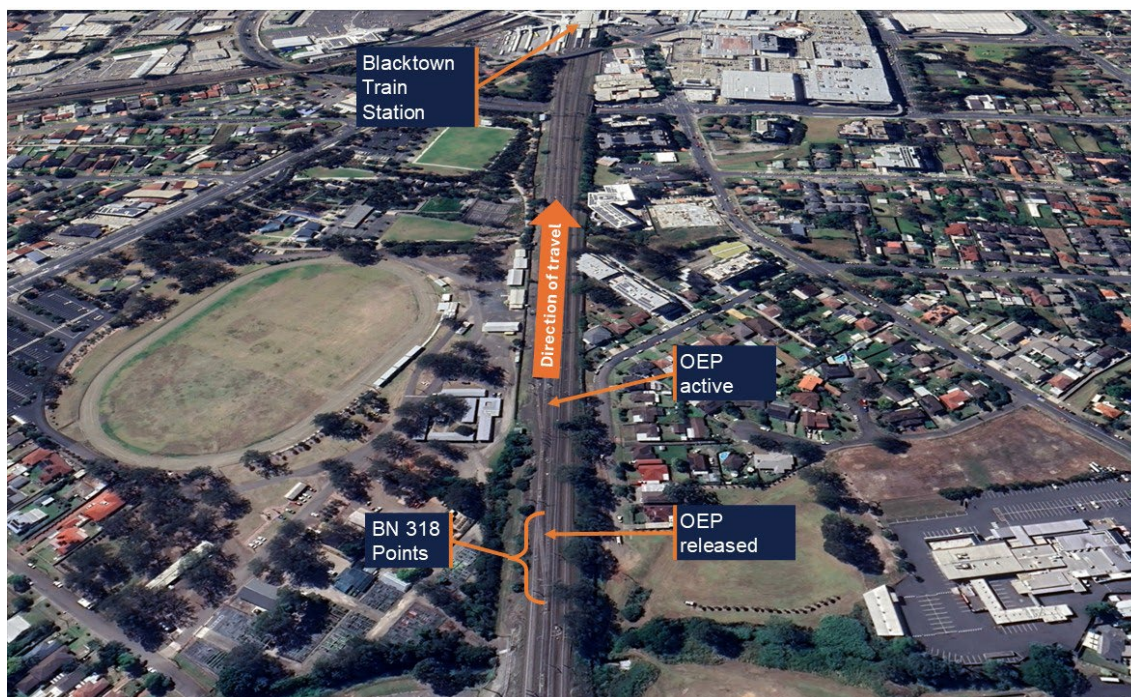
Figure 10: Approach to Blacktown Station

The Operator enabled pedal (OEP) was released by the driver passing through BN 318 points and turnout at approximately 101 km/h. Source: Google Earth, annotated by OTSI

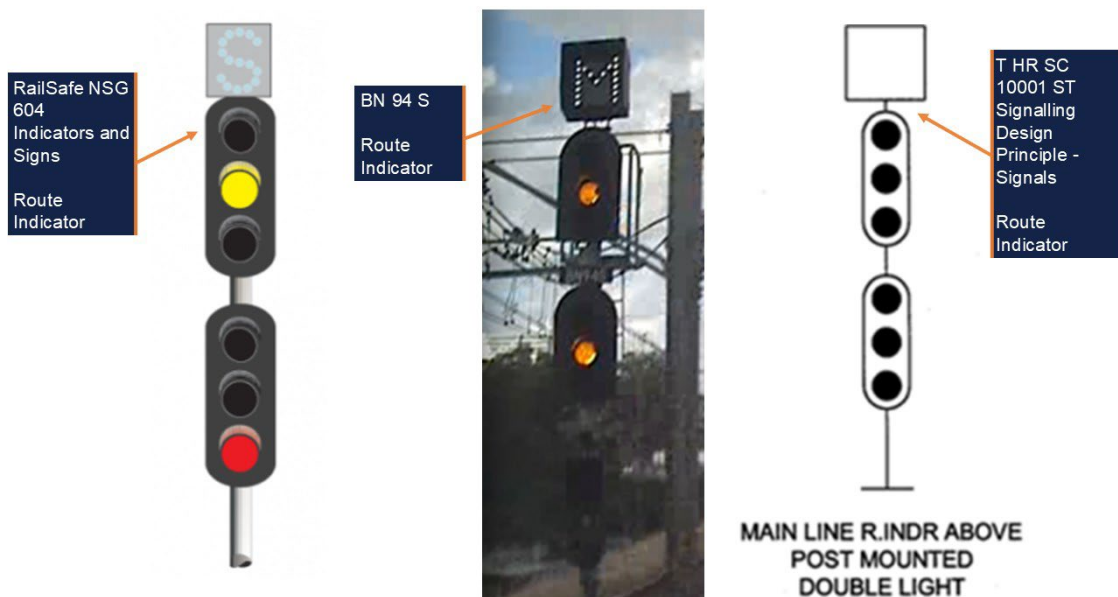
Figure 16: Route indicators

If a route was set for the Up Main or Up Loop via BN 318 turnout, the route indicator would show an 'M' or an 'L' respectively. At the time of the incident, signal BN 94 S was displaying a Medium Turnout indication with a corresponding 'M' route indication. This was compliant with the TfNSW standard and the Network Rules (Figure 16).

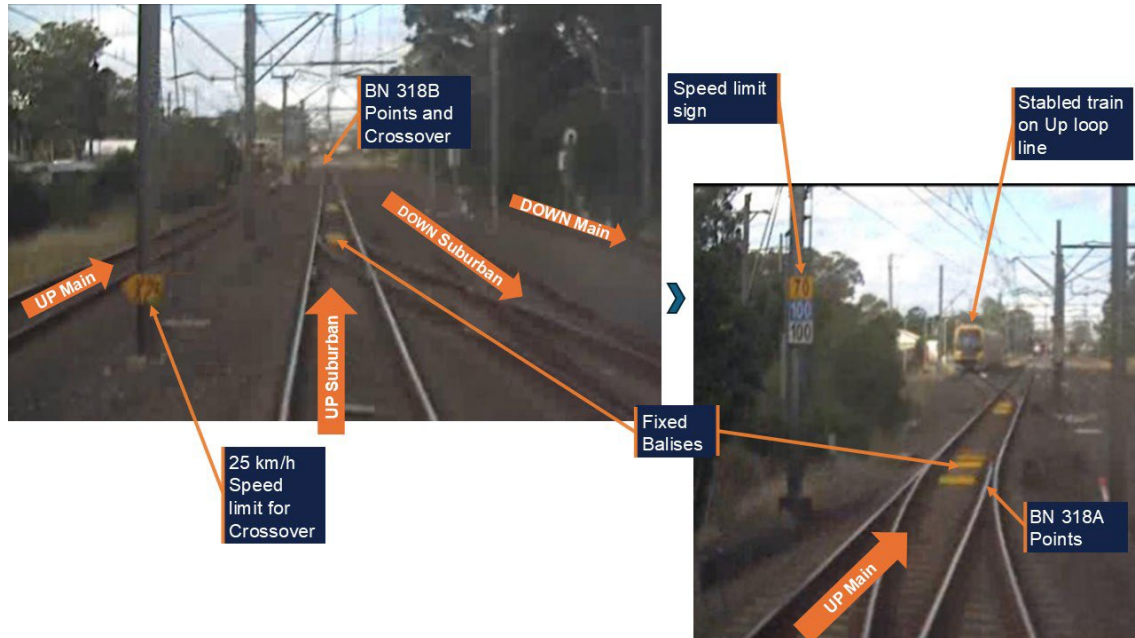
Figure 18: BN 318 points and crossover (turnout)

Fixed balises were used in some parts of the Sydney Trains network, including at BN 318 turnout (Figure 18).

While fixed balises were installed on BN 317 and BN 318 turnouts, it was found during the investigation that the balises had different functions on each turnout and in the Up and Down directions.
