Engine failure and collision with terrain involving a Cessna 210, VH-ERU

77 km ENE of Cue, Western Australia, on 1 August 2015

ATSB Transport Safety Report
Aviation Occurrence Investigation
AO-2015-090
Final – 4 November 2015

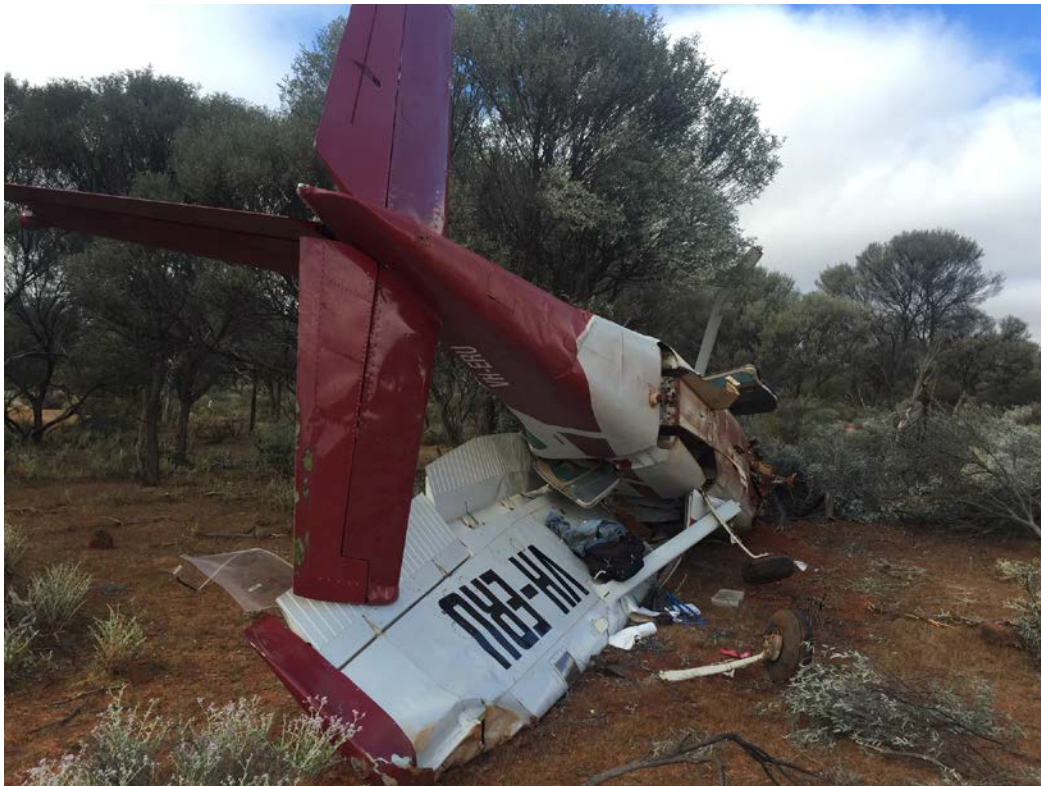
Figure 2: Accident site showing damage to VH-ERU

The pilot lowered the landing gear and extended the flap. When at about treetop height, the pilot selected the master switch and fuel off. The pilot also tightened the seatbelt and opened the aircraft door. As the pilot flared the aircraft to land, the right wing and strut collided with a tree. The aircraft yawed to the right, and the right main landing gear struck the ground and broke off. Although the pilot applied full left rudder to try to regain control of the aircraft, it collided with another tree and rolled onto its left side, before skidding and coming to rest against a third tree. The pilot suffered minor injuries and the aircraft sustained substantial damage (Figure 2).

The right fuel line ruptured during the impact sequence, causing fuel to run down into the cabin and onto the pilot. The pilot quickly exited the aircraft, concerned about the risk of fire, particularly as there was about 240 L of fuel in the tanks.

- The number three cylinder failed and blew a hole in the top of the engine casing.
- The pilot usually carried a satellite phone, but did not have it on this flight as it was being serviced.
- It was about a 40-minute flight to Cue, and the pilot would normally have advised someone of the planned route and expected arrival time, but omitted to do so on this day.
- The pilot had water, a first aid kit and a lighter in the aircraft, and planned to get a personal location beacon to carry in future.
