Australian Transport Safety Bureau

ATSB TRANSPORT SAFETY REPORT
Occurrence Investigation Report AO-2007-001
Final

Microburst event
Sydney Airport, NSW
15 April 2007
VH-OJR
Boeing Company 747-438

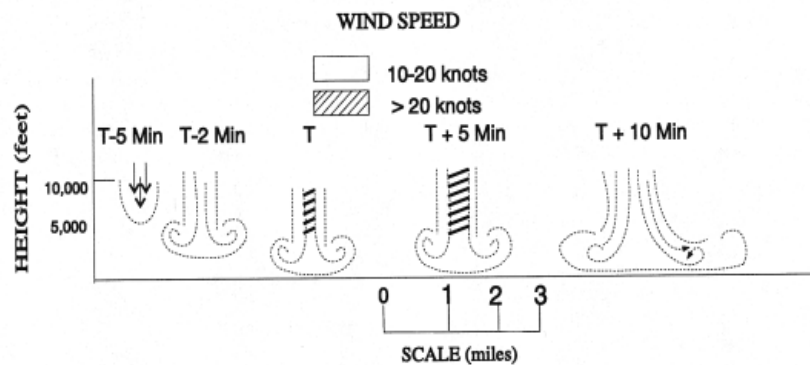
FIG 7-1-13
Evolution of a Microburst

Vertical cross section of the evolution of a microburst wind field. T is the time of initial divergence at the surface. The shading refers to the vector wind speeds. Figure adapted from Wilson et al., 1984, Microburst Wind Structure and Evaluation of Doppler Radar for Wind Shear Detection, DOT/FAA Report No. DOT/FAA/PM-84/29, National Technical Information Service, Springfield, VA 37 pp.

c. The life cycle of a microburst as it descends in a convective rain shaft is seen in FIG 7-1-13. An important consideration for pilots is the fact that the microburst intensifies for about 5 minutes after it strikes the ground.

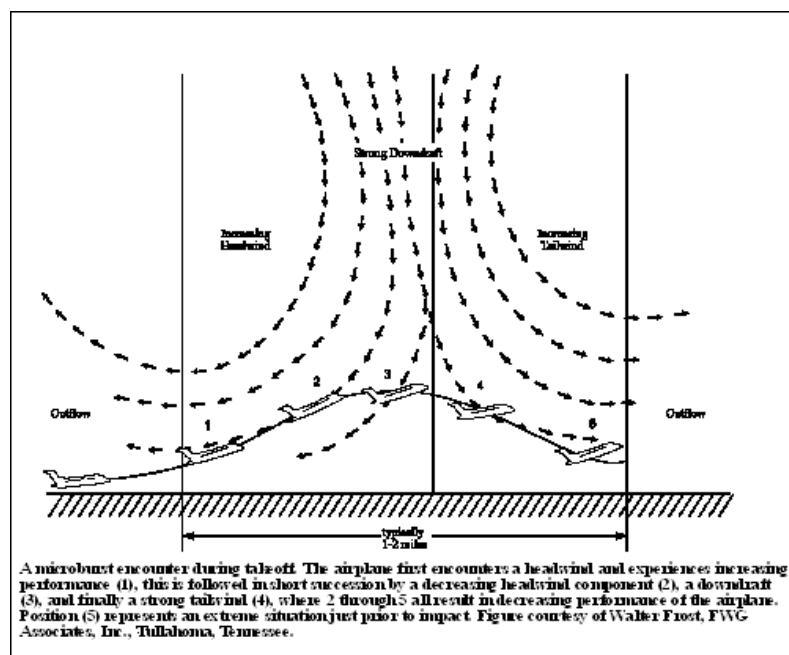
FIG 7-1-14
Microburst Encounter During Takeoff

e. Microburst wind shear may create a severe hazard for aircraft within 1,000 feet of the ground, particularly during the approach to landing and landing and take-off phases. The impact of a microburst on aircraft which have the unfortunate experience of penetrating one is characterized in FIG 7-1-14. The aircraft may encounter a headwind (performance increasing) followed by a downdraft and tailwind (both performance decreasing), possibly resulting in terrain impact.
