APPENDIX B: ANALYSIS BY AIRCRAFT MANUFACTURER

Performance Analysis – Qantas 747-400 VH-OJR
Windshear Encounter during Approach to Sydney – 15 April 2007

APPENDIX C: ANALYSIS BY EGPWS MANUFACTURER

Analysis of B747-400 Windshear event
Rev: New 5-14-2007

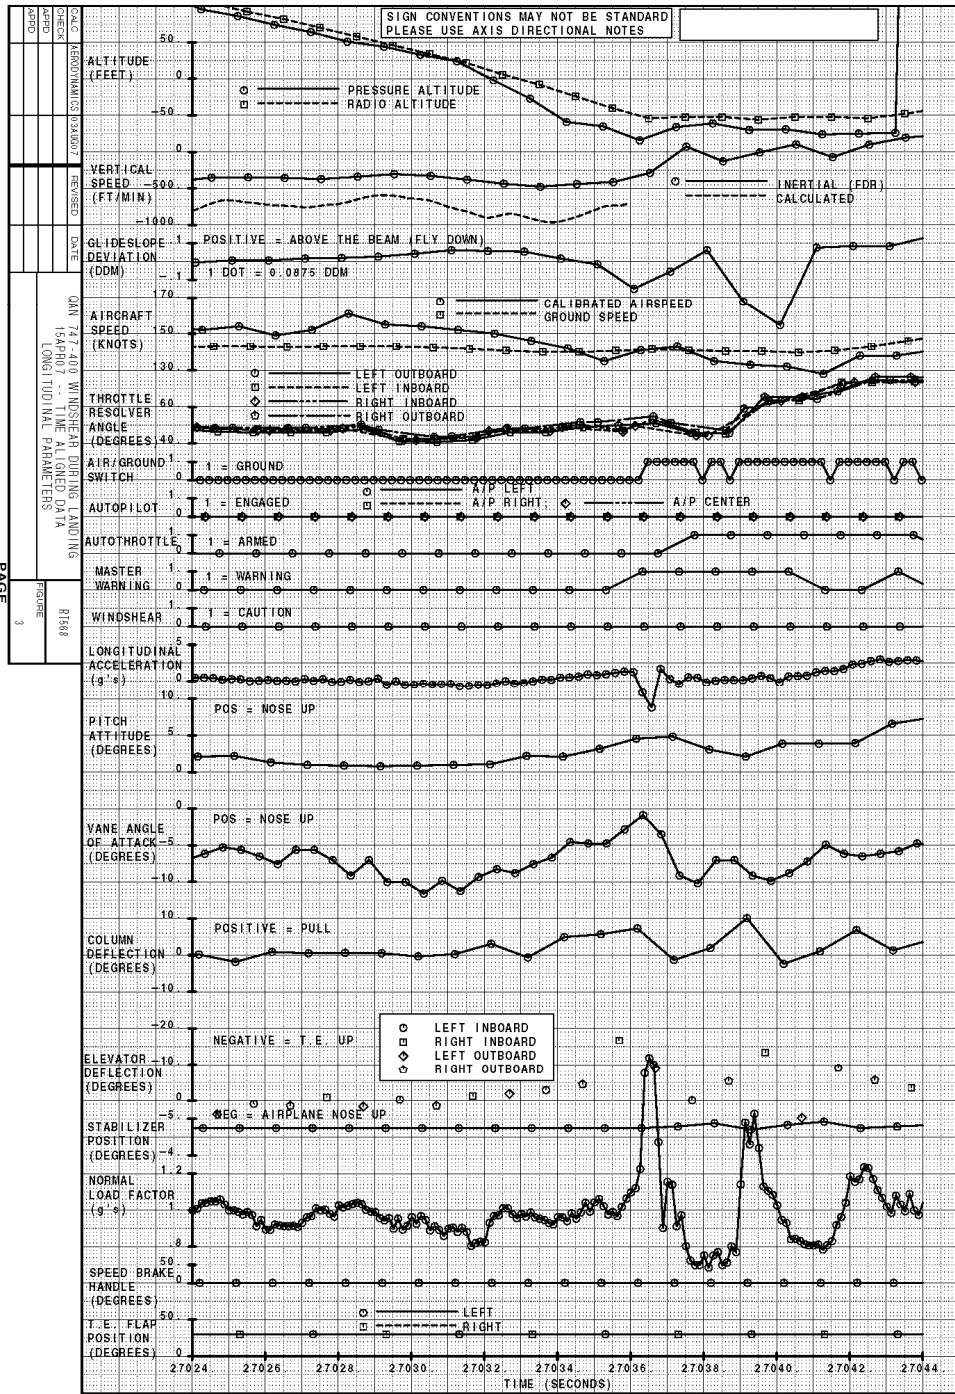
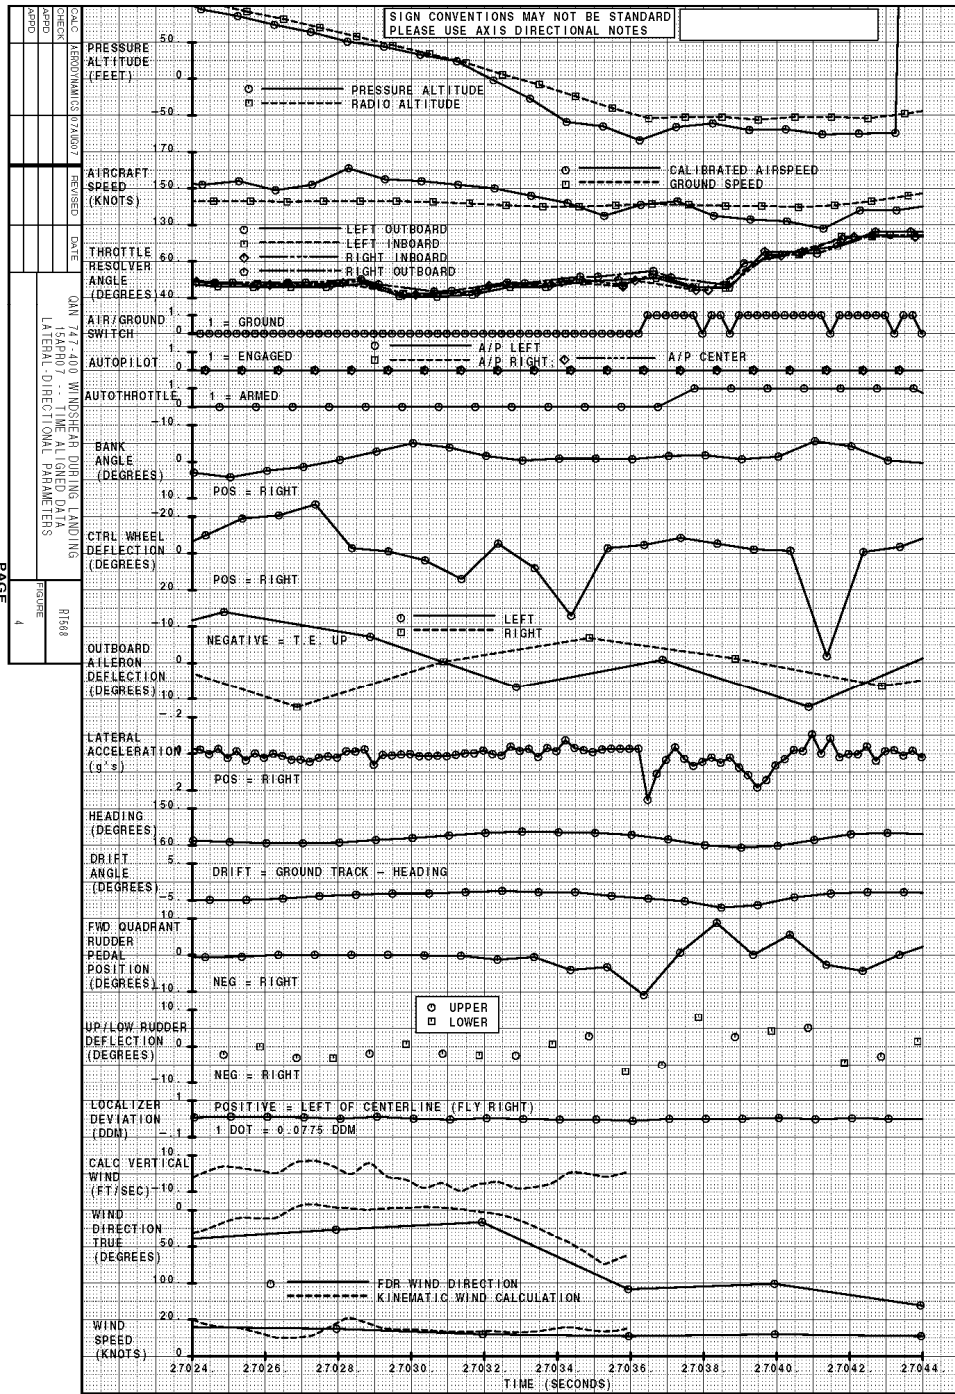
The FDR data for the event landing are plotted on Figures 1 through 4. Figures 1 and 2 show the longitudinal and lateral-directional parameters respectively for the approach and touchdown. Figures 3 and 4 show the longitudinal and lateral-directional parameters respectively for the aircraft right before and during touchdown. Figure 4 includes kinematically calculated winds and vertical speed. Parameter sign conventions were validated using previous on-ground and in-flight maneuvers available in the data.

The FDR data show the aircraft on a flaps 30 approach at a calibrated airspeed of approximately 154 knots. A comparison of the airspeed and ground speed shows a 15 knot headwind that diminished just before touchdown. The recorded gross weight of the aircraft at this time was 555,000 lbs. The appropriate V_{ref} speed for this aircraft configuration is 144 knots. The approach speed would then be calculated as follows: $V_{ref} + \frac{1}{2}$ headwind component + full gust increment (above the steady wind). The winds during the final approach were reported to be 180 degrees at 22 knots. The gust information was not reported to Boeing. Therefore, this would give an approach speed of at least 154 knots and a touchdown speed of at least 144 knots. These speeds would increase if the gust magnitude was reported to the crew as well.

At time 27029 seconds, the vertical speed began to increase (altitude reduction) as the throttles were reduced. At this same time, a vertical wind occurs, resulting in an 8 ft/sec downdraft just before touchdown. At time 27031 seconds, the thrust was then slightly increased at the same time the flare was initiated. This reduced the sink rate slightly. At time 27032 seconds, the wind direction shifted from a right quartering headwind with a magnitude of 15 knots, to a left crosswind. This shift in headwind caused a 15 knot loss in airspeed just before touchdown. A master warning triggered at time 27035 seconds, just after the aircraft experienced this loss in airspeed. The FDR Windshear caution discrete did not toggle at this time. The master warning light will be set if there is a windshear alert displayed on the primary flight display indicating that there is a windshear. It is unclear why the FDR windshear caution discrete did not toggle, however the master warning triggered near the time the crew reported seeing the windshear alert.

A 35 degree right wheel input was commanded to control the sudden left crosswind. This resulted in a lift loss from the raised spoiler panels causing the sink rate to increase. As a result of this lift and airspeed loss, the aircraft touched down with a calibrated airspeed of 141 knots, a recorded normal acceleration of 1.84 g's and a calculated sink rate of 720 ft/min (12 ft/sec). QAN reported a touchdown normal acceleration of 2.3 g's as recorded in the QAR data. The differences seen between the QAR peak value and FDR peak value

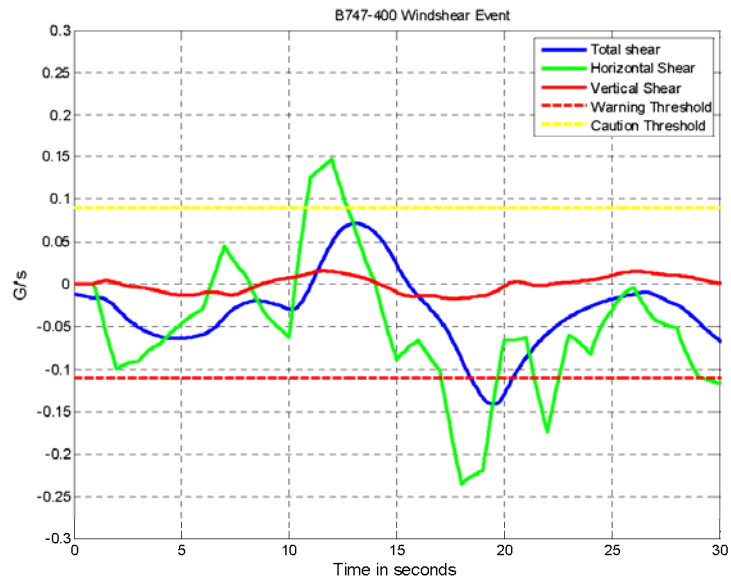
Figure 1 – Shear value

Figure 1 below shows a graph of the EGPWS calculated windshear value (total shear) versus the threshold values. The Windshear Caution threshold is set at +0.09 g's, and the Windshear Warning threshold is set to -0.11 g's. The graph also shows separate values for the horizontal and vertical Windshear components as calculated by the EGPWS.

As can be seen from the graph the Windshear Warning threshold was exceeded at time 19 seconds. The Windshear event is triggered by a large horizontal Windshear. Very little vertical shear (downdraft) is detected.
