Landing gear overspeed involving Embraer E190, VH-A2T

19 km east of Cairns Airport, Queensland, on 24 July 2025

Aviation Occurrence Investigation (Short)

AO-2025-044

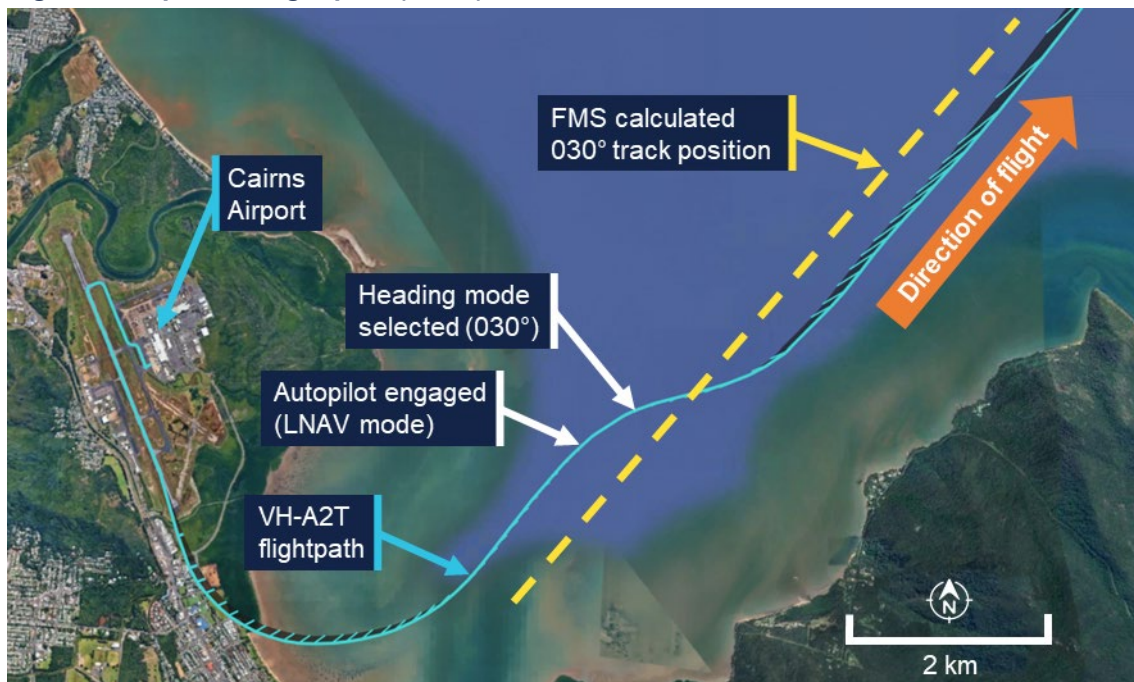
Figure 1: Departure flight path (initial)

the section titled *Flight instrumentation*) and turned onto the SID 030° track³ to the left of the FMS calculated track position (Figure 1). As the turn continued, the FMS targeted the wider track and the crew observed the flight director indications on the primary flight display unexpectedly command a right turn. The first officer briefly followed the right turn command by reducing the angle of bank from 24° left to 10° left before then increasing the angle back to 20° left to complete the turn.

Once the first officer established the aircraft on a 030° track, the autopilot was engaged while the flight director continued to indicate a right turn. The autopilot then started a right turn to intercept the FMS calculated 030° track position. At about the same time, air traffic control instructed the crew to change radio frequency. As the aircraft commenced the right turn, the captain identified the turn away from the SID track toward the high terrain and instructed the first officer to turn left to follow the 030° track. The first officer then engaged the autopilot heading mode and selected 030° and the aircraft turned left to a heading of 030° and continued climbing.

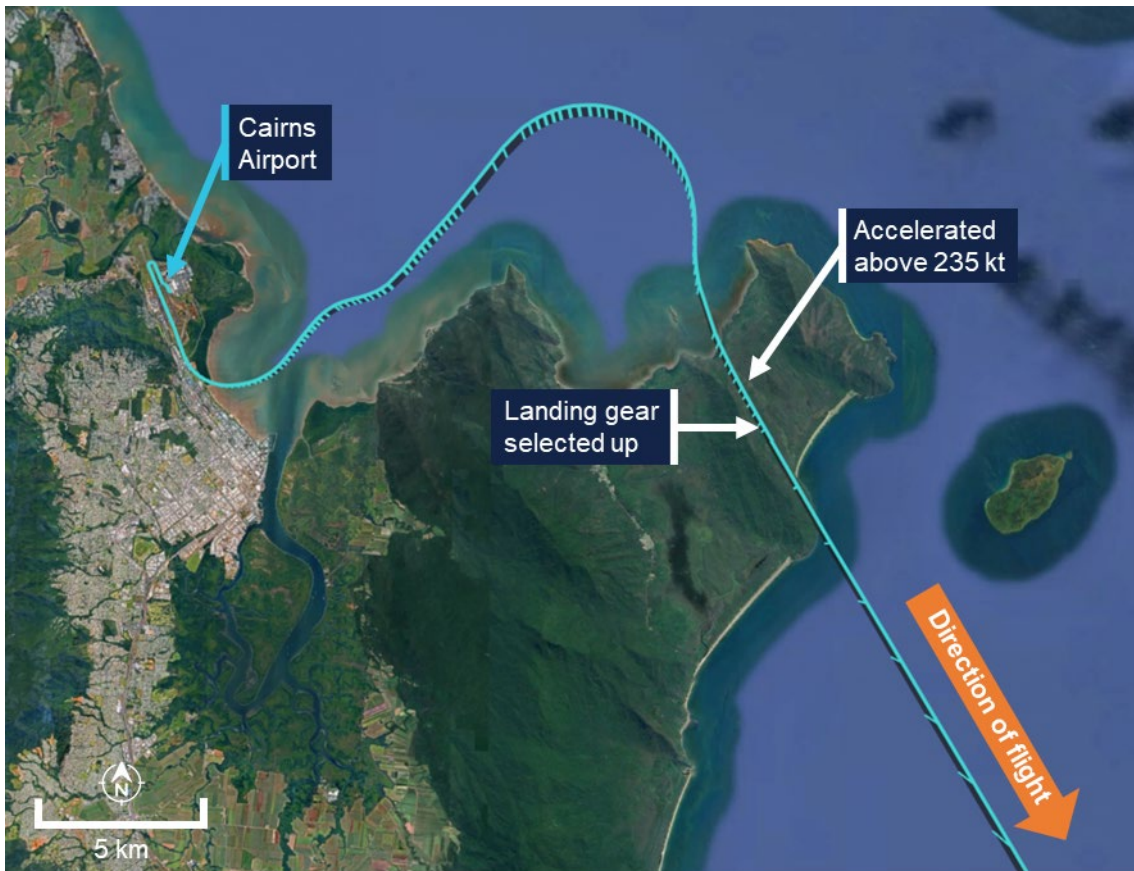
Figure 2: Departure flight path

The aircraft then continued along the SID and after climbing above 4,000 ft AMSL, turned right toward the waypoint AKROM. As the aircraft continued climbing toward AKROM, the captain, whose headset was not noise-cancelling, noted that the ambient noise was louder than expected and recognised that the landing gear was still extended. At about the same time, the first officer noted the landing gear extended indication on the EICAS. In response, while the aircraft was accelerating through 243 kt – 8 kt above the maximum landing gear retraction speed of 235 kt – the captain retracted the landing gear without first checking the indicated airspeed. The landing gear completed retracting when the aircraft had reached a speed of 252 kt, 17 kt above the maximum retraction speed (Figure 2).

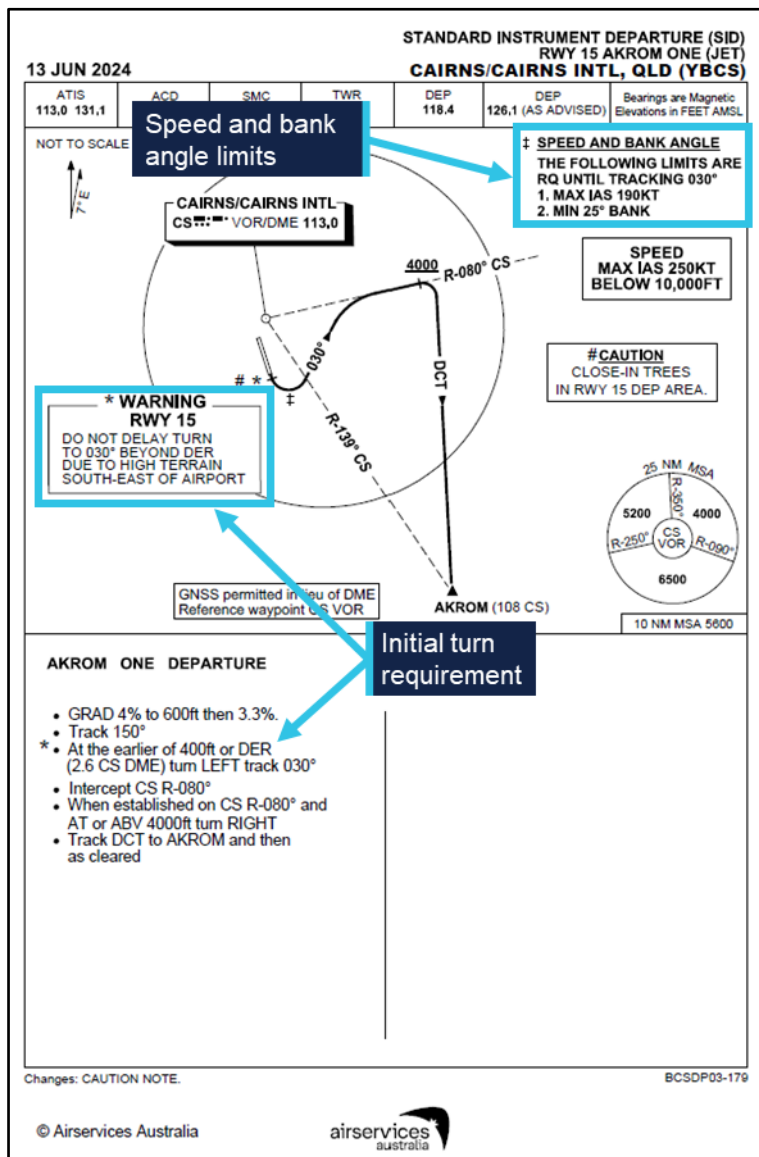
Figure 3: Runway 15 AKROM 1 standard instrument departure

(SID) required aircraft departing runway 15 to make a left turn at the earlier of either reaching 400 ft AMSL or passing the departure end of the runway (DER) (Figure 3). During the turn, flight crew needed to maintain a bank angle of at least 25° and a speed of no more than 190 kt until the aircraft was established on a track of 030°. The location of the 030° track was dependent upon both the position that the left turn was commenced and the radius of the turn. The departure required maintenance of the 030° track until intercepting the 080° radial of the Cairns very high frequency omni range navigation aid (VOR) and then followed that track until the aircraft climbed above 4,000 ft AMSL. The departure then turned to the waypoint AKROM.

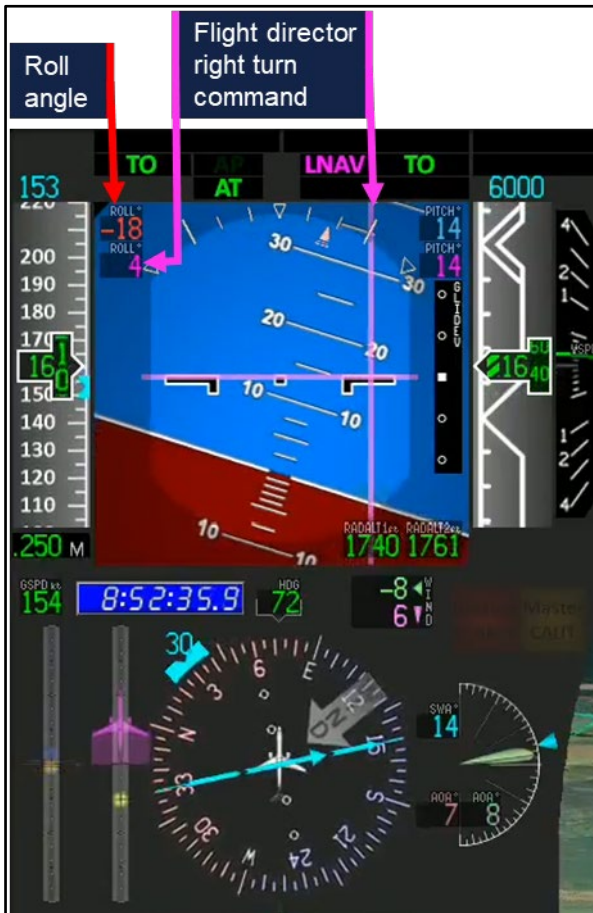
Figure 4: Representation of primary flight and navigation displays during the left turn

Subsequently, and as intended by design, the FMS did not recalculate the location of the 030° track during the turn. As a result, when the crew turned to the 030° track to the left of the FMS precalculated track, the FMS, still targeting the wider track, commanded a right turn to intercept that track (Figure 4).

Note: The figure is based on an animation of the incident. The flight director representation is different to actual aircraft, and indications are included that are not presented in the actual aircraft. Negative roll values indicated a left turn, positive a right turn.
 Source: Embraer, annotated by the ATSB

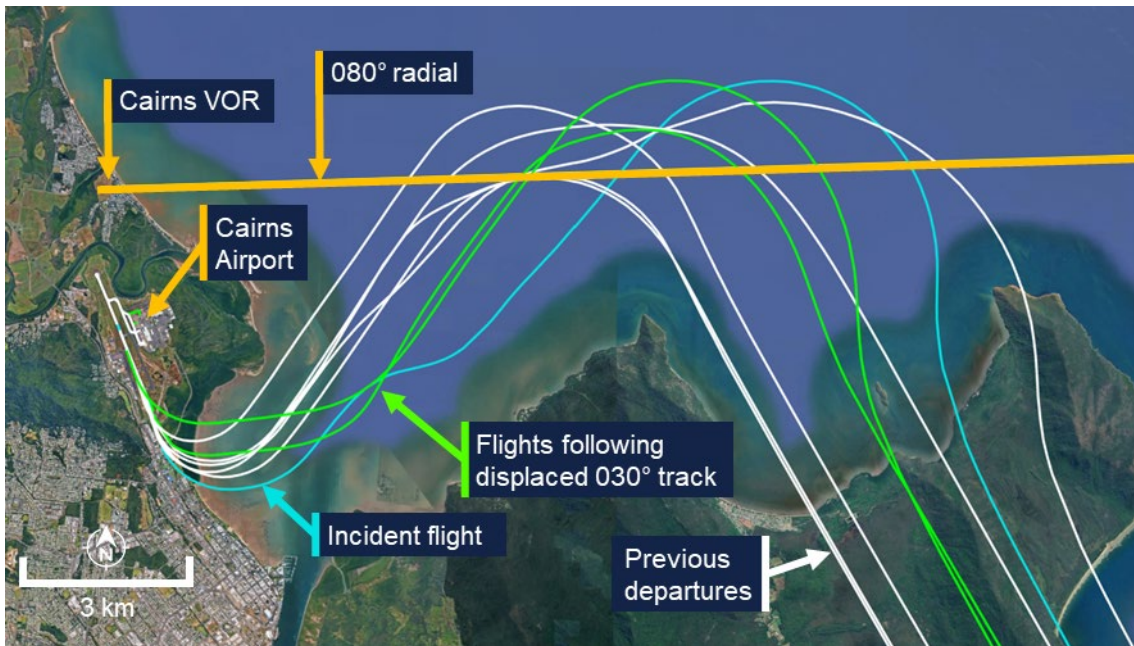
Figure 5: Departures of VH-A2T equipped with ‘load 25’ avionics

Recorded automatic dependent surveillance broadcast (ADS-B) data from previous AKROM 1 departures flown by VH-A2T identified 2 additional flights where the FMS had precalculated the 030° track at a wider location. On those occasions, the ADS-B data indicated that the flight crews followed the flight director commands and intercepted the wider track (Figure 5).

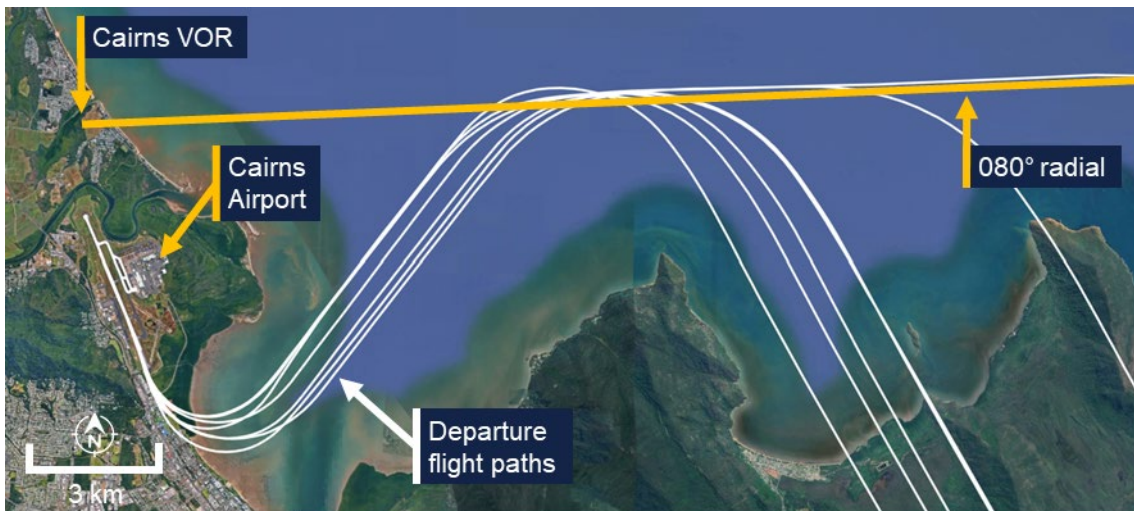
Figure 6: Departure paths of an E190 equipped with ‘load 27’ avionics

For ‘load 27’ equipped aircraft, the flight path was continuously updated as FMS track legs were flown and while in transition between them. This resulted in more accurate tracking of departure paths (Figure 6).

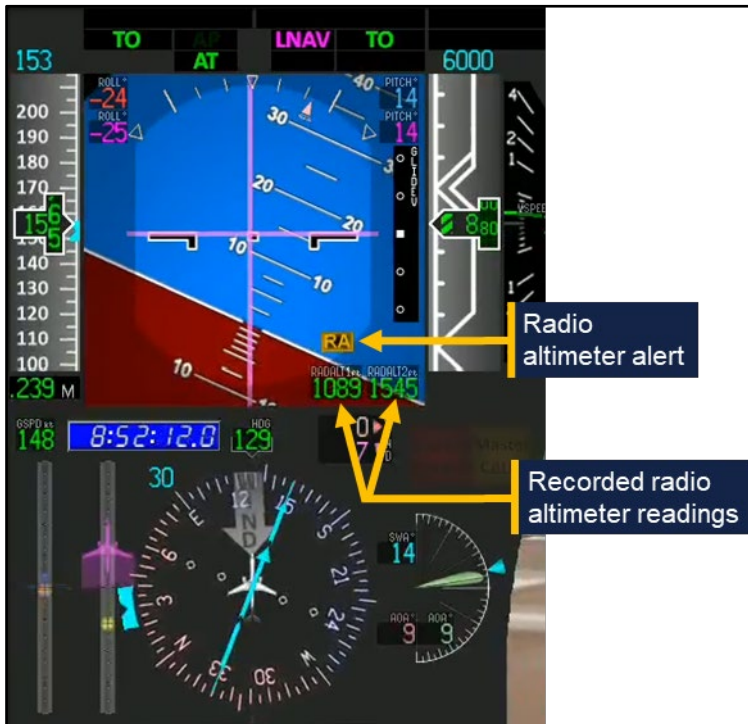
Figure 7: Radio altimeter alert

The Embraer ERJ 190 was fitted with 2 radio altimeters. These provided each crewmember with an indication of the height of the aircraft above underlying terrain measured using radio waves. When a difference in the height measured by the 2 radio altimeters exceeded a dynamic threshold, an ‘RA’ alert was presented on the primary flight display (Figure 7) and the RADALT MISCOMPARE alert was presented on the EICAS. Whenever this condition was detected, the associated EICAS message APPR 2 NOT AVAIL was also displayed.

On departure from Cairns, the alerts were generated while the aircraft was operating over relatively flat terrain and when the aircraft's pitch angle was about 14° nose up and the roll angle about 23° left. While the investigation did not determine the reason for the different radio altimeter readings that led to the radio altimeter alerts, the aircraft's pitch and roll values at the time exceeded the guidance and measurement conditions specified in the FAA circular.

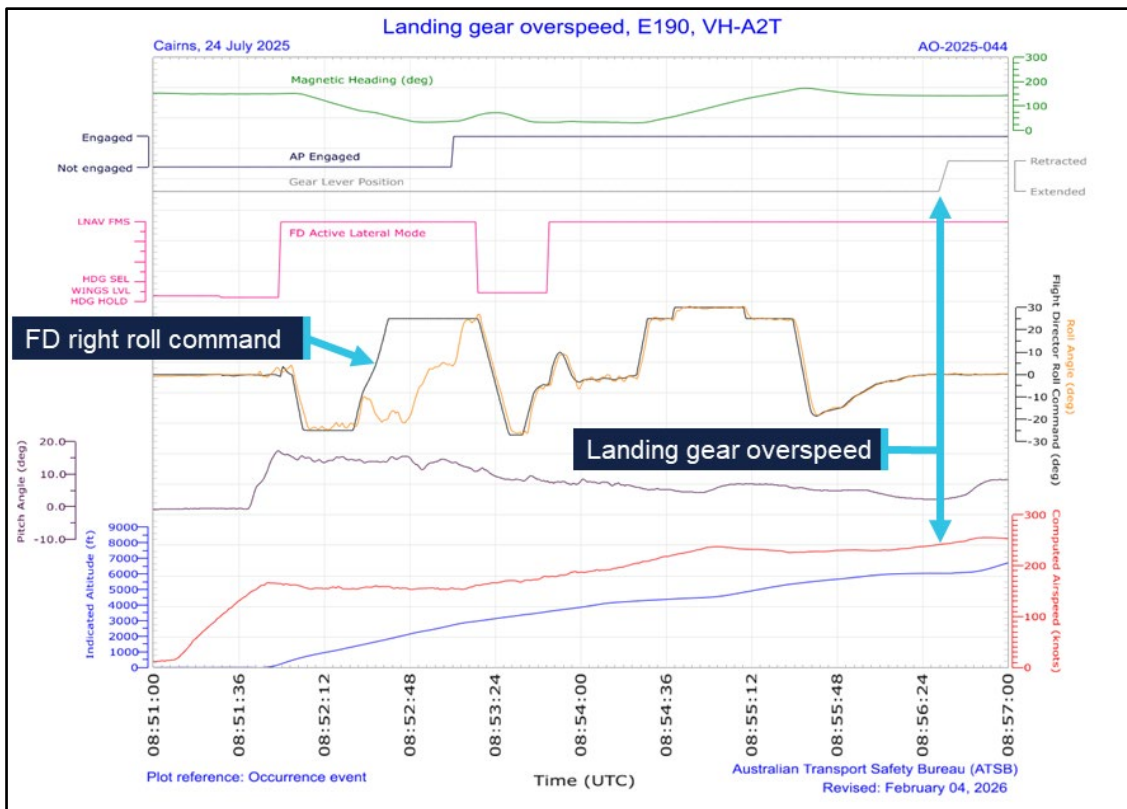
Figure 8: Recorded flight data

Analysis of flight data from the flight data recorder fitted to VH-A2T showed that the rotation rate during the take-off was 1.49 degrees per second until the aircraft was pitched 9.7° nose up and then 1.73 degrees per second until 14.9° nose up. The pitch attitude stabilised at about 16° nose up during the turn.

As the aircraft turned left through a heading of 080°, the flight director began commanding a right turn (Figure 8). At 1853:08, the autopilot was engaged in the lateral navigation mode and while the flight director continued to command a right turn. The aircraft then rolled right, following that command. At 1853:20, while flying a heading of 058° the autopilot mode changed from lateral navigation mode to heading mode with 030° selected. The aircraft then began rolling left to turn to that heading.

At 1856:35, the landing gear was selected up at a speed of 243 kt. The landing gear completed the retraction sequence at 1856:47 as the aircraft accelerated to 252 kt.
