Collision with terrain involving Beechcraft B200C, VH-PUY

near Normanton Airport, Queensland, on 6 February 2026

ATSB Transport Safety Report
Aviation Occurrence Investigation
AO-2026-060
Preliminary – 1 April 2026

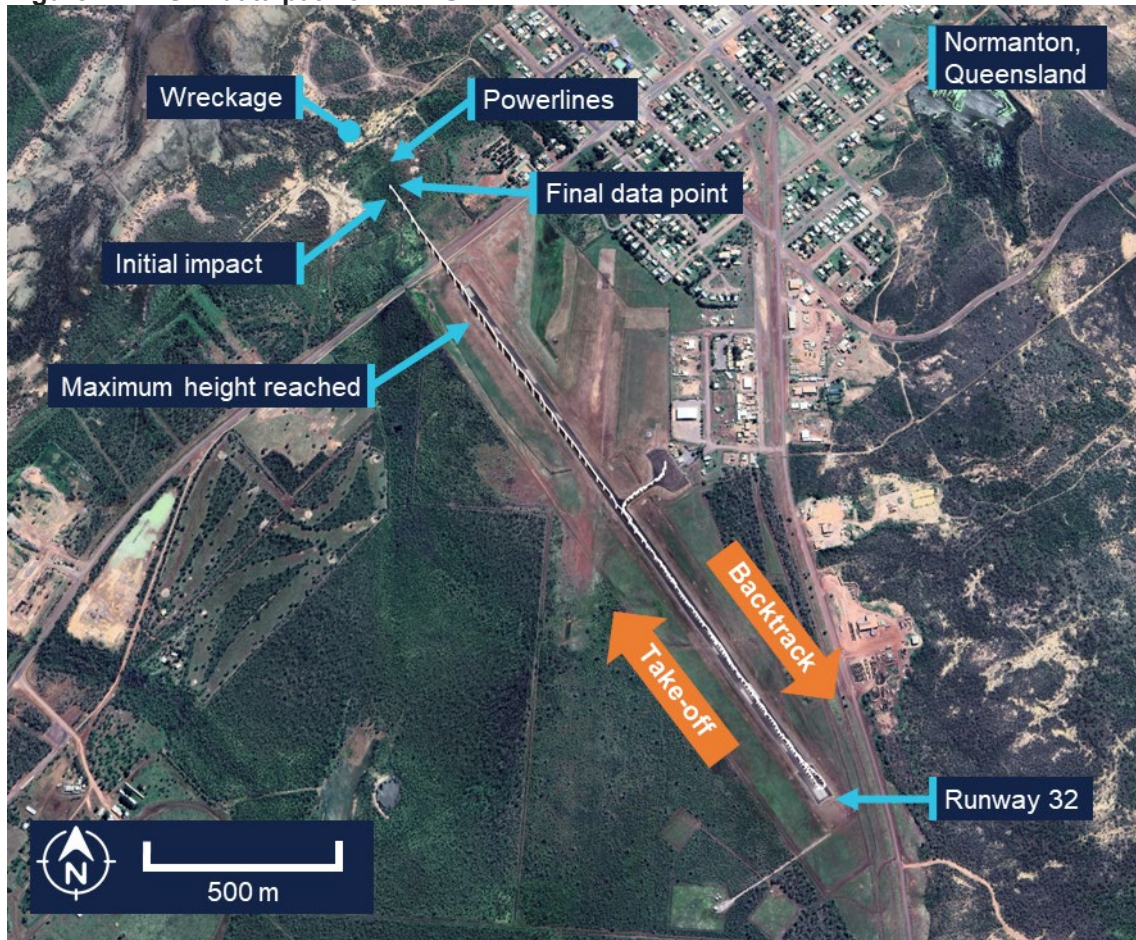
Figure 1: ADS-B data path of VH-PUY

Based on recorded ADS-B⁷ data, the aircraft commenced take-off from runway 32 at 1950. The aircraft accelerated and climbed to a maximum height of about 150 ft above ground level prior to entering a descent (Figure 1).

The aircraft impacted a small tree, 360 m from the end of the runway, prior to impacting the ground in a wings-level attitude. Following the ground impact, the aircraft slid beneath powerlines and while there was no indication that the aircraft struck the wires, it triggered a local power outage. While sliding along the ground, the aircraft commenced a gradual right yaw,⁸ impacting trees and breaking up in the process before coming to rest in flood water 580 m beyond the end of the runway.

At 1951:28, the final ADS-B position transmitted from the aircraft indicated that it:

- was 370 m beyond the end of runway 32 (after the initial impact with the tree)
- had a ground speed of 162 kt
- had descended from the previous transmitted position to that point at 1,100 fpm.

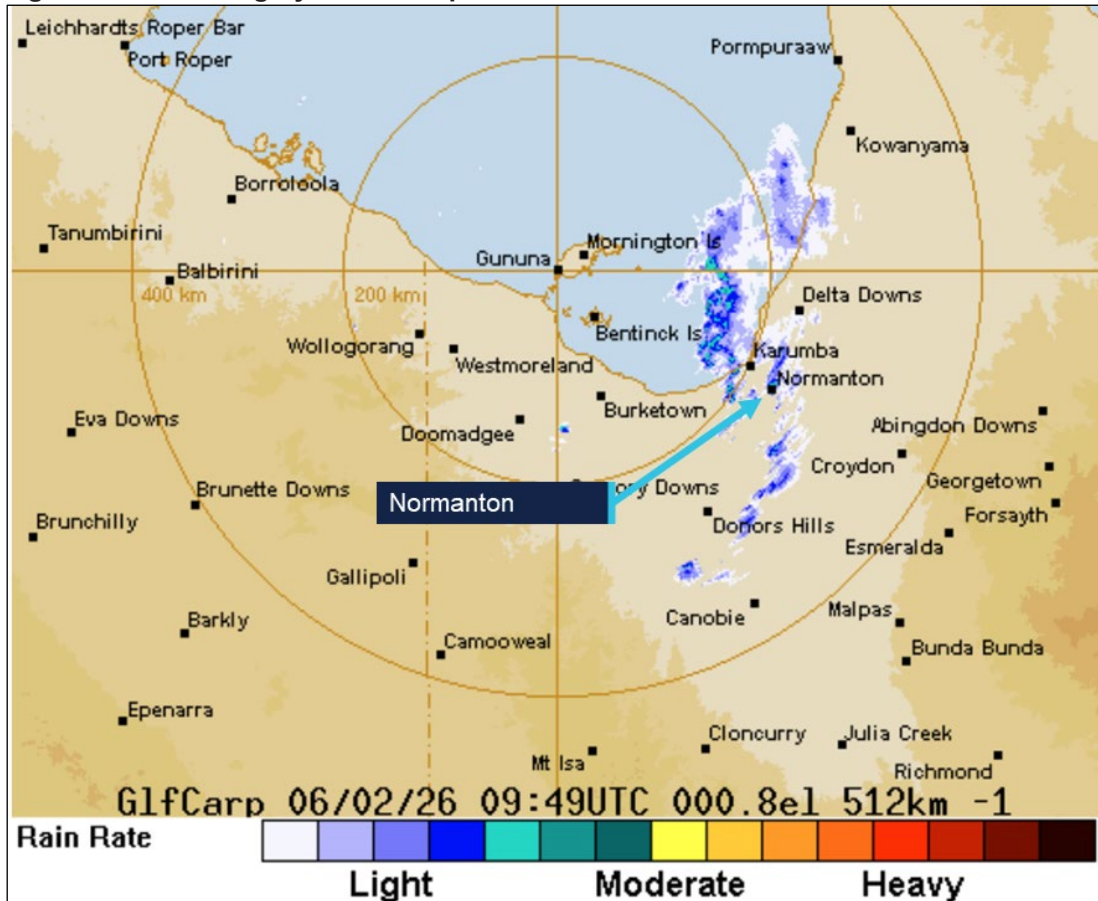
Figure 2: Radar imagery 2 minutes prior to the accident

Figure 2 shows the Bureau of Meteorology weather radar, 2 minutes prior to the accident, with light to moderate rain rate detected to the north-west of Normanton.

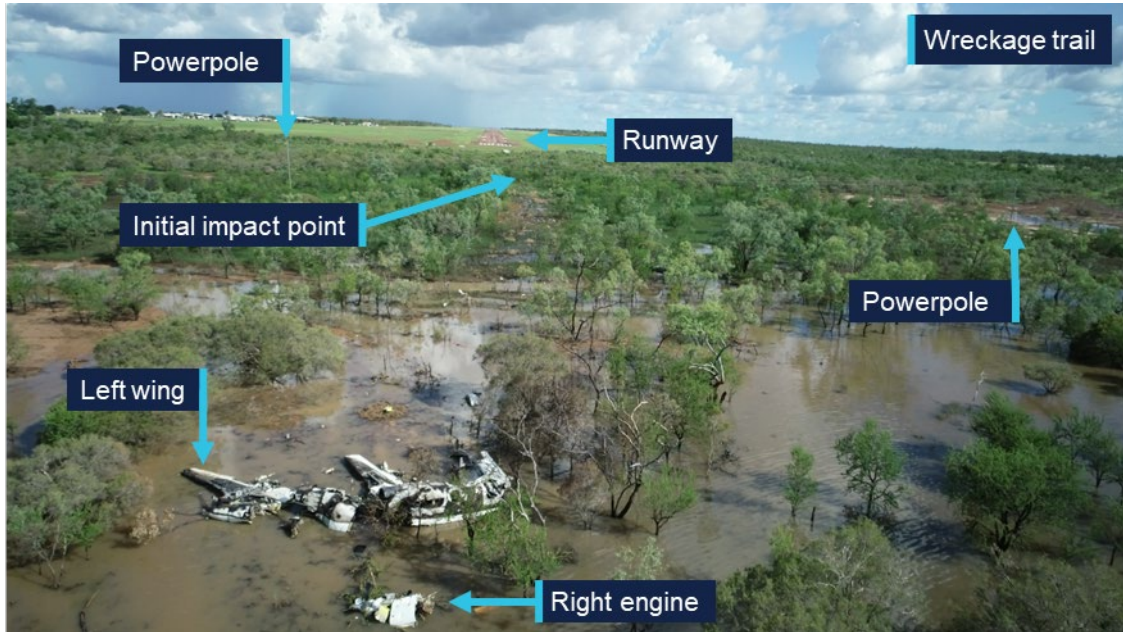
Figure 3: Wreckage trail of VH-PUY

The wreckage trail commenced at an impact mark at the top of a small tree to the left of an extended runway centreline, 360 m from the end of the runway (Figure 3). Propeller slash marks were evident on another tree approximately 20 m after the initial tree impact, followed by evidence of the aircraft fuselage's impact with the ground.

The left and right wing tips were located embedded in trees on either side of the wreckage trail, 60 m from the initial tree impact. Browning of vegetation commenced from this point onwards in the direction of travel, indicating rupturing of the wing fuel tanks. From there, the aircraft slid, underneath a set of powerlines, with a gradual right yaw that continued until its final resting place. There was no evidence of landing gear marks anywhere in the wreckage trail, indicating that all landing gear was in the 'up and locked' position.

The main fuselage was located in an upright position with the empennage fractured at the base of the vertical stabiliser (T-tail), which was lying on its right side. The cockpit had separated from the aircraft at the rear of the pilot's seat and was resting on its left side, partially submerged in water. The left wing and both engines had separated from the aircraft during the accident sequence. The fuselage, cockpit and right wing were heavily damaged from a post-impact fire.

Impact damage to the engine propellers indicated they were being driven by the engine during the impact sequence. All flight controls were located with the aircraft and measurements were taken of the flap, rudder trim and elevator trim actuators for further analysis.
