Engine failure involving Boeing 737, VH-VYH

Sydney Airport, New South Wales, on 8 November 2024

Aviation Occurrence Investigation (Short)

AO-2024-057

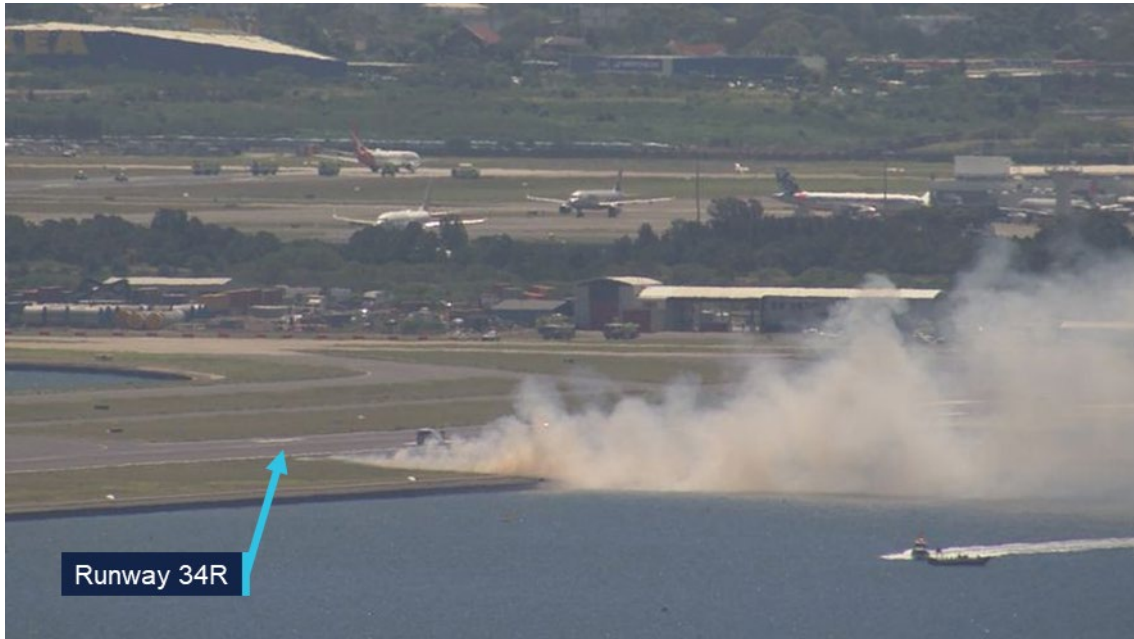
Figure 1: Grass fire next to runway 34R

The flight crew requested a return to Sydney Airport and ATC directed the flight accordingly. The aircraft was slightly over its maximum landing weight due to unspent fuel, and the expected landing distance was higher for a single engine landing. The flight crew therefore planned to land on runway 34L, which was longer than runway 34R (3,962 m vs. 2,438 m). In addition, ATC closed runway 34R, due to fragments from the engine, which ignited a grass fire next to the runway (Figure 1).

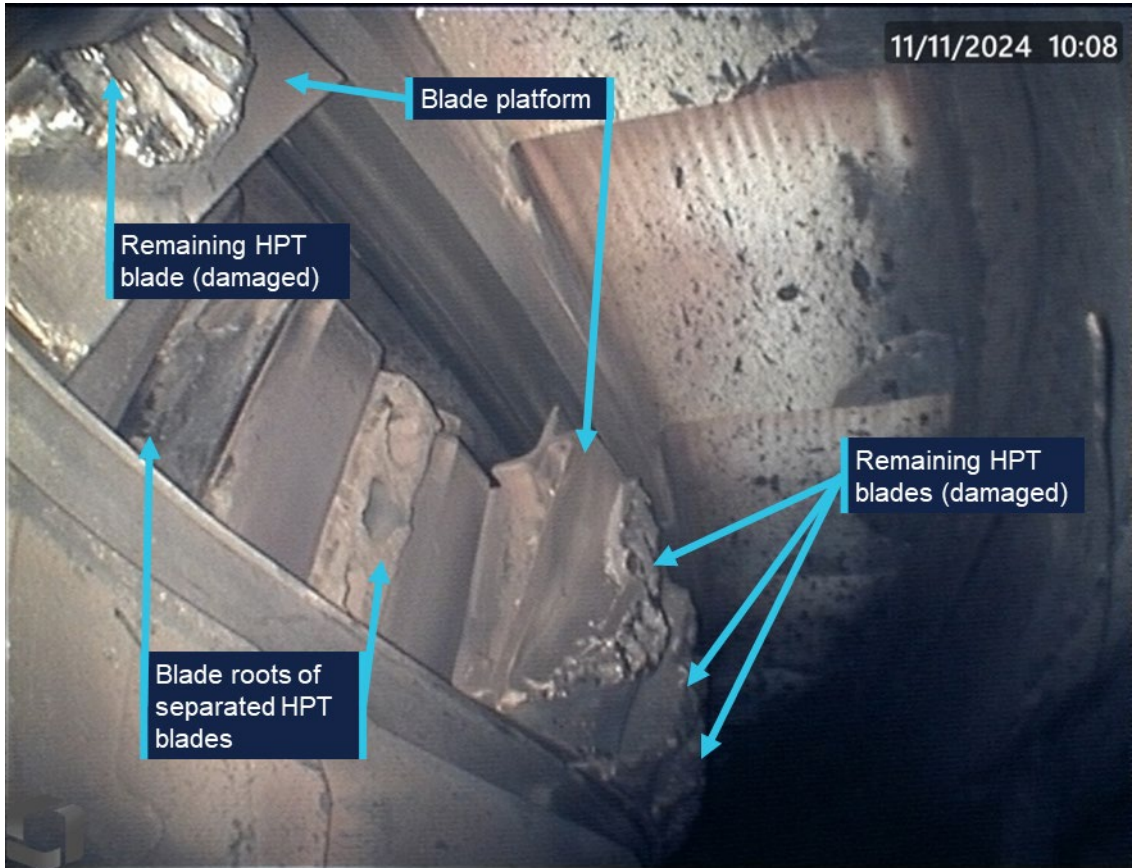
Figure 2: Below-platform separation of 2 HPT blades

The failed right engine was inspected for damage by Qantas engineering personnel. Examination of the engine confirmed that the engine failure was contained. Borescope imagery found that 2 high-pressure turbine (HPT) blades had undergone a below-platform separation from the HPT disc (Figure 2).

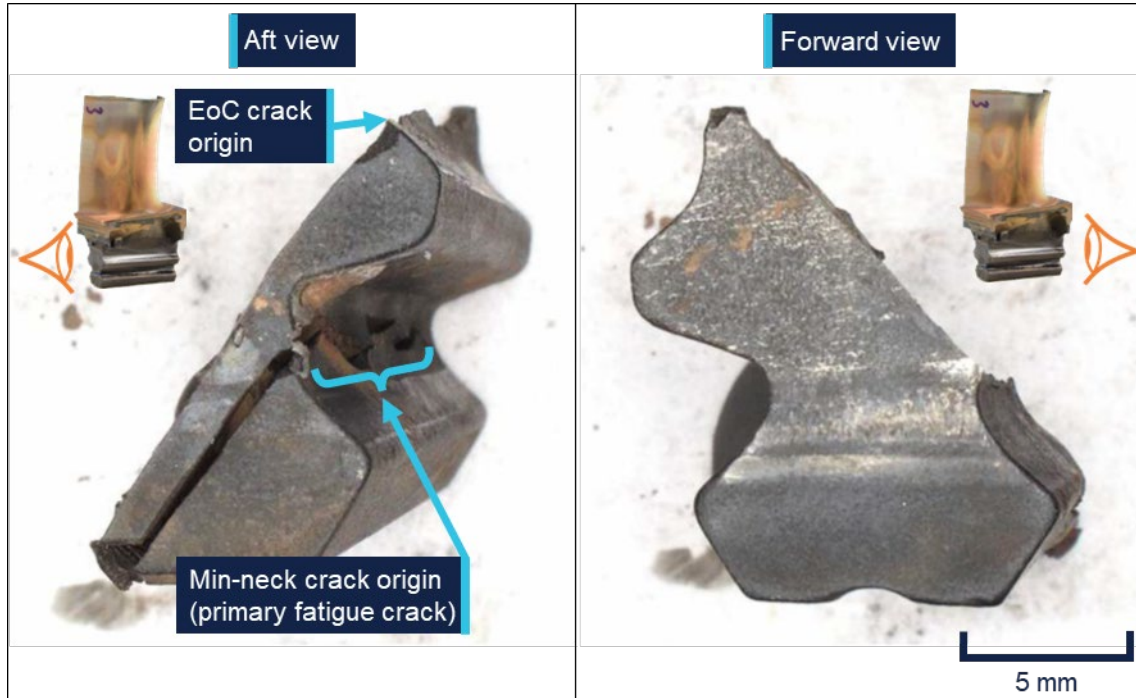
Figure 6: Dovetail of blade 50 recovered from the HPT disc

Blade number 50 was one of the 2 blades that experienced a below-platform failure. It exhibited the most extensive fatigue cracking. Conversely, the other blade with a below-platform failure, blade 51, exhibited no evidence of fatigue, failing purely due to tensile overstress. The manufacturer noted that there had been previous occurrences involving a below-platform fatigue failure where the adjacent blade failed in the dovetail due to tensile overstress resulting from contact with the liberated blade. The remaining 74 blades failed due to overstress fractures at the base of each aerofoil.

The fracture morphology of blade number 50 was examined to determine how the cracking progressed. The dovetail recovered from the HPT disc is shown in Figure 6.

The edge-of-contact (EoC) crack originated where the blade made contact with the HPT disc during normal operation. The min-neck crack originated where the dovetail's cross-section was at its thinnest.
 Source: CFM International, annotated by the ATSB

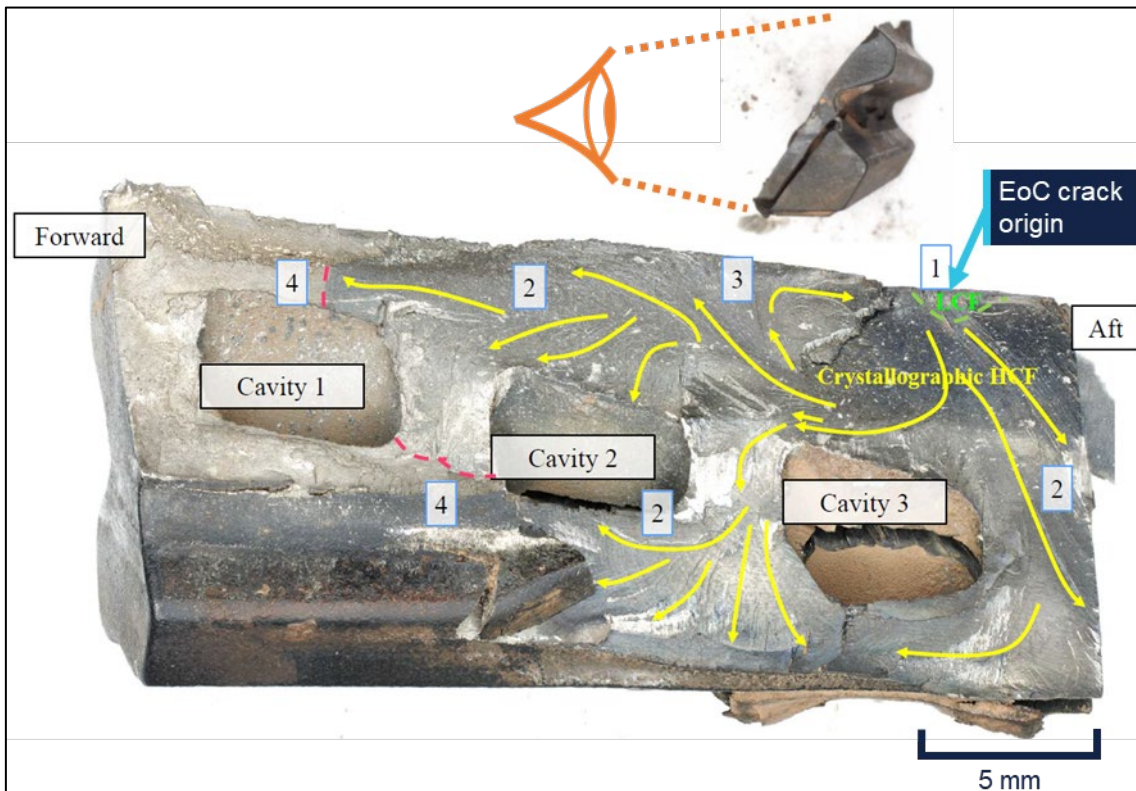
Figure 7: Concave view of the edge-of-contact fracture surface

There were 2 fatigue cracks observed, propagating in a diagonally downward direction on parallel planes. These cracks initiated with small regions of low-cycle fatigue³ (LCF) which transitioned to a larger high-cycle fatigue⁴ (HCF) region. One crack originated at what the manufacturer described as the ‘edge-of-contact’ or ‘EoC’, where the blade contacted the HPT disc during normal operation. This crack propagated through approximately 70% of the dovetail cross-section. This resulted in an overstress failure of the remaining 30%, liberating the top section of the blade, including the platform and aerofoil, from the HPT disc. The edge-of-contact fracture as viewed from the concave side of the blade is shown in Figure 7.

From the crack origin, LCF cracking propagated to the green dashed line. The fracture morphology then transitioned to HCF, which propagated along crystal planes within the material until it reached the red dashed lines. The remaining material then failed in overstress, resulting in the top section of the blade becoming liberated from the HPT disc.
 Source: CFM International, modified by the ATSB

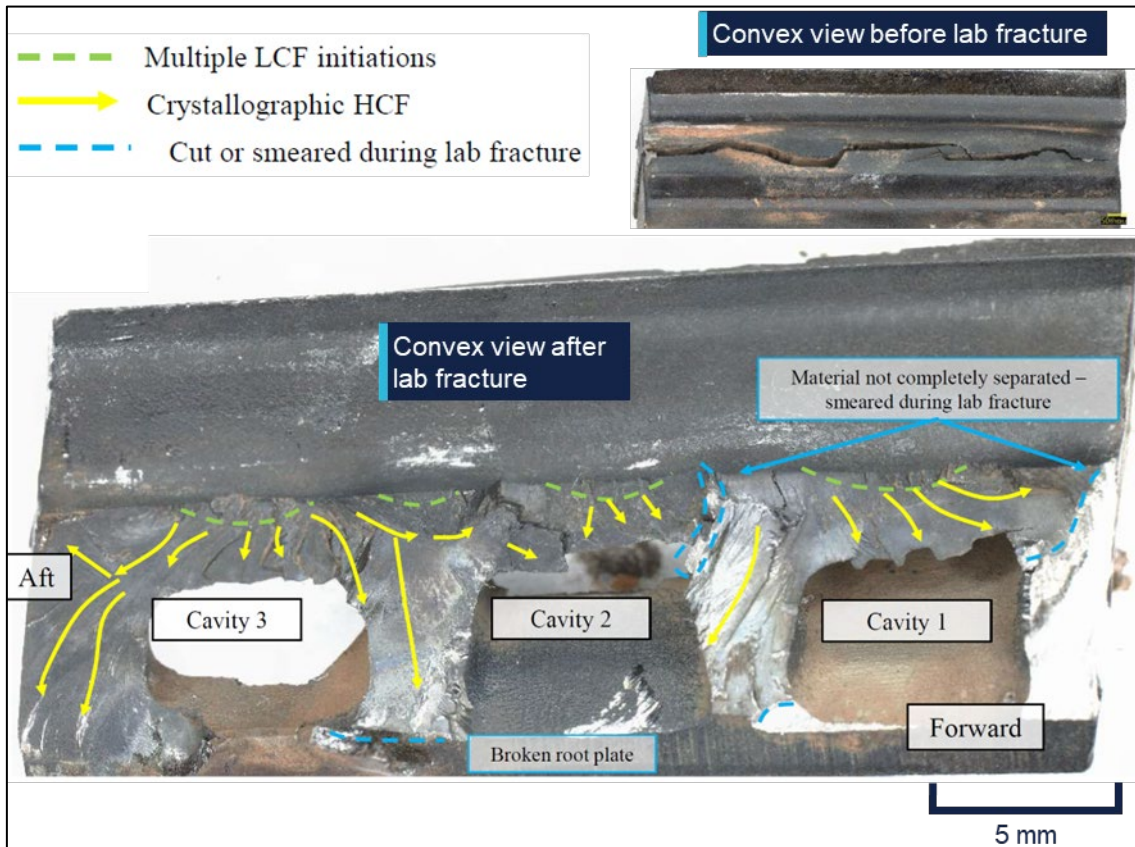
Figure 8: Convex view of the min-neck fracture surface

The other crack originated in the min-neck region of the dovetail. This crack propagated through approximately 80% of the dovetail’s cross-section. The remaining cross-section was still intact when the blade separated. As part of the manufacturer’s examination, the remaining material was fractured in the laboratory, and the crack opened for inspection (Figure 8).

Multiple crack origins were observed, from which LCF propagated in small thumbnails. These fatigue cracks transitioned to HCF travelling along crystal planes within the material, consuming approximately 80% of the dovetail's cross-section.
Source: CFM International, annotated by the ATSB

The manufacturer's analysis found that the min-neck cracking observed in blade 50 was the primary fracture within the blade. As the cracking propagated downward through the blade, tensile forces from disc rotation could no longer be effectively transmitted to the bottom half of the dovetail. Consequently, excessive force was placed on the top half, resulting in the propagation of the edge-of-contact crack and eventual separation of the blade.

In March 2025, as a result of its ongoing reliability monitoring, the engine manufacturer published a revised RRT for 2403M91P03 blade configurations, reducing it to 17,200 cycles. The 2403M91P02 fleet reliability was found to be consistent with existing reliability targets and was not adjusted. The more recent 2403M91P06 blade design included an adjusted dovetail geometry in order to reduce instances of min-neck fatigue cracking.
