Runway excursion involving Cessna 310, VH-NXA

Lake Evella Aerodrome, Northern Territory, on 29 May 2025

ATSB Transport Safety Report

AO-2025-024

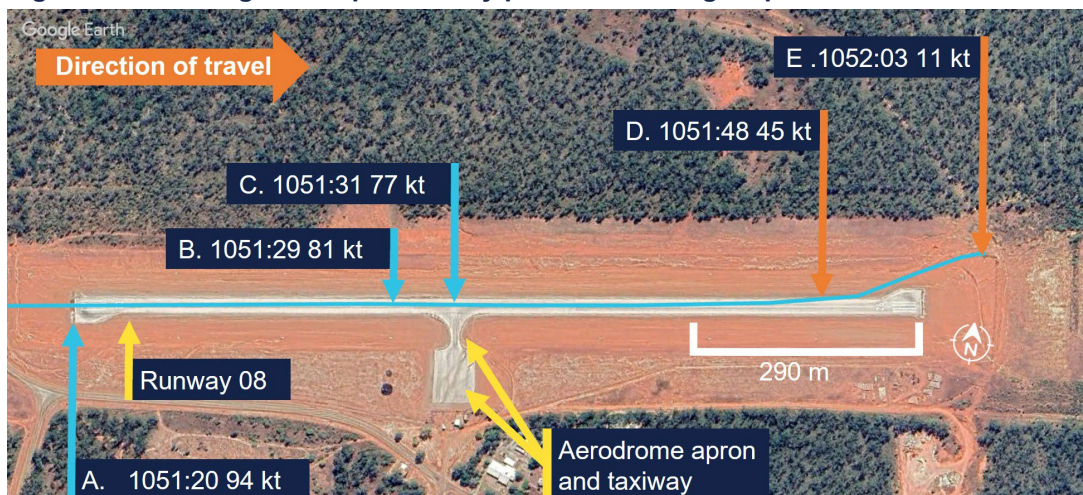
Figure 2: VH-NXA ground speed at key points in landing sequence

The pilot and the passenger seated directly behind them estimated that the aircraft touched down approximately 200 m past the threshold. ATSB analysis of recorded data indicated touchdown at 1051:29 (the corrected altitude of the aircraft matched the terrain elevation of runway 08), which was 402 m past the threshold (Figure 2, B). The passenger seated in the front row beside the pilot recalled passing the taxiway immediately after touchdown (Figure 2, C).

Another pilot on the ground standing at the apron who witnessed the landing reported observing VH-NXA a few feet above the ground in the ‘flaring attitude’ about a third of the distance along the runway. They also recalled that the aircraft was travelling faster than what they thought was normal and landed just beyond the taxiway (Figure 2, C).

The pilot reported that after touchdown, they applied the brakes passing the apron area about halfway along the runway (Figure 2, C). At that point, they reported that the aircraft did not appear to be slowing as expected and the passenger in the last row recalled the aircraft passing the apron ‘very fast’.

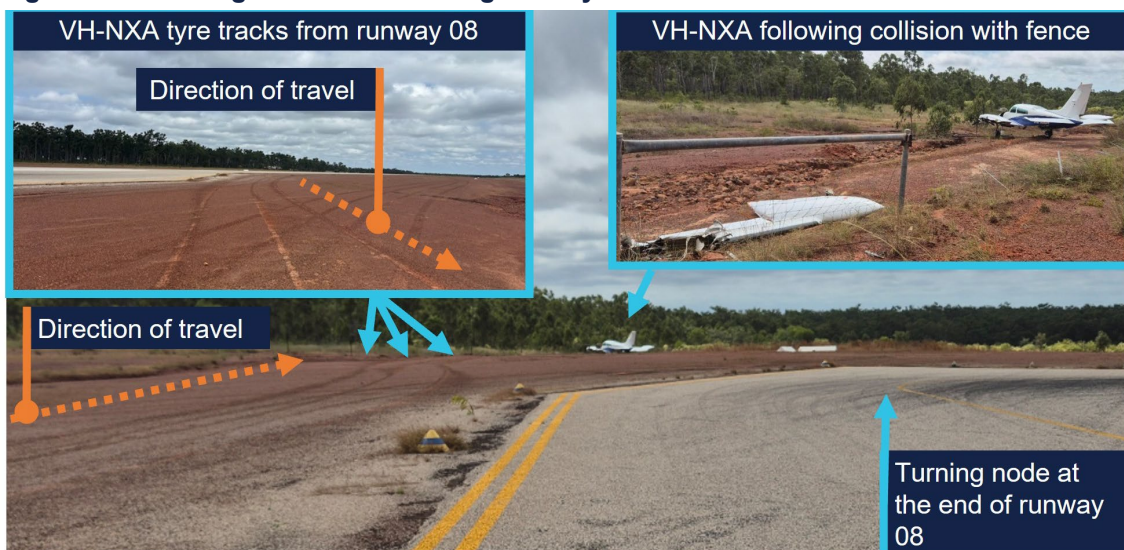
Figure 3: VH-NXA ground roll following runway excursion

The aircraft departed the left side of the runway, 118 m from the runway end (Figure 2, D) (Figure 3, inset left), while the passenger seated beside the pilot verbally prompted the passengers to ‘brace.’ Recorded data indicated the aircraft was travelling at 45 kt at this point. The left wing subsequently collided with a fencepost (Figure 2, E) (Figure 3, inset right) located 193 m from the point the aircraft departed the runway.

Following the collision, the aircraft came to a stop and the pilot and passengers disembarked through the right cabin door. There were no injuries to the pilot or passengers, however the aircraft sustained substantial damage (see *Post-accident inspection*).

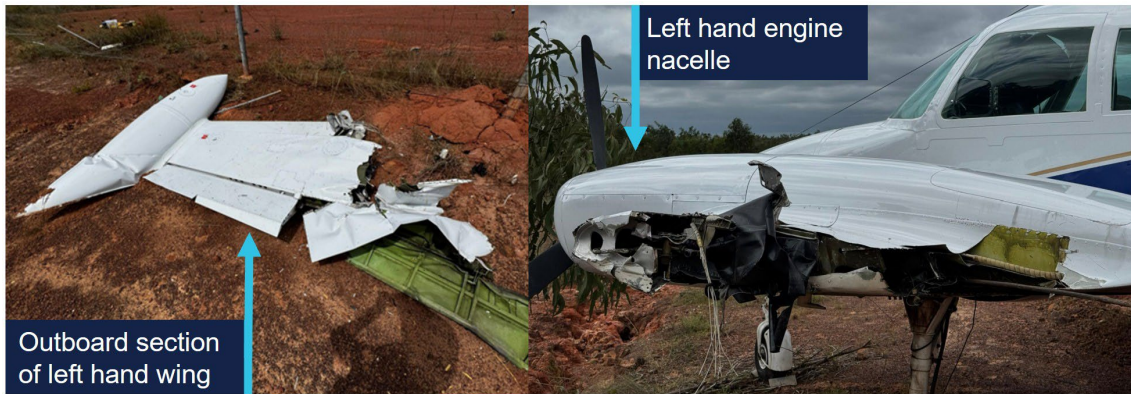
Figure 4: VH-NXA damaged left wing

Following the occurrence, the LAME inspected the aircraft at Lake Evella Aerodrome on 18 June 2025 and documented the aircraft damage. The aircraft had sustained significant damage to the left wing (Figure 4), which separated from the fuselage outboard of the left engine nacelle. The pitot tube, right tip tank, propeller and nose gear door were also damaged following the runway excursion.

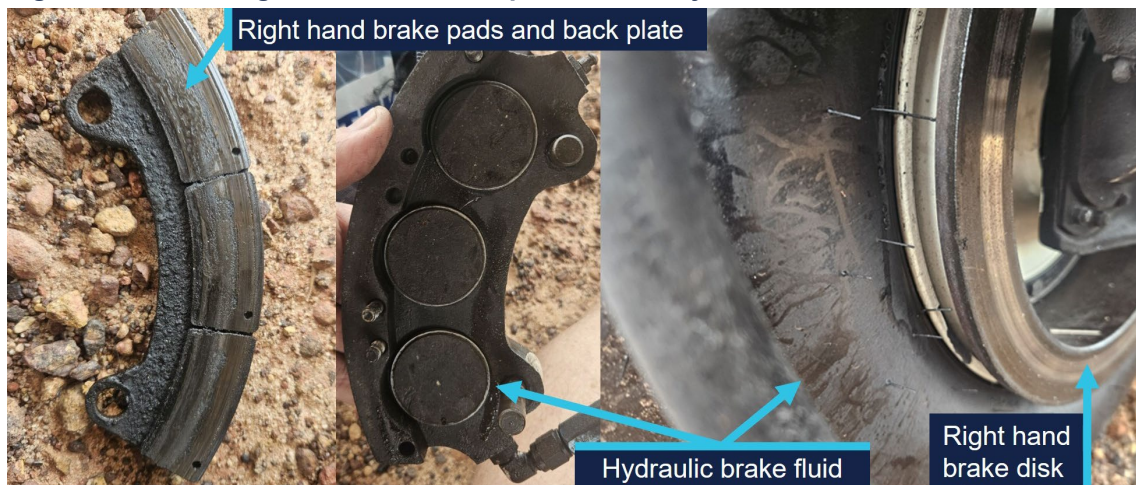
Figure 5: VH-NXA right hand brake components and hydraulic brake fluid

The LAME found that the right brake reservoir was empty, with evidence of hydraulic fluid leakage on the right tyre, however stated that the right brake disc was serviceable.

They identified that the right brake pads were ‘heavily worn.’ Images supplied by the LAME also indicated the presence of hydraulic brake fluid, originating from the brake piston adjacent to the brake line (Figure 5). They also indicated that the hydraulic fluid on the tyre may have been from fluid spilling when the brakes were topped up on the morning of the occurrence flight.

No defects were identified on the left brake system and the right brake calliper was removed and tested in Darwin by the LAME. The right brake calliper was bolted onto a brake disc with sufficient pressure applied to prevent calliper movement. After 13 days, sufficient hydraulic fluid had leaked, which allowed the calliper to be moved in relation to the brake disc. The LAME subsequently disassembled the right brake calliper and identified a ‘very small’ hydraulic fluid leak, which they did not consider was the cause of the fluid loss during the occurrence.

Due to the worn right brake pad and the lack of hydraulic fluid in the right brake system, there was insufficient braking capacity available to prevent a runway overrun following the landing and the application of brakes about halfway along the runway.

D & T Aircraft Engineering advised that, following the occurrence, a debrief with maintenance personnel highlighted the importance of increased vigilance during inspections conducted after maintenance tasks, and that the organisation also identified opportunities to improve internal processes following similar occurrences.

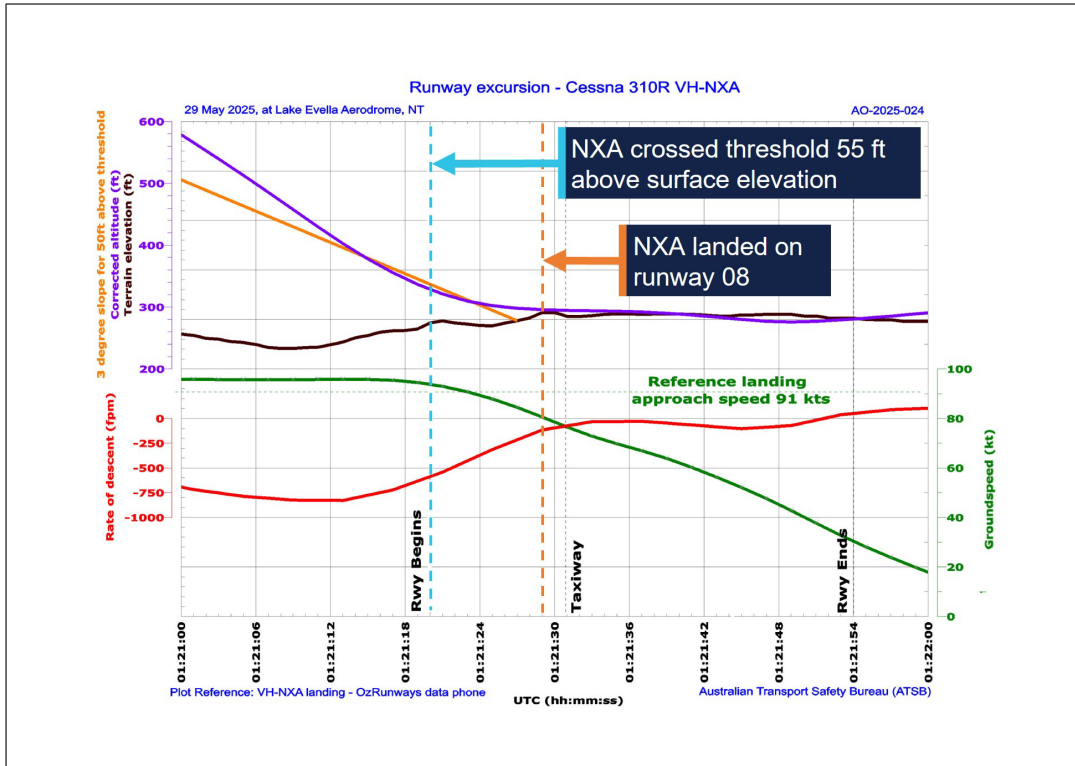
Figure 6: VH-NXA approach and landing

At 1051:29, the corrected altitude of the aircraft matched the terrain elevation, which indicated that the aircraft landed 402 m along the runway with a groundspeed of 81 kt. The pilot reported applying brakes as the aircraft passed the apron area, which occurred about 2 seconds after touchdown. Following a ground roll distance of about 540 m, the aircraft decelerated to a groundspeed of 45 kt when it vacated the left side of the runway at 1051:48.
