Derailment involving Pacific National freight train 2BS4

near Kyogle, New South Wales, on 31 May 2022

ATSB Transport Safety Report
Rail Occurrence Investigation (Defined)
RO-2022-006
Final – 08 April 2026

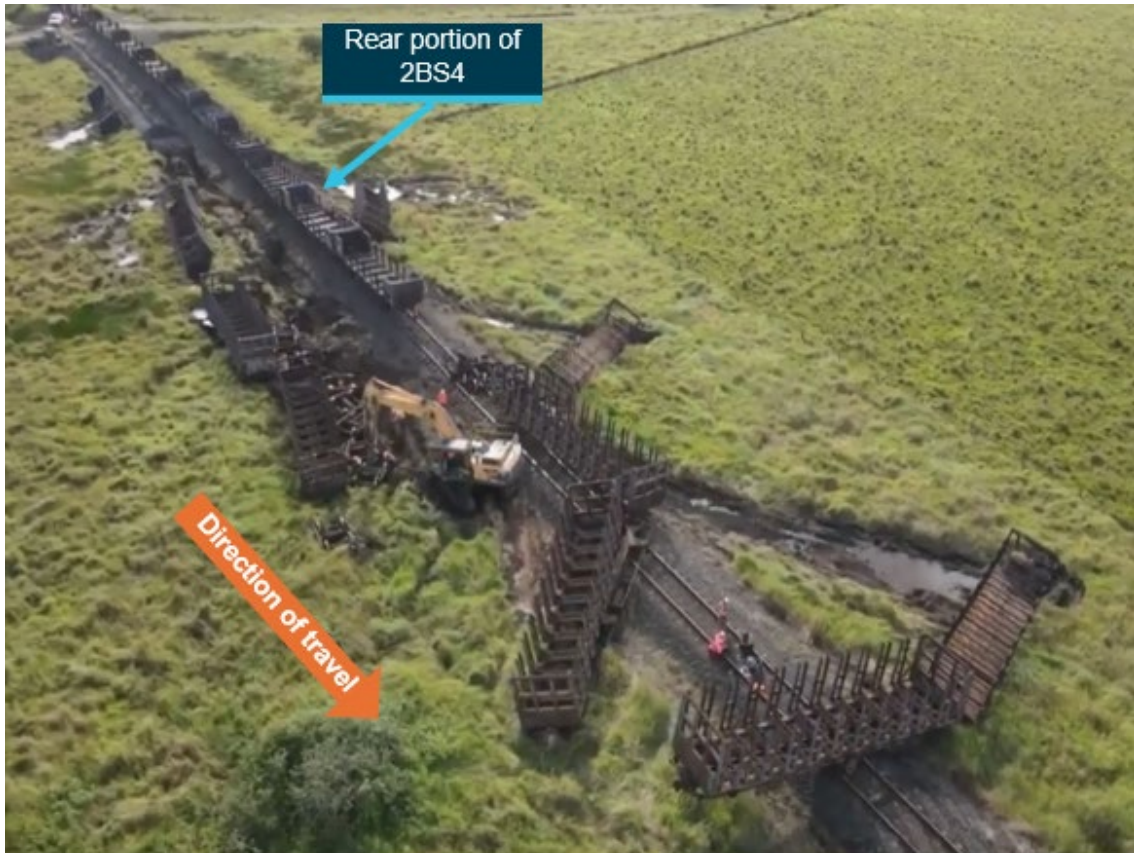
Figure 1: Top view of derailment

A total of 11 empty wagons were found to have derailed in the incident, out of the consist of 56.

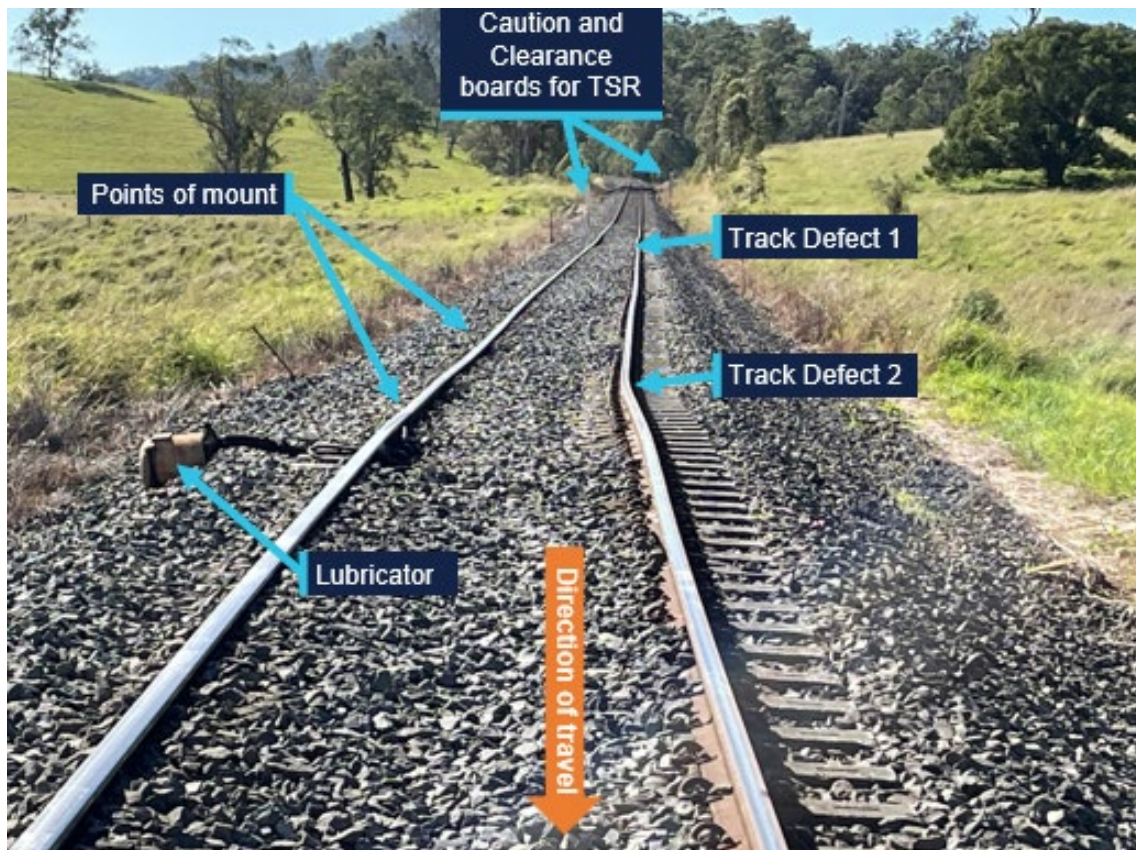
Figure 9: Post-incident view of track at point of initial derailment, facing in the down direction

Onsite photographic evidence of the track at the initial derailment location showed a significant loss of top, line and superelevation/cross level.

There was a sign posted temporary speed restriction in place of 20 km/h between 828.350 km and 828.450 km.

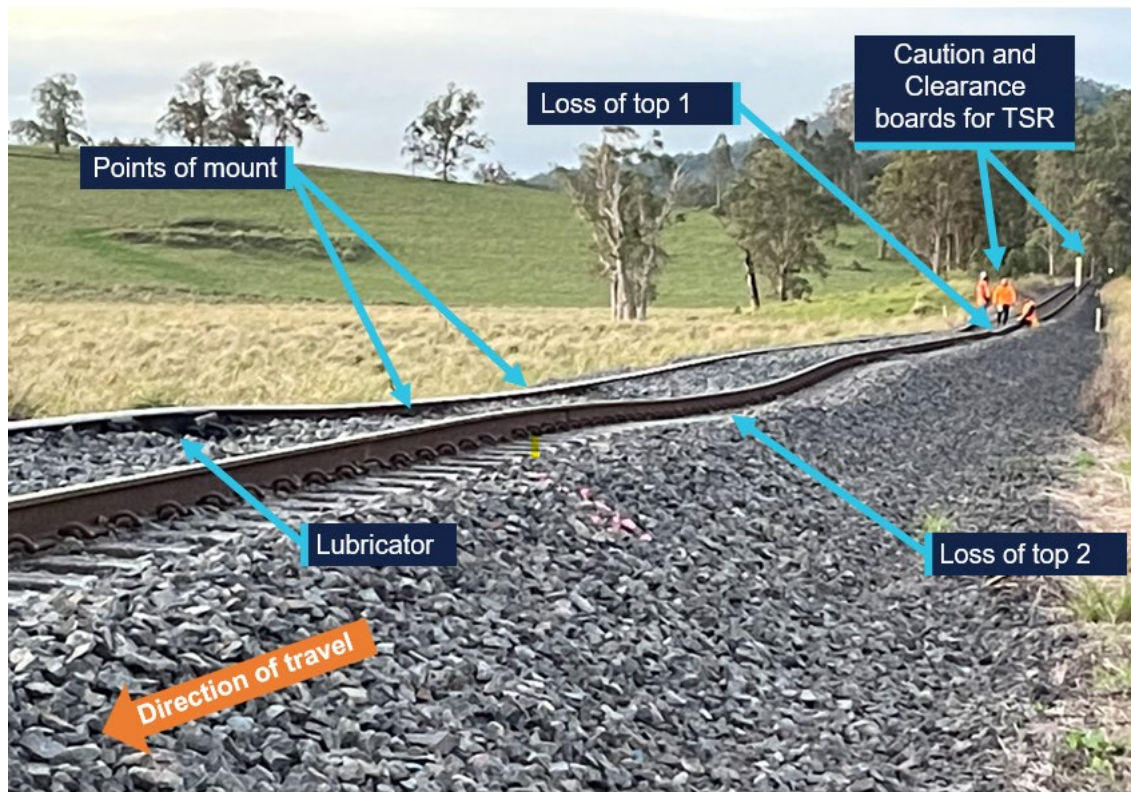
Figure 10: Post-incident view of track at point of initial derailment, facing in the down direction

Site photos post-incident showed significant water saturation of the surrounding area, within the TSR boundaries. There was also notable sinking of the ballast at 2 locations, which had caused visible top depressions of the track.

Side view of track, demonstrating the loss of top due to sinking soft formation.
Source: OTSI

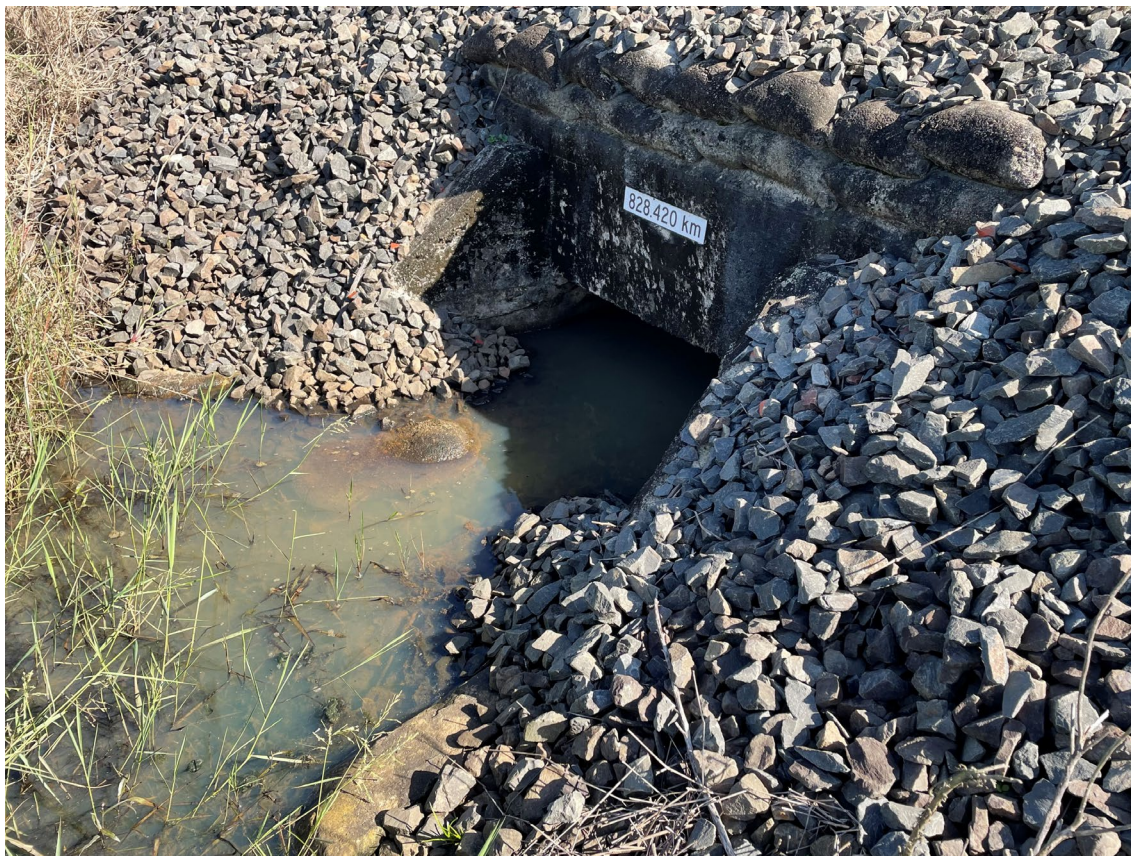
Figure 11: Drainage culvert beneath initial derailment location

Track maintenance records for scheduled track inspection and tamping activities that took place at this location prior to the incident made no mention of such significant formation issues, or that soft formation had been considered as the potential cause for repeated track geometry issues (see History and management of track defect).

Drainage culvert directly below initial derailment site (828.420 km) showing pooled water beneath the track and formation.
Source: OTSI

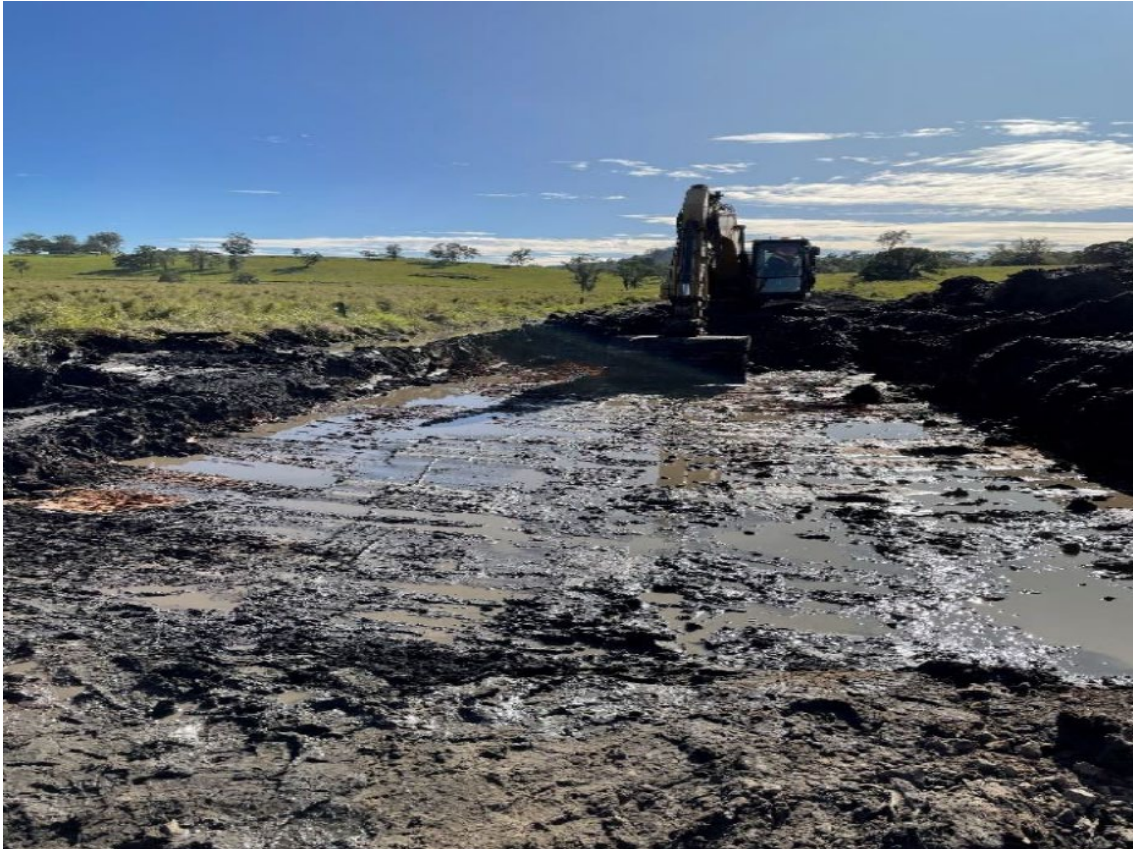
Figure 12: ARTC post-incident track works

A significant amount of mud and water was found under the formation during post-derailment rectification works.
Source: ARTC

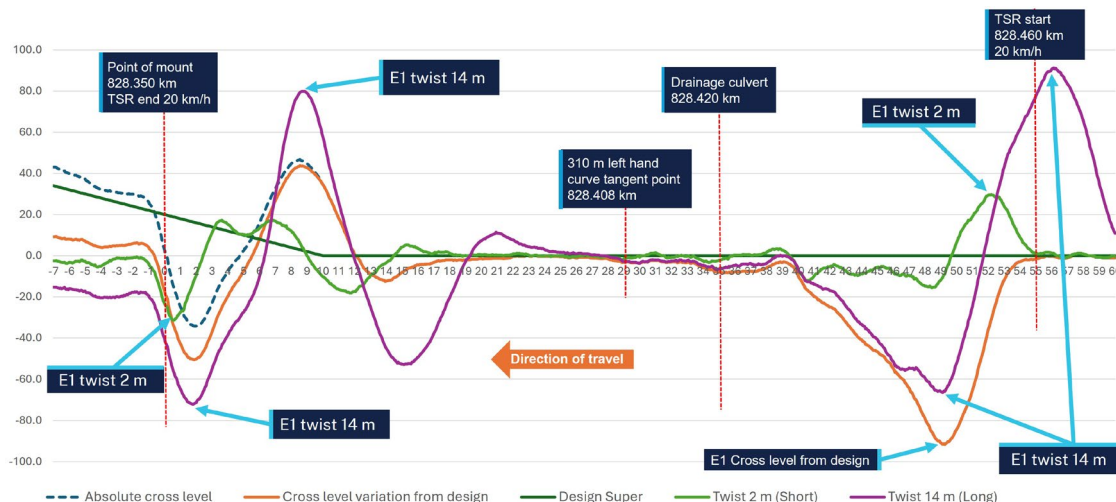
Figure 13: Onsite track geometry measurements

Also, track measurements taken between 828.300 km and 828.509 km recorded a combination of twist and superelevation track geometry defects consistent with an E1 category defect as per ARTC Track and Civil Standards. An E1 Category defect required that the track be inspected and repaired prior to the passing of the next train.

Track measurements taken onsite post -incident, detailing point of mount, locations of categorised track geometry defects, temporary speed restriction limits and infrastructure details. X-axis details track measurement station numbers at 2 m intervals from the point of mount at 0. Y-axis details distance measurement in mm.
 Source: ARTC Data (graph constructed and annotated by OTSI)

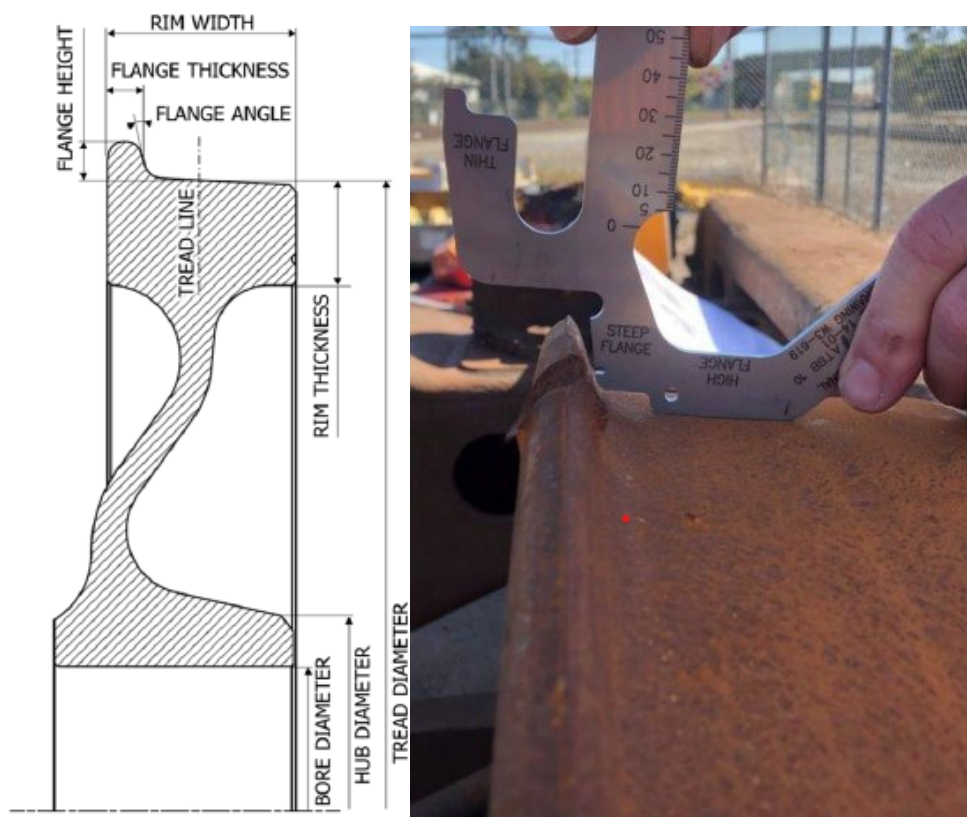
Figure 14: Wheel limiting dimensions

Wheel condemning operational limits are guided by an industry code of practice. Measurement of derailed wheelsets.
 Source: Rail Industry Standards Board (RISSB) Wheel defects code of practice and ATSB

The wheel tread condition of the derailed bogies was also examined and identified bogie RRXE 649 (lead bogie of the 29th vehicle RQRY 1011W) had sustained the most damage.
