Misaligned take-off involving Bombardier DHC-8-315, VH-TQM

Mildura Airport, Victoria, on 25 February 2025

ATSB Transport Safety Report

AO-2025-008

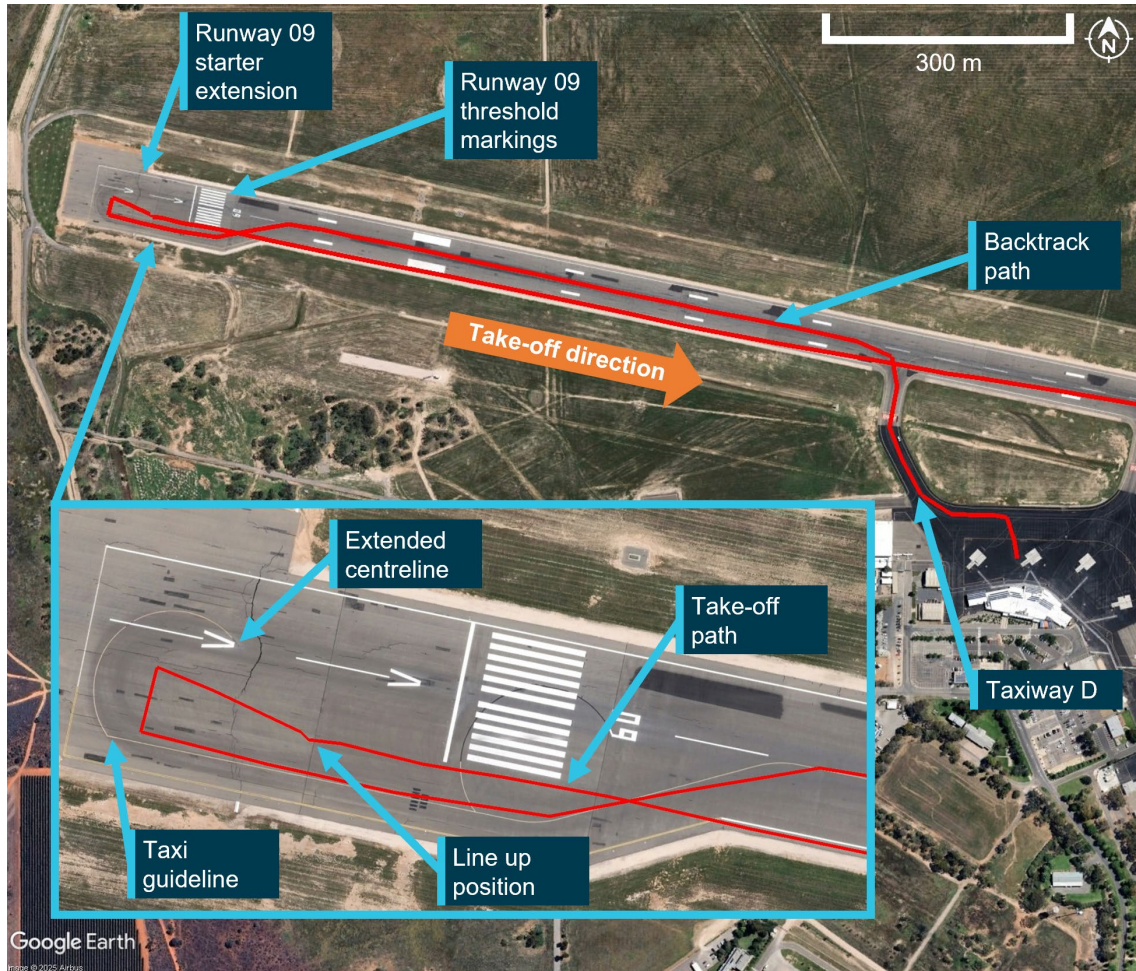
Figure 1: Flight tracking data for the take-off with the starter extension inset

The recorded flight data⁴ showed that the aircraft path followed the taxi guideline marking into the starter extension but was turned right, prior to the end, and away from the guideline, which led to the extended centreline. The captain explained that their initial intent was to use the complete starter extension. However, once established in the extension, they chose not to do so to avoid inadvertently exiting the pavement in the dark conditions. The FO reported that this was not communicated to them at the time nor were they aware that the aircraft had been turned earlier. The aircraft path during the turn remained to the right of the extended centreline, resulting in it being positioned close to the right edge of the runway (Figure 1).

The captain recalled that, about the time the FO called '70 kt', the sounds and sensations became more intense and identified that the aircraft was on the runway edge (Figure 1). They then manoeuvred the aircraft to its correct position along the centreline.

The aircraft track (within the inset) at the end of the starter extension shows a sharply clipped turn, which is due to the fidelity of the data. Source: Google Earth, with aircraft flight data overlaid and annotated by the ATSB

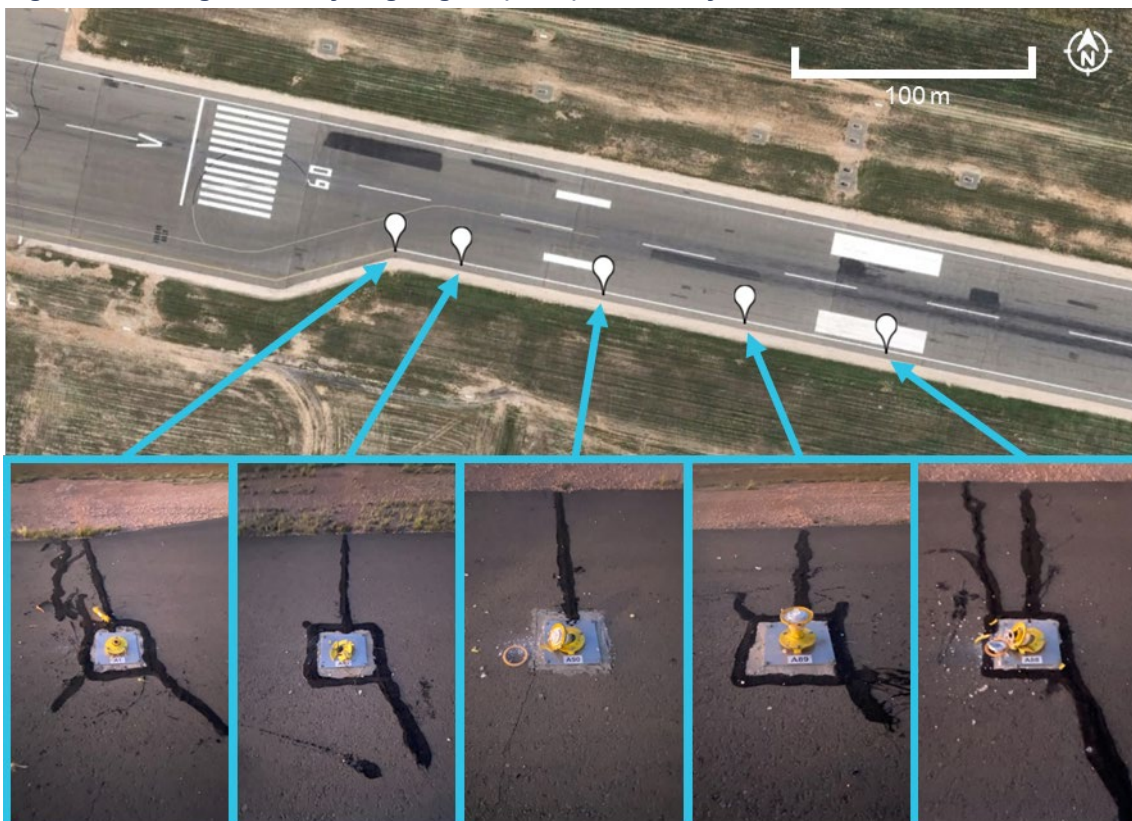
Figure 2: Damaged runway edge lights (inset) on runway 09

During the initial climb, the flight crew realised that they may have contacted the runway edge lights. The FO contacted the Mildura Airport aerodrome reporting officer and advised them of this. They requested the area be inspected and for them to report back on any debris located. The flight crew were subsequently advised that there was damage to 5 lights on the right edge of runway 09 (Figure 2). No aircraft debris was identified.

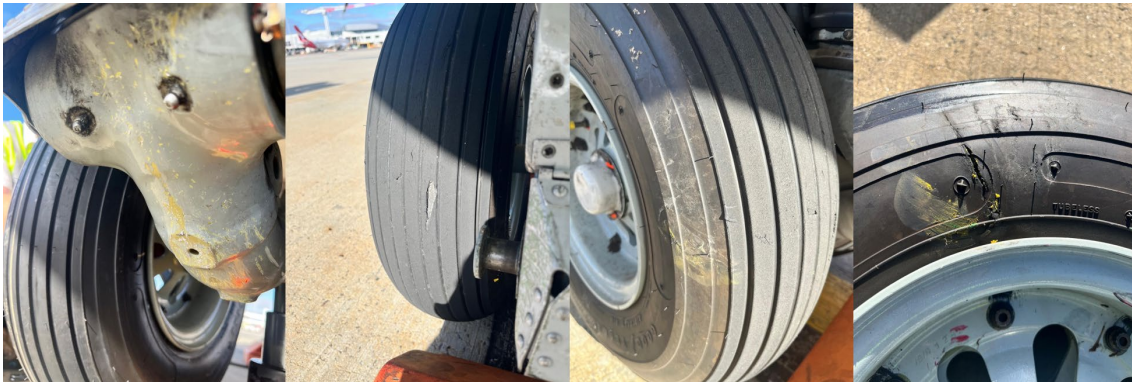
Figure 3: Nose landing gear damage

Damage was identified to the nose landing gear, including both tyres, the cover for the weight on wheels sensor, and the trailing arm (Figure 3). The lower fuselage skin sustained minor impact damage (to 17 areas) and there was minor impact damage to the leading edge sheath of a right propeller blade. Both tyres, the weight on wheels sensor cover and the nose landing gear trailing arm were replaced. The remaining damage was assessed to be within the limits in accordance with manufacturer guidance.

From left to right: trailing arm impact damage, tread cuts and chunking, tyre impact damage, tyre sidewall slice.
Source: QantasLink

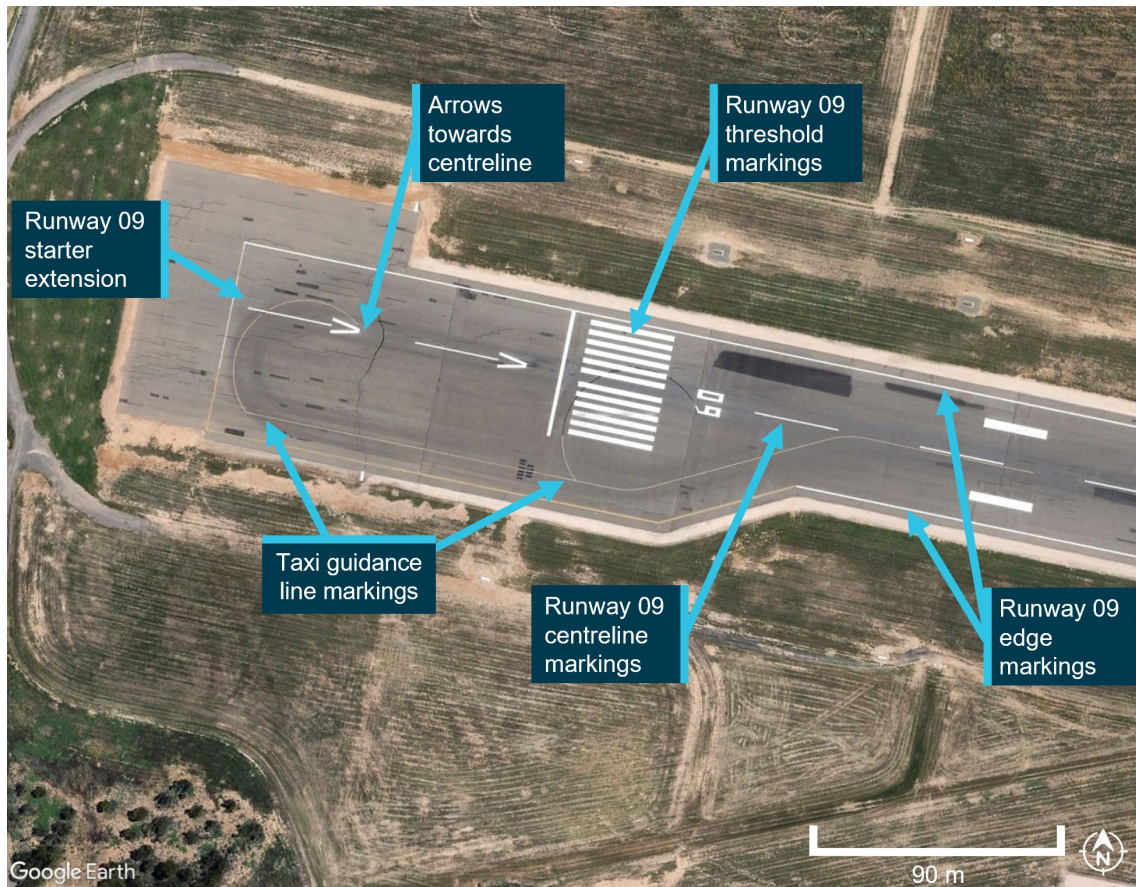
Figure 4: Runway 09 starter extension bypass pad

The extension included taxi guideline markings with turn guidance to realign the aircraft with the centreline. It also had arrows aligned with the runway centreline and pointing to the runway threshold (Figure 4).

The starter extension included a taxi guideline that curved around towards the extended centreline. The guideline was likely visible to the crew as the flight data showed that the aircraft was taxied along the line from the time it entered the starter extension bypass pad until the time it commenced the right turn to line up on runway 09. The captain reported that, although their intention was to use the full length of the extension, it was not required and due to the dark, ambient conditions, they did not want to continue that plan and risk exiting the pavement. As such, they turned the aircraft early.

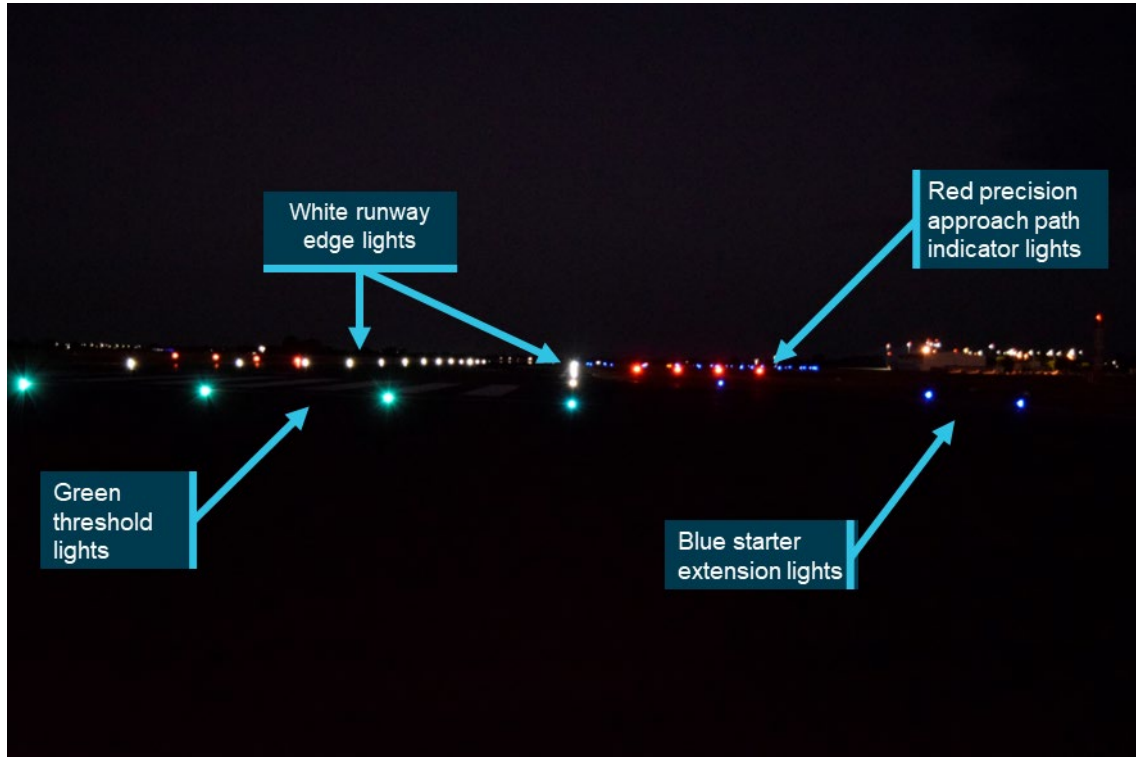
Figure 5: View of the runway 09 lighting that was available to the flight crew when lined up with the right edge of the runway

is indicative of the view that was likely available to the flight crew after lining up on the right edge of runway 09.

However, imagery of runway 09 in similar conditions to the incident flight did show that the runway threshold lights, edge lights and right side precision approach path indicator lights would have been visible to the crew from their line-up position. Confirmation bias is the tendency for people to seek information and cues that confirm their tentatively held hypothesis or belief (Wickens et al, 2022). As the flight crew believed they were correctly aligned with the runway centreline, they commenced the take-off roll.
