Antenna failure involving Beechcraft King Air B200, VH-EEL

55 km west of Bankstown Airport, New South Wales, on 18 June 2025

ATSB Transport Safety Report

AO-2025-031

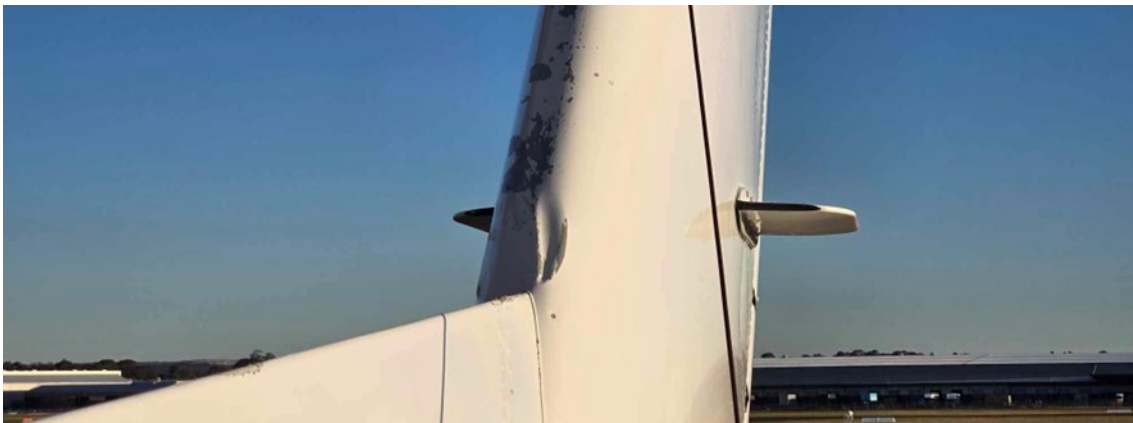
Figure 1: Damage to the vertical stabiliser

After landing, the pilot conducted an external inspection of the aircraft and found that the VHF antenna on top of the fuselage was missing, and the vertical stabiliser was damaged (Figure 1). Further information on the damage is in *Aircraft information* and *Antenna examination*.

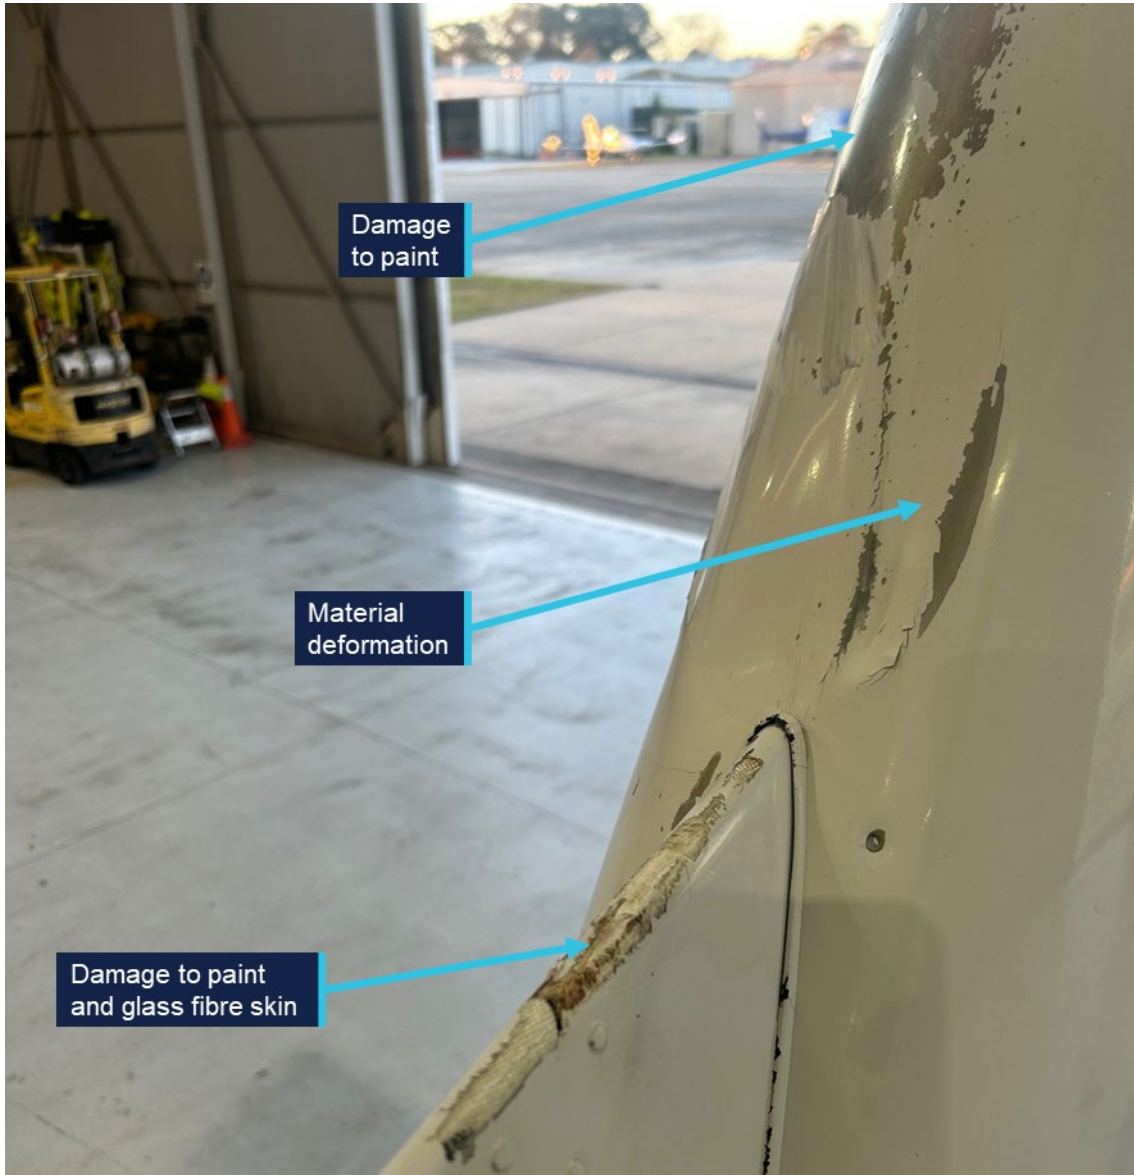
Figure 3: Damage on the front of the empennage

Following the occurrence, the aircraft was sent to a maintenance facility for examination and repair. The examination (not attended by the ATSB) identified that the leading edge of the vertical stabiliser had experienced deformation, and there was damage to the skin and paint on various parts of the empennage (Figure 3 and Figure 4). There also appeared to be some transfer of black material, possibly paint or rubber, onto the right side of the vertical stabiliser. The base of the antenna was still secured to the fuselage by 6 fasteners, but the glass fibre skin of the antenna had failed around each of the fasteners and separated from the aircraft (Figure 5).

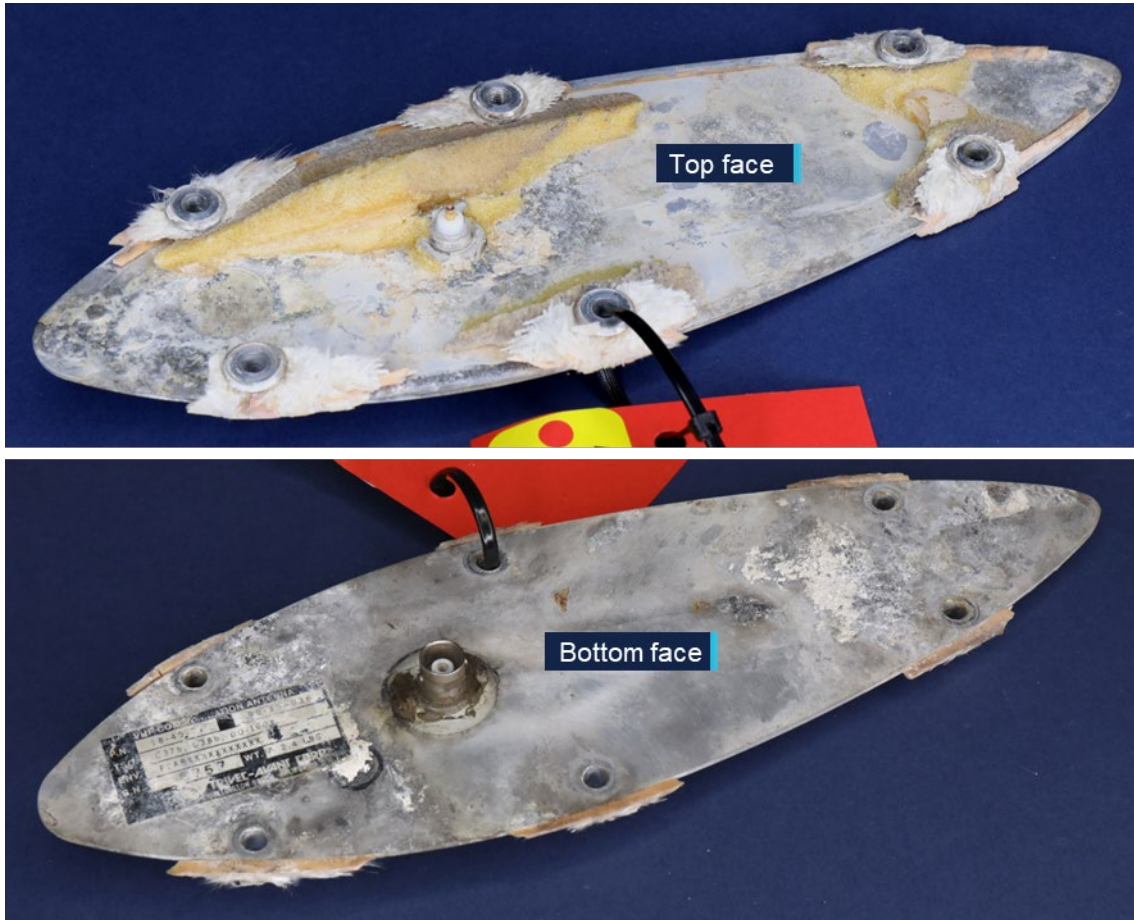
Figure 7: Antenna base from the aircraft

The antenna base from VH-EEL was an aluminium plate with 6 holes for fasteners and a central coaxial connection for the internal electrical antenna (Figure 7). A yellow foam adhered to the top face of the antenna was likely an expanding polyurethane product that was injected into the antenna during its construction in order to increase rigidity (Figure 8). Some fractured glass fibre composite material was observed around each of the fasteners. Fragments of a polymer seal were observed around the edges of the antenna base.

Based on the aluminium oxide and chlorine found on the surface of the VHF antenna base – a part of the antenna that should be fully enclosed and sealed – the antenna failed in flight due to pre-existing damage resulting from corrosion. The corrosion was almost certainly due to moisture ingress into the unit.

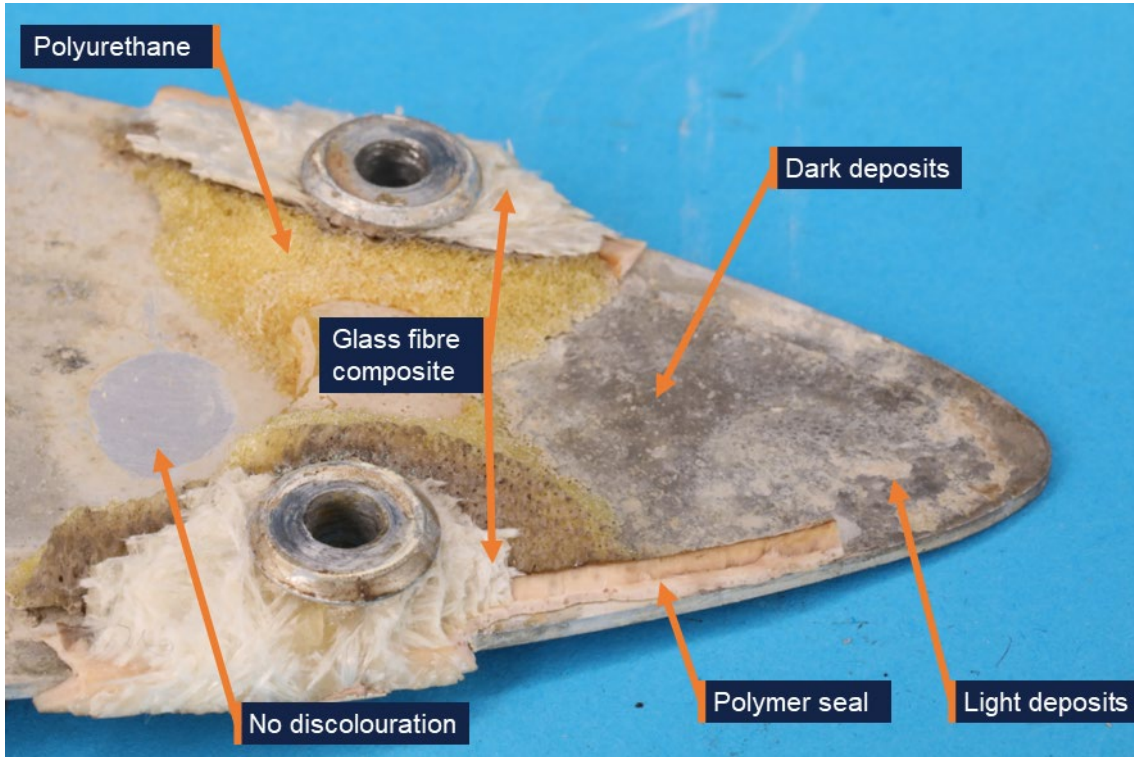
Figure 8: Aft end of the antenna base, top face

Both surfaces of the plate showed discoloration in several locations, identified as deposits on the surface of the metal (Figure 8). The deposits varied in colour. Samples of the dark-coloured and light-coloured deposits were scraped from the antenna using a plastic spatula and analysed for elemental composition using energy-dispersive X-ray spectroscopy (EDS). EDS analysis found that the composition of the light and dark deposits was very similar. Both predominantly contained aluminium, oxygen, and a smaller quantity of chlorine. The presence of chlorine indicated that the plate was exposed to salt water, resulting in corrosion of the aluminium plate, forming aluminium oxide.

The discolouration was not uniformly distributed over the base, and there were some regions, such as the one shown in Figure 8, where there was no evidence of deposits or discolouration. Similarly, while much of the base's edge was discoloured, there were some regions underneath the polymer seal that appeared relatively unaffected (Figure 9).

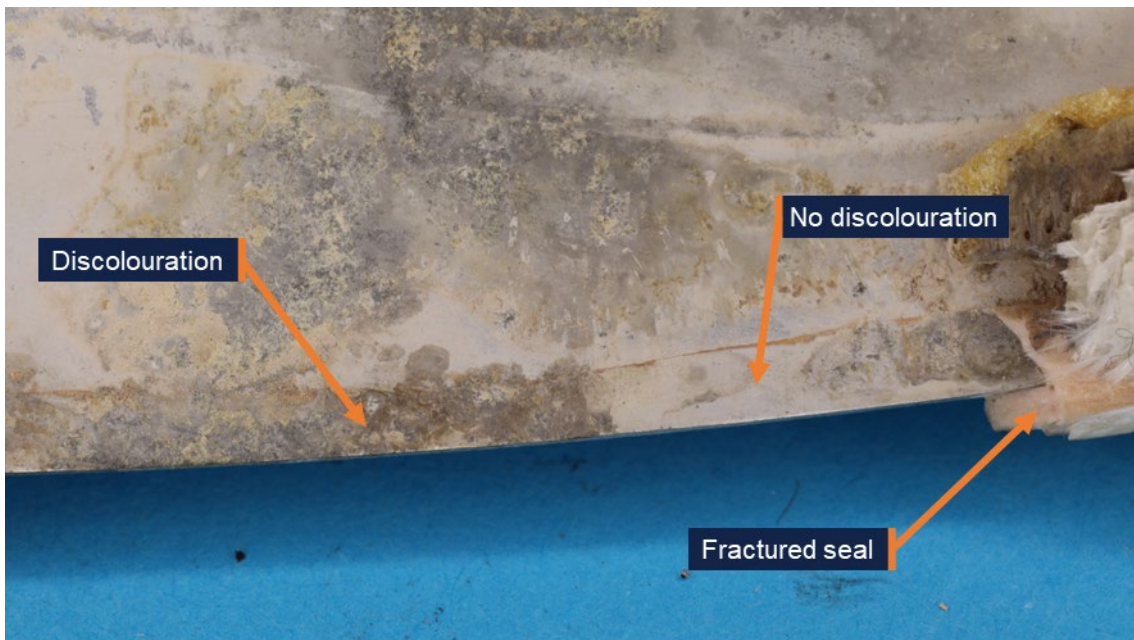
Figure 9: Discolouration under the polymer seal, at the edge of the top face

Since most of the antenna was not recovered, there was no way to determine the pathway through which moisture entered the antenna. Most of the seal surrounding the base had separated with the top half of the antenna. There was evidence of moisture under the seal in some regions, while some parts of the seal appeared to have prevented corrosion. The moisture under the seal could indicate a point of ingress, but it is possible that all the corrosion observed under the seals was due to moisture already inside the antenna, rather than evidence that the seal had been compromised.
