Engine malfunction involving GippsAero GA8, VH-LHC

Djarindjin/Lombadina Airport, Western Australia, on 22 August 2025

AO-2025-052

Final – 8 May 2026

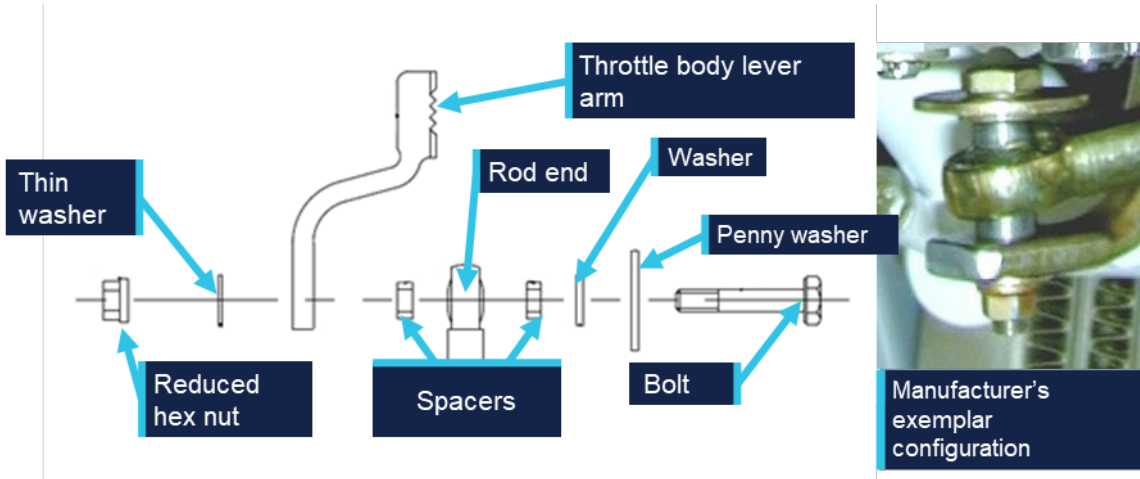
Figure 3: Throttle cable attachment assembly

Figure 3 shows the exploded diagram of the linkage from the aircraft manufacturer's illustrated parts catalogue (IPC) and an exemplar assembly provided by the manufacturer.

The threaded end of the bolt specified in the IPC (AN3-11) is drilled allowing a split pin to be used as a secondary securing mechanism. However, the specified nut (MS21042-3) is a reduced hex nut that uses interference with an out of round section to lock the nut onto the bolt and consequently does not require a split pin. This combination, while permitted and approved, was not commonly used as a reduced hex nut is typically used in combination with a non-drilled bolt. When consulted, the manufacturer could not advise why this hardware combination had been prescribed for the aircraft. However, they advised that some elements of the design for this aircraft had been reproduced from the design of another aircraft, including the specified bolt.

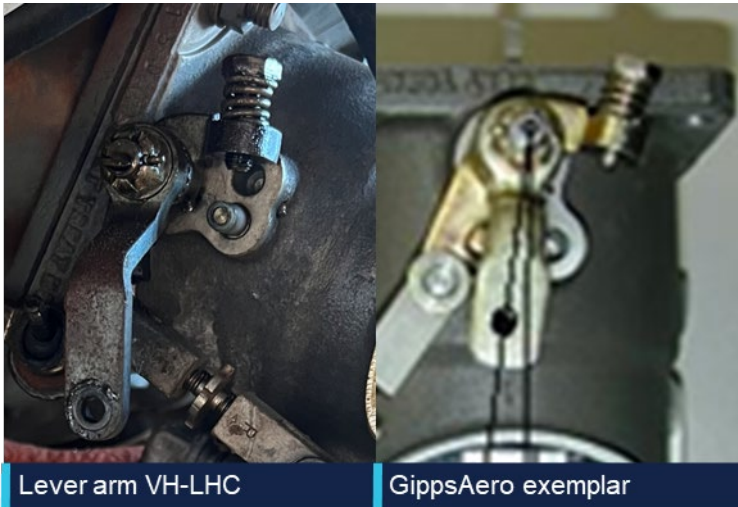
Figure 4: Throttle lever arm comparison

The throttle body lever arm on the GA8 was developed by GippsAero by modifying the design of the standard arm supplied by the engine manufacturer. The modification made the arm approximately 12 mm shorter than when used for other applications with the same engine. This modification altered the arc through which the arm moved to ensure that the geometry between the throttle cable and the throttle body was correct. The manufacturer's review of the images of VH-LHC's throttle arm identified that a standard lever arm was fitted rather than the GippsAero lever arm.

Figure 4 shows the throttle lever arm as fitted to VH-LHC in comparison to an exemplar of the shortened lever arm as prescribed for the aircraft by GippsAero in the IPC. Note the throttle positions shown in the images are not the same and the image has been rotated to show the difference in length between the lever arms.

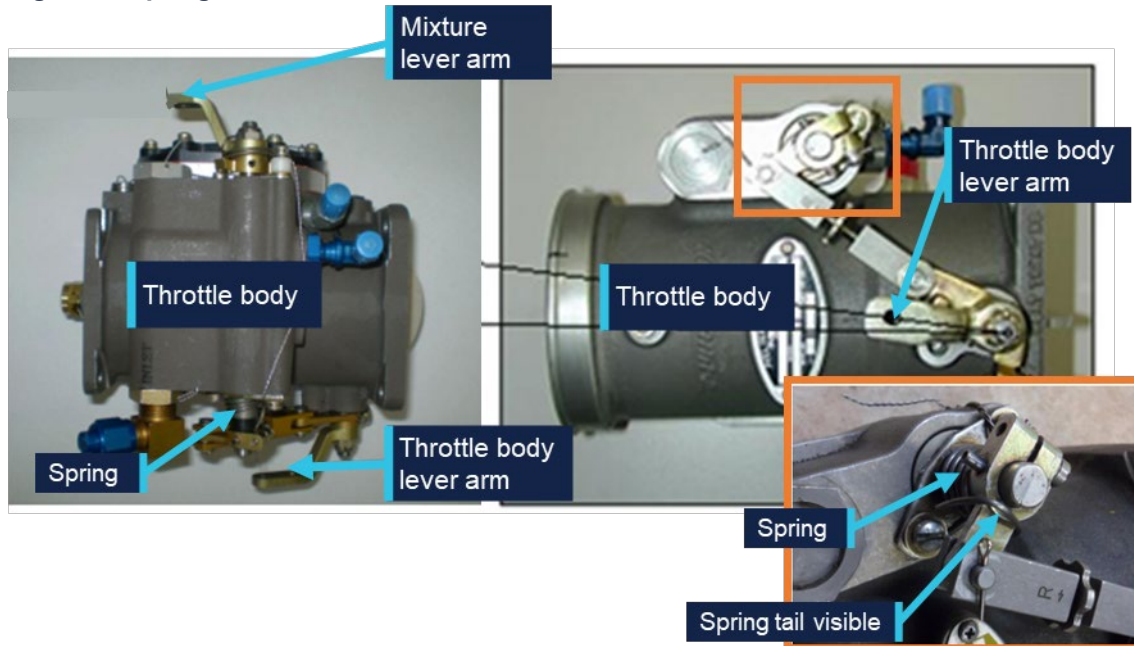
Figure 5: Spring location

For the GA8 to comply with this requirement, the throttle body linkage was fitted with a torsion spring with sufficient tension to drive the throttle to at least 75% of the full throttle setting. The torsion spring is mounted directly to the throttle body as shown in Figure 5 and can subsequently drive the throttle to the required position in the event of a disconnection anywhere along the throttle linkage.

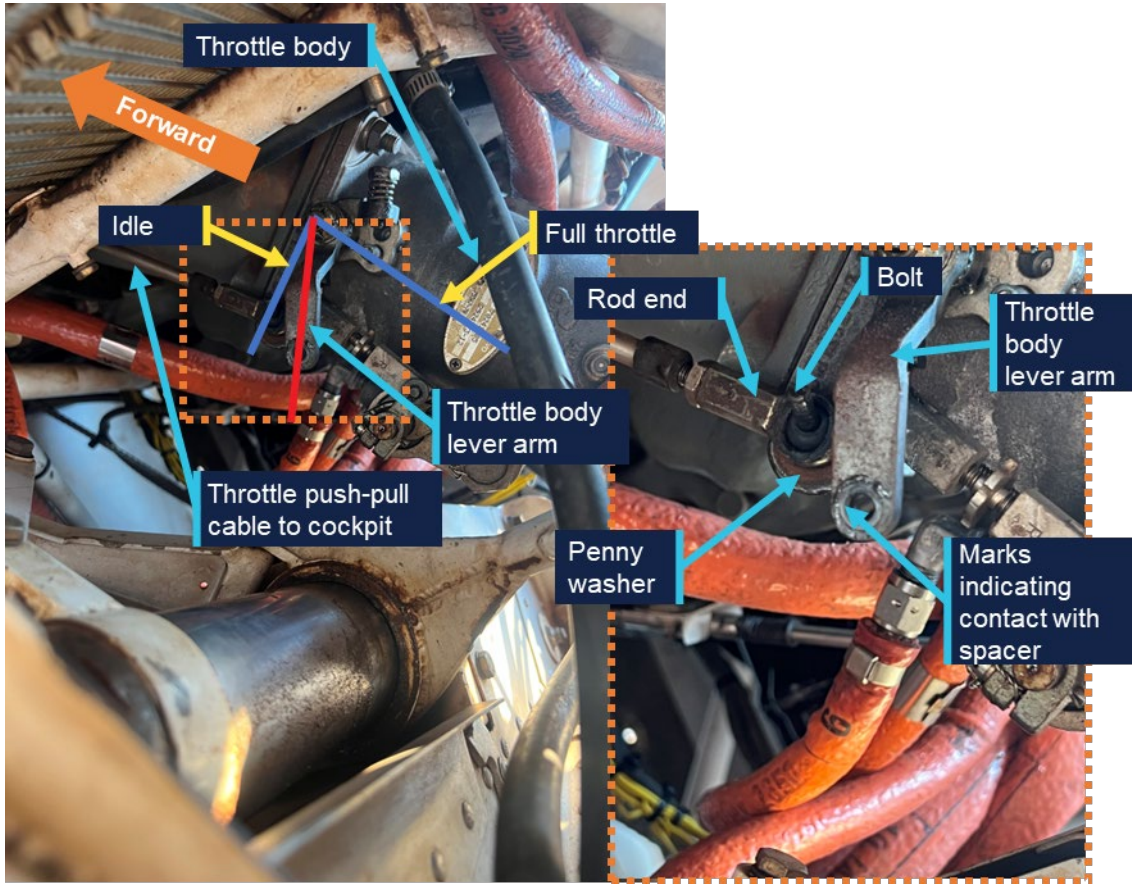
Figure 6: Post-occurrence image of throttle body and throttle cable attachment assembly

The ATSB was provided with an image taken by the pilot immediately after the occurrence (Figure 6). It shows the throttle body lever arm at approximately 25% travel with the through bolt from the rod end disconnected from the lever arm. Only the bolt and penny washer from the cable attachment assembly were visible in the image. The remaining components including the nut, washer and spacers were unable to be identified.

The image captured by the pilot immediately following the occurrence showed the throttle in a low power position, well below the 75% open position that was required by the manufacturer. Due to the number of factors that can impact the relationship between throttle position and observed manifold pressure, it was not possible to determine what the manifold pressure should have been if the throttle was open to 75%. However, as

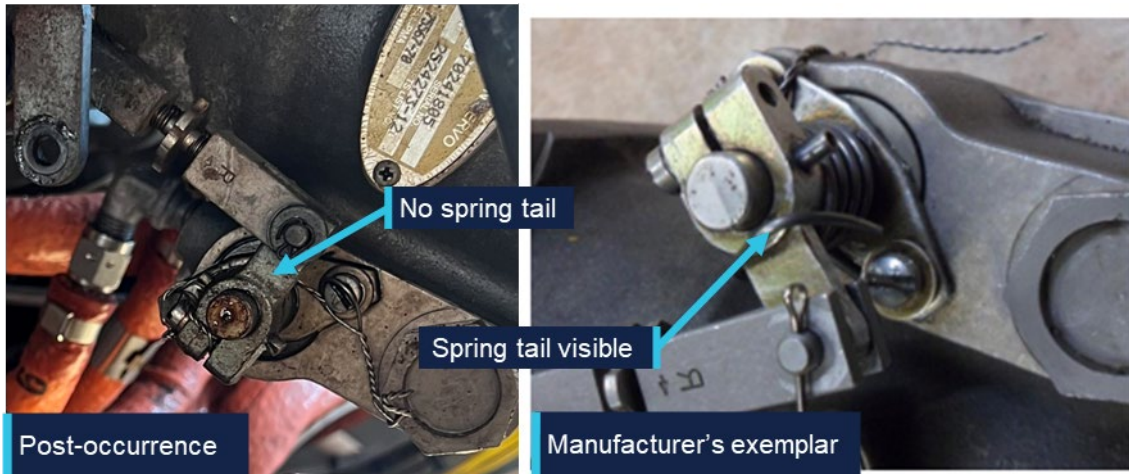
Figure 7: Post-occurrence imagery identifying location of throttle mechanism spring

Following the occurrence, the ATSB and the manufacturer reviewed the available imagery. The manufacturer stated that the imagery appeared to show an incorrect configuration of the throttle cable attachment assembly, with markings on the end of the throttle body lever arm indicating that at least one of the spacers had been incorrectly located. The ATSB also identified, and the manufacturer confirmed, that the spring on the throttle mechanism was missing (Figure 7).

It was further identified and confirmed by the manufacturer that the torsion spring was not visible in the imagery captured immediately after the occurrence. The ATSB considered 2 possible scenarios for the missing torsion spring. The first was that the spring had been present and had failed since the last maintenance activity or during the occurrence and the second was that the spring was not fitted at the time of the engine change.

While it could not be conclusively determined if the required torsion spring was fitted at the time of the occurrence, it was considered very likely that it was not fitted due to:

- the visible lack of the spring
- the fact that the spring would have been retained should it have failed
- the limited time between maintenance and the occurrence for the spring to become detached and be lost
- the fact that the throttle did not open, which is the purpose of the spring being fitted.

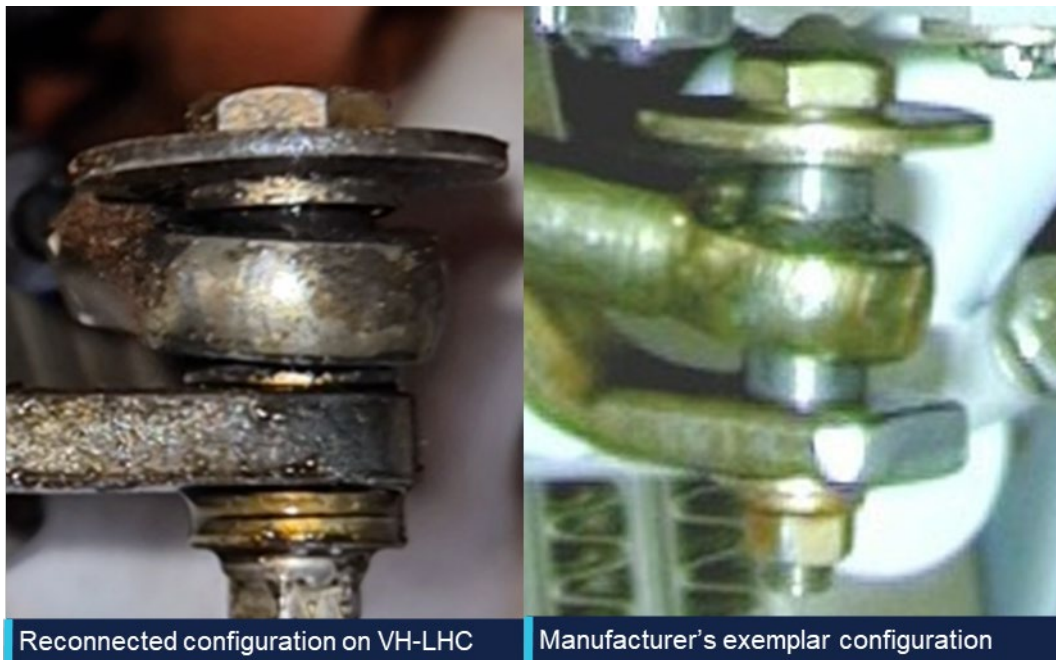
Figure 8: Throttle linkage assembly comparison

Figure 8 compares the reconnected linkage configuration on VH-LHC (left) with the manufacturer’s exemplar configuration (right). The spacers shown in the manufacturer’s configuration provide increased clearance between the penny washer, rod end and the throttle body lever arm compared to the washers used in the reconnected configuration.

The pre-occurrence configuration of the linkage fitted to VH-LHC was unable to be determined. However, the reconnected configuration showed a limited clearance between the rod end and the penny washer due to the missing spacers. This lack of clearance meant that the rod end was likely to contact the penny washer when the throttle was moved through the full range of motion.

As identified by the CAA’s investigation, this creates a risk of interaction between these parts and potential for loosening and disconnection of the linkage. In comparison, the spacers used in the manufacturer’s configuration separate the rod end from the penny washer to prevent interaction.
