# **Collision with terrain at night involving Robinson R22 Beta II, VH-LYD**

25 km south-south-east of Kowanyama, Queensland, on 9 October 2025

**ATSB Transport Safety Report**

AO-2025-063

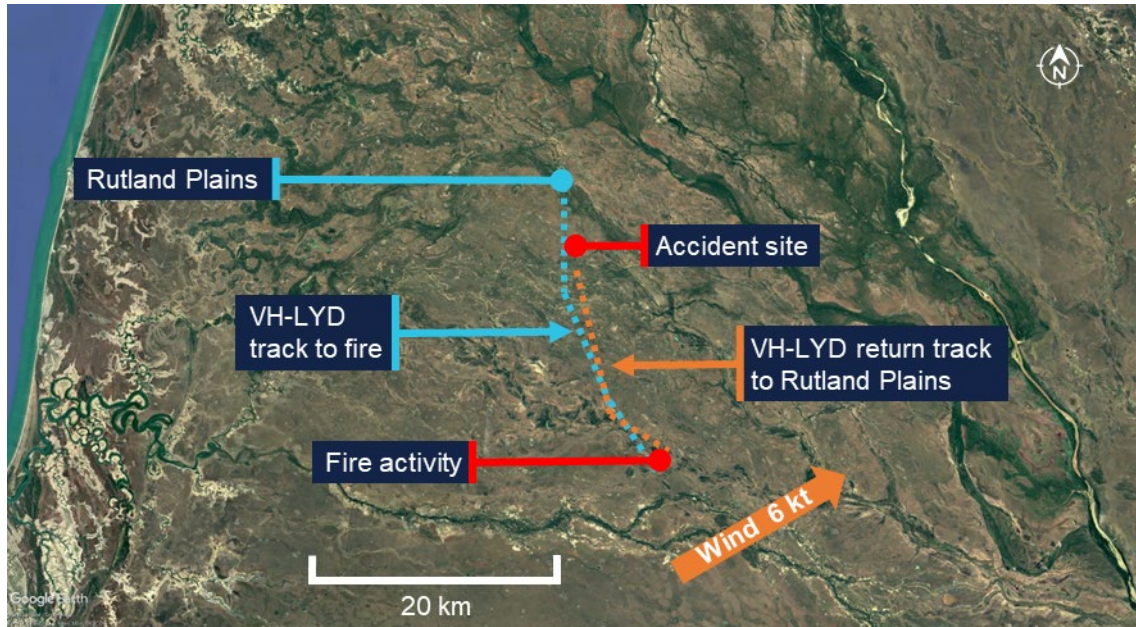
**Figure 2: Fire location and VH-LYD track**

At around 1935, crew at the station checked to see if the pilot had landed. Discovering that the helicopter had not returned, they tried contacting the pilot by radio. When radio contact was unsuccessful, they escalated the non-arrival within the company and sought information from a satellite tracking system on board the helicopter to establish its location. Tracking had stopped at 1929 around 7.5 km south-south-east of the station (Figure 2).

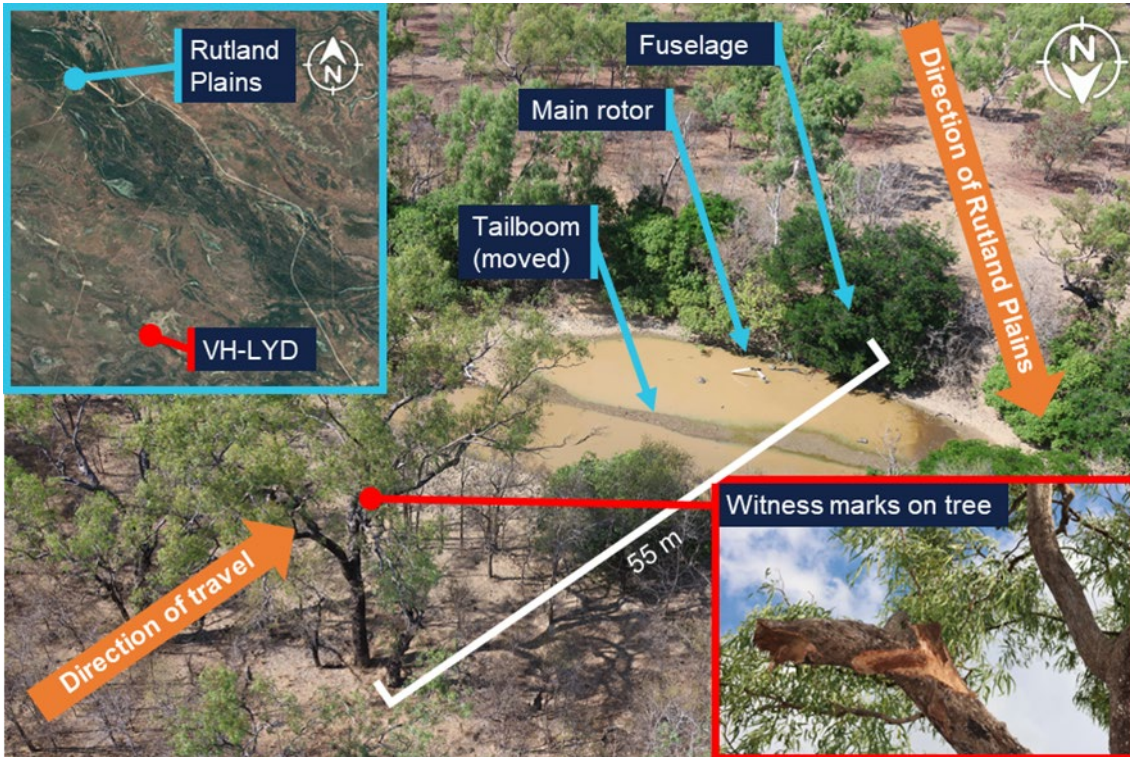
Figure 4: VH-LYD accident site

Site photographs and wreckage inspection indicate that VH-LYD was moving at high speed, around 90 degrees off track, at the time of the collision with terrain (Figure 4). The helicopter was significantly damaged by tree and ground impacts with the main rotor and transmission assembly separating from the helicopter. There were no pre-accident defects identified, and the engine was driving the main and tail rotor system at the time of the collision. The impact with terrain was not considered to be survivable.

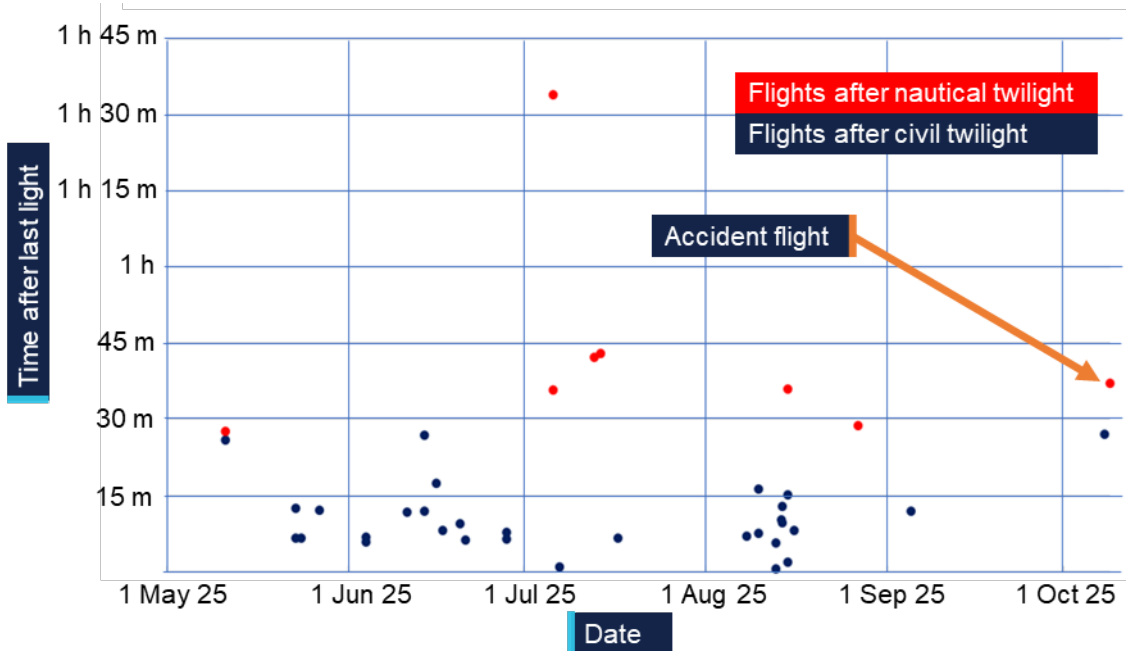
**Figure 6: Latest time flown after last light for 39 flights in company R22 helicopters**

The tracking data (Figure 6) showed that in the 6 months preceding the accident, the 4 company helicopters operated on 596 days. Of the 596 days of operation, company helicopters were flown after last light on 39 occasions, around 6.5% of days of operation across the 4 helicopters. The level of exceedance ranged from under a minute up to 1 hour 34 minutes, with the average exceedance being 17 minutes. Eight of the late flights, including the accident flight, extended beyond nautical twilight.

The largest exceedance of around 1 hour 34 minutes after last light took place in July 2025 in the vicinity of Mount Windsor Station, Queensland. While cloud cover is not known, the moon rose at 1404 and was approaching three quarters full at an altitude of 70° when the helicopter landed.

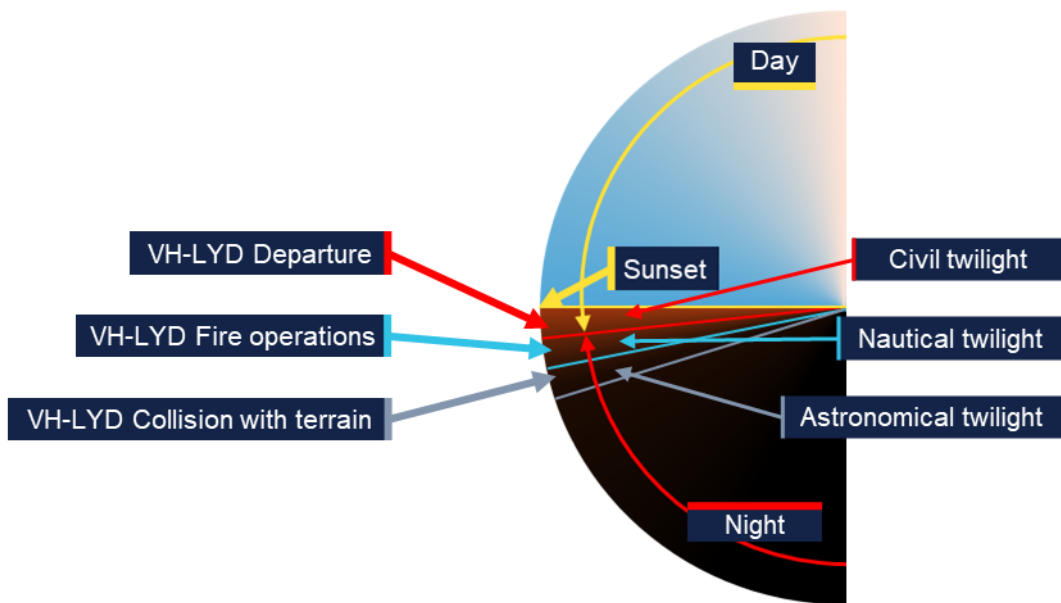
**Figure 7: VH-LYD night flight**

Witness statements and tracking data for VH-LYD on the night of the accident showed it was moving after last light and beyond nautical twilight. The last movement of VH-LYD was recorded at 1929, 37 minutes after last light (end of civil twilight at 1852) and 12 minutes after nautical twilight (1917) (Figure 7). Moonrise would not happen until 2045. The combination of cloud obscuring celestial light from stars, no artificial lighting on the ground, and no moonlight meant it was almost certainly very dark. This made the pilot susceptible to spatial disorientation and loss of control of the helicopter.
