Collision with terrain involving Cessna 172, VH-SCU

about 6 km south of Newcastle Waters, Northern Territory, on 7 November 2025

Aviation Occurrence Investigation (Short)

AO-2025-066

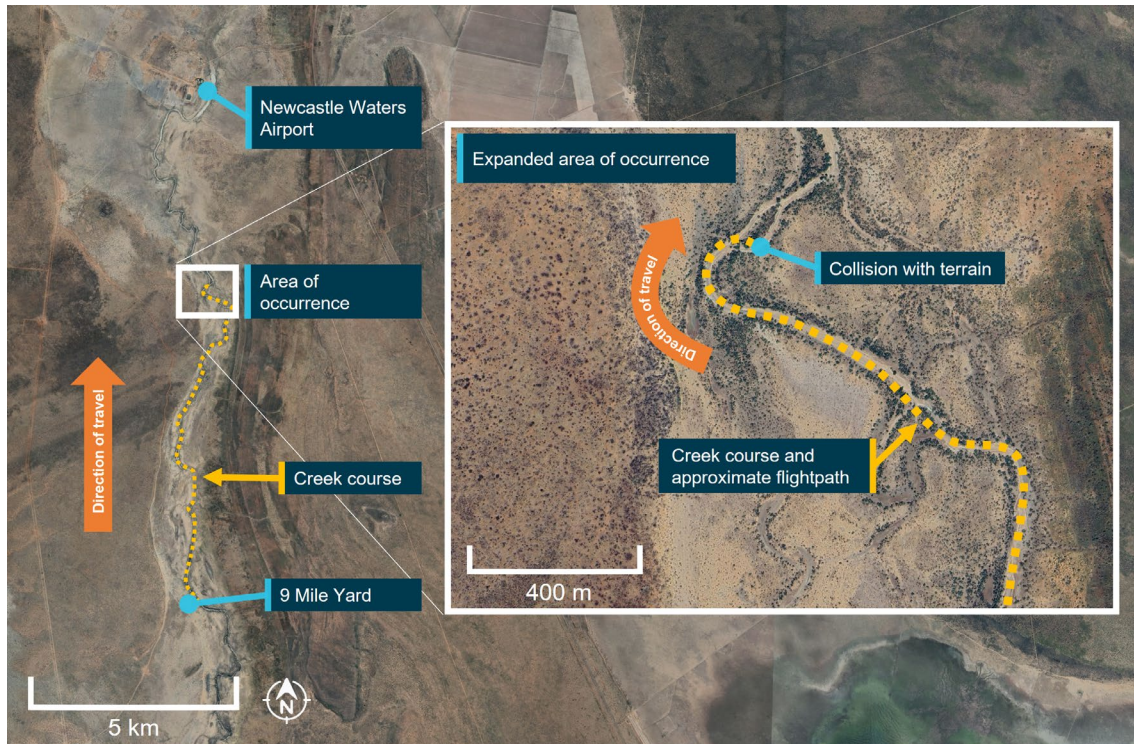
The instructor then asked the pilot to return to the departure airport by following the Newcastle Waters Creek in a northerly direction, simulating a water course survey activity (Figure 1). The task commenced at an altitude of 300 ft and the pilot was reminded not to descend below the pre-briefed minimum altitude of 200 ft. At around 0750, a few minutes into the activity, the pilot observed that the creek bed ahead made a sharp turn to the right and they began to manoeuvre the aircraft to keep the ground feature directly below the aircraft. At the start of this manoeuvre, the aircraft was flying approximately 300 ft above the terrain at an airspeed of around 80 kt, with flaps retracted.

Figure 1: Low-level flightpath over the Newcastle Waters Creek and the location of the collision with terrain

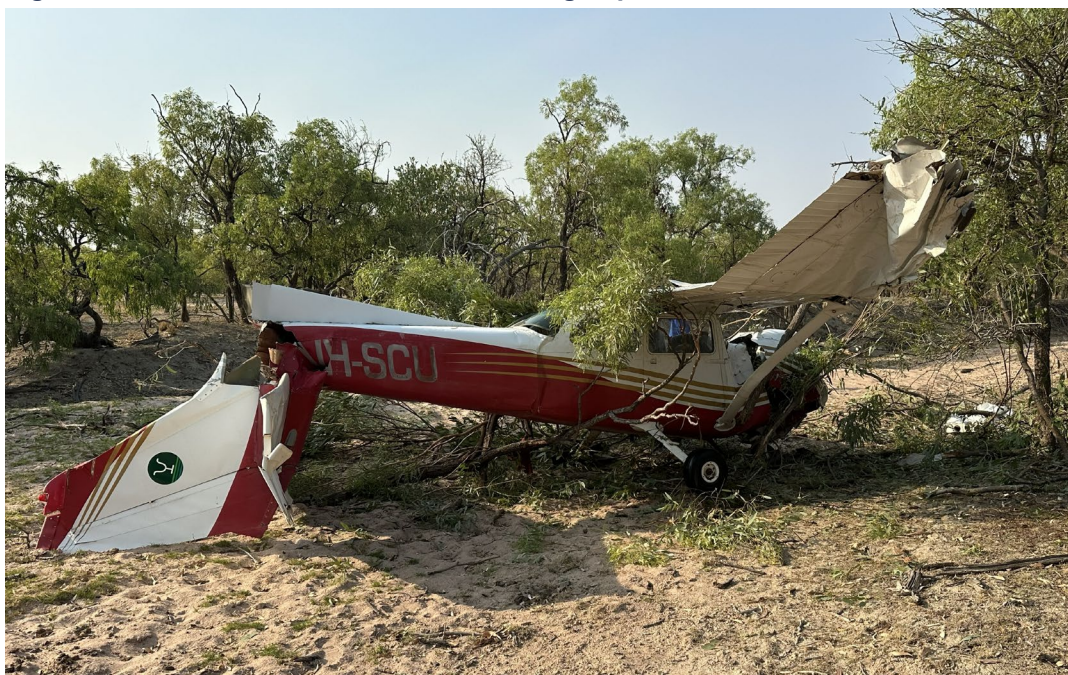
As the aircraft descended below the height of the treetops, its pitch attitude had almost levelled, its roll angle had reduced, and it was yawing to the right. The aircraft then impacted the trees, before coming to rest upright on its undercarriage, on relatively flat terrain. It had yawed during the impact sequence, such that it was facing back along its flightpath through the trees. The aircraft sustained extensive damage, particularly to its wings and tail section, with the latter being almost completely detached from the rear fuselage (Figure 2).

Figure 2: VH-SCU as it came to rest following impact with trees and terrain

- While training to follow a ground feature at low level, the pilot flying applied and held inappropriate control inputs, which led to an aerodynamic stall and limited the instructor’s ability to make corrective actions, resulting in the aircraft colliding with terrain.

The flight training provider undertook a critical review of its training practices and risk mitigation measures.
