Forced landing and collision with terrain involving Van's RV-8, VH-YGY

40 km west of Gladstone Airport, Queensland, on 23 November 2025

Aviation Occurrence Investigation (Short)

AO-2025-068

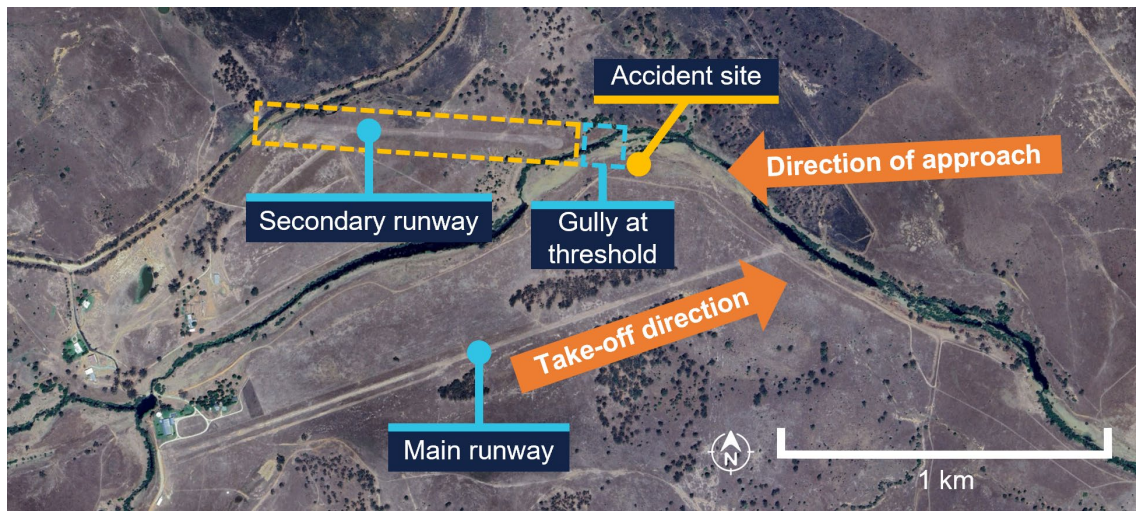
Figure 1: Take-off and approach directions

The pilot attempted to return to Old Station with the intention to land on the secondary runway (heading 260°). Out of concern that the aircraft would not make the secondary runway and because of a deep gully at its threshold, the pilot made a forced landing into a nearby paddock (Figure 1).

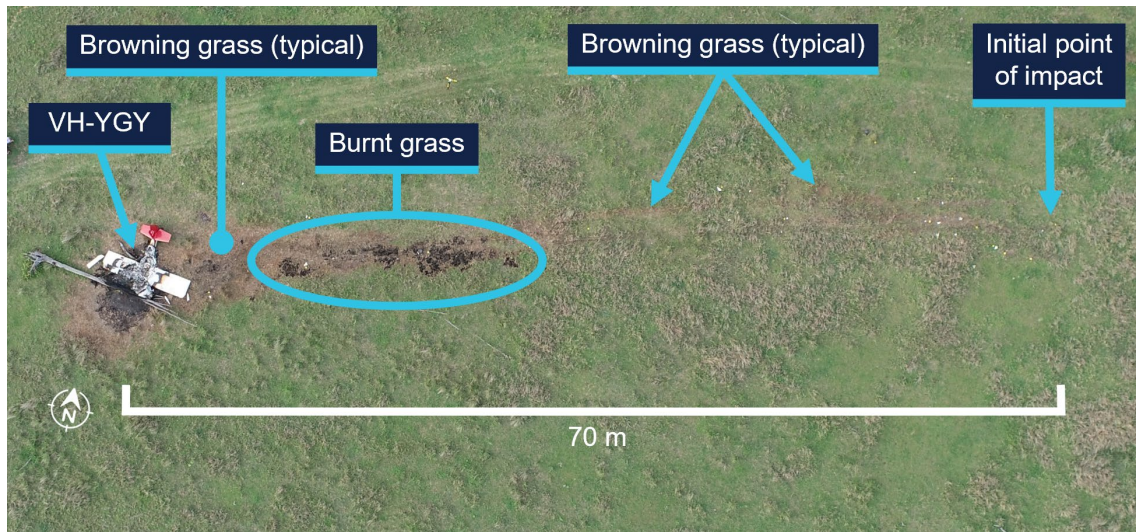
Figure 3: Accident site overview

The accident site was located in open farmland that was flat and slightly sloping down toward the west. The aircraft slid for about 70 m before coming to rest against a fallen tree. As evidenced by post-accident browning of the grass, fuel had been liberated from one or both of the wing fuel tanks from about 7 m from the initial point of impact until where the aircraft came to rest. The grass in the path of the aircraft was burnt in places about 45 m from the initial point of impact and around the aircraft (Figure 3).

This image was taken on the day of the accident; the browning grass was more prominent in the days following.
 Source: Queensland Police, annotated by the ATSB

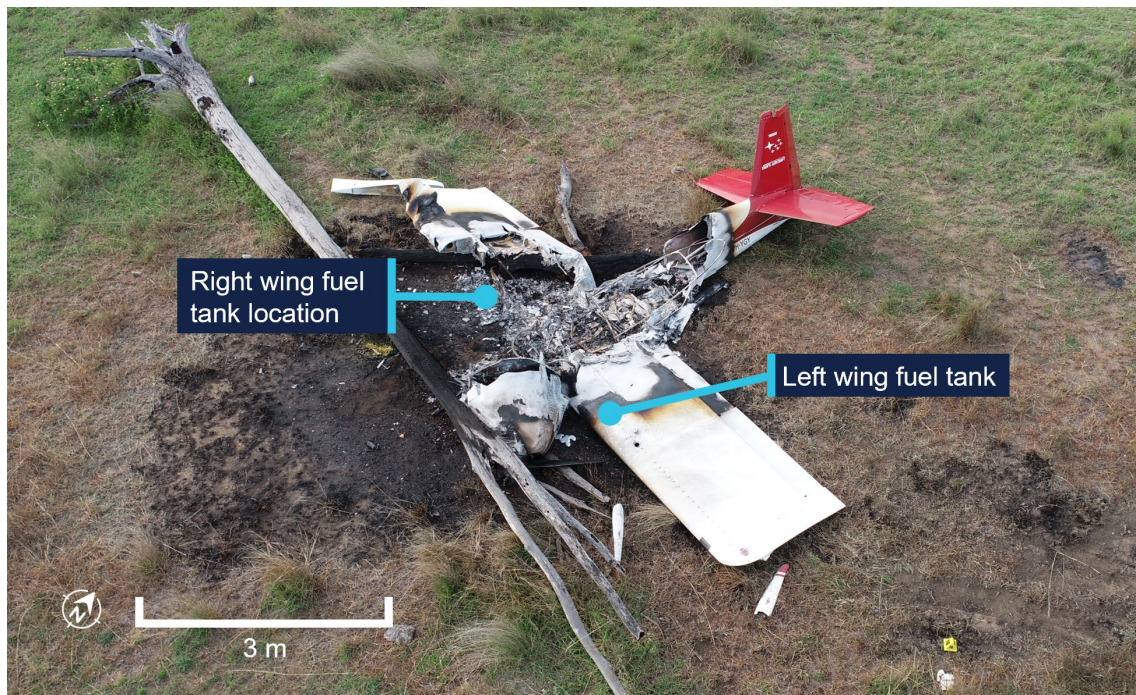
Figure 4: VH-YGY at the accident site

There was no fuel remaining in the aircraft’s fuel tanks suitable for testing. The aircraft’s engine, cabin, wings and fuselage were mostly destroyed by the fire, limiting the extent to which pre-impact defects could be identified (Figure 4).

Note: the left-wing fuel tank cap was removed by first responders for fire suppression.
 Source: Queensland Police, annotated by the ATSB

- Fragmentation and the position of a propeller blade (1 of 4) indicated that the engine was not running at impact.
- Both main landing gear axles, brakes and wheel assemblies had separated from the main landing gear legs which in turn had collapsed under the aircraft.

- The wing/fuselage structure and engine mounting frame was buckled by impact forces.
- The flap actuator extension was consistent with the flaps being close to, or fully, retracted.

Numerous engine components were destroyed by the fire. This included wiring, flexible hoses and fuel system components. The fuel pressure regulator that had been replaced 3 days prior to the accident was not identified (or any remnants of it) at the accident site or during a follow-up aircraft and engine inspection conducted by the ATSB.
