Main rotor strike involving Leonardo Helicopters AW139, VH-TJF

42 km south-east of Corryong Airport, New South Wales, on 5 January 2026

Aviation Occurrence Investigation (Short)

AO-2026-002

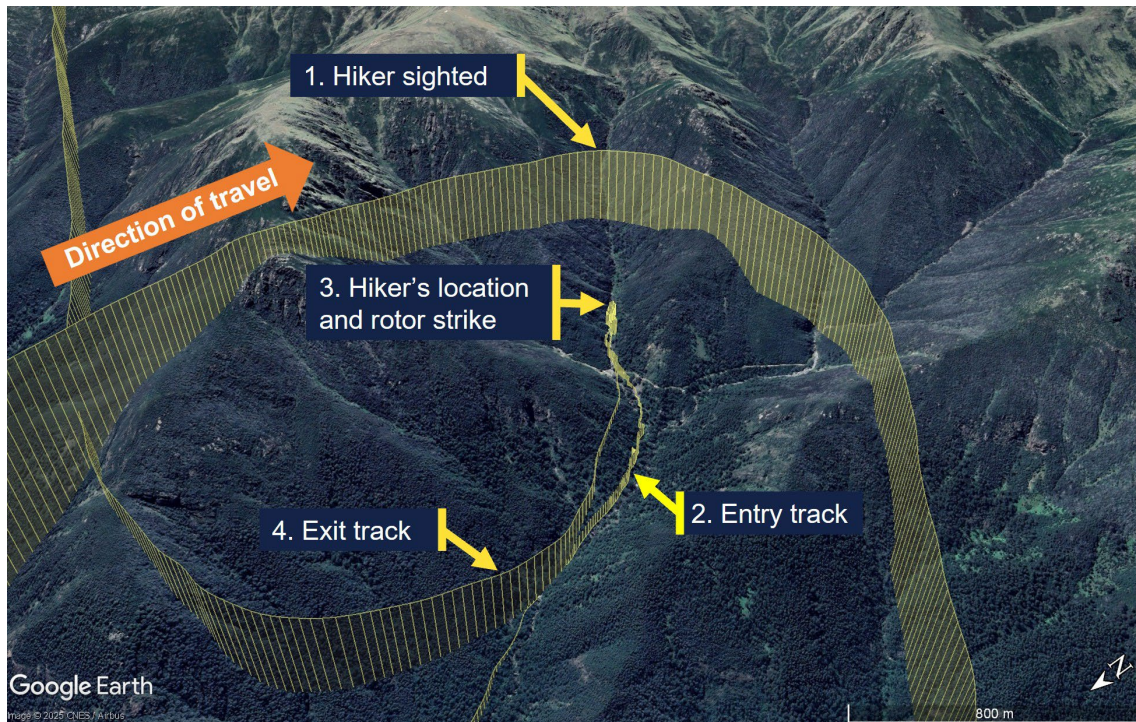
Figure 1: Entry and exit tracks to the hiker's location and rotor strike

On approach to the reported location, the low flying checks were completed, and the ACO opened the right cabin door for the search. The pilot then saw a flare appear below them on the right side of the helicopter and the ACO identified the hiker near a waterfall in a re-entrant,² which was the reported location. They assessed that the helicopter would need to be flown slowly up the re-entrant towards the waterfall and then turned around prior to winching, to provide an escape route down the valley.

The crew conducted their winch checks and then the pilot conducted the power check and confirmed that the helicopter had sufficient power margin to keep the doctor on board for the winching. The helicopter then descended into the re-entrant and transited up the left side at slow speed (Figure 1). Before they reached the hiker's location, the pilot momentarily stopped the transit as they experienced a 'power-suck'³ and assessed that they had a tail wind. When the power stabilised, the pilot turned the helicopter around and reversed the helicopter into the re-entrant for the final 200 m to the hiker's location.

After the helicopter transitioned to forward flight, the pilot conducted a control check, and the ACO detected a clicking noise. The pilot announced that Perisher was the closest pad and requested confirmation of what struck the tree. The ACO and doctor confirmed it was the main rotor that struck the tree in the 7–8 o’clock position and not the tail rotor. The pilot made a PAN call to air traffic control, and the paramedic notified their base of the incident and that they would land at Perisher. The helicopter landed at Perisher at 1737 with minor damage. The hiker subsequently walked out and declined medical assistance.

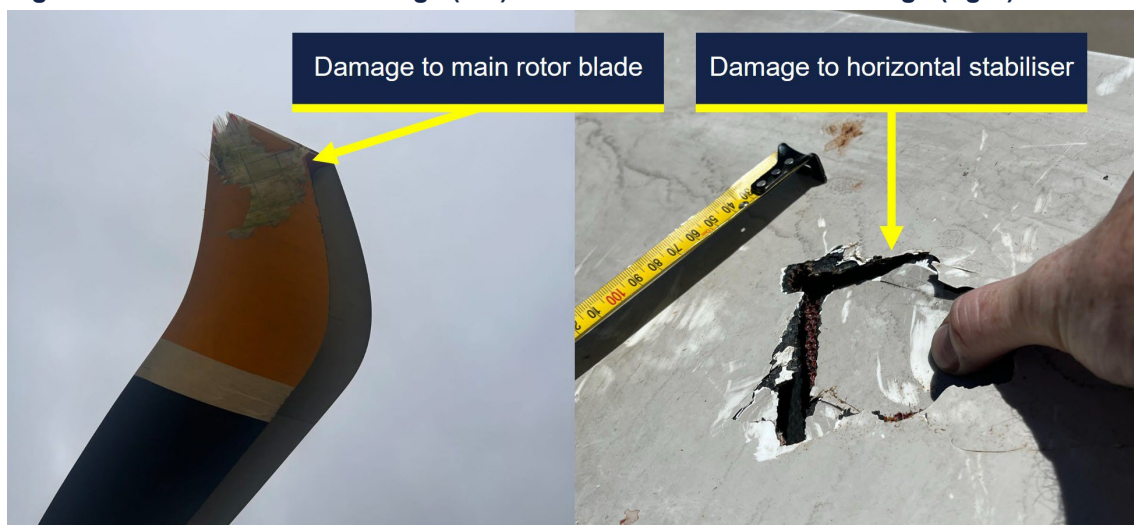
Figure 2: Main rotor blade damage (left) and horizontal stabiliser damage (right)

The operator reported minor repairable damage to 3 main rotor blade tips (Figure 2). In addition, there was minor damage to the horizontal stabiliser and tail boom, which were struck by debris from the tree struck by the main rotor.

This obstacle was a tree with the nearest branch located above the main rotor disk and laterally clear of it by about 10 ft, which complied with the operator's minimum clearance requirements. However, the proximity and height of the surrounding trees resulted in recirculation disturbing the helicopter from a stable hover position, which increased the control inputs required by the pilot compared with their initial higher hover height.

The doctor alerted the crew to the fact that they appeared to be drifting to the left as soon as the ACO started to winch the paramedic down, which triggered a 'move right' call from the ACO to the pilot. In response, the pilot applied a small roll input to the right combined with a small increase in collective and the main rotors struck the nearby tree.

- increased their rotor clearance limit to 20 ft (6 m) in all circumstances
- provided additional guidance on determining spacing from overhanging obstacles
- provided additional guidance on the requirements for error tolerant references
- emphasised the need to prioritise error tolerant hover reference(s) selection over escape and downwash considerations.
