Main landing gear wheel separation involving Saab 340, VH-VEZ

Canberra Airport, Australian Capital Territory, on 29 January 2026

Aviation Occurrence Investigation (Short)

AO-2026-008

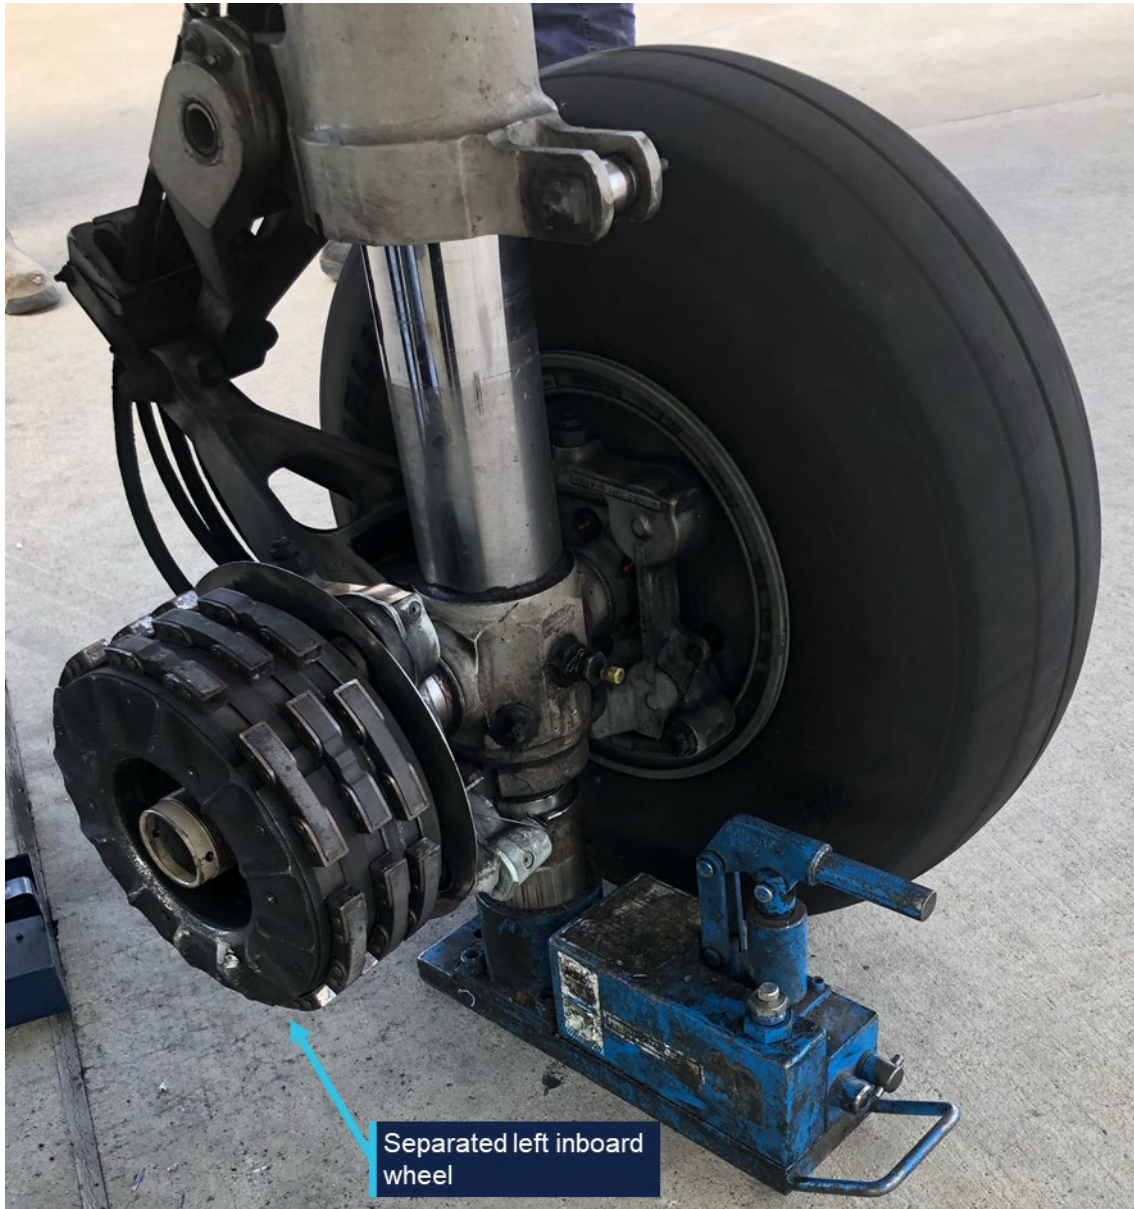
Figure 1: VH-VEZ left main landing gear with separated inboard wheel

At 1611, the aircraft landed safely and was brought to a stop at the end of the runway (Figure 1). Airport emergency services reported no fire, smoke, or fluid leaks from the landing gear. The crew shut down both engines on the runway, and the aircraft was towed to the apron, where passengers were disembarked. Canberra Airport safety personnel located the main wheel against an internal airport fence on the eastern side of runway 35.

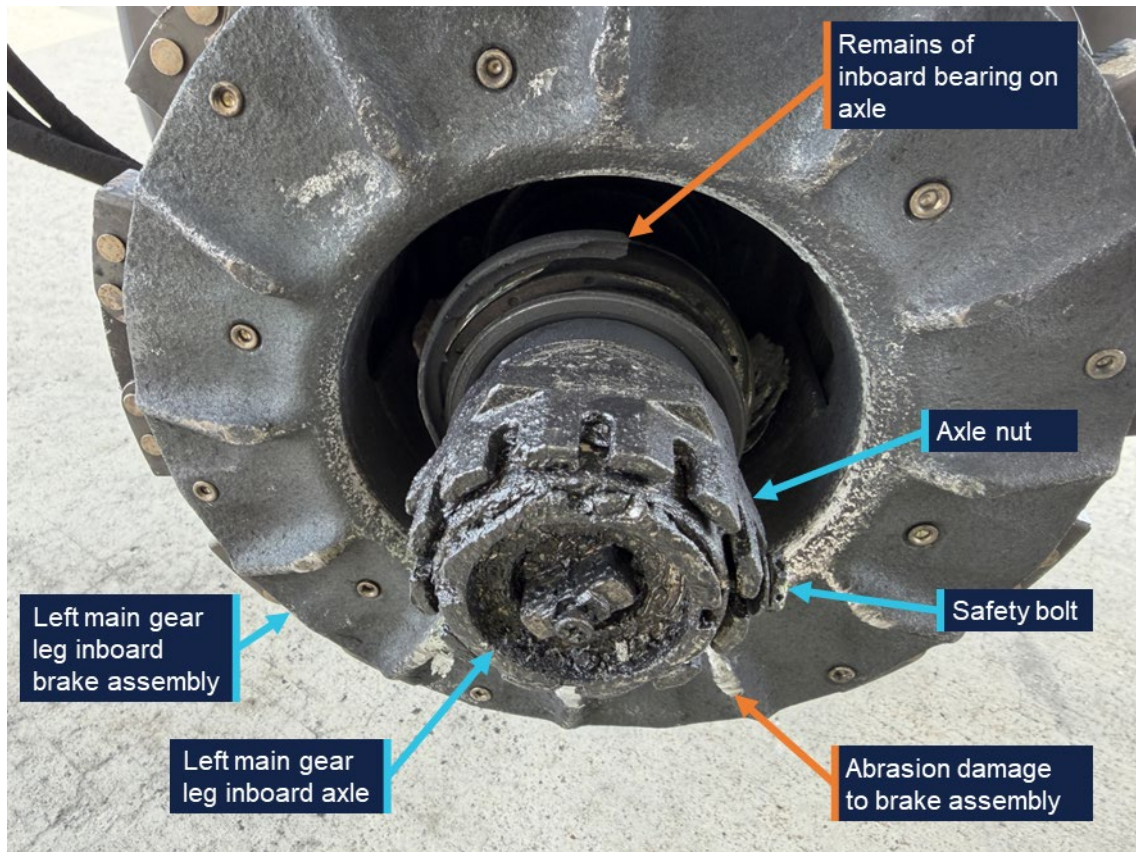
Figure 5: Left main gear leg inboard axle

A post-incident inspection of the left main landing gear wheel and the main landing gear axle identified significant damage to both components. The axle nut and safety bolt remained in place on the axle (Figure 5). Remains of the inboard bearing were also identified on the axle, and there was visible abrasion to the brake assembly.

As the aircraft rotated, the left inboard main landing gear wheel separated from the aircraft. Post-flight inspection of the aircraft identified that the axle nut remained secured on the end of the axle. As such, the potential mechanisms for wheel detachment were limited to a fracture of the wheel or bearing failure.

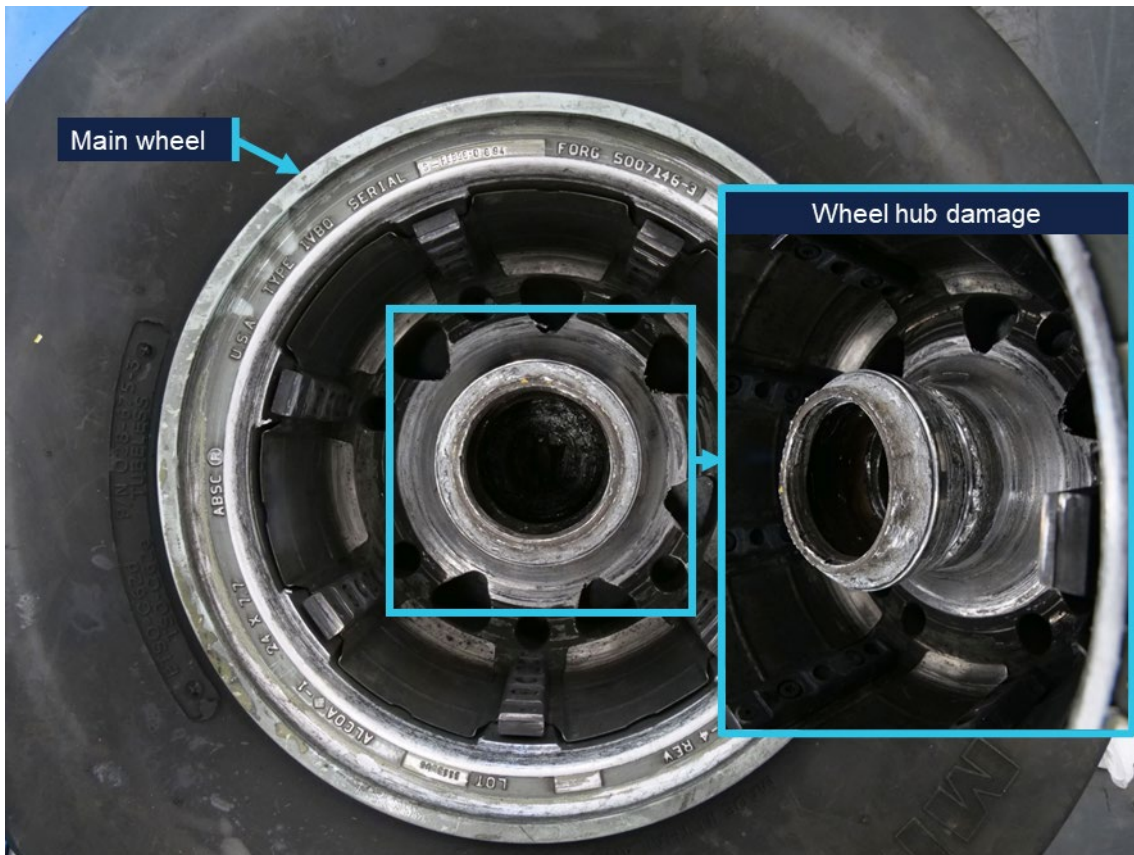
Figure 6: Main wheel hub damage

The inboard side of the wheel sustained significant damage (Figure 6). A circumferential fracture surface was visible on the inboard region of the hub encompassing the inboard bearing cone seat. The hub surfaces in proximity to the brake assembly when the wheel is installed exhibited deep rotational gouging and scoring.

Pieces of bearing material were found with the wheel, including 13 roller elements, fragments of the roller cages and bearing seals. The outboard cup remained installed in the wheel. All of the bearing races exhibited significant damage and smearing,⁴ including deformation from impact with loose rollers. Both cones had heat colouration as evidence of exposure to high temperatures.

The fractured sections of wheel hub also had evidence of heat damage. To the extent that could be established,⁵ the ATSB did not identify any evidence of progressive cracking or pre-existing defect that might have contributed to the fracture.

The level of damage to both bearings, and the absence of any identified pre-existing cracking or defect on the fractured hub pieces supported failure of the bearings as the initiating event. The hub fracture was assessed as secondary, the result of abnormal loading during continued wheel rotation with collapsed bearings.

In response to the occurrence, the operator conducted a fleet-wide inspection of main wheel assemblies and nose wheel assemblies for any defects. No faults were found on any aircraft at the time of inspection.

In addition, the operator has elected to replace wheel bearings on-condition or at every second wheel overhaul, whichever occurs first.
