Power loss and ditching involving Robinson R44, VH-8HR

19 km north-west of Hamilton Island, Queensland, on 25 January 2026

ATSB Transport Safety Report

AO-2026-009

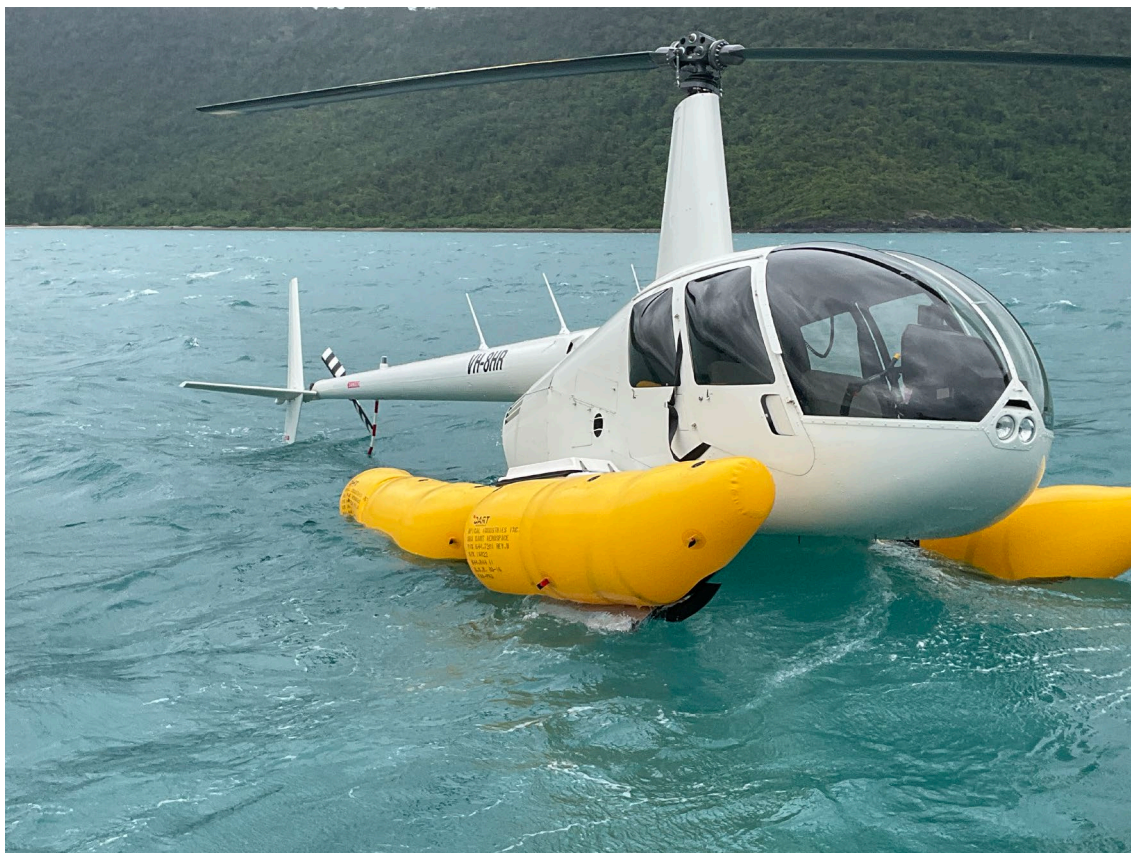
Figure 1: VH-8HR shortly after pilot was met by local water police

The pilot attempted to slow the helicopter to the best rate of climb speed of 55 kt. As the helicopter airspeed slowed to about 60 kt it was still descending and they were still unable to maintain altitude. The pilot reported that the engine RPM again reduced while over water and they elected to enter an autorotation. The helicopter was beyond gliding distance from land, and the pilot activated the emergency pop-out floats and conducted a ditching onto the ocean (Figure 1).

The helicopter landed and remained upright on the water without further damage. The pilot then transmitted a MAYDAY call which was received by a nearby fixed-wing aircraft that relayed the distress call to Brisbane Centre air traffic control. The pilot observed a knocking sound which they suspected was coming from the engine and shut the helicopter down.

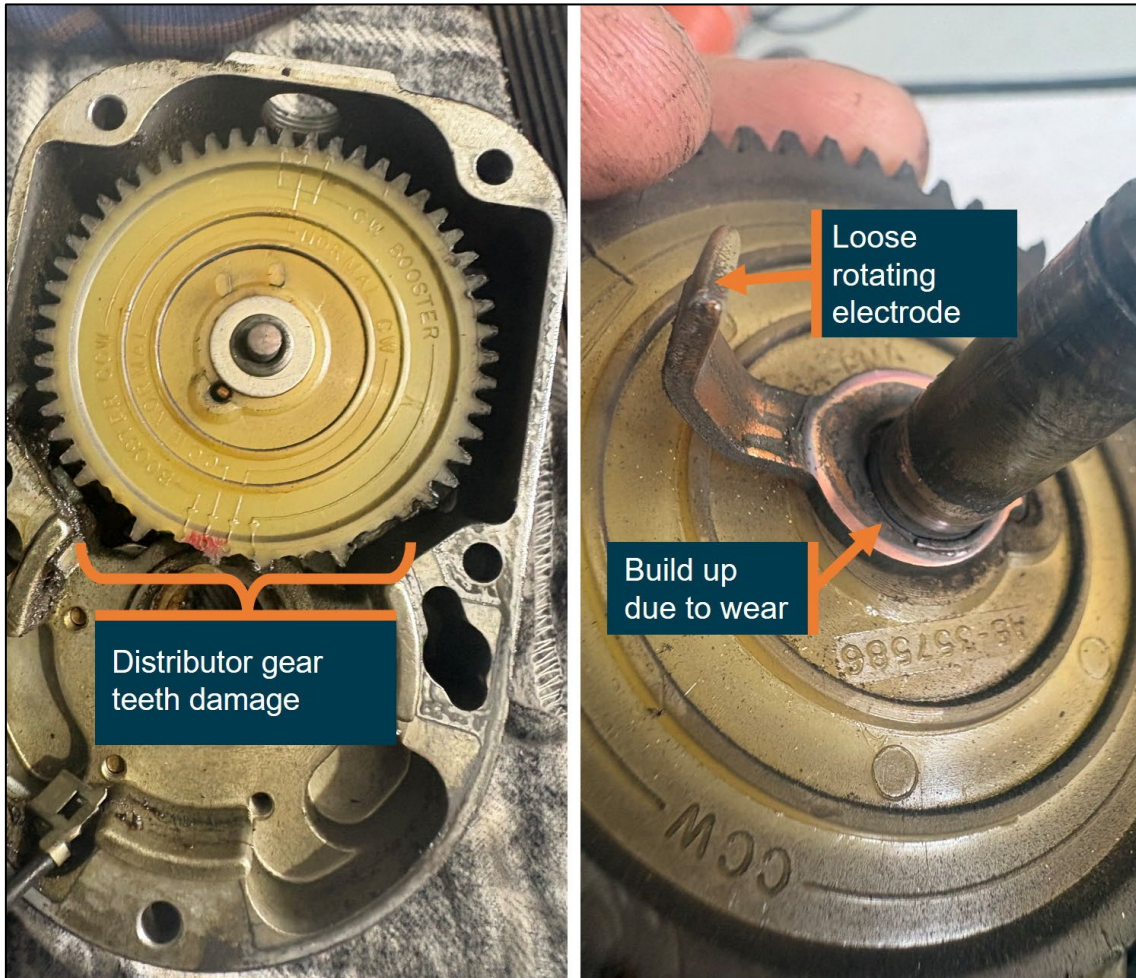
Figure 3: VH-8HR engine-right magneto distributor gear

Following the occurrence, the operator’s maintenance provider inspected the engine-right magneto and identified that the rotating electrode on the distributor gear had come loose and subsequently contacted the distributor block, jamming the gear which resulted in numerous gear teeth being stripped (Figure 3).

The engine-right magneto had been fitted to the helicopter for about 18 months and 727 flying hours. The magneto distributor gear was last inspected on 7 April 2025. After that inspection, the helicopter operated a further 335.6 hours before the magneto failed. At the time of the occurrence, the 500-hour magneto distributor gear inspection was due in 164.4 hours flying time.

CAT reviewed the supplied images and a summary of the occurrence and advised that the distributor gear rotating electrode could detach due to:

- Mechanical fatigue or vibration: High cyclic loading and torsional vibration in the O-540 engine can weaken the electrode attachment over time.
- Improper staking or attachment during a prior overhaul: If the rotor assembly was not correctly staked, riveted, or assembled during the last 500-hour inspection, the electrode can loosen prematurely.
- Internal contamination or sudden rotor binding: Foreign material or gear debris can momentarily jam the rotor, placing abnormal shear loads on the electrode.
- Heat distortion: Excessive magneto temperature (due to lean running, under-cowl heat, or advanced timing) can warp the rotor plate or insulator, stressing the electrode until it separates.

The reason for the loose electrode on the distributor gear was not able to be determined, however the magneto manufacturer indicated that the rotating electrode could become loose due to fatigue, vibration, incorrect installation, or heat damage.

The loose electrode likely caused the distributor gear to jam, damaging the gear. Either due to this damage or a result of the jamming, the timing of the electrical supply to the spark plugs was affected and caused the engine to misfire.

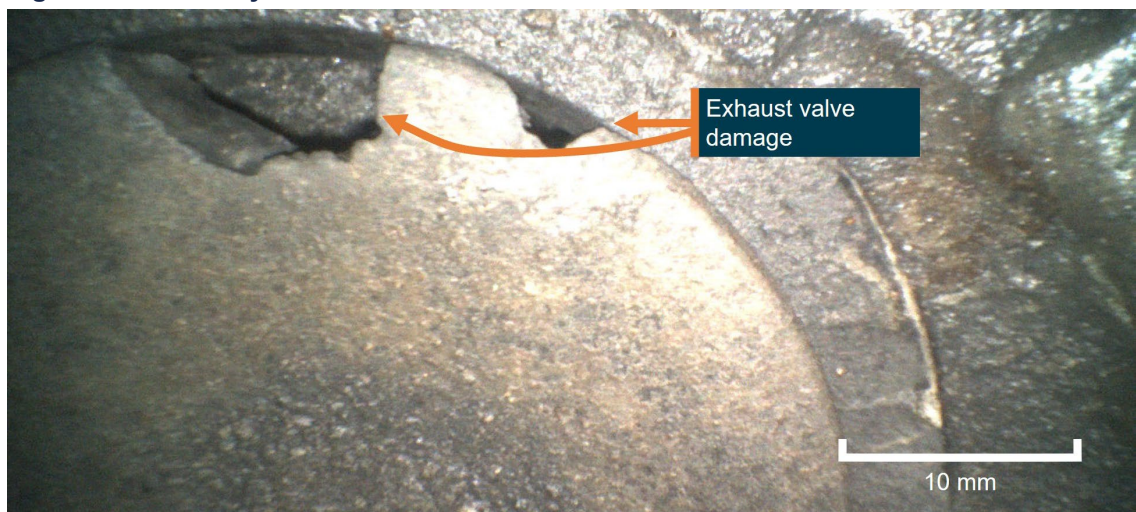
Figure 4: VH-8HR cylinder one exhaust valve

The post-occurrence engine inspection also identified damage to the exhaust valve on the number one engine cylinder, with a compression test indicating nil compression. The maintenance organisation reported the erosion damage was likely from environmental

conditions, fuel and exhaust deposits. The maintenance organisation identified that the combination of a magneto failure and lack of compression in the cylinder would have resulted in a substantial power loss.

CAT also provided an assessment of the exhaust valve damage (Figure 4) stating that it was entirely consistent with late, weak or erratic ignition timing and provided the following explanation:

A jammed magneto or slipping distributor gear causes late or erratic ignition timing. When ignition occurs too late:

- Combustion continues as the exhaust valve opens, exposing the valve face to extremely hot combustion gases.
- This leads to localized overheating, erosion, and burning of the valve edge, matching the borescope damage observed on No. 1 cylinder.
- Intermittent or weak ignition can also cause backfiring or detonation, further overstressing the exhaust valve and increasing temperature spikes.

Late timing = combustion into exhaust stroke → valve overheating → valve burning.

The helicopter had accumulated 1,116.8 total flying hours and had mostly been operated throughout the Whitsunday Islands and Great Barrier Reef, exposing the helicopter to a corrosive salt air environment. The helicopter's maintainer reported erosion damage to the valve sealing face following the occurrence, likely due to the corrosive operational environment, fuel or exhaust deposits.

The magneto manufacturer, Continental Aerospace Technologies (CAT), stated the damage to the valves was consistent with late ignition timing due to the damaged magneto. The late timing of the ignition resulted in combustion during the exhaust stroke and therefore overheated the exhaust valve resulting in burning, increasing the likelihood of premature failure.

The damage to the exhaust valve prevented adequate compression during the combustion cycle in the cylinder, leading to a reduction of power.

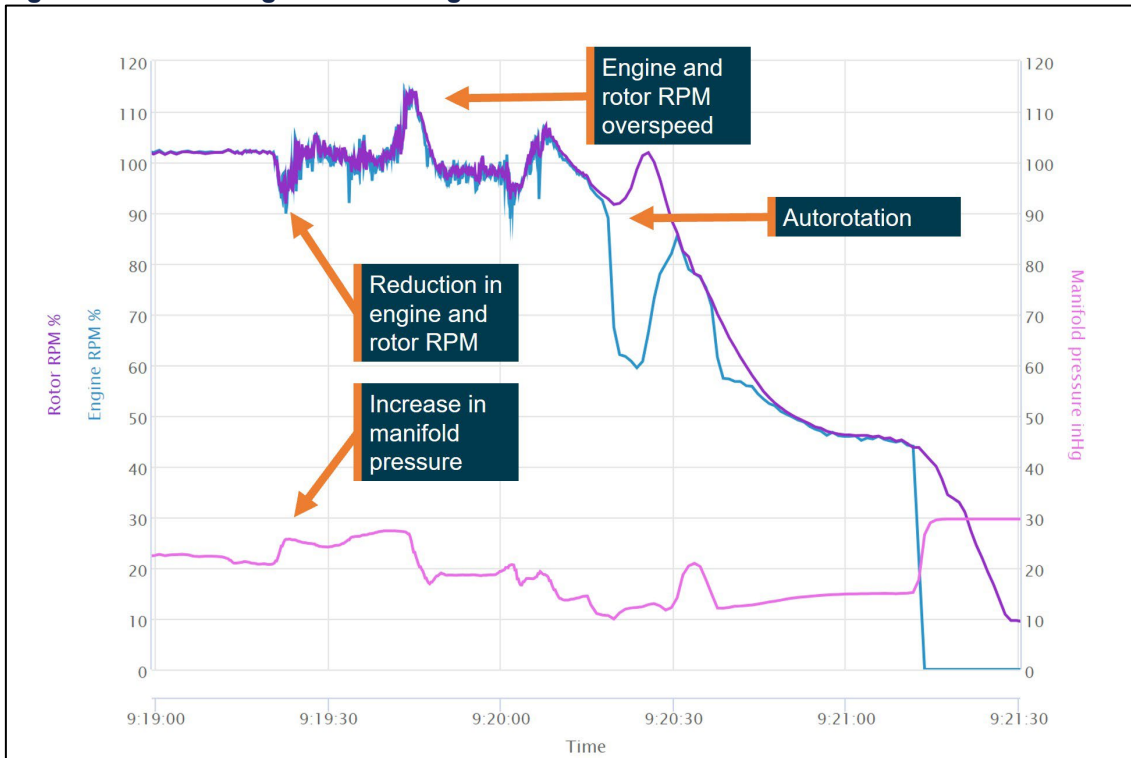
Figure 5: VH-8HR engine monitoring unit data

The engine RPM then reduced and stabilised at about 98% for about 10 seconds. At about 0920 the engine RPM again dropped below 90% and then increased to about 104%.

The damaged right magneto likely caused the engine tachometer to incorrectly read the engine RPM and therefore throttle inputs made by the governor were not accurate and resulted in engine RPM fluctuations. The fluctuations resulted in several reductions in engine RPM and one significant engine RPM increase which increased both the engine and rotor RPM over the manufacturer's limits, increasing the likelihood of damage to the helicopter.

The pilot reported that following the overspeed, they elected to switch the governor control off and fly the aircraft using manual throttle control. The engine monitoring unit (EMU) data showed a 10-second period where the engine and rotor remained at about 98% RPM, consistent with the pilot manually controlling the throttle. The data then showed a further, momentary engine RPM reduction. The governor switch position was not a parameter recorded by the onboard EMU and therefore the ATSB was unable to determine if the cause of the further reduction was caused by inputs from the governor.
