In-flight engine shutdown and forced landing involving Cessna 441, VH-LBZ

3.6 km from Broome Airport, Western Australia, on 19 March 2026

ATSB Transport Safety Report
Aviation Occurrence Investigation
AO-2026-068
Preliminary – 2 June 2026

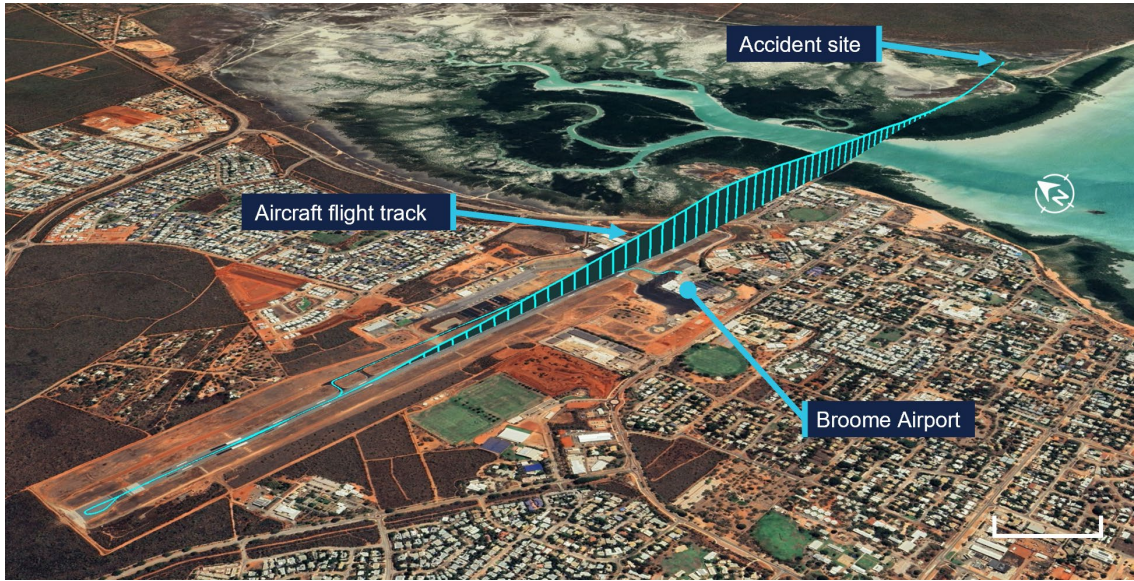
Figure 1: Flight track and location of accident site

The training captain conducted a controlled descent and moved the condition levers to shut-off just before the aircraft impacted terrain at 1117:54, at a ground speed of 76 kt (141 km/h) (Figure 1). As a result of the impact, one passenger was seriously injured and the 2 pilots and 4 passengers received minor injuries. The aircraft was substantially damaged.

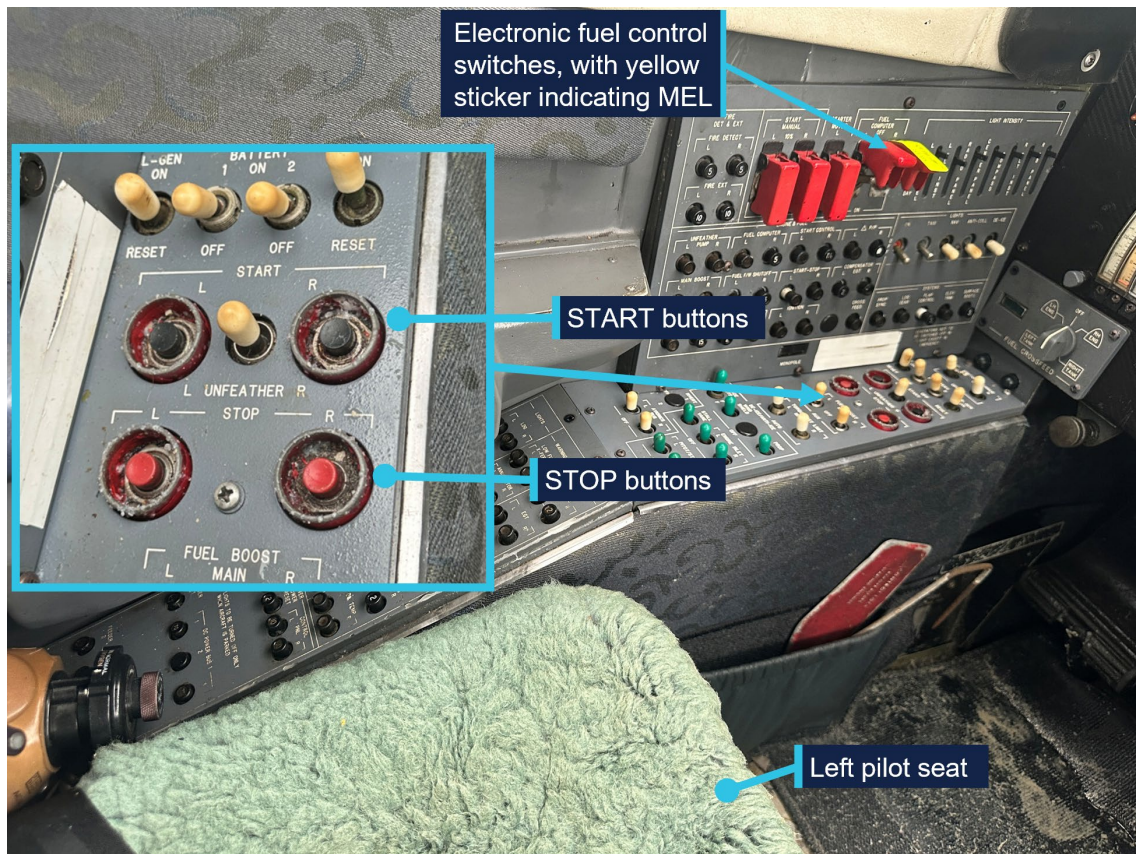
Figure 2: Location of START and STOP buttons and electronic fuel control switches

The aircraft was fitted with START (black) and STOP (red) buttons for the left (L) and right (R) engines. Slightly recessed, the buttons were located in proximity on a horizontal switches panel to left of the left pilot seat (Figure 2). The START button was pressed momentarily to initiate the start sequence, in normal and manual modes.

When the STOP buttons were pressed, this activated the electrical fuel shutoff valve initiating an immediate cessation of fuel flow. When using the STOP buttons for a normal shutdown, the airplane flight manual advised that the buttons were to be pressed and held for 5 seconds to allow for any remaining fuel in the system to be purged.

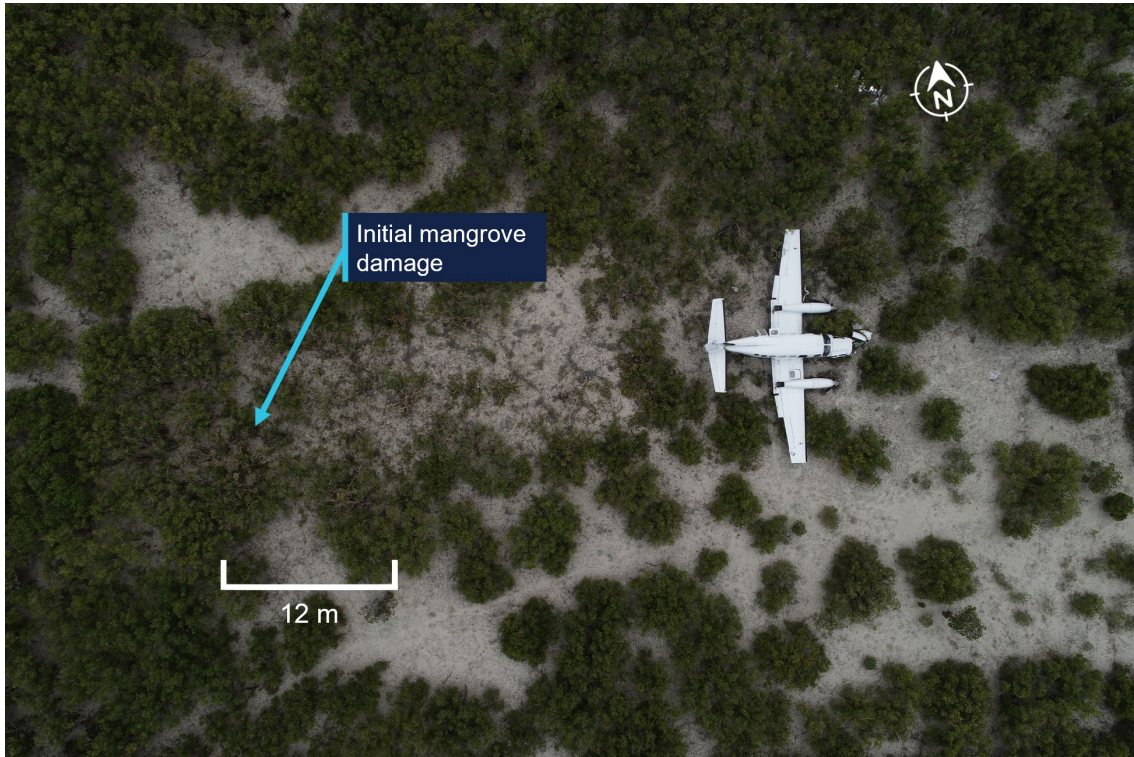
Figure 3: Overhead view of aircraft accident site

The forced landing area was in mangrove swampland about 3.6 km east of Broome Airport, in-line with the aircraft's approximate take-off track. The flight path angle was about 9° nose down and the distance between the initial contact with mangrove trees and the wreckage was about 30 m (Figure 3).

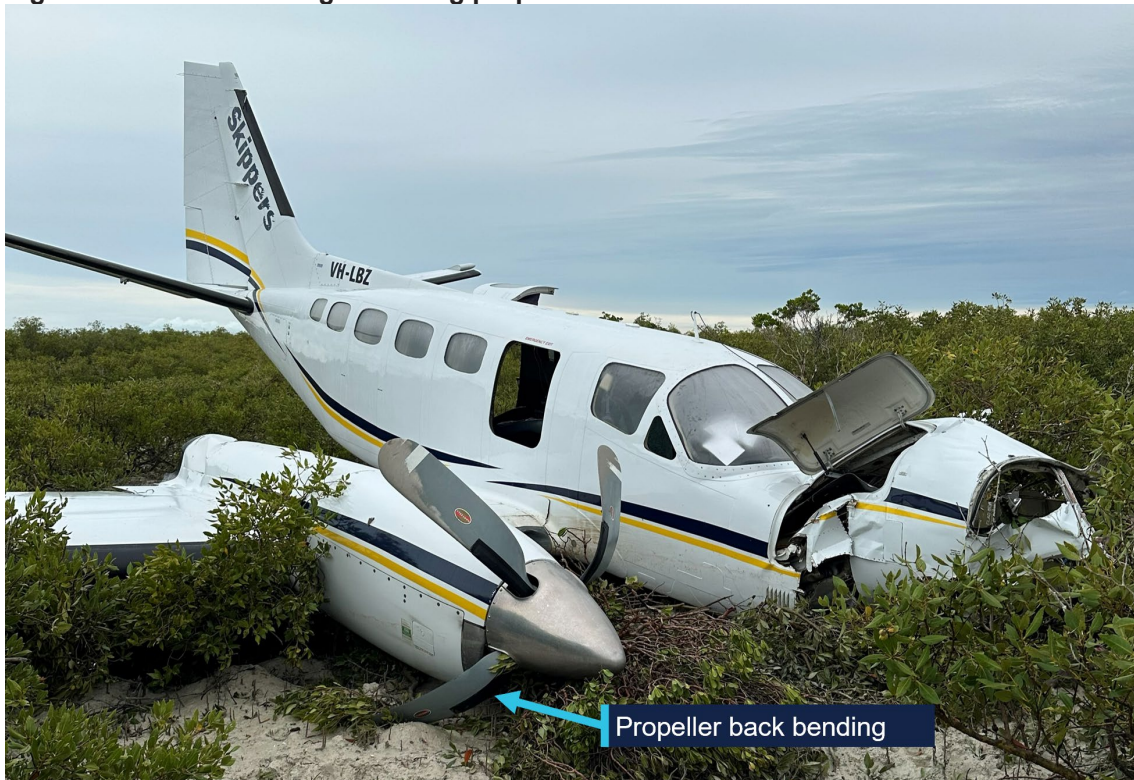
Figure 4: Aircraft wreckage showing propeller back bend

- The aircraft was relatively intact with the landing gear down and the flaps partially extended. The aircraft rapidly decelerated once the landing gear had contacted the muddy terrain.
- There was fuel in the left and right wing tanks and clean fuel in the left and right engine-driven fuel pump filter bowls.
- Examination of the left and right engine turbines viewed through the exit ducts did not show any observable damage.
- Damage to the left and right propeller showed back bending and limited rotational abrasion damage, which indicated the engines were not driving the propellers at the time of the impact (Figure 4).

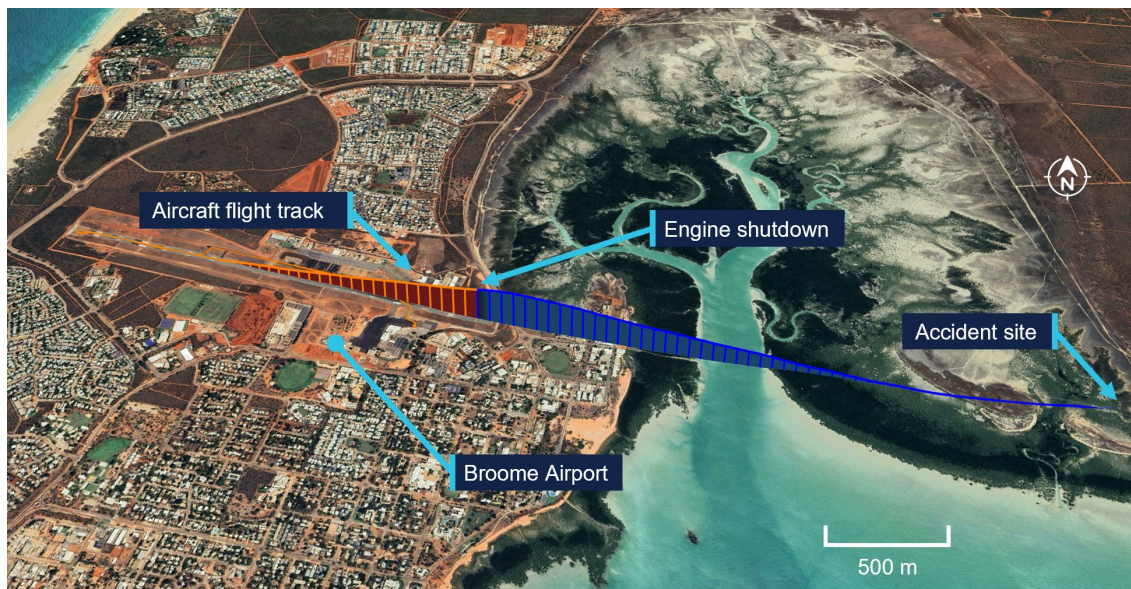
Figure 5: Location of aircraft engine shutdown

The data retrieved also indicated that, at 1116:59, the aircraft (Figure 5):

- was at an altitude of 490 ft above mean sea level
- had an indicated airspeed of 141 kt (261 km/h)
- was climbing at 1,225 ft/min

- had about 9° nose-up attitude and 4° left roll
- was on a heading of about 107°.

Orange section is with power available, blue section is following the engine shutdown.
Source: ATSB

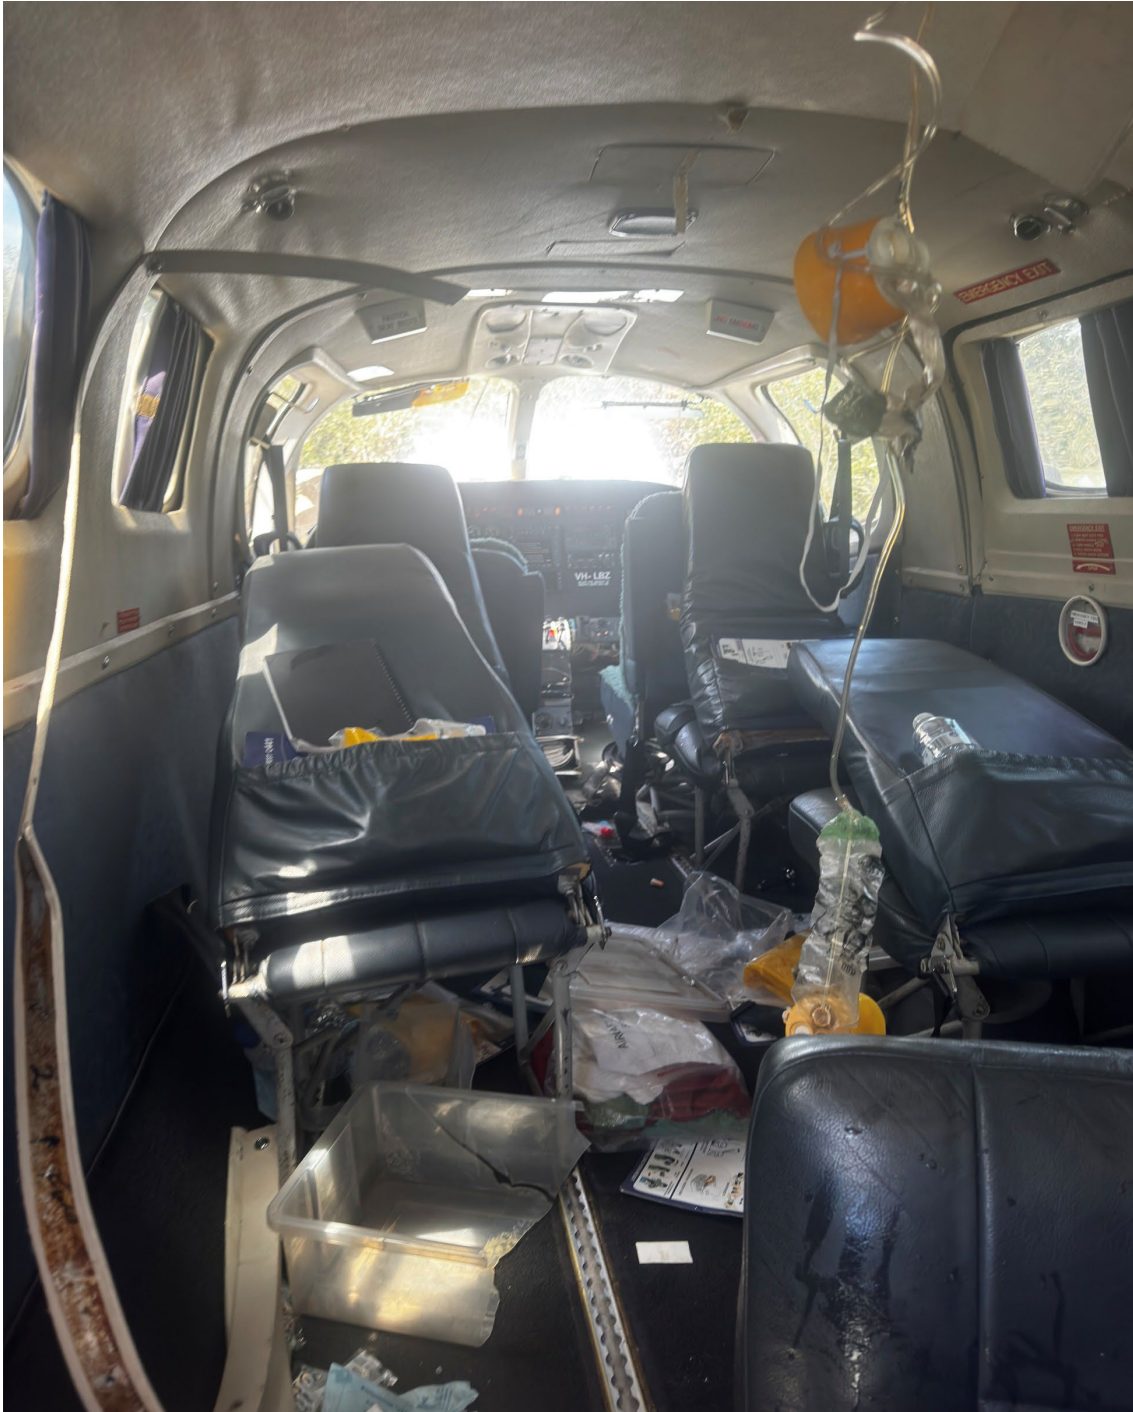
Figure 6: Aircraft cabin immediately after the accident

The liveable space within the aircraft cabin was maintained, and the exits were tested by the ATSB and found to function correctly. However, there was significant disruption to the cabin interior including displaced equipment, deployed oxygen masks and the complete detachment of 2 passenger seats from their seat tracks, with some of the floor structure lifting. An additional seat had partially detached and the seat behind the right pilot was significantly distorted, with a backward bend of almost 45° (Figure 6).

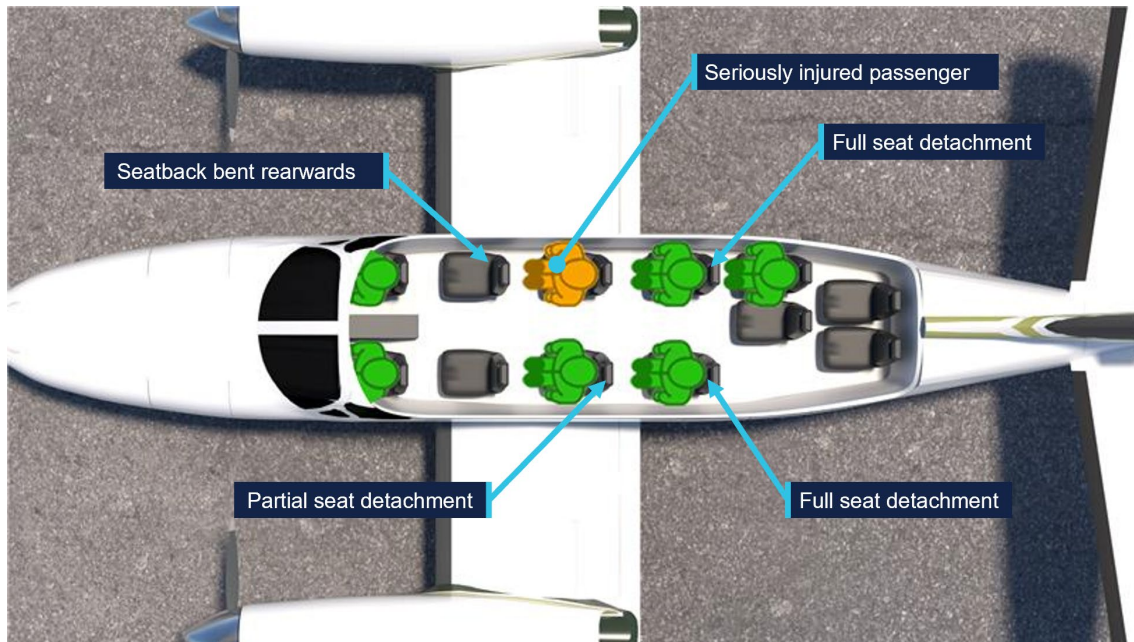
Figure 7: Location of seat failures and seriously injured passenger

In addition, a passenger seated on the right side of the second row of passenger seats reported that their seatbelt failed during the impact, throwing them forward into the back of the seat ahead before coming to rest between the 2 pilots. This passenger received serious injuries. Figure 7 shows the location of the full and partially failed seats, and where the seriously injured passenger was seated. All other passengers and the pilots received minor injuries.
