# Collision with terrain involving Wolf Pitts S1-11X, VH-PVX

Avalon Airport, Victoria, on 28 March 2025

## **ATSB Transport Safety Report**

AO-2025-017

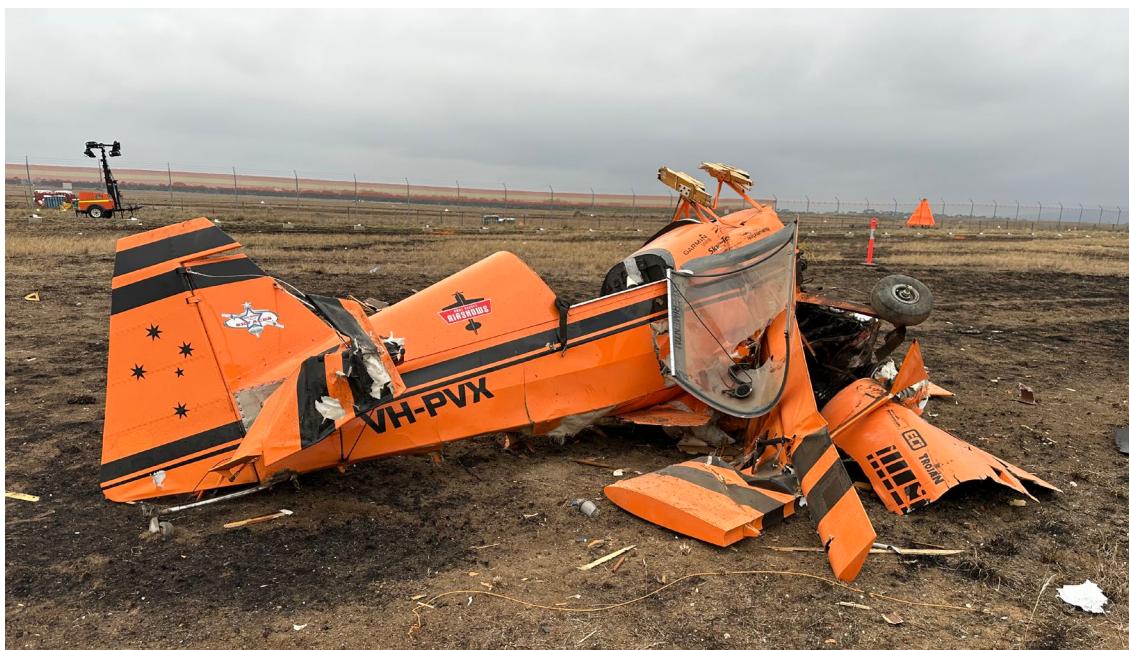
**Figure 2: Aircraft wreckage**

The pilot entered the first half of the loop from approximately 100 ft above ground level (AGL) (see *Recorded information*). At the top of the loop, while in an inverted position, the altimeter showed that the aircraft was approximately 800 ft. The pilot then initiated 3 snap rolls, during which the aircraft drifted toward the show line (see *Air display information*). The pilot finished the snap rolls inverted with the aircraft banked away from the show line. They then began the descending part of the loop, however, they had insufficient height to recover. At about 1717, the aircraft collided with terrain, resulting in substantial damage to the aircraft (Figure 2).

The ATSB conducted a preliminary examination of the aircraft at the accident site, but due to access restrictions for the operational airport and airshow, the wreckage was then relocated to a secure facility for detailed examination. Examination of the wreckage identified:

- There was no evidence of any defects or failures that may have been present before the impact, and which could have contributed to the development of the accident.

- The uppermost section of the canopy windshield was fractured partly from the accident sequence and then from first responders accessing the cockpit.
- The engine mounts had fractured, with the engine remaining tethered by the main fuel line, engine controls and wiring loom.

- The forward main landing gear had permanently splayed outward, the tailwheel strut exhibited some upward deflection, the engine sump cover had fractured, and the lower fuselage section had sustained compression damage, consistent with a hard landing in an upright orientation.

- The upper wings had separated from the aircraft, with the wing spars fracturing outboard of the cabane strut attachment. The lower wings sustained impact damage but remained secured to the fuselage.

- The rigid lines between the fuel tanks and selector valve were fractured, resulting in post-accident leakage of fuel. However, the fuel tanks remained intact and there was no post-impact fire.

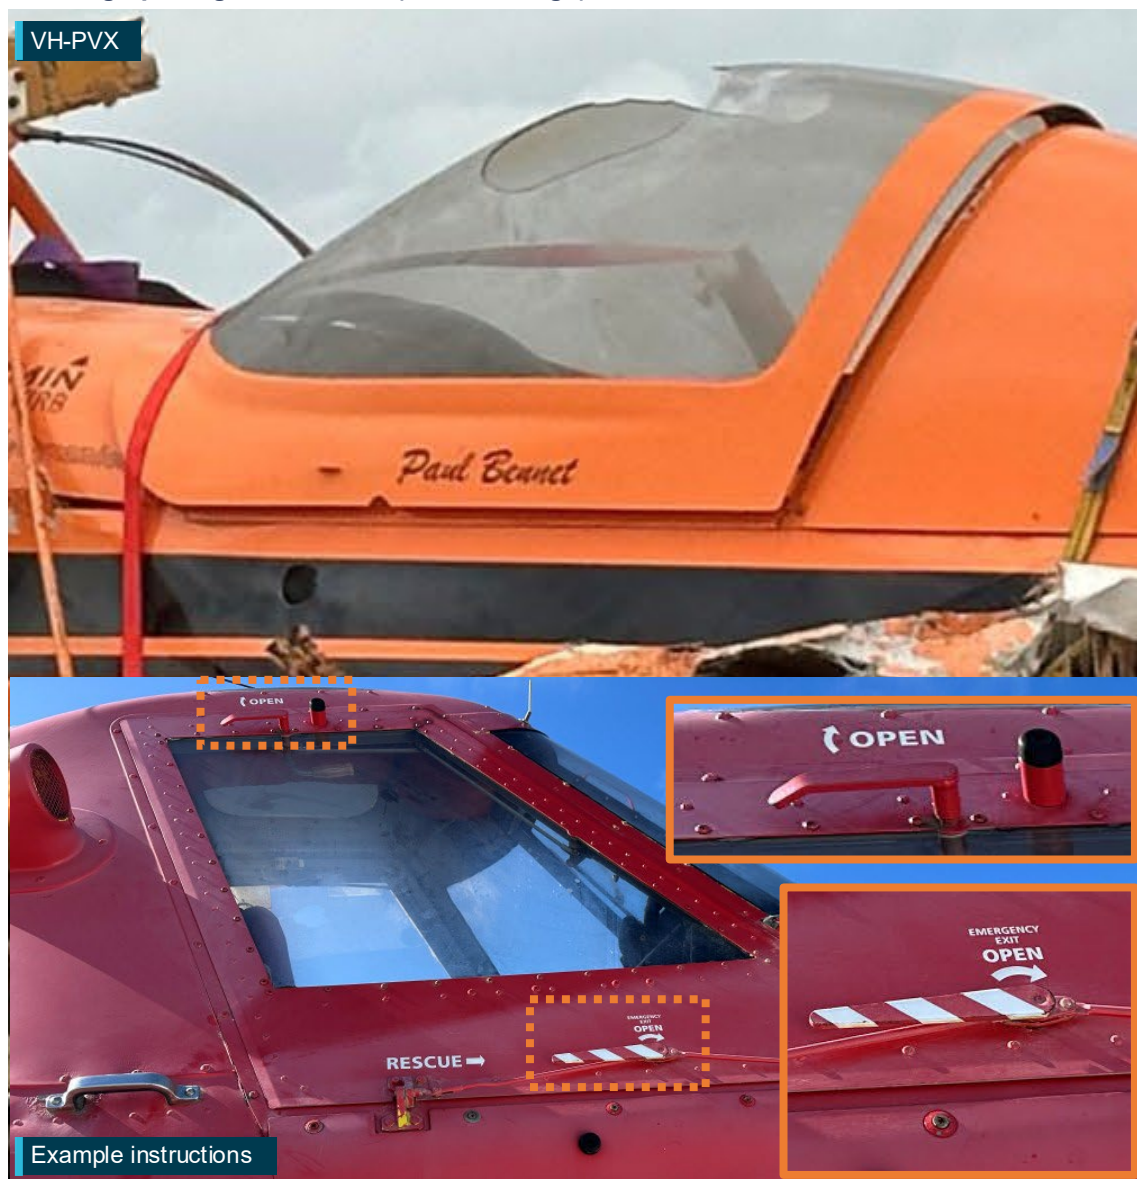
**Figure 4: Outside of canopy on VH-PVX (top image) compared with a different aircraft showing opening instructions (bottom image)**

VH-PVX was fitted with a side-opening canopy. There were no instructions for opening the canopy visible on the outside of the aircraft (Figure 4 top image). This was contrary to the Civil Aviation Safety Authority Civil Aviation Order 101.28 *Airworthiness certification requirements – Amateur-built category aeroplanes*, section 3.27 *Markings and placards* that stated markings were required:

...on both the outside and inside of each exit door, hatch or canopy, indicating the position of the opening handles with locks fully engaged and also providing essential operating instructions for opening.

An example of such instructions on another aircraft is shown in Figure 4 (bottom image).

The pyrotechnicians reported having difficulties in opening the aircraft's canopy, as the opening mechanism was not obvious from the outside. The onboard video showed that the pyrotechnicians took approximately 50 seconds to forcefully remove the canopy, which appeared to have already been damaged in the accident sequence.

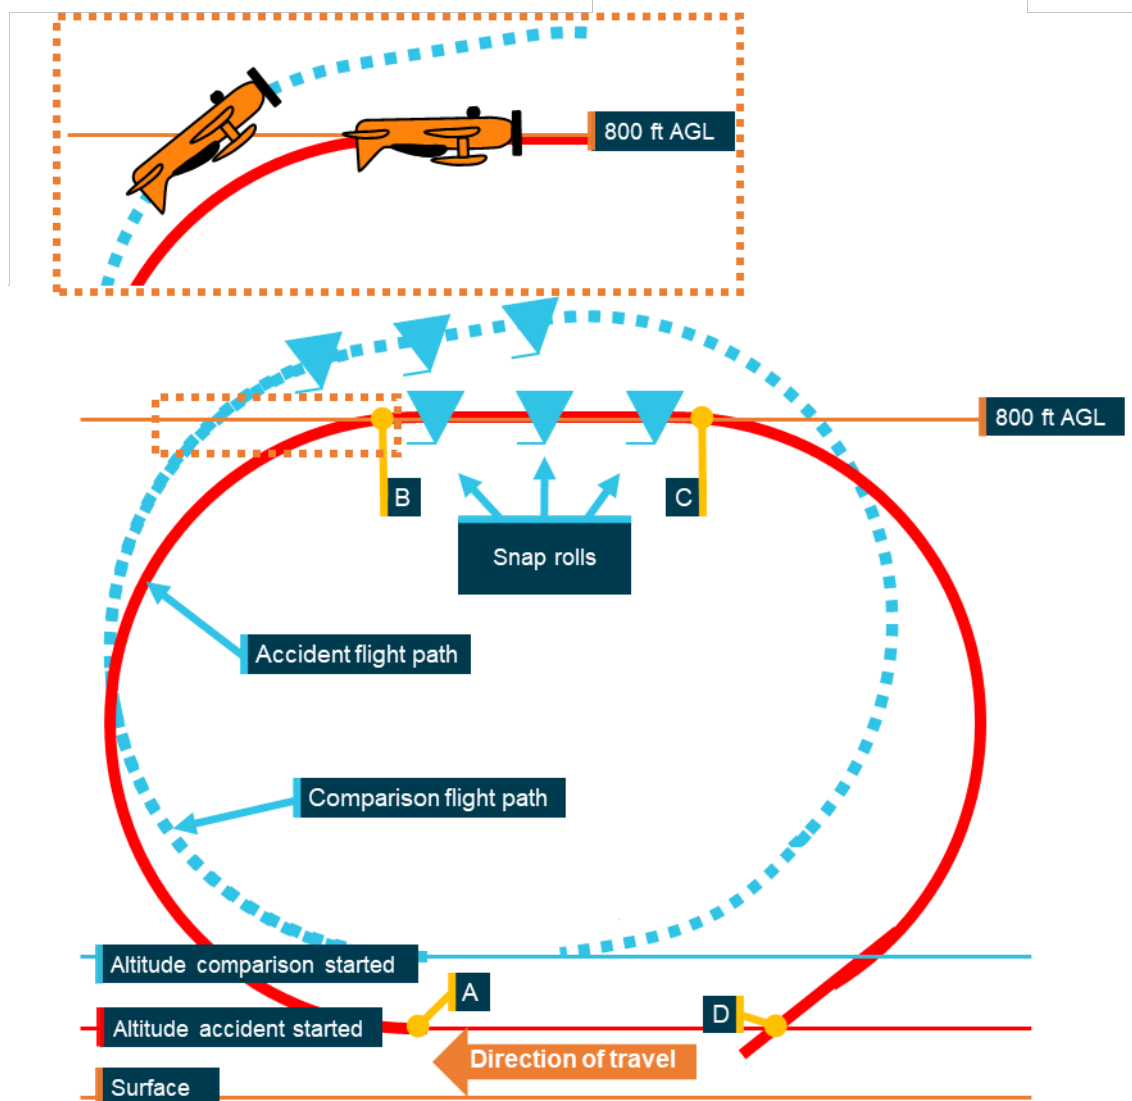
**Figure 5: Comparison of the previous and accident flights, showing the nose attitude when reaching 800 ft when starting the first part of the loop at different heights**

There were discrepancies between the estimated height and the onboard altimeter. Such as during the descent, at 0.4 seconds (Figure 5 D) before the collision with terrain, the altimeter showed 100 ft AGL. At that point, the ATSB estimated height was 47 ft. Although, it was possible that the altimeter was lagging the actual height of the aircraft for the short time it was visible due to the descent rate.

However, it was noted that the low-level passes performed during the display and when the altimeter was visible, the aircraft instrument indicated the pilot was flying at approximately 100 ft. Therefore, it was determined that the entry height to the first part of the loop was likely to be about 100 ft. This was 100 ft lower than seen in the comparison flights.

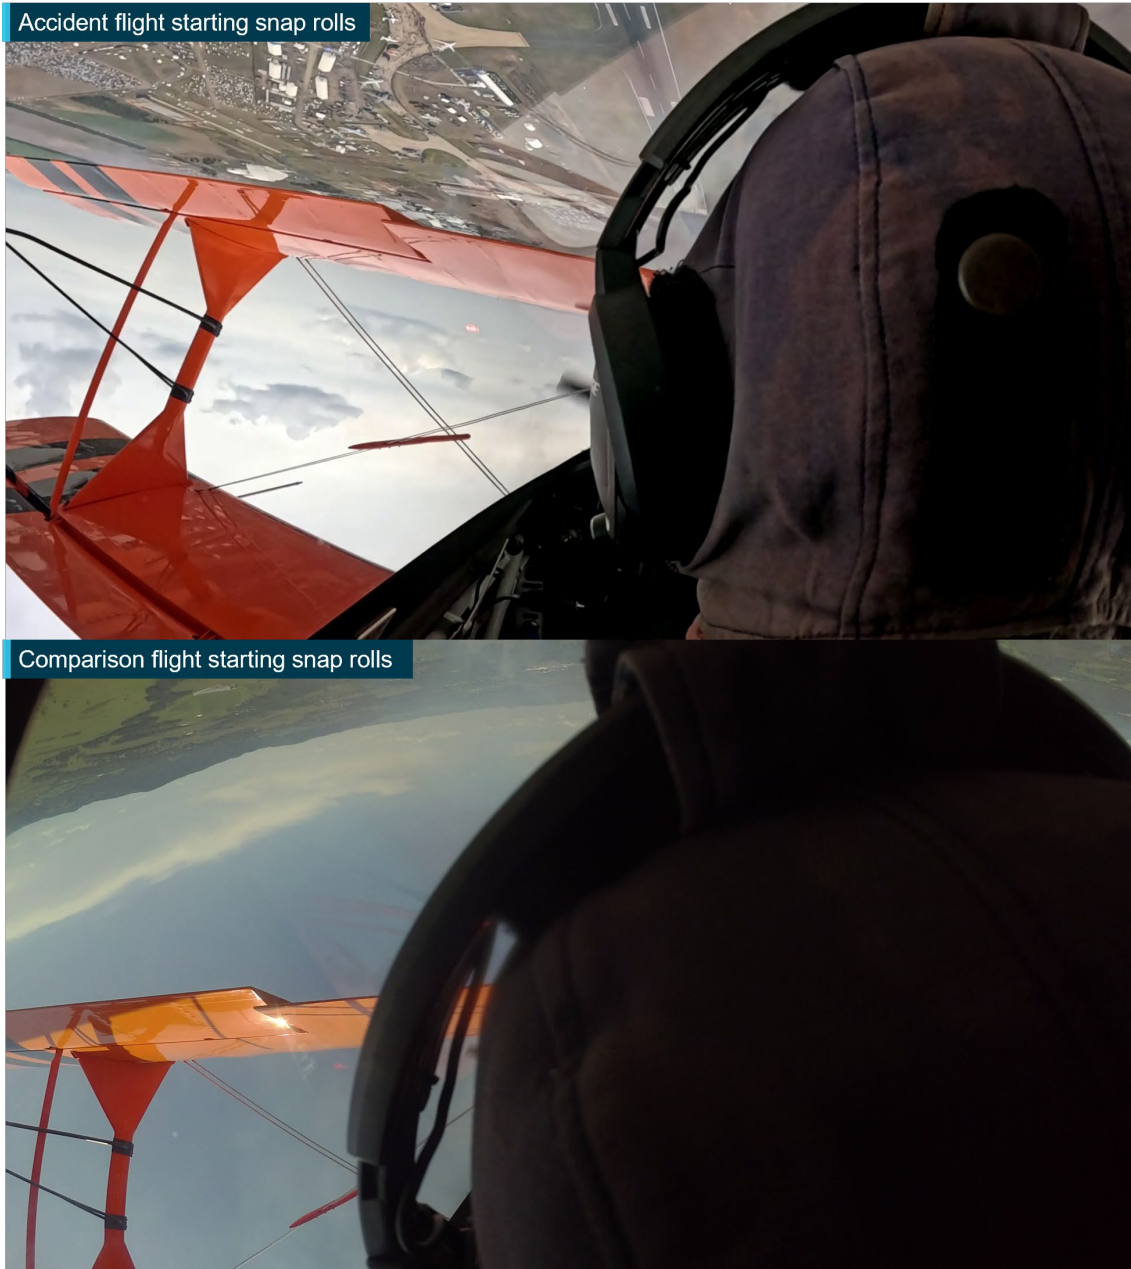
**Figure 6: Aircraft's nose attitude when starting the snap rolls for the accident flight (top image) and a comparison flight (bottom image)**

Figure 6 shows the accident flight nose attitude is closer to the horizon when starting the snap rolls than seen in the comparison flight. Figure 7 shows that the accident flight finishes the snap rolls with a lower nose attitude than the comparison flight. Although, it is harder to make a comparison in this image due to the bank angle on the accident flight.

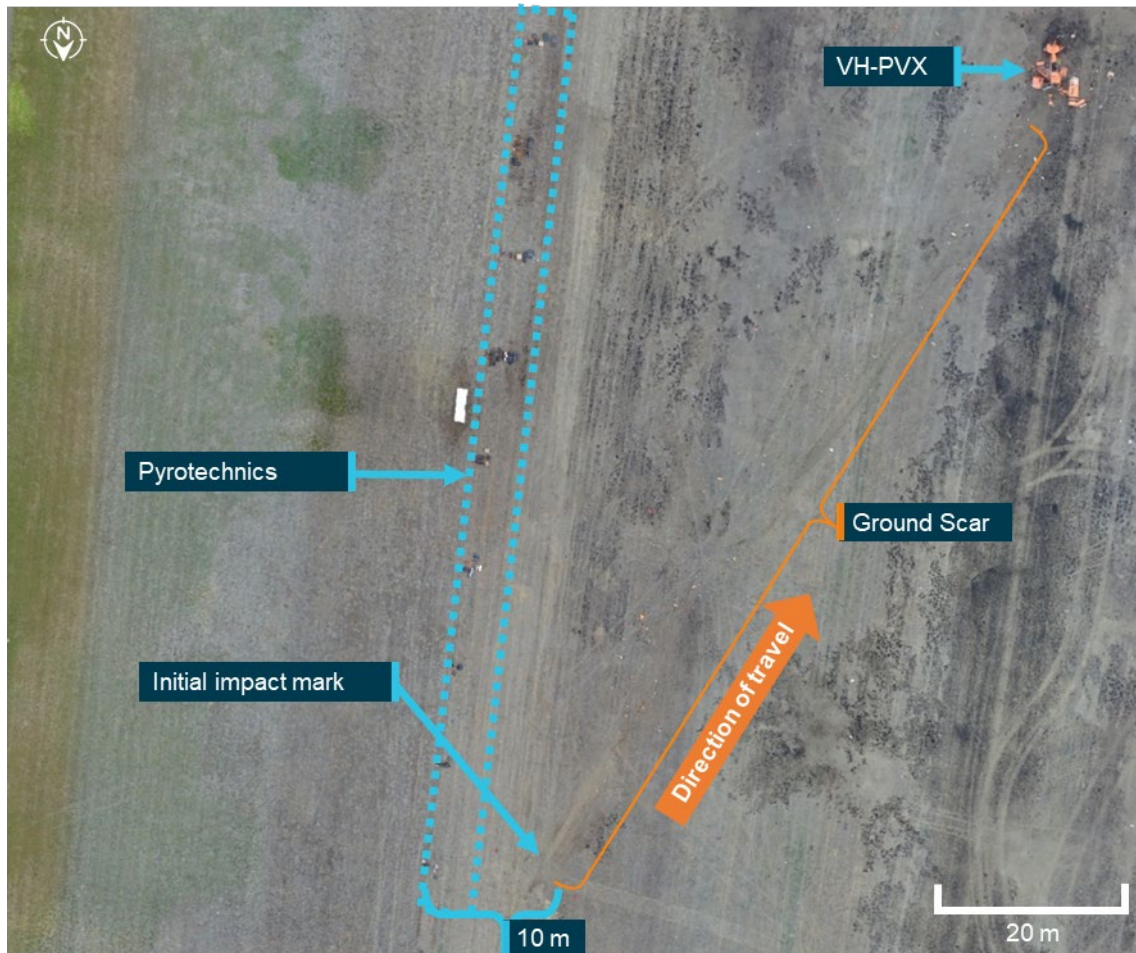
**Figure 8: Overview of pyrotechnics and point of VH-PVX collision with terrain**

A ground scar, approximately 95 m long, was on a south-south-west heading (Figure 8). The aircraft tumbled around the nose and came to rest upright and oriented toward north, almost opposite the direction of the impact sequence and debris trail. The initial impact point occurred about 10 m from the fuel boxes within the pyrotechnics (Figure 8).

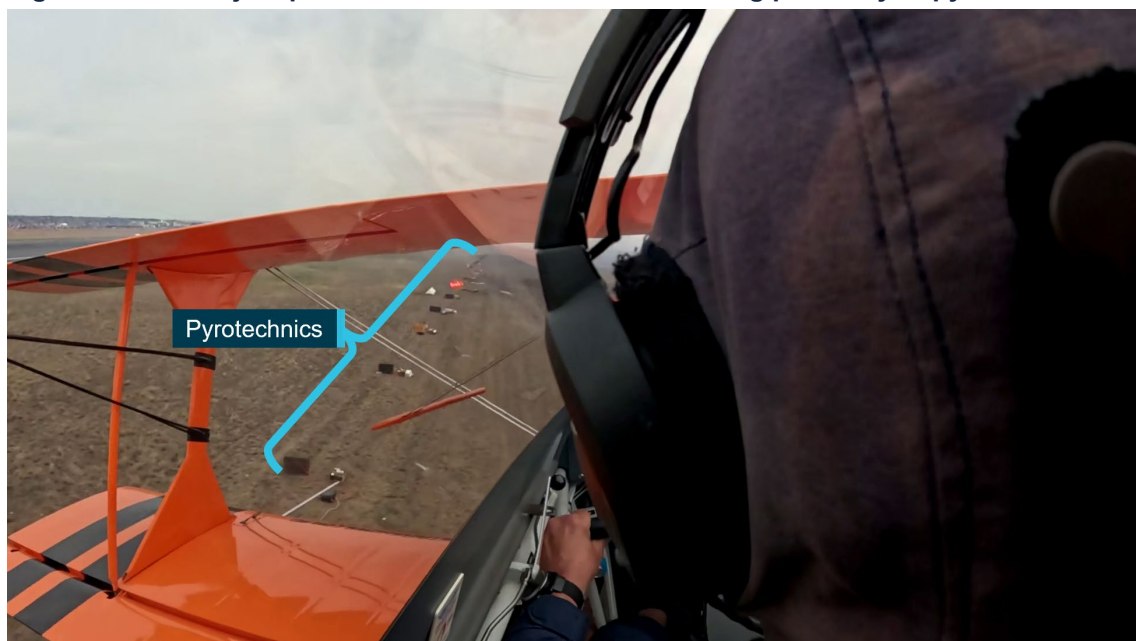
**Figure 9: VH-PVX just prior to collision with terrain showing proximity to pyrotechnics**

An image taken from the onboard camera showed that the aircraft was in close proximity to the pyrotechnics before (Figure 9) and at the point of the collision with terrain.

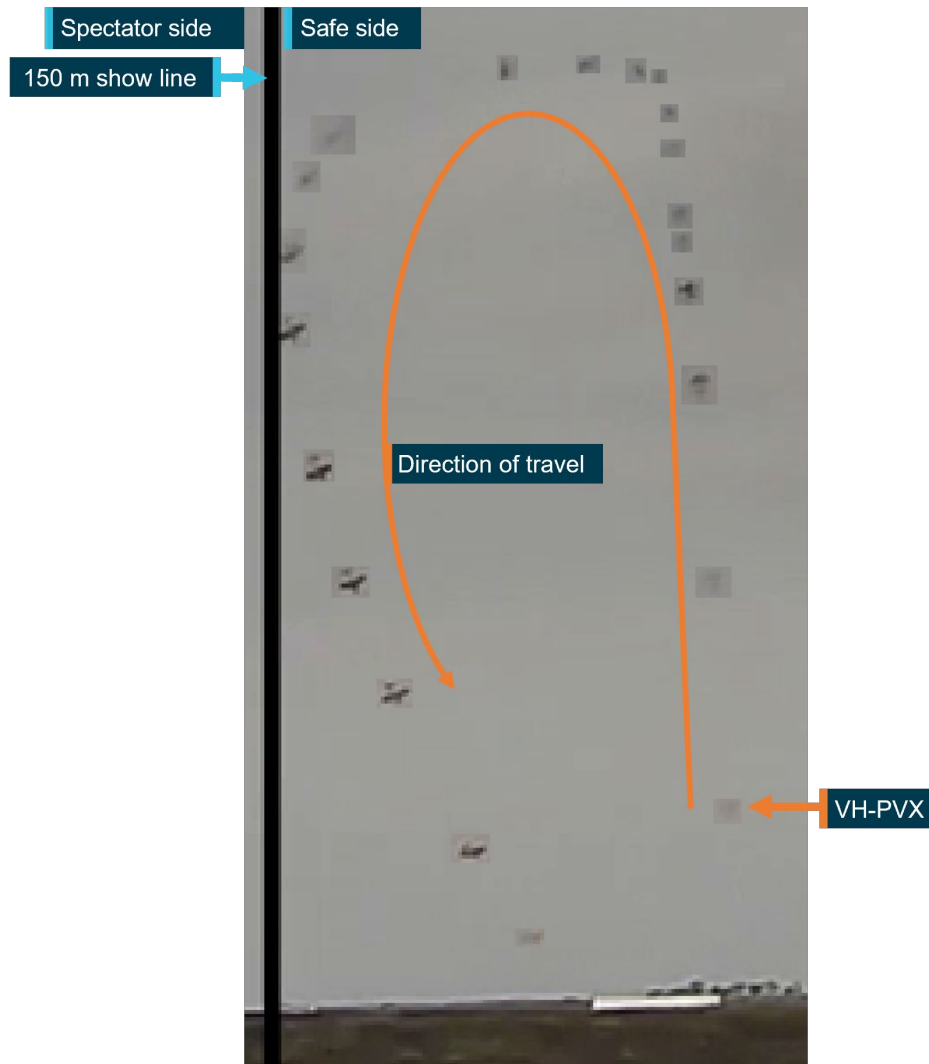
**Figure 11: VH-PVX reference to 150 m show line, shows the aircraft moving towards the show line, then away from the line**

During the snap rolls, the aircraft moved towards the 150 m show line. When the pilot reviewed the accident video, they believed they attempted to correct this, which was also evident from the show line video (Figure 11).

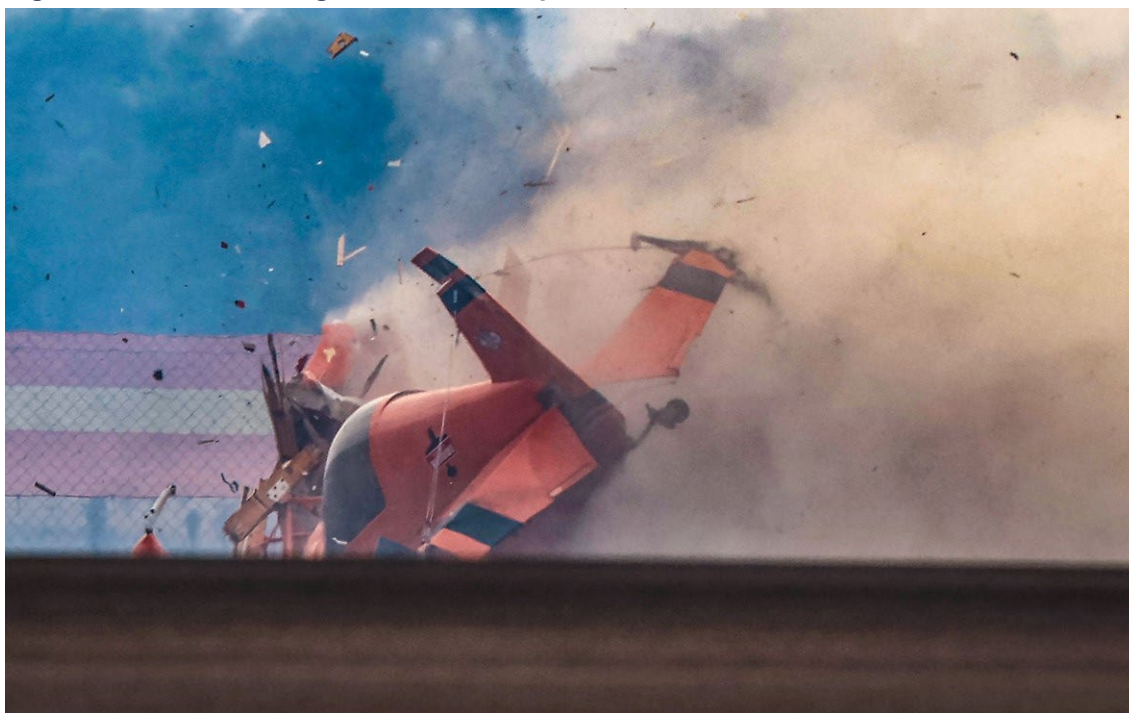
**Figure 13: VH-PVX during the accident sequence**

After the initial impact, the aircraft tumbled around the nose (Figure 13), destroying the wings and propeller. The pilot was effectively retained in their seat by the 5-point restraint, minimising flail injuries, and the space around the pilot in the cockpit was retained. However, the canopy fractured and was associated with a superficial scalp injury. Had the pilot been wearing a hard-shell helmet, that injury would probably have been avoided, but it would unlikely have reduced the severity of other injuries.
