Fuel starvation involving Piper PA-31, VH-PGO

28 km west of Meekatharra Airport, Western Australia, on 5 June 2025

ATSB Transport Safety Report

AO-2025-026

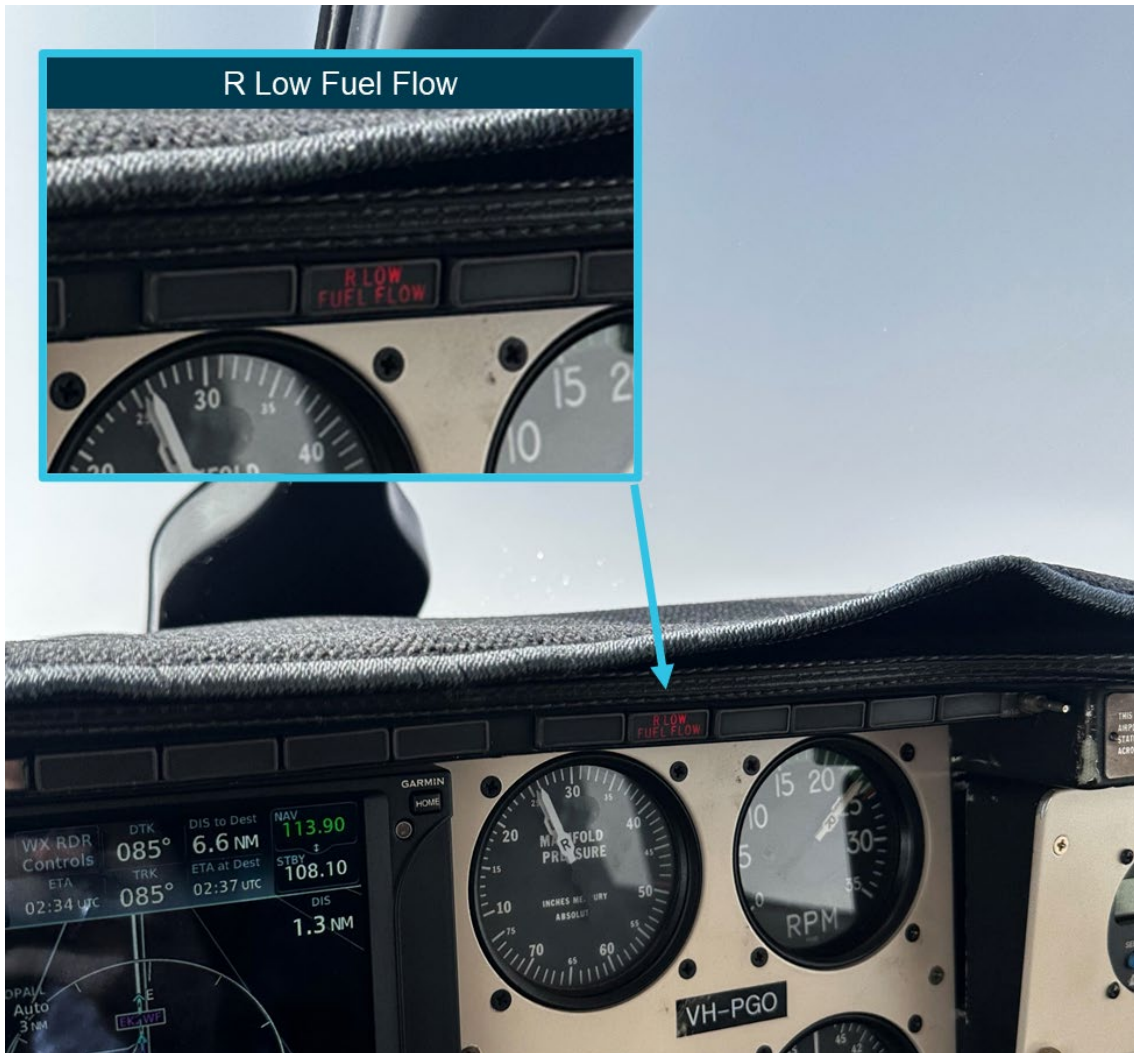
Figure 2: Right low fuel flow annunciator illumination during approach to Meekatharra

The pilot descended the aircraft to 1,700 ft AGL and levelled off in accordance with the instrument approach procedure, before commencing the final approach to runway 09 with the intention of conducting a circling approach to runway 27. During this segment the R LOW FUEL FLOW warning light illuminated on the annunciator panel (see Figure 2 and the section titled *Fuel system*).

The pilot scanned the engine indications and noted they were normal, with no discrepancies between the engines. The pilot reported observing that the left and right fuel flow gauges were stable and indicating similar values, the fuel pumps were selected on, the engine mixtures were set to full rich, and the fuel boost pump circuit breakers were in and not tripped. The pilot also checked the fuel quantity gauges and stated that, while they did not recall the exact readings, nothing appeared abnormal or suggested that a tank was empty. The pilot continued the approach to Meekatharra. On the final approach segment, the aircraft entered instrument meteorological conditions (IMC).⁵ After entering IMC, the R FUEL BOOST INOP warning light (see the section titled *Fuel system*) illuminated, followed by the right engine surging and associated aircraft yaw.

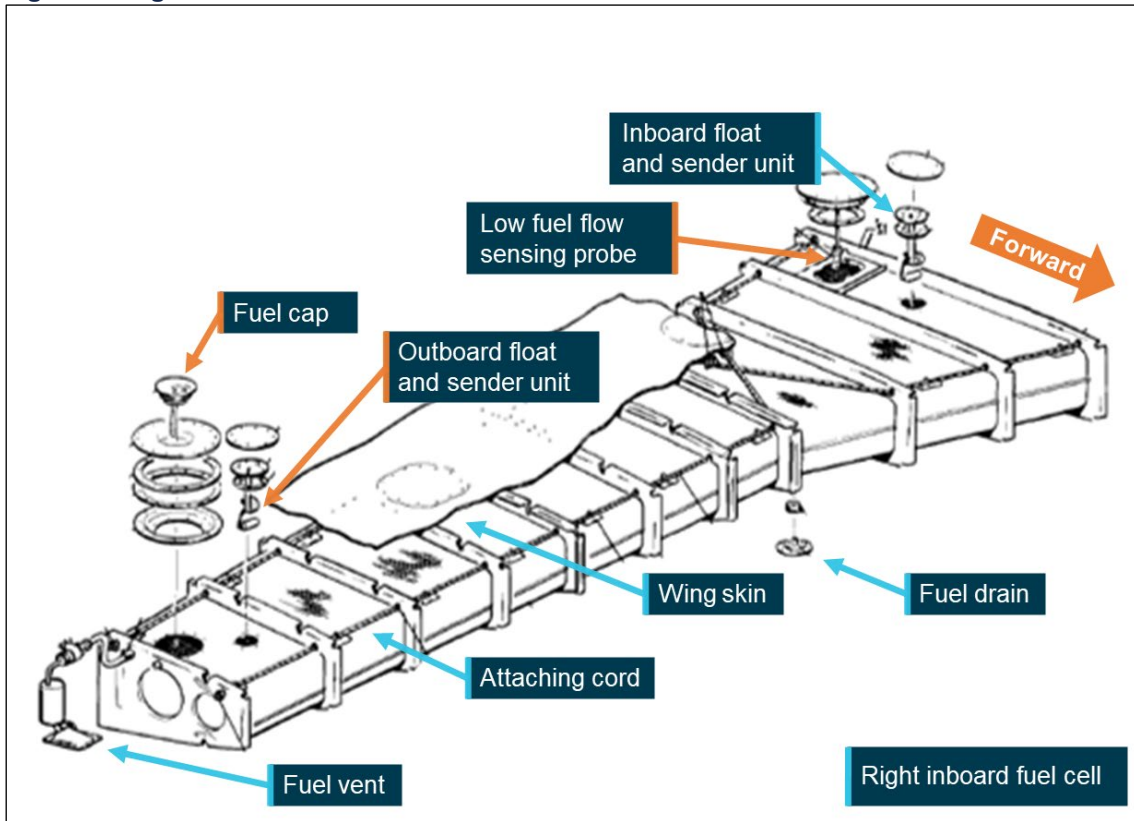
Figure 3: Right inboard fuel cell

Two electric fuel quantity gauges are also mounted on the overhead switch panel (Figure 5). These indicate the fuel tank level from float-style sender units in each tank. The gauges indicate left inboard or outboard tank, and right inboard or outboard fuel tank quantities dependent on selector valve position. The inboard tanks contain 2 sender units each, one near the wing root and one near the filler cap (Figure 3).

The chief engineer observed that the bottom of the fuel cell had been drawn up towards the fuel cap and required manual reseating. They filled the inboard tanks to maximum capacity; 67 L was required to fill the left inboard tank, and 204 L was required to fill the right inboard tank. The chief engineer stated that they were satisfied that the fuel cell had reseated correctly within the fuel tank cavity.

During flight, the rate of fuel being siphoned through the fuel cap was likely sufficient to overcome the vent's ability to equalise pressure in the fuel tank. This resulted in negative pressure collapsing the fuel cell as observed by both the pilot and the chief engineer during their post-occurrence inspections. As the fuel cell was secured by a single cord around the upper perimeter, the collapse of the fuel cell resulted in the base of the cell lifting towards the filler port.

As one of the right inboard fuel tank float-style sender units was located near the fuel filler port, it is likely that the upwards lifting of the fuel cell floor toward the filler port, raised the outboard sender unit's float. This resulted in an overreading of the cockpit fuel quantity gauge. ATSB occurrence brief AB-2021-009 identified a similar failure mechanism where the fuel cell collapsed resulting in the fuel gauge overreading its contents. The Civil Aviation Safety Authority's advisory circular (AC) 91-25 *Fuel and oil safety, section 6*, also contained information about collapsing fuel cells interfering with the accuracy of fuel gauge readings.

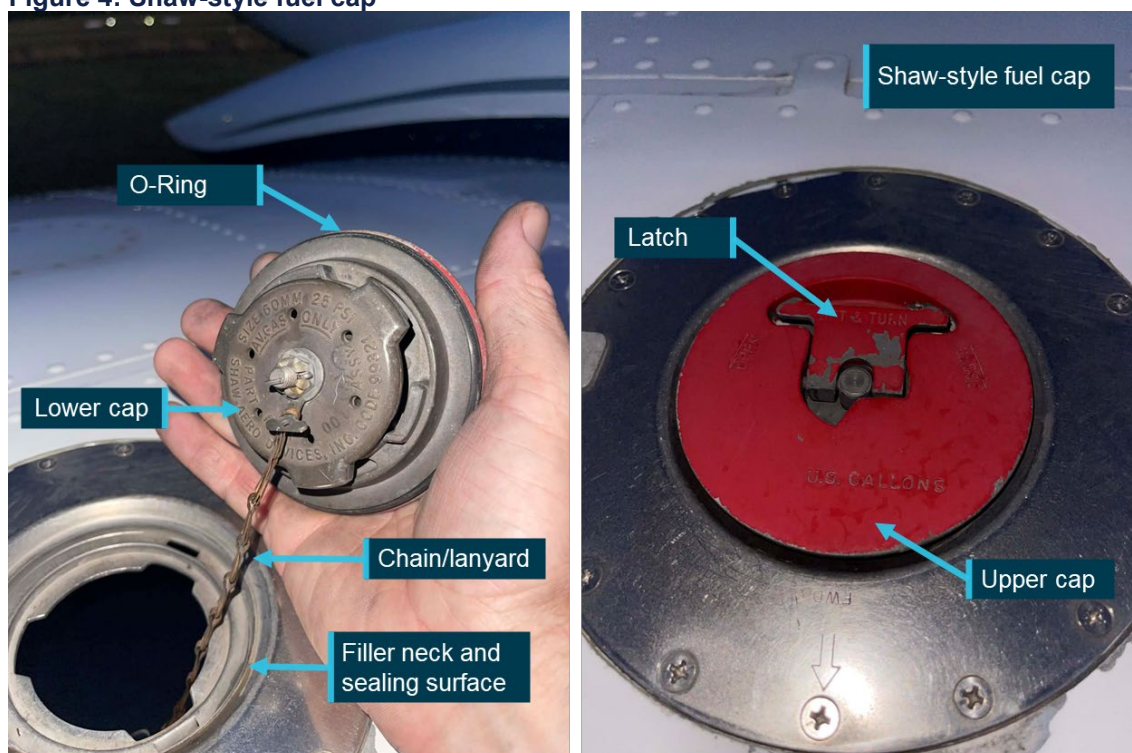
Figure 4: Shaw-style fuel cap

Each tank has a separate Shaw-style fuel cap for servicing (Figure 4). The inboard tank caps are located on the upper centre section of each wing and the outboard tank caps are on the upper outboard section of each wing. The right inboard fuel cap is not visible from the pilot's seated position. The fuel caps are installed on the filler neck of each tank and utilise a twist-to-lock cam mechanism. As the latch is rotated, the upper and lower sections are drawn together, compressing the O-ring seal against the filler neck to form a secure, fuel- and water-tight closure. The lower cap lugs engage under the filler neck flange to hold the cap in place against vibration, pressure changes, and airflow that is encountered in flight. The caps are also attached to the wing by a lanyard.

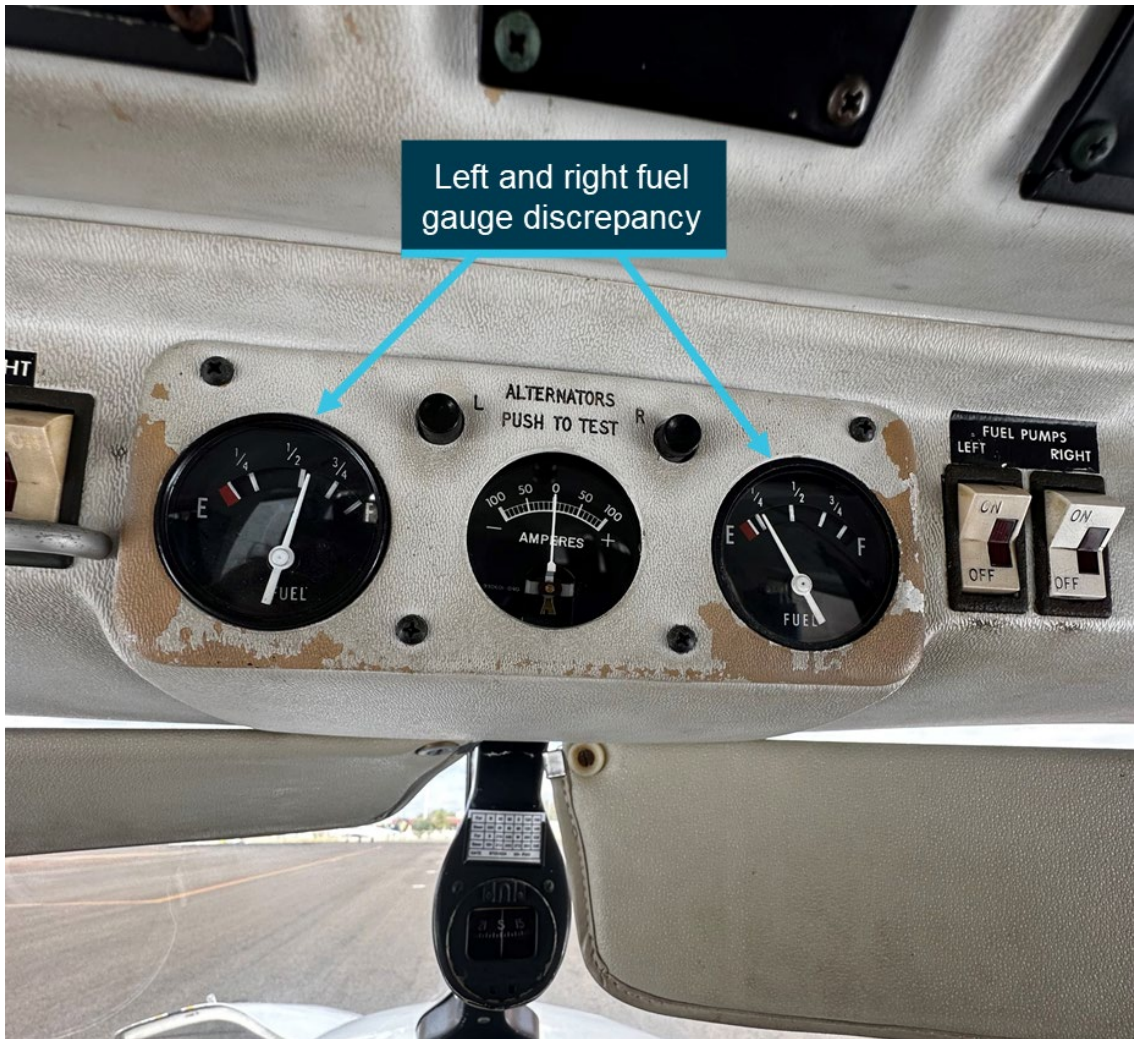
Figure 5: Inboard tank quantity discrepancy after landing

After landing and shutting down the left engine, the pilot escorted the passengers to the terminal, reported the occurrence to Shine Aviation, and then returned to the aircraft. The pilot then applied battery power and noted that the right inboard tank fuel quantity gauge was indicating just above a quarter full, and the left inboard tank fuel quantity gauge was indicating half a tank (Figure 5). The pilot recalled that this was unusual and was more significant than the minor discrepancy observed at the top of descent.

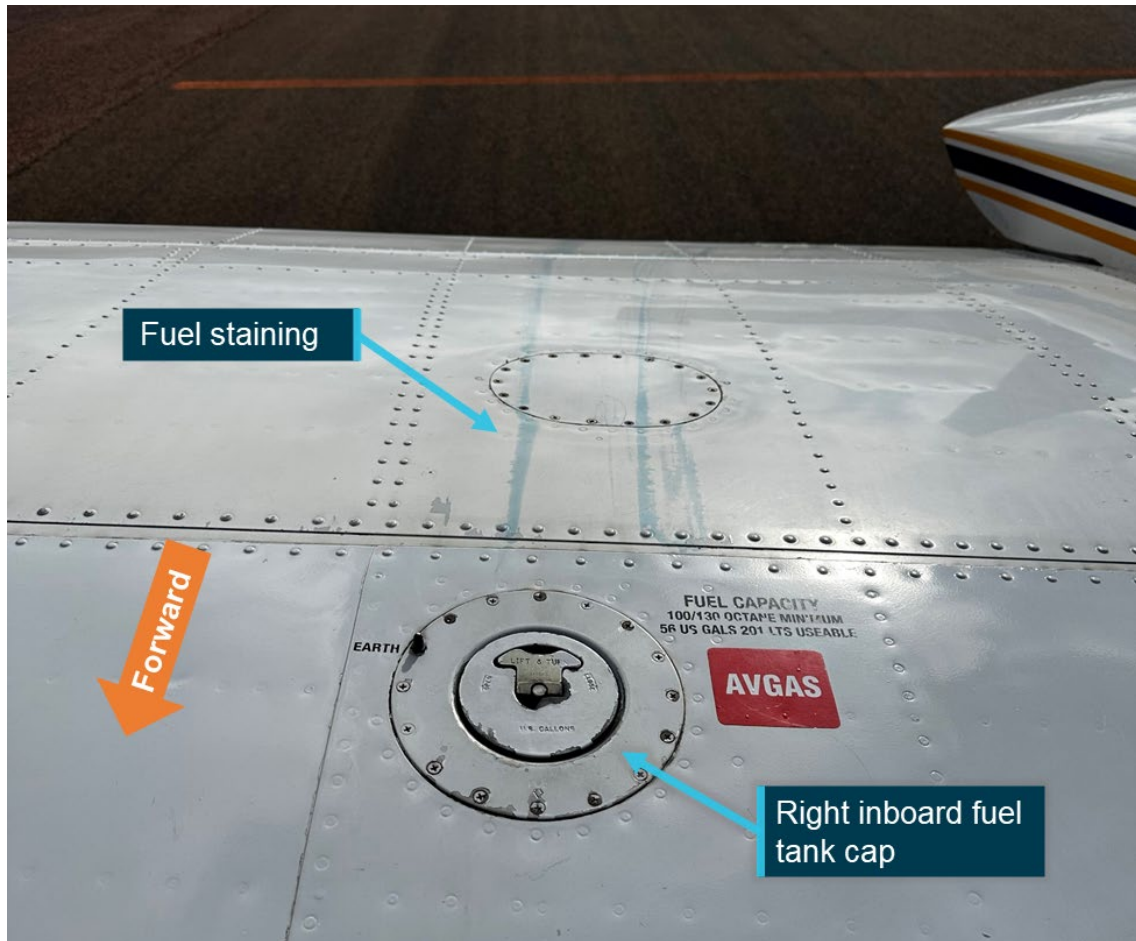
Figure 6: Fuel staining aft of right inboard fuel cap

The pilot then conducted a visual inspection of the right wing area and noted blue fuel streaks behind the right inboard fuel cap (Figure 6). After attempting to drain fuel out of the right inboard fuel tank without success, the pilot then removed the right fuel cap to see if any fuel was present. The pilot noted that the fuel cap latch was 'extremely' difficult to unlatch and required the use of both hands. Upon looking in the tank, the pilot observed that it was empty, and the bottom of the fuel cell had been sucked up towards the fuel filler area. The pilot then reinstalled the cap, commenting that the cap latched normally and without difficulty.

Photographs taken by the pilot after landing at Meekatharra Airport show fuel staining immediately aft of the right inboard fuel cap, consistent with fuel leaking from the cap in flight. This staining, in conjunction with the pilot's observation that the right inboard tank was emptied earlier than expected based on calculated consumption, and that the tank cell collapsed upwards towards the cap, all indicate that fuel had likely been siphoned through the cap in flight. The pilot also reported that the fuel cap latch was difficult to lift, suggesting the cap may not have been correctly seated.

During the post-occurrence inspection, the chief engineer found no evidence of any other fuel leaks around the right inboard tank. The pilot had removed and reinstalled the cap prior to this inspection, therefore the chief engineer could not determine exactly how the cap was incorrectly fitted. The chief engineer was also unable to reproduce an incorrect installation. However, the chief engineer considered it likely that the fuel cap had been incorrectly secured, including the possibility of the attaching lanyard interfering with the cap and seal. No damage was observed to the cap, seal, or lanyard and the chief engineer replaced the O-ring on the cap as a precaution, although they considered the removed O-ring serviceable. Subsequent flights, including the immediate post-occurrence flight with the chief engineer observing the cap, did not reproduce the leak. As the leak did not recur, it was almost certain the fuel cap was incorrectly secured in Carnarvon.

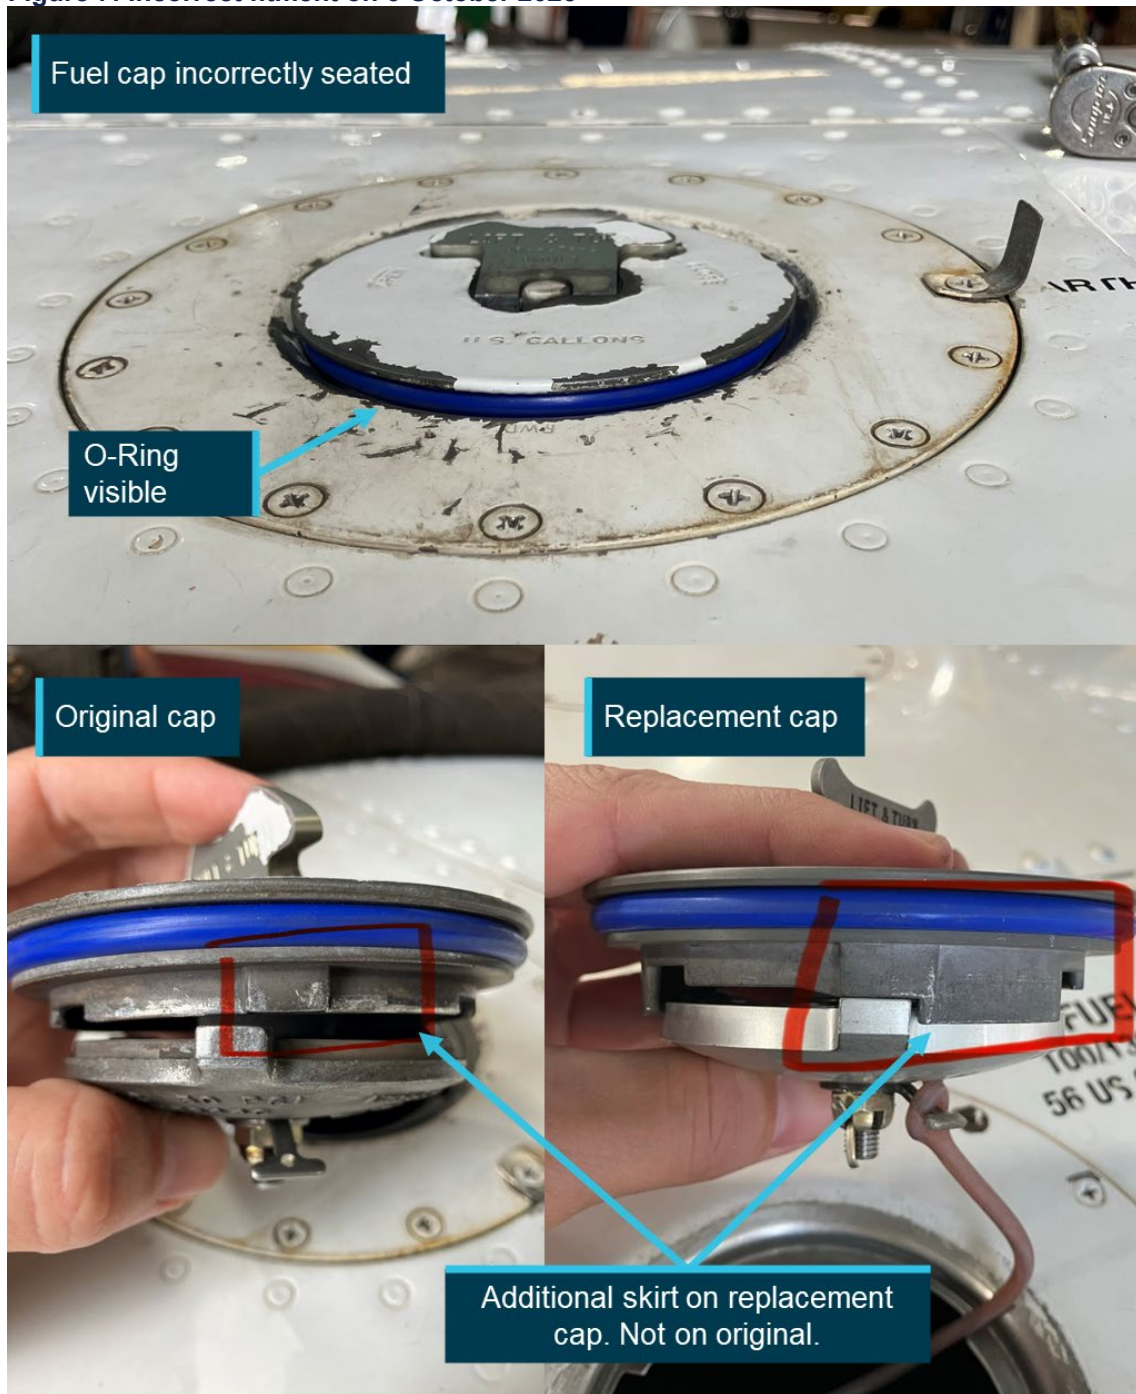
Figure 7: Incorrect fitment on 6 October 2025

During the draft report review process, the ATSB was informed of a repeat incorrect fitment of VH-PGO's right inboard fuel cap that resulted in fuel leaking during flight. The operator advised that this occurred on 6 October 2025, 4 months and an estimated 60–70 refuels after the initial occurrence. However, the chief engineer was able to observe the cap in its incorrectly fitted state where they determined that the cap had not been seated correctly prior to being latched. This resulted in the upper and lower portions of the cap clamping on the filler neck of the wing (Figure 7). Following the second occurrence, the chief engineer elected to replace the fuel cap as a precaution.

Upon receipt of the new fuel cap the chief engineer noted that a skirt had been incorporated into the design of the replacement cap therefore limiting the ability of the upper and lower portions of the cap to clamp on the filler neck of the wing (Figure 7). The ATSB contacted the manufacturer for further information on the apparent design change. However, at the time of publication no response had been received.

Following a repeat incorrect cap fitment in October 2025, Shine Aviation elected to replace the fuel cap as a precaution, with no further incidents reported.
