Unstable approach involving Airbus A320, VH-VQL

Hervey Bay Airport, Queensland, on 11 August 2025

ATSB Transport Safety Report

AO-2025-050

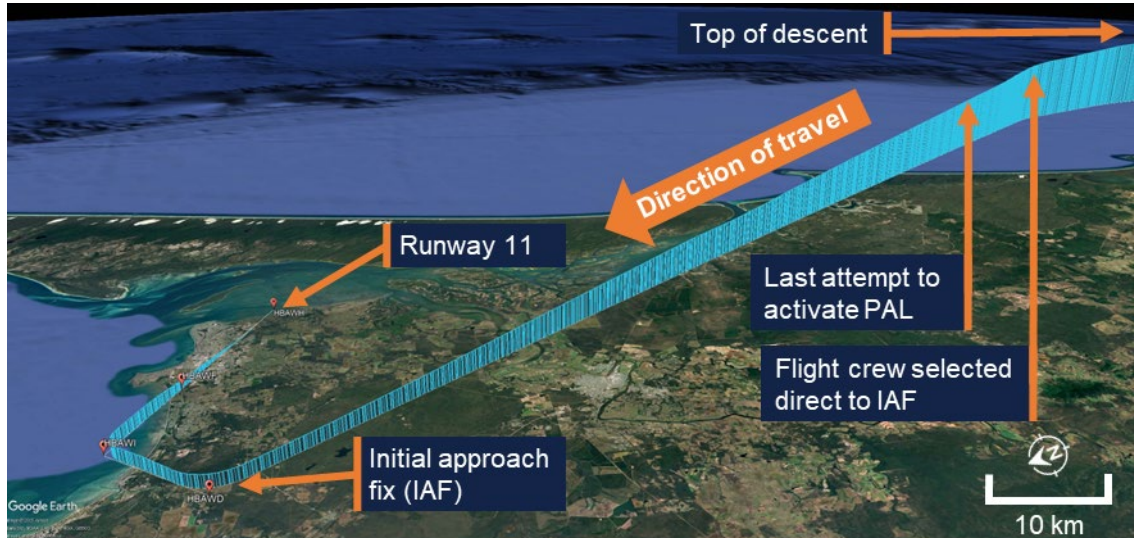
Figure 1: Flight path from top of descent

At about 1328 while the aircraft was descending, the crew selected DIR TO (direct to)⁵ the IAF in the flight management system (FMS).⁶ This action was to direct the autopilot to track to this position at which point the crew would commence the approach to land (Figure 1).

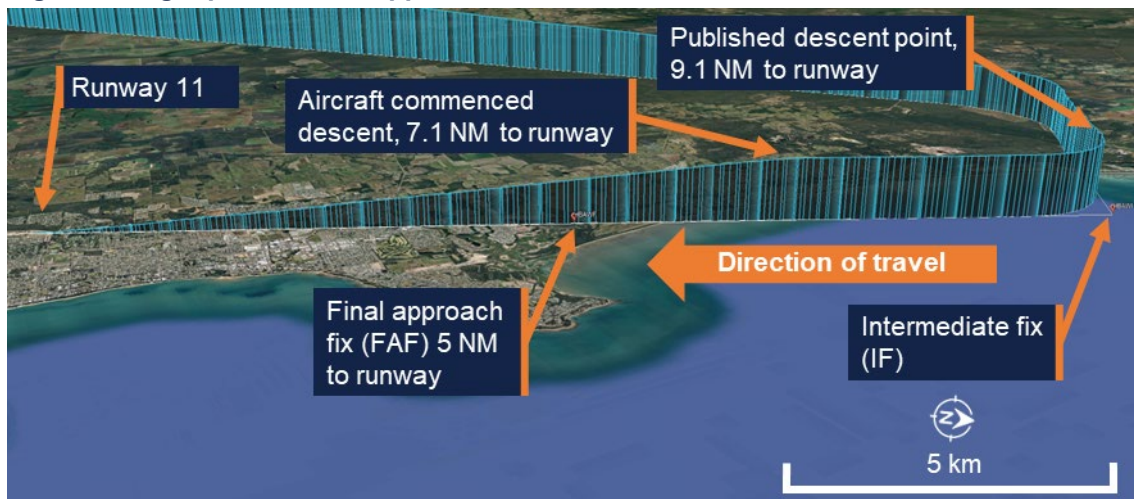
Figure 2: Flight path on final approach

The aircraft levelled out at about 3,200 ft.¹² The normal descent profile for this approach was 3° and commenced at the intermediate fix (IF), 9.1 NM (17 km) from the runway. The aircraft passed this point at about 1343:53. Flight data indicated that the aircraft commenced the approach descent from 3,000 ft at about 1345:00, when 7.1 NM (13 km) from the runway. Unknown to the flight crew, this resulted in the flight management system (FMS) generating an approach angle of greater than 4° (Figure 2; also see *Vertical guidance temporary abnormal behaviour*). The steep approach profile resulted in a high vertical speed. The landing gear was extended at about 2,000 ft.

Observing the high vertical speed, the flight crew used speed brake¹³ to reduce the aircraft's energy (see *Recorded data*) and the aircraft slowed to the maximum speed with flaps fully extended (V_{FE}) when passing 1,070 ft.

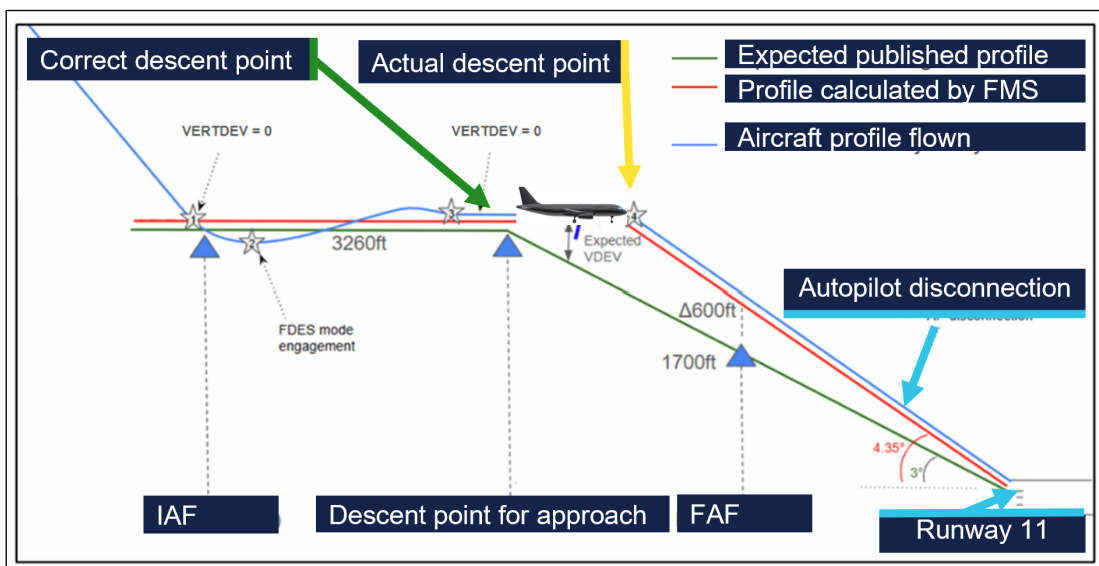
Figure 5: Relationship of profile expected vs constructed vs flown

Airbus advised that, in this occurrence, the FMS used an erroneous (higher) true airspeed value, leading to an erroneous (longer) calculated track length. Figure 5 shows the intended, correct, descent profile (shown in green). In this figure, the incorrect profile calculated by the FMS is shown in red, and the aircraft's actual path in blue. Throughout the descent, the FMS was calculating the intended vertical guidance (altitude) based on the aircraft's distance to the runway, but the actual distance to the runway was shorter at any given time. This made the actual approach profile generated by the FMS steeper. Airbus stated the FMS 'computed an incorrect vertical profile with a slope (-4.35°) greater than the one requested by the chart (-3°), and consequently the autopilot guided the aircraft on the incorrect profile.'

In order to compute the turn radius of the horizontal path, the FMS uses the current TAS at the time of the DIR TO insertion. This is the cause to the erroneous calculation. Instead, the FMS should use the TAS that is predicted at the DIR TO waypoint.

Jetstar advised that it would be updating its A320 fleet to the H3 software standard, which resolves the temporary abnormal behaviour (TAB) relevant to this occurrence.

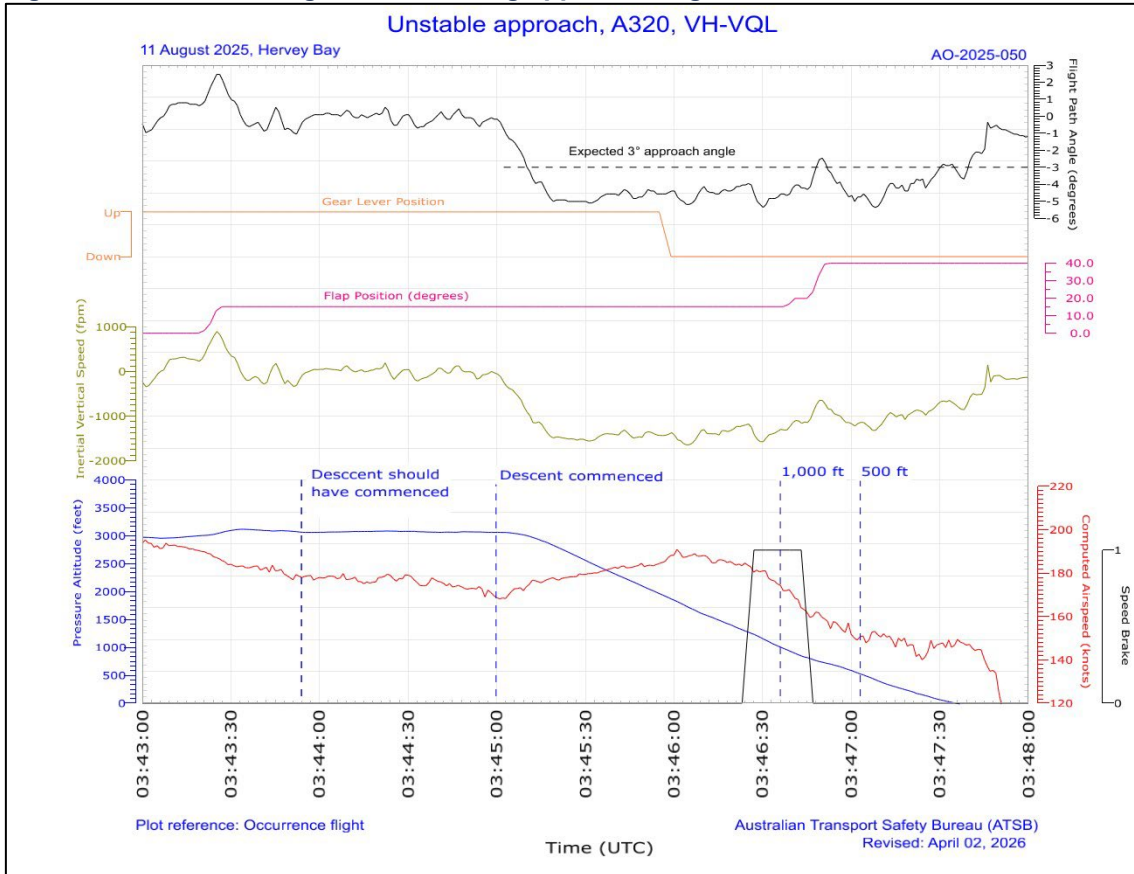
Figure 7: Occurrence flight data showing approach angle

Distance to next waypoint (NM)	Distance to runway threshold (NM)	Barometric corrected altitude (ft)	Altitude expected for approach (ft)	Difference (ft)
4.1 (at IAF)	9.1	3,253	3,000	253
4.0	9.0	3,253	2,970	283
3.0	8.0	3,240	2,650	590
2.0	7.0	3,214	2,330	884
1.0	6.0	2,794	2,020	774
(at FAF)	5.0	2,321	1,700	621
4.0	4.0	1,823	1,380	443
3.0	3.0	1,383	1,060	323
1.9	1.9	960	710	250
1.2	1.2	609	480	129
(Runway 11)	0.0	---	---	---

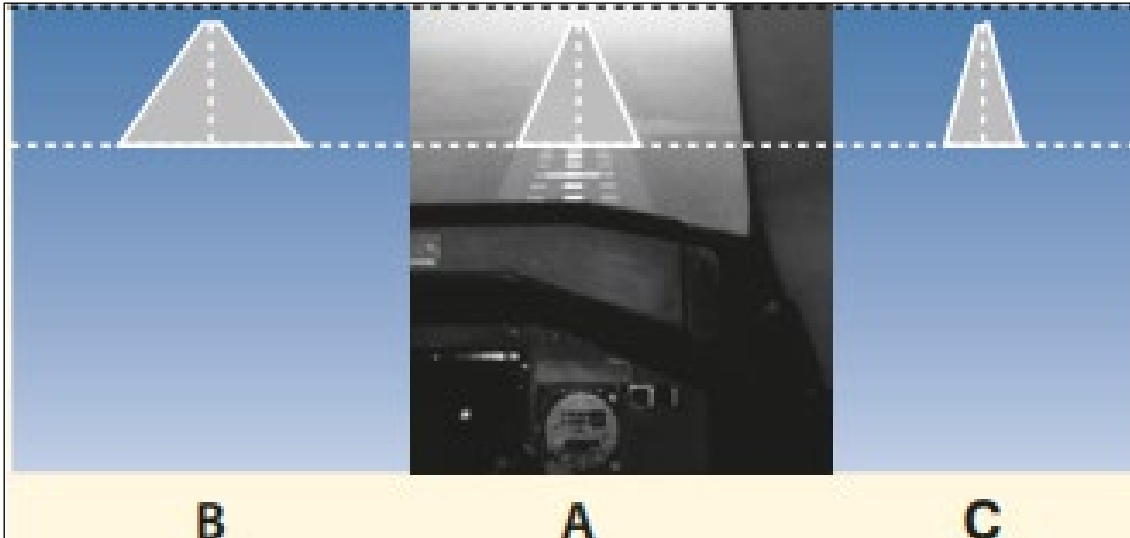
Figure 8: Runway with affecting approach perception

If a runway is either wide or narrow it can present a visual illusion to the pilots. A final approach to a narrow runway may produce the visual illusion of being high. The below illustration shows an aircraft on a 3° profile (Figure 8) (Flight Safety Foundation, 2000). The visual perspective shows a contrast between 3 different pilot views:

A 45 m wide runway is standard for an air transport aircraft. The runway at Hervey Bay Airport was 30 m wide.
