# **Collision with terrain involving Piper PA-32R-300, VH-JVA**

Shellharbour Airport, New South Wales, on 11 October 2025

Aviation Occurrence Investigation (Short)

AO-2025-064

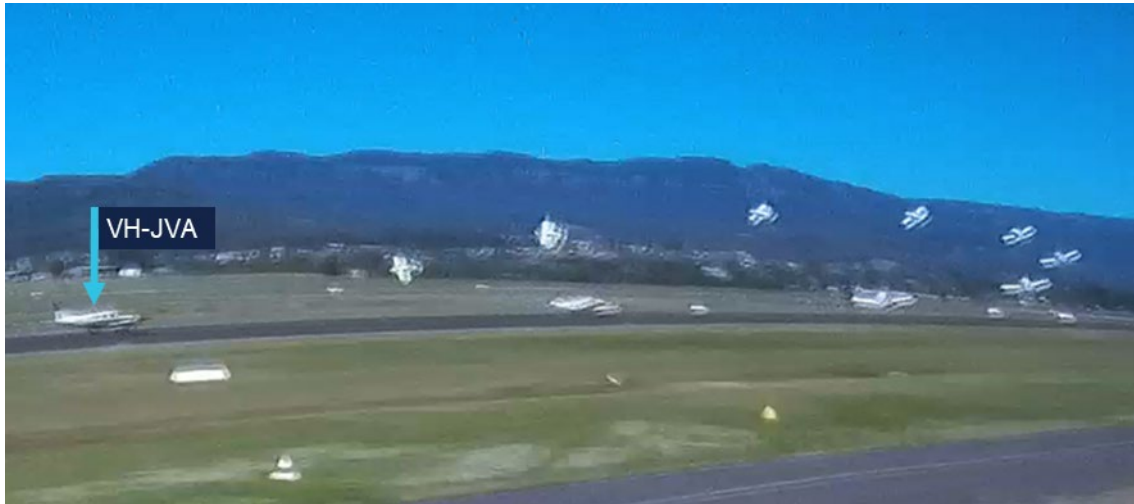
**Figure 1: Composite image of recorded security camera footage of the flight**

About a minute after the Cessna departed, VH-JVA began a take-off from runway 26. Following a ground roll of about 410 m, VH-JVA abruptly pitched up and yawed left as it became airborne. The aircraft then climbed away from the runway in a nose high attitude while skidding<sup>3</sup> and rolling left (Figure 1 and Figure 2).

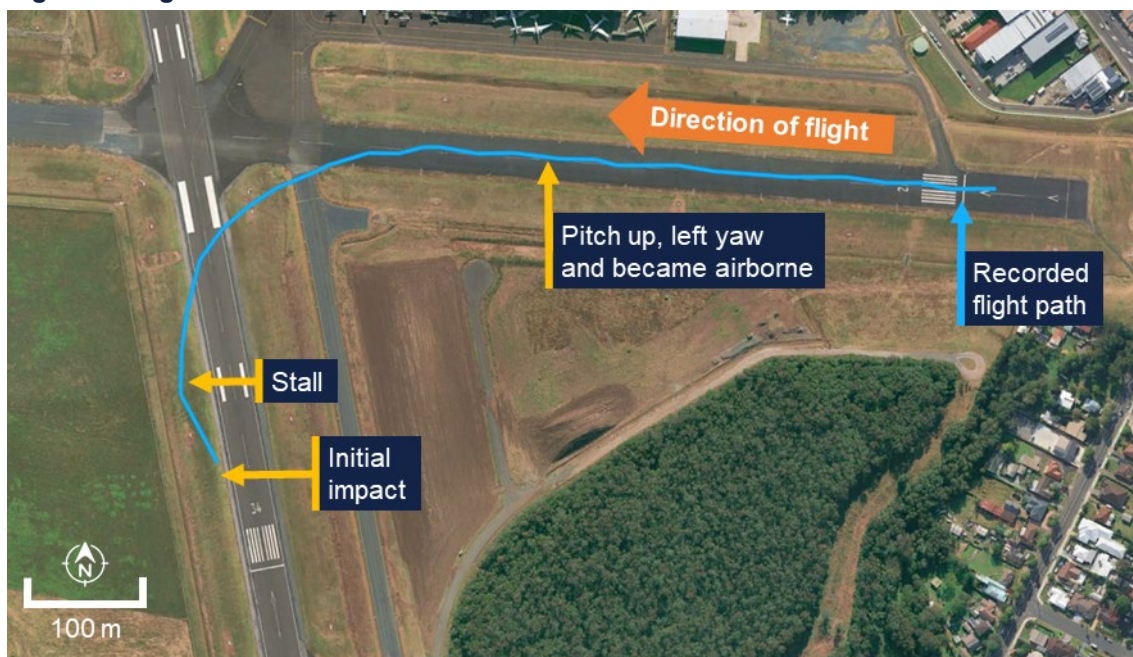
**Figure 3: Flight overview**

The angle of bank then appeared to stabilise briefly as the aircraft followed a left-turning flight path (Figure 3). As it turned to a heading of about 200° magnetic (M), it reached a maximum recorded altitude of about 50 ft above ground level (AGL) and then began descending. Three seconds after reaching 50 ft AGL, the aircraft appeared to stall, the angle of bank increased, and the descent rate began increasing rapidly. As the descent rate increased, engine power reduced before the aircraft collided with terrain.

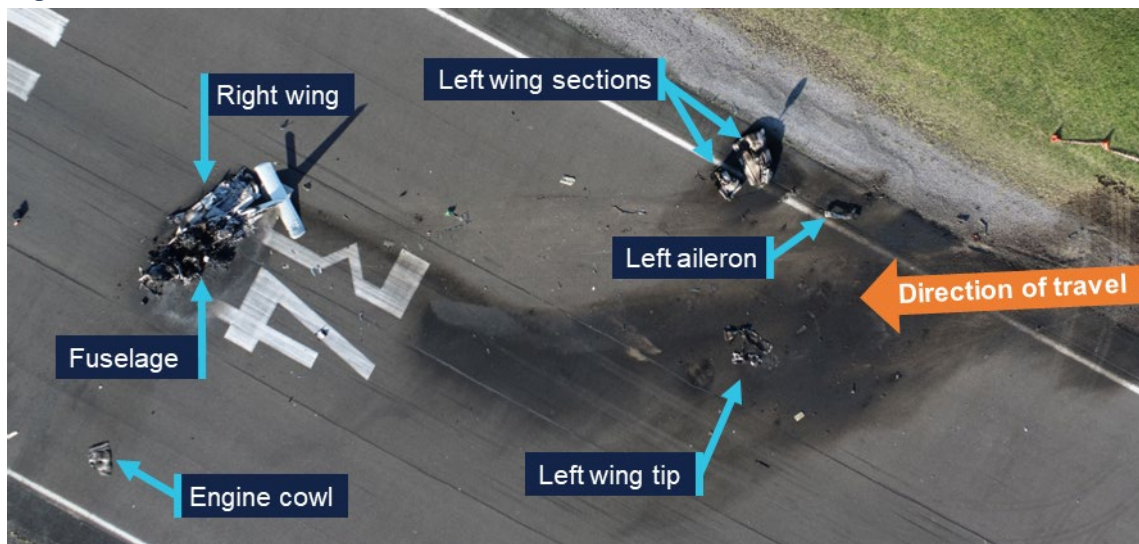
**Figure 8: Accident site**

The aircraft impacted the ground to the west of runway 34 while travelling in the 138° M direction (Figure 8). The left wing tip impacted the ground first with the aircraft at or near a 90° angle of bank and with a nose down attitude. The propeller and engine then impacted the ground about 12 m from the wing tip impact. The left wing separated from the aircraft and the main wreckage continued along the ground for a further 47 m before coming to rest on runway 34 near the runway threshold. The integral fuel tanks in both wings ruptured during the accident sequence, leading to a post-impact fire that destroyed most of the fuselage (Figure 9).

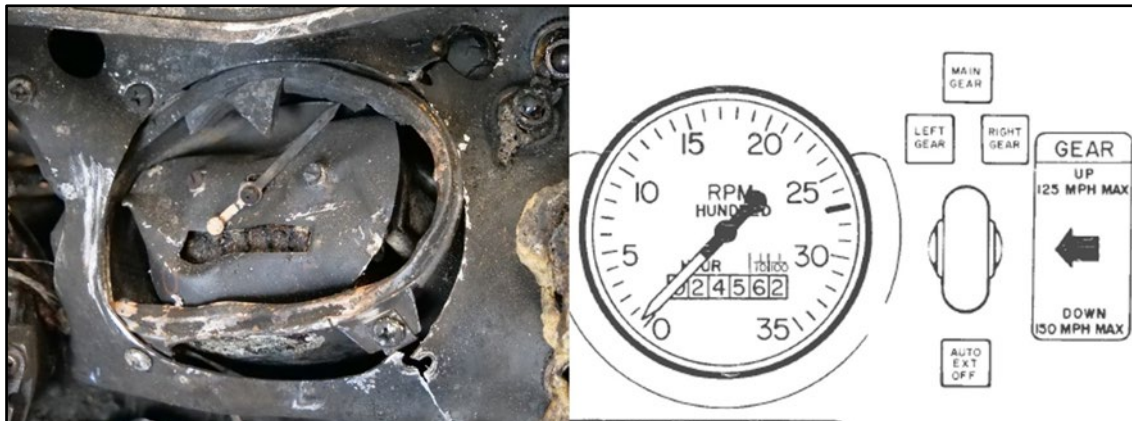
**Figure 10: Tachometer from the aircraft (left) and an extract from the pilot's operating handbook (right)**

The propeller blades were all retained in the propeller hub. The blades and the spinner also exhibited signatures consistent with the propeller being driven by the engine at moderate power at the time of impact. Propeller ground scars and the tachometer needle position indicated that the engine was rotating at about 2,000 to 2,200 RPM at the time of the ground impact (Figure 10).

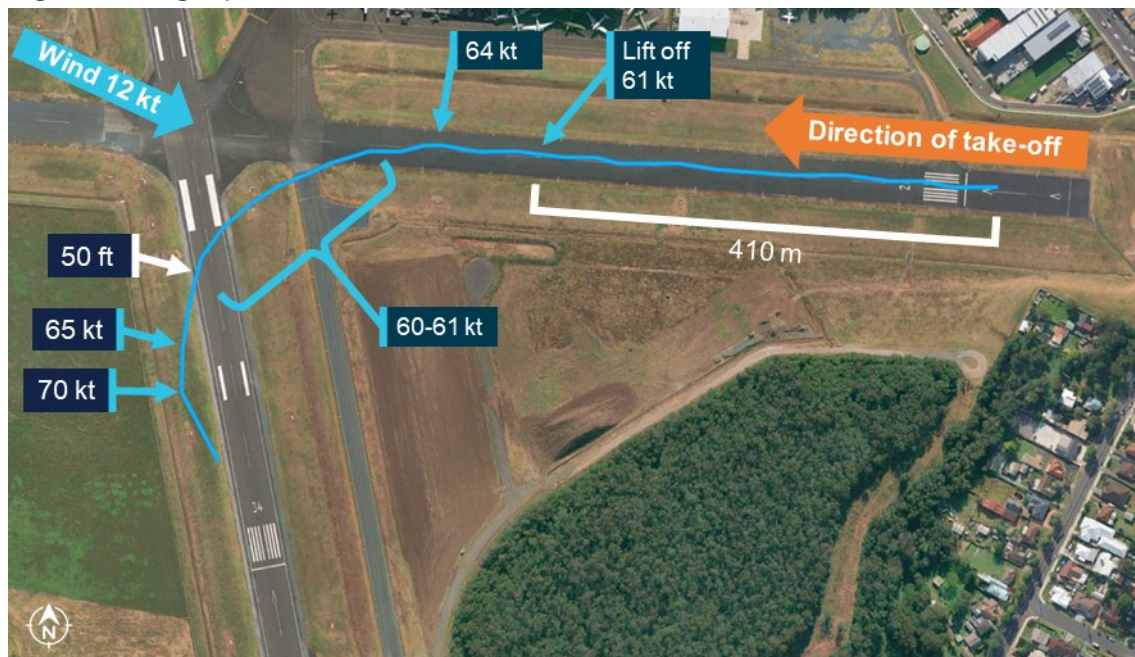
Figure 12: Flight path and recorded data

- the primary flight controls were not locked
- during the initial take-off ground roll, the stabilator was in a neutral position
- the initial take-off ground roll appeared normal

- the recorded groundspeed at the time the aircraft became airborne was 61 kt
- the groundspeed increased to 64 kt as the aircraft commenced turning left and then remained between 60–61 kt as the aircraft turned through 180° M. As the turn continued and with an increasing tailwind component, the groundspeed increased to the recorded maximum of 70 kt immediately before impact

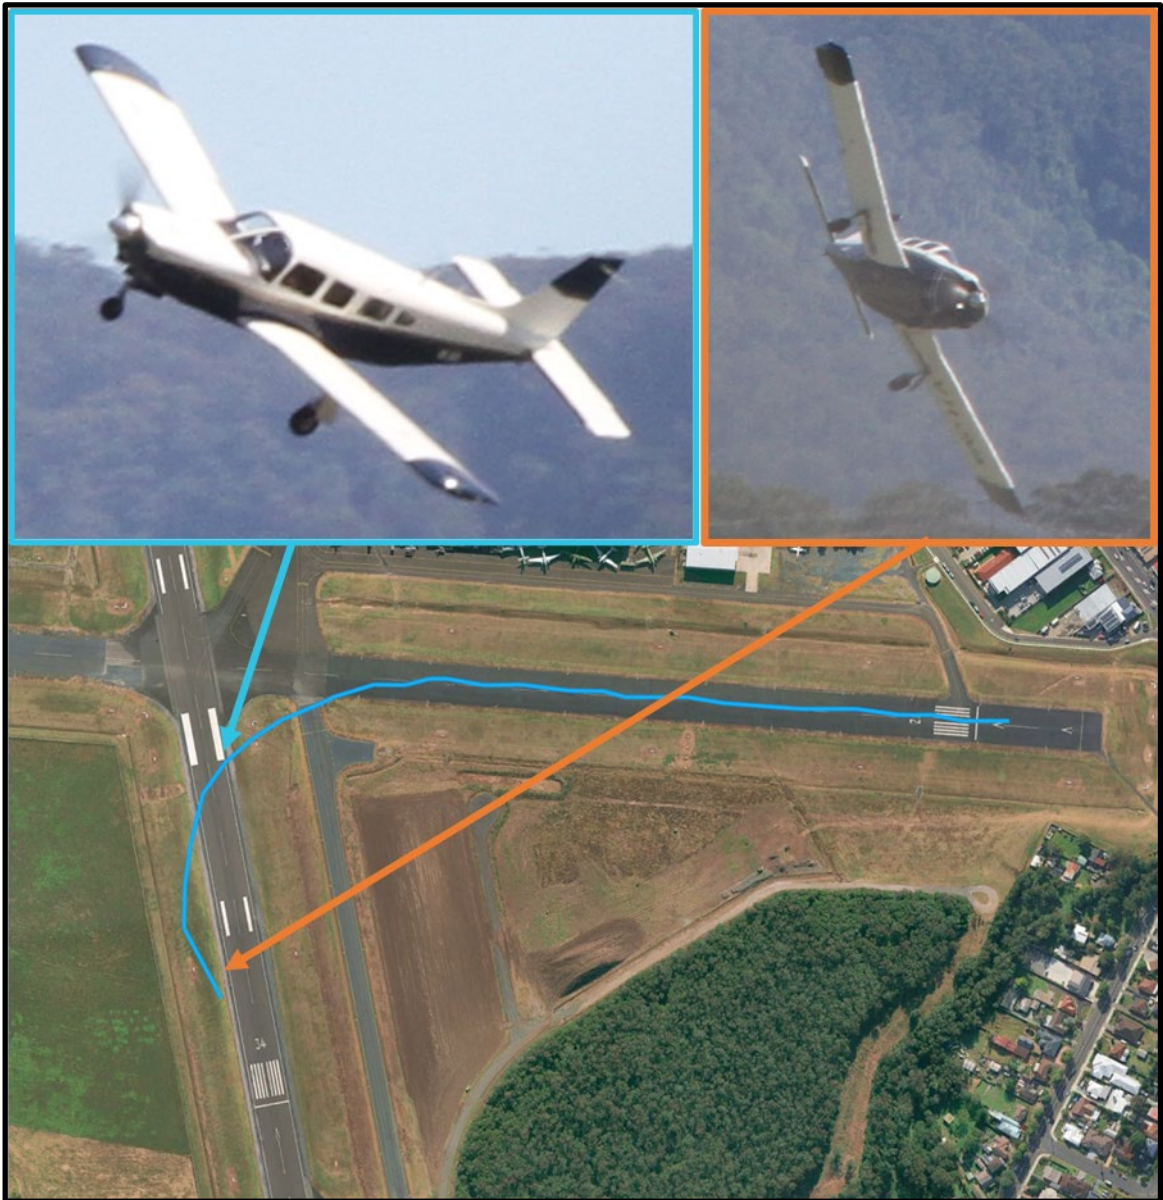
**Figure 13: Photographs of the aircraft during the accident flight**

- in the second photograph (Figure 13), taken just before impact, the propeller was rotating at about 2,700 RPM
- there was no evidence of an animal strike

- all cabin and baggage compartment doors appeared to be correctly secured
- in the 2 photographs, the rudder was at a near-neutral position, the stabilator was at a full, or near-full, nose up deflection and the ailerons were partially deflected to the right

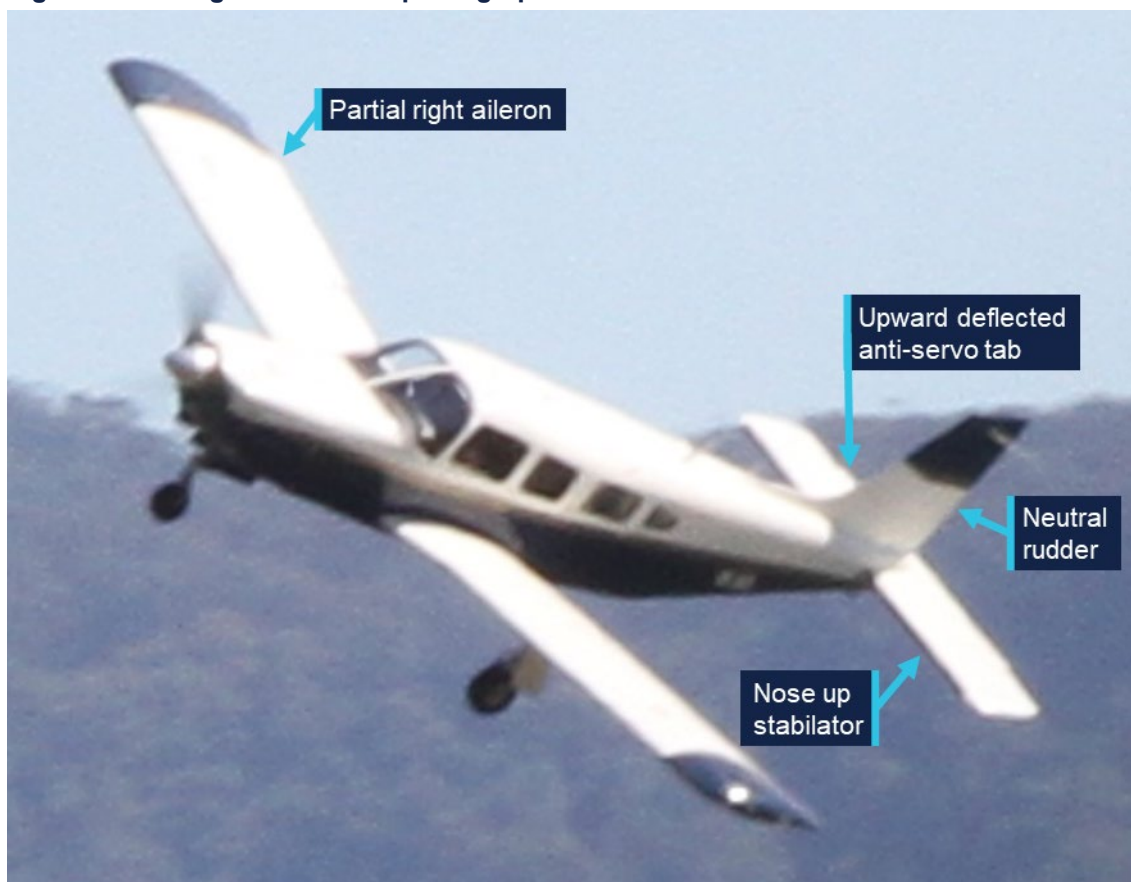
**Figure 14: Enlargement of first photograph**

- in the first photograph (Figure 14), the stabilator trim anti-servo tab was deflected up (the tab is not visible in the second photograph)
- the security camera footage was not of sufficient resolution to determine control deflections during the flight.
