# **In-flight break-up involving Robinson R22 Beta, VH-ESG**

42 km south-east of Jericho, Queensland, on 20 April 2026

**ATSB Transport Safety Report**  
Aviation Occurrence Investigation  
AO-2026-073  
Preliminary – 11 June 2026

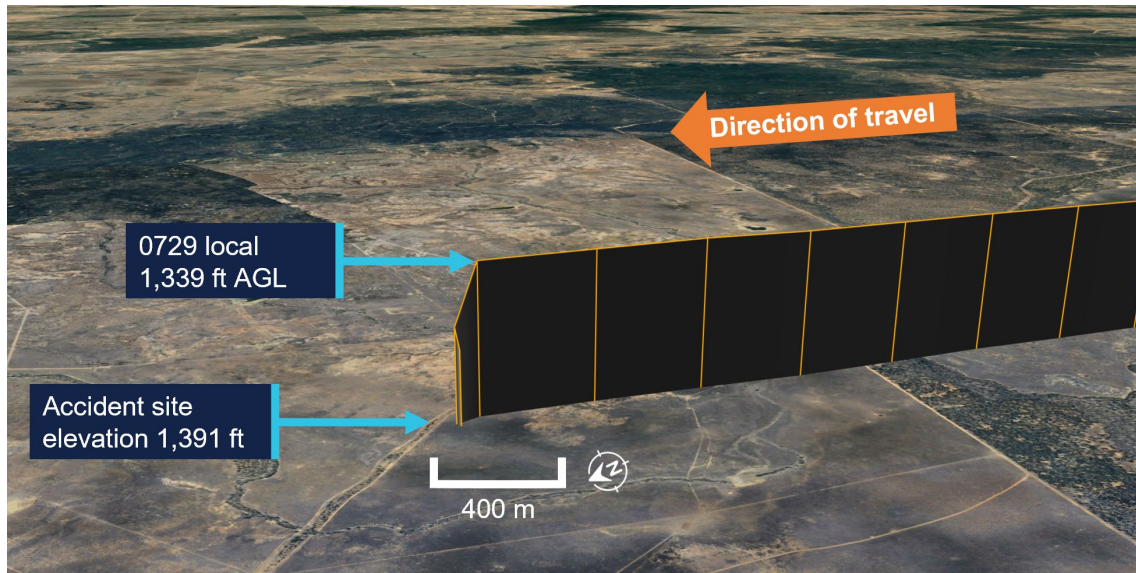
**Figure 1: Flight path of VH-ESG and accident location**

Tracking data (see *Recorded data*) shows that the helicopter continued north and at 0729 was about 45 km from the destination when it entered a steep descent from about 1,339 ft AGL (Figure 1).

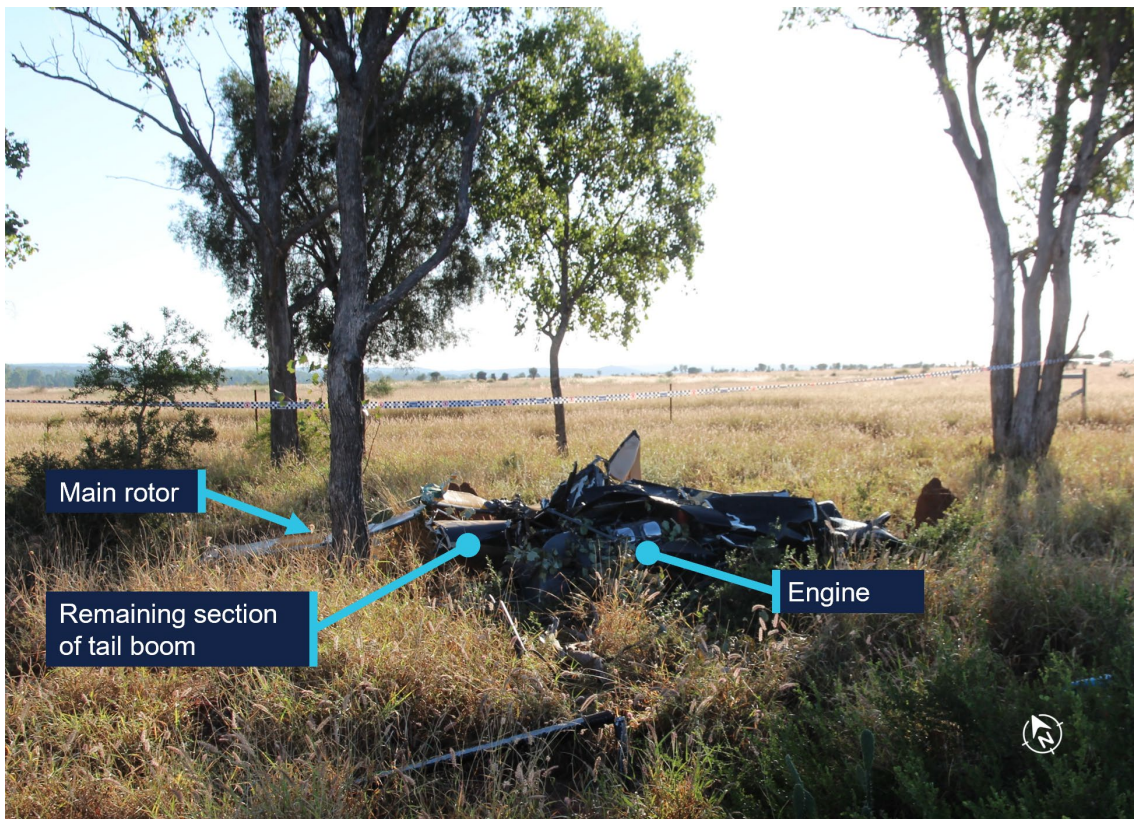
**Figure 2: VH-ESG main wreckage**

The accident site was located in flat, open farmland. Topographical data showed the accident site elevation was about 424 m above sea level (1,391 ft AMSL). The main wreckage included the cabin, engine, mast, and main rotor assembly (Figure 2).

Both fuel tanks had ruptured due to impact forces. However, there was no fire.

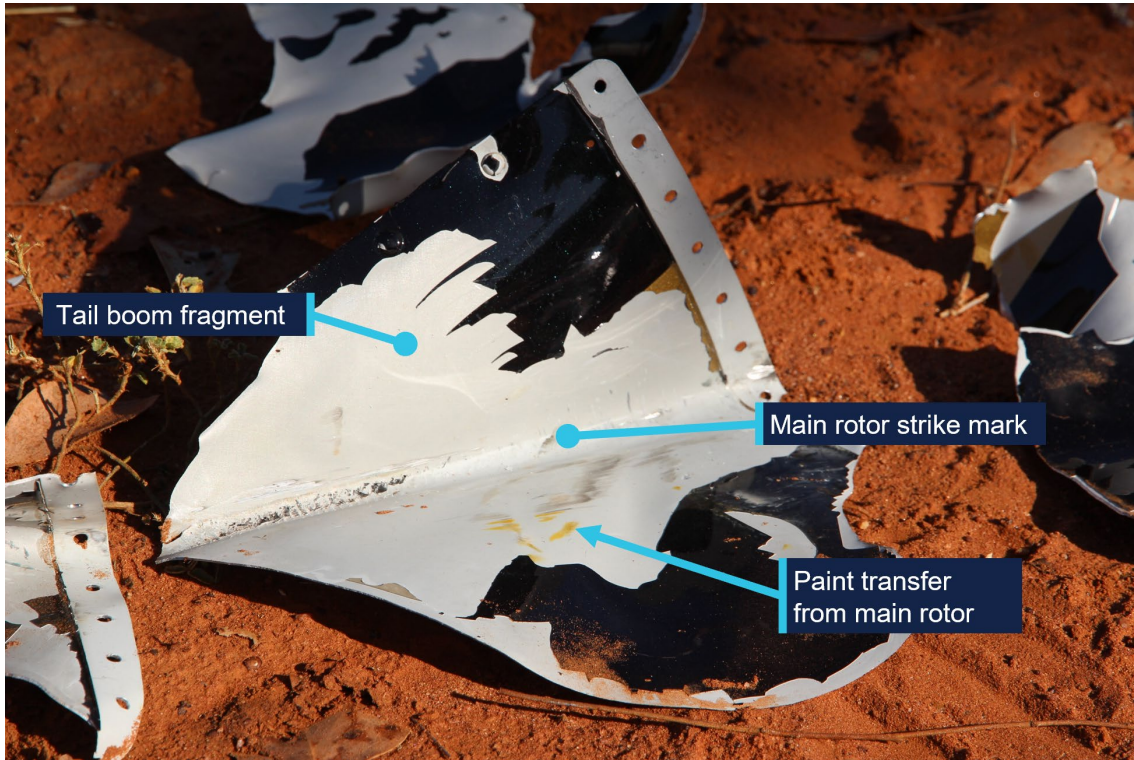
**Figure 3: Tail boom fragment showing main rotor strike mark**

Damage to the main rotor blades, tail boom, and other components indicated that the main rotor had impacted the tail boom in flight (Figure 3).

Fragments of the tail boom were spread throughout a debris field that extended up to 400 m south of the main wreckage. The tail rotor and gearbox assembly was located about 250 m away from the main wreckage and sections of the tail rotor drive shaft were located throughout the debris field. This spread of debris, along with evidence of the main rotor striking the tail boom in flight, indicates that there was an in-flight break-up.
