Australian Transport Safety Bureau

Collision with terrain involving Diamond DA42, VH-YQP

Parafield Airport, South Australia, on 29 April 2026

ATSB Transport Safety Report
Aviation Occurrence Investigation
AO-2026-074
Preliminary – 23 June 2026

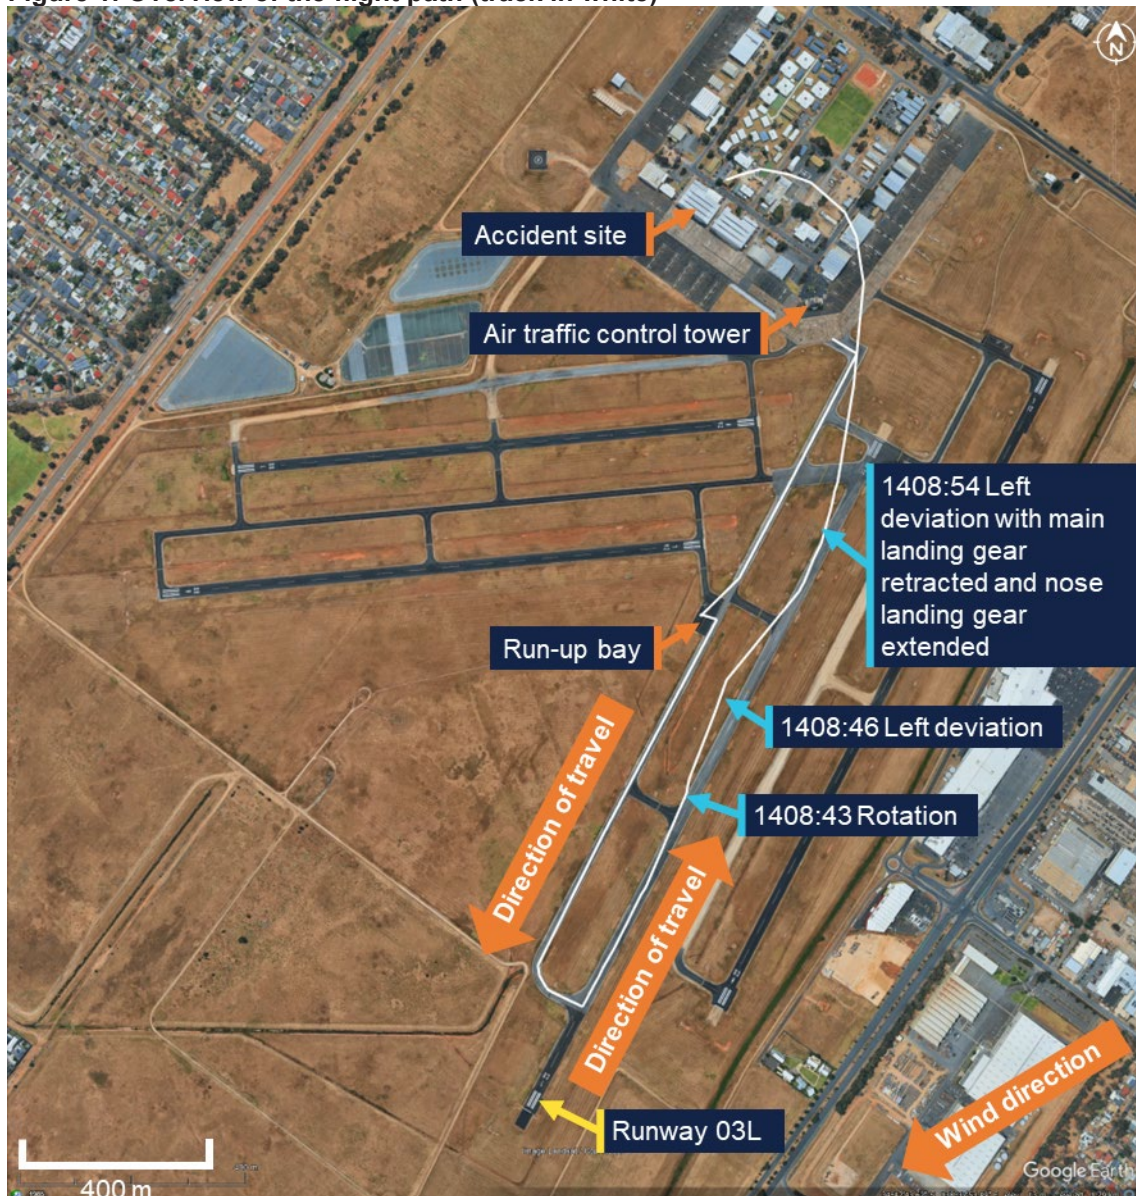
Figure 1: Overview of the flight path (track in white)

The ADS-B data showed that the aircraft began its take-off roll on runway 03L at 1408:29. At 1408:43, the aircraft rotated⁶ and 3 seconds later (at 1408:46) deviated left of the runway at an estimated airspeed of 75 kt. At 1408:52, closed-circuit television (CCTV) footage showed the landing gear was extended. At 1408:53, the aircraft was realigned with the runway heading, with wings level at 96 ft above ground level and an estimated airspeed of 100 kt. One second later, at 1408:54, the CCTV showed that the main landing gear had been retracted, but the nose landing gear (NLG) remained extended. From this time onwards, the aircraft began veering left of the runway heading.

At 1409:02, while at 111 ft and 104 kt, the aircraft pitched up, and banked left. The aircraft continued to turn with the left wing down. At 1409:11, the aircraft reached a maximum altitude of 161 ft and the estimated airspeed had slowed to 90 kt. From this point, the aircraft entered a steep descent. A witness's photograph taken around this time showed the NLG was still extended and the main landing gear retracted.

At 1409:15, the left wing of the aircraft struck a room attached to a hangar, before the aircraft continued through the hangar wall and came to rest inside the building. A post-impact fire ensued, destroying the aircraft as well as damaging another 4 within the hangar. The pilot and instructor were fatally injured. Nine people working in the hangar were reported to be taken to hospital.

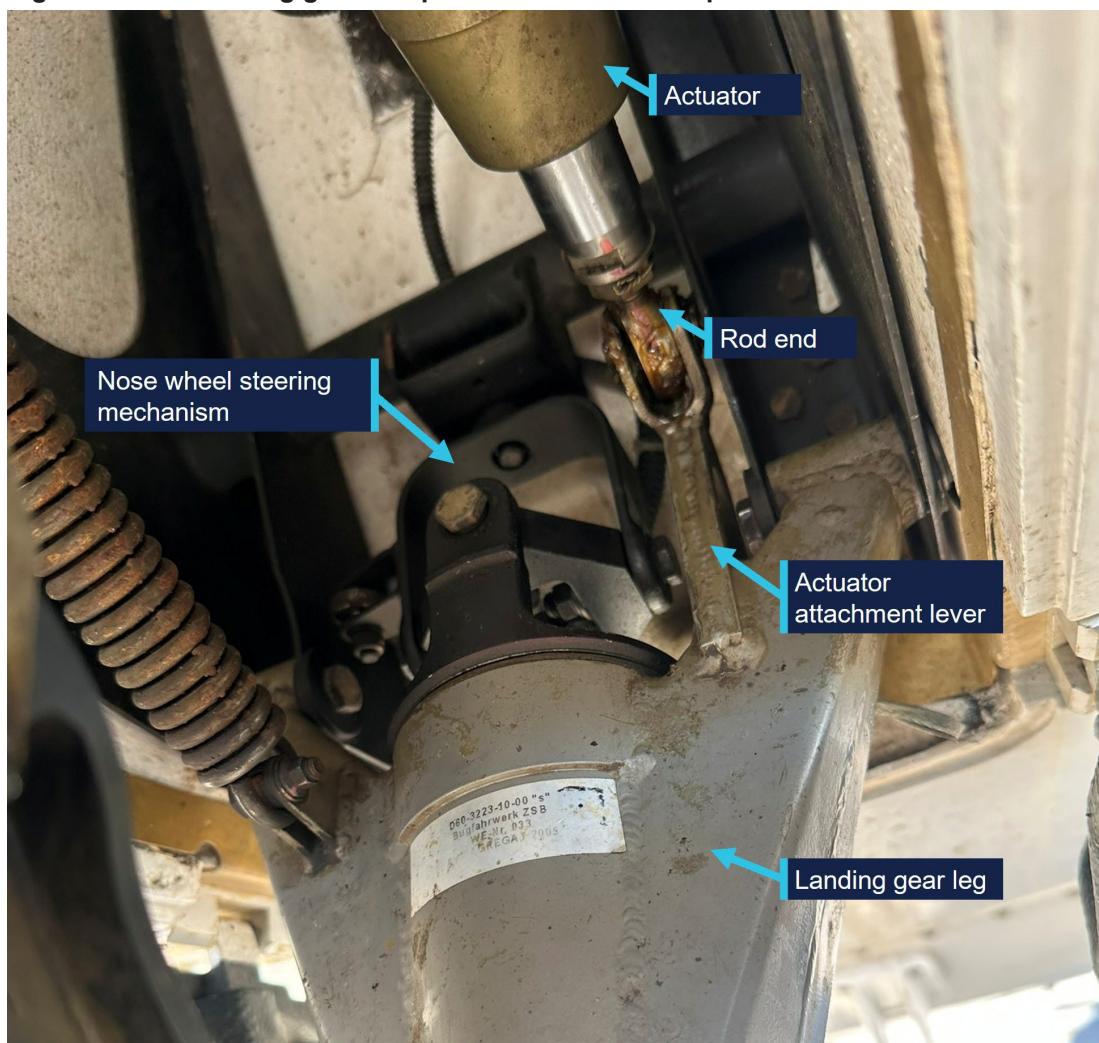
Figure 2: Nose landing gear components from an exemplar aircraft

The Diamond DA42 has a hydraulically-driven, retractable tricycle landing gear. The hydraulic pressure is provided by an electric pump. Each landing gear assembly (nose and 2 mains) is fitted with an actuator (Figure 2). When the landing gear lever is moved by the pilot to the 'up' position to retract, hydraulic pressure is directed to the actuators. The main landing gears retract first, followed by the nose landing gear (NLG) approximately 1.5 seconds later.

Another DAI mandatory service bulletin (MSB 42-136/1) published in EASA airworthiness directive AD 2019-0066 from 2019 described an event where the failure of the NLG actuator attachment lever due to unidentified cracking occurred in-flight. The bulletin indicated that the fractured NLG actuator, which was no longer attached to the gear leg 'interacted with the rudder/NLG controls in such a way that the rudder was forced into left hand deflection'. The pilot reportedly regained full rudder control after extending the landing gear. The service bulletin introduced a recurring inspection of the NLG lever arm for cracks.

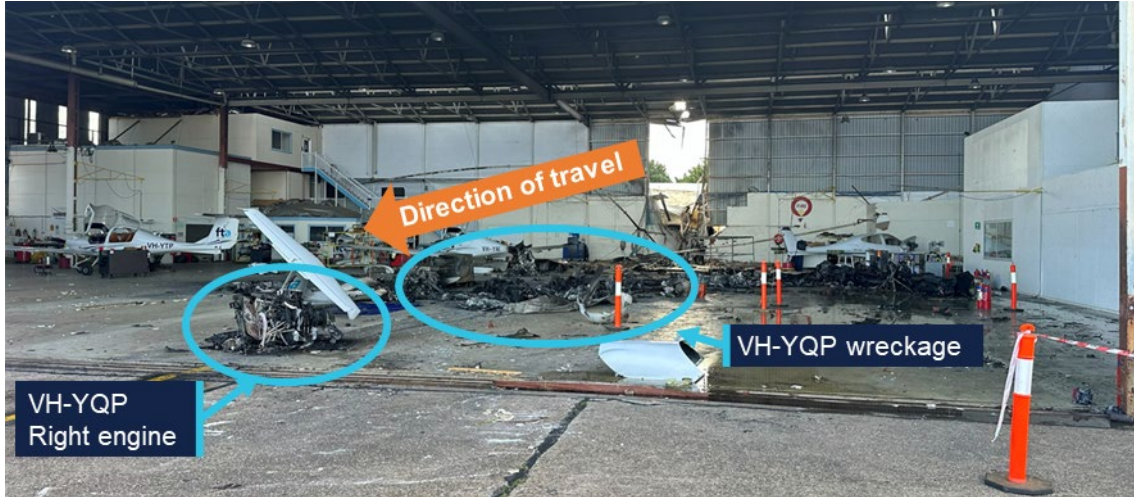
Figure 3: Overview of the wreckage

The wreckage was mostly contained within the hangar but was consumed by the post-impact fire (Figure 3). The ATSB's onsite wreckage examination found that:

- the left engine did not show signs of rotation
- the right engine propeller hub showed signs of rotation
- the left propeller was in the feathered⁸ position and the right propeller was in fine pitch⁹ position
- the rudder trim indicator was found in a nose left position
- there was fuel in the tanks
- all major aircraft components were present at the accident site

- the NLG actuator had separated from the leg
- where possible, flight control continuity was observed.

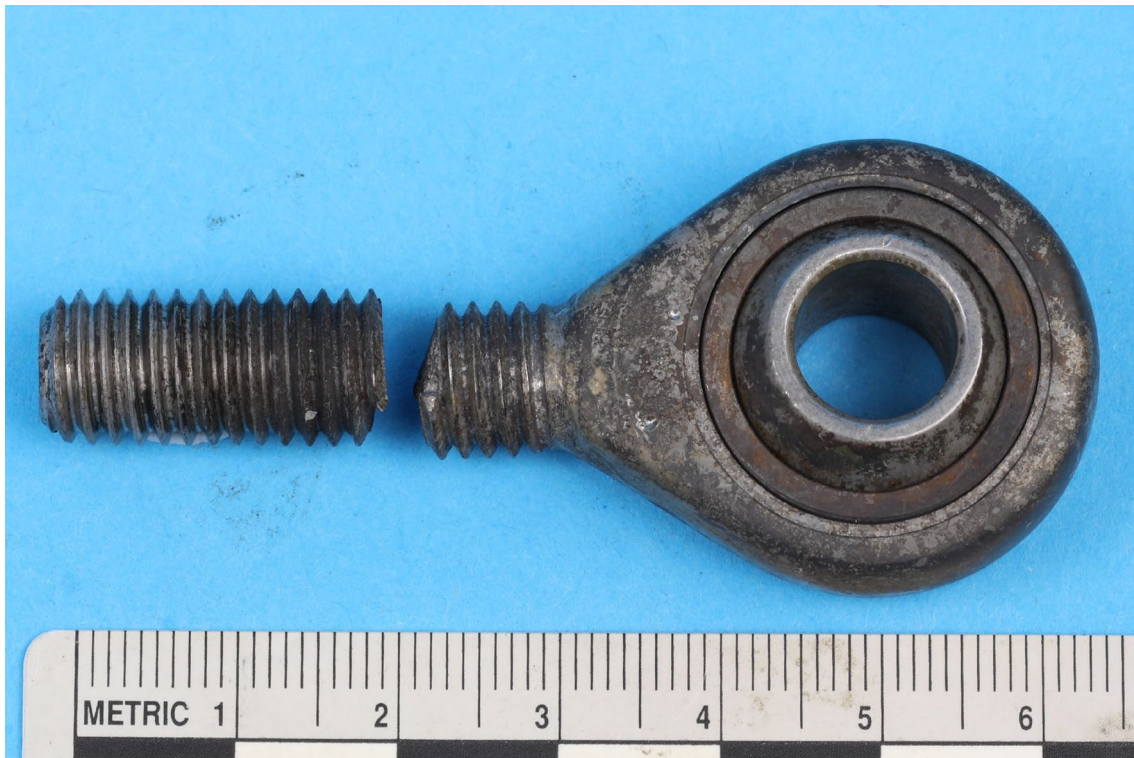
Figure 4: Fractured actuator rod end

The wreckage examination identified that the NLG actuator rod end had fractured (Figure 4), detaching the actuator from the lever arm on the gear leg (see Figure 2). While metallurgical assessment of the component is ongoing, preliminary examination of the rod end by the ATSB identified indications of progressive (fatigue) cracking.

The circumstances of the accident were consistent with pre-accident fracture of the rod end, resulting in the NLG being observed down (while the main gear was retracted). While it was possible that the separated NLG actuator interfered with the steering/rudder controls, as per the previously-reported occurrence in the DAI MSB, further examination and analysis is required by the ATSB. The ATSB is also considering other scenarios to explain the accident sequence.

The ATSB has published a safety advisory notice (AO-2026-074-SAN-001) detailing the NLG actuator fracture and the increased risk of an uncommanded left rudder control deflection.
