Australian Transport Safety Bureau

Safety advisory notice

Number: AO-2026-074-SAN-001

Nose landing gear actuator detachment

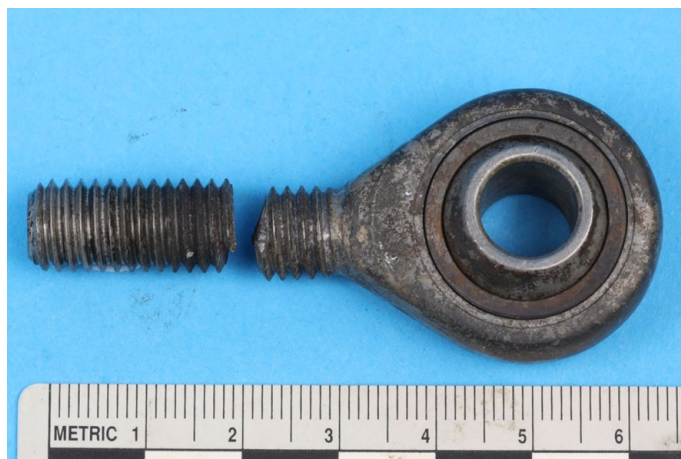
Onsite aircraft wreckage analysis found that the NLG actuator rod end had fractured, with preliminary ATSB examination identifying indications of progressive (fatigue) cracking. The ATSB identified 2 Diamond Aircraft Industries (DAI) mandatory service bulletins, issued in 2013 (MSB 42-099/1, also published in European Union Aviation Safety Agency (EASA) airworthiness directive (AD) 2013-0121) and 2019 (MSB 42-136/1, also published in EASA AD 2019-0066), which described the potential for an NLG actuator to become separated from the gear leg and interfere with the nose wheel steering/rudder control mechanism. In one instance, it was reported this interference forced the rudder control into a left-hand deflection, which was rectified by the pilot re-extending the landing gear, after which full rudder control was regained.

AO-2026-074-SAN-001: The ATSB encourages operators of Diamond DA42 aircraft to review the Diamond Aircraft Industries mandatory service bulletins, and associated airworthiness bulletins, and be aware that there is the potential for a fractured NLG actuator to interfere with the rudder controls during landing gear retraction.
