Breakaways involving *Wide India*, *Volans*, *Viking Passama* and *MSC Barbara*

Port of Brisbane, Queensland, on 24 November 2025

ATSB Transport Safety Report
Marine Occurrence Investigation
MO-2025-012
Interim – 5 June 2026

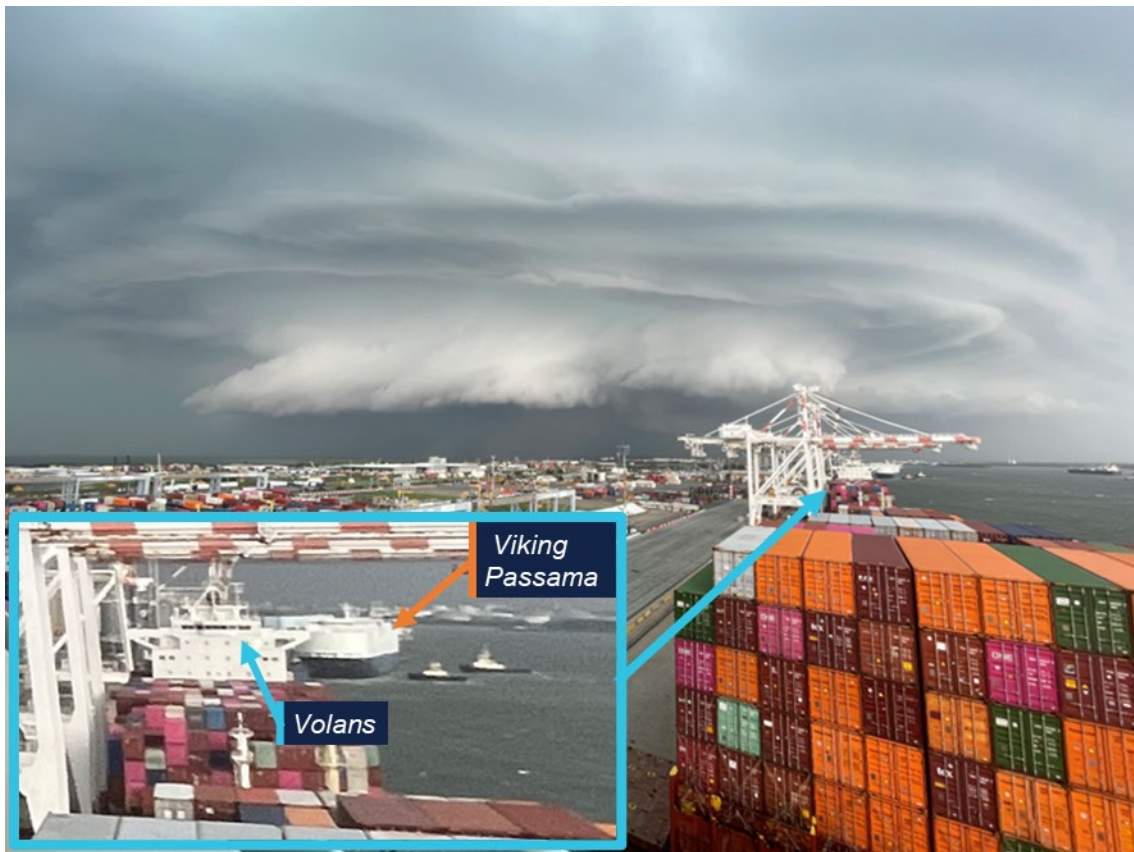
Figure 4: View of approaching storm from *Wide India* at 1503

The master of *Wide India* later reported that they did not receive the 1448 VTS warning broadcast on the port VHF working channel. Instead, the chief officer was warned by the departing stevedores. The master and chief officer reported that at this time, the storm was visibly approaching from the south (Figure 4). The master urgently requested the duty engineer to make the ship's main engine and bow thruster ready for manoeuvring.²

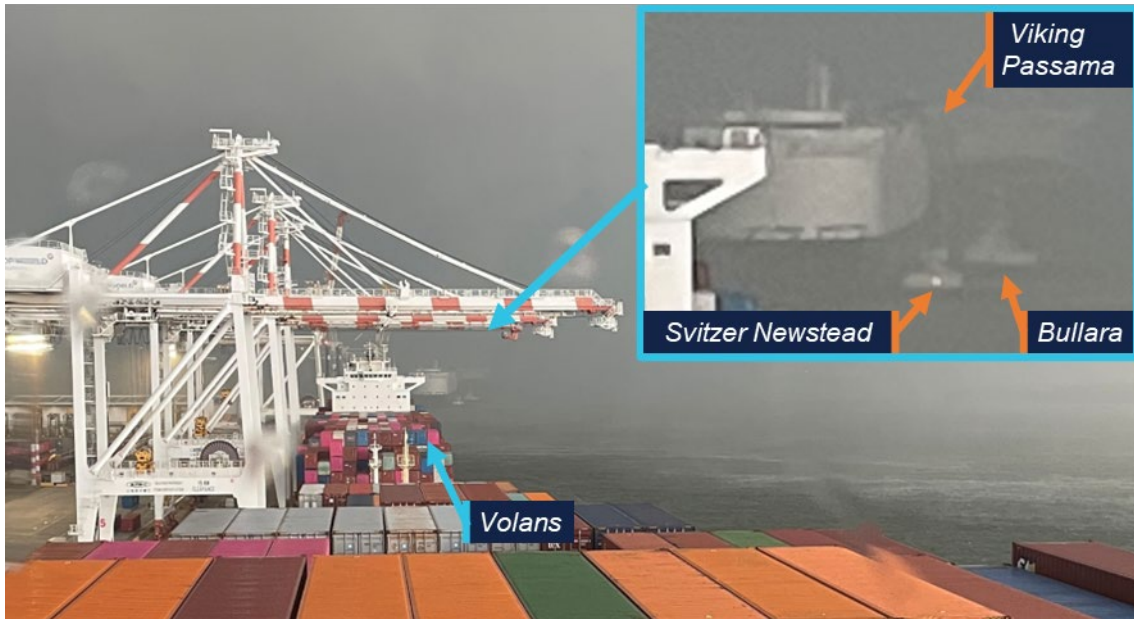
Figure 5: View from *Wide India* at 1510

At 1505, wind speeds briefly subsided to calm conditions for about 2 minutes before increasing and abruptly changing direction to the south-east. In response, *Viking Passama*'s pilot ordered the tugs to push the ship alongside (Figure 5) and at 1510, it came to rest on the shore fenders. The crew passed mooring lines ashore while the rapidly increasing wind was pushing the ship off the berth. The chief mate reported wind speeds of over 60 knots on the bridge anemometer, and the master and pilot had to take shelter against the accompanying rain and large hail stones.

The ship was slowly blown further off from the berth, despite both tugs pushing at full power and, at 1517, the remaining lines parted.

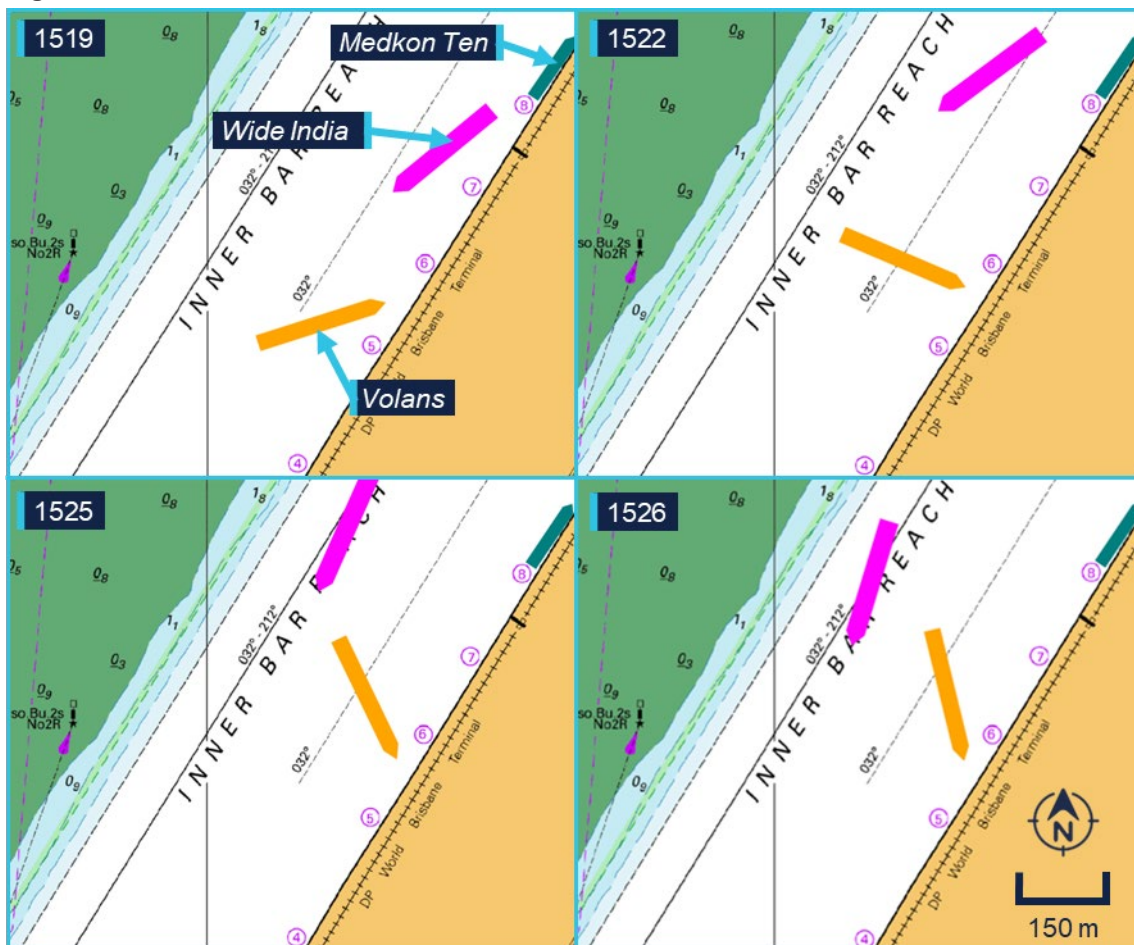
Figure 6: *Volans*' and *Wide India*'s movements

At about 1515, the rapidly increasing wind on *Volans*' stern caused its aft mooring lines to part due to the increased strain. The ship's unsecured stern was pushed off the berth.³ (Figure 6)

The ship then continued to swing around its bow which was still connected to the berth by 2 headlines and held by its port anchor. Eventually rotating about 135°, with its bow now facing into the wind and its stern impinging into the adjacent channel. The crew lowered the starboard anchor to assist in holding the ship in position but were unsuccessful at deploying additional mooring lines.

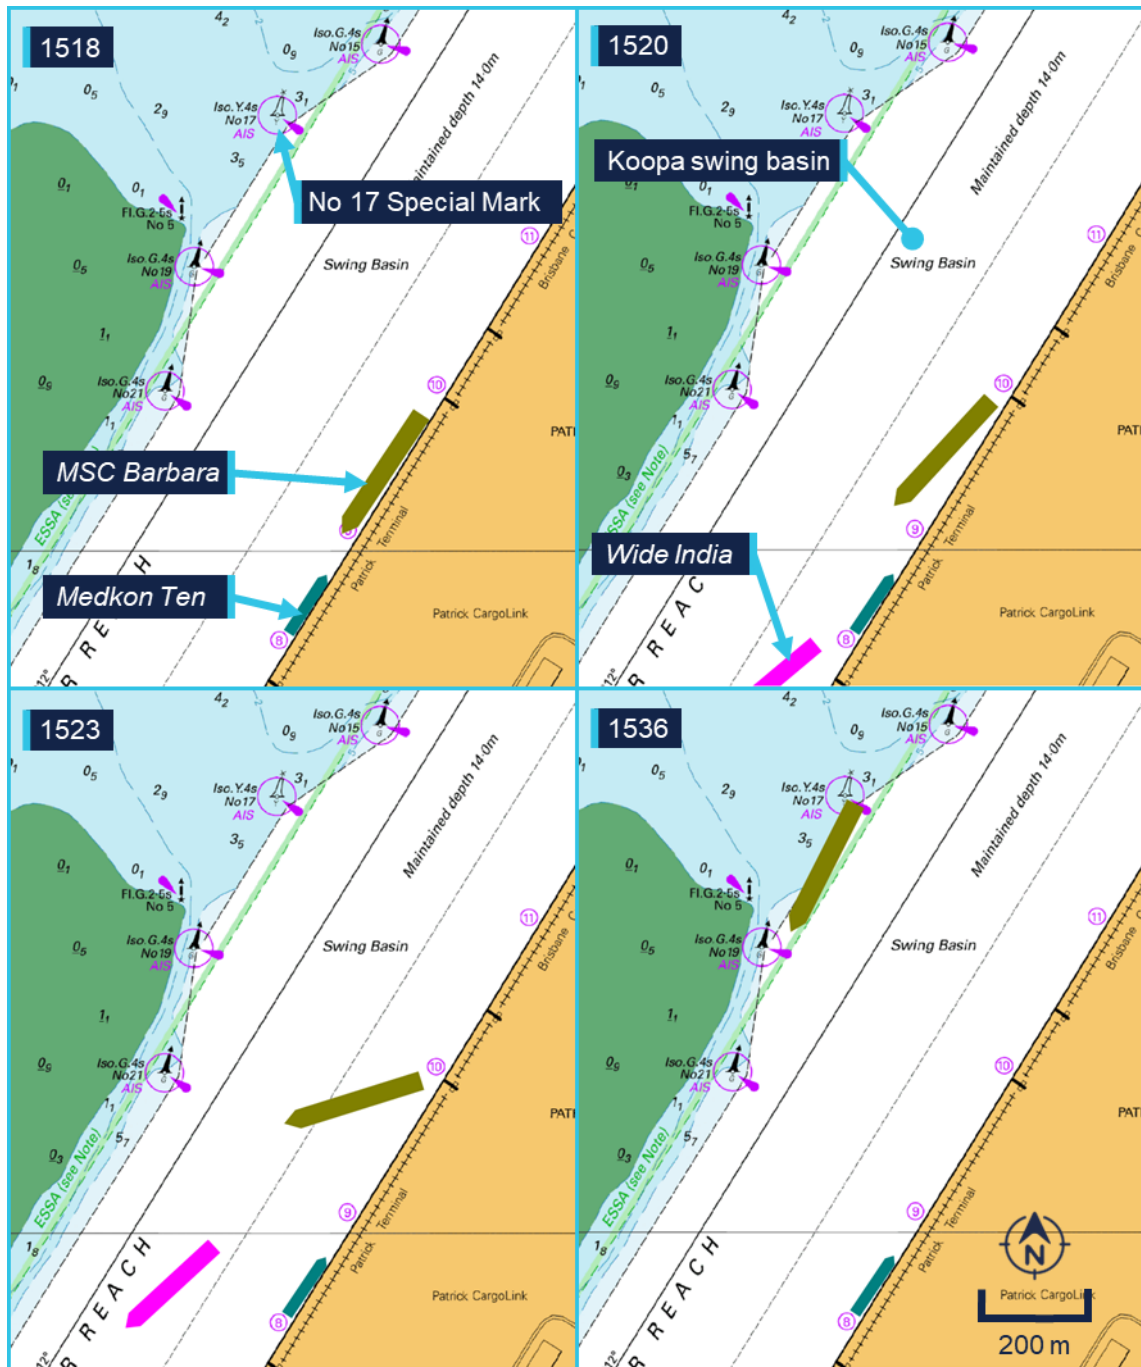
Figure 8: *MSC Barbara's* movement across the channel

At about 1520 the wind force on *MSC Barbara* moorings caused its winch brakes to render. As the wind pushed the ship further off the berth, its mooring lines eventually ran off the winch drums. The lines were still connected to the shore mooring bollards and streamed across the channel. At 1523, its master requested tug assistance on the port VHF working channel. The VTSO then informed the master that tugs were 'a short time away' and that the RHM had given permission to manoeuvre.

Six of the ship's hatch cover pontoons, which had been offloaded ashore as a routine part of cargo operations were left behind on the berth.

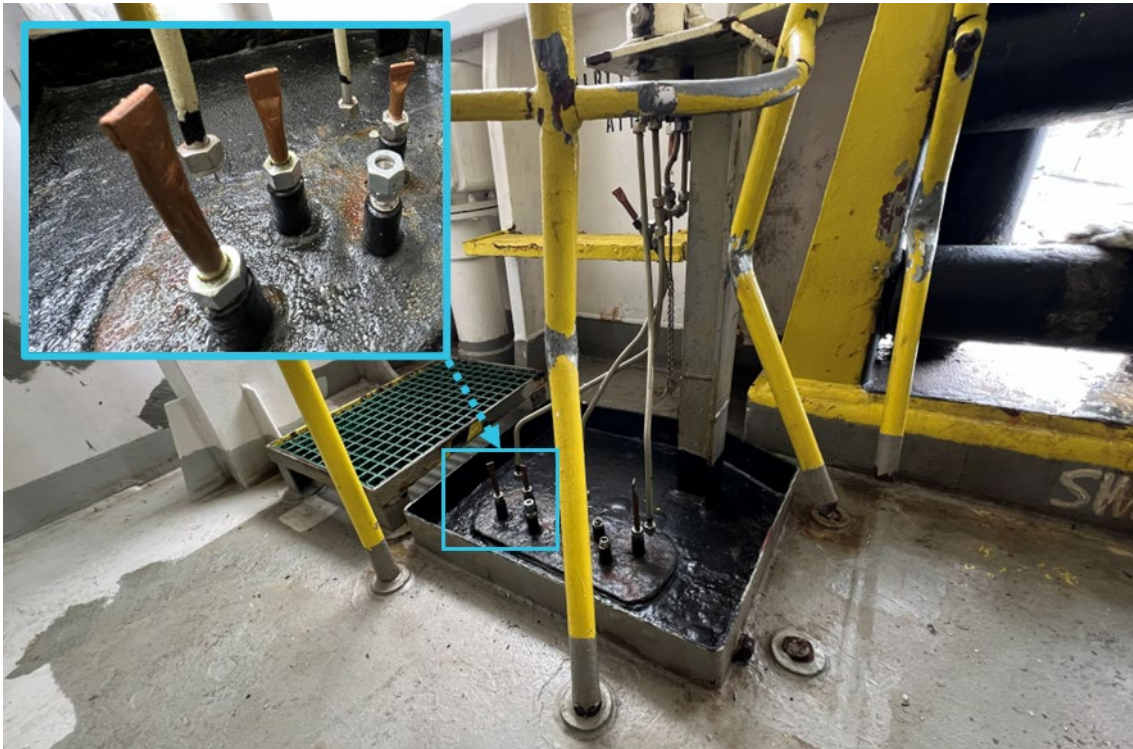
Figure 9: *Viking Passama* winch control emergency repair

However, the aft lines could not immediately be deployed due to the damage to the winch controls. This meant the aft tug (*Bullara*) had to be kept pushing up on the stern, while the ship's engineering crew made emergency repairs to the aft winches (Figure 9). On completing the repairs, *Bullara* was released at 1644 for tasking to another ship.

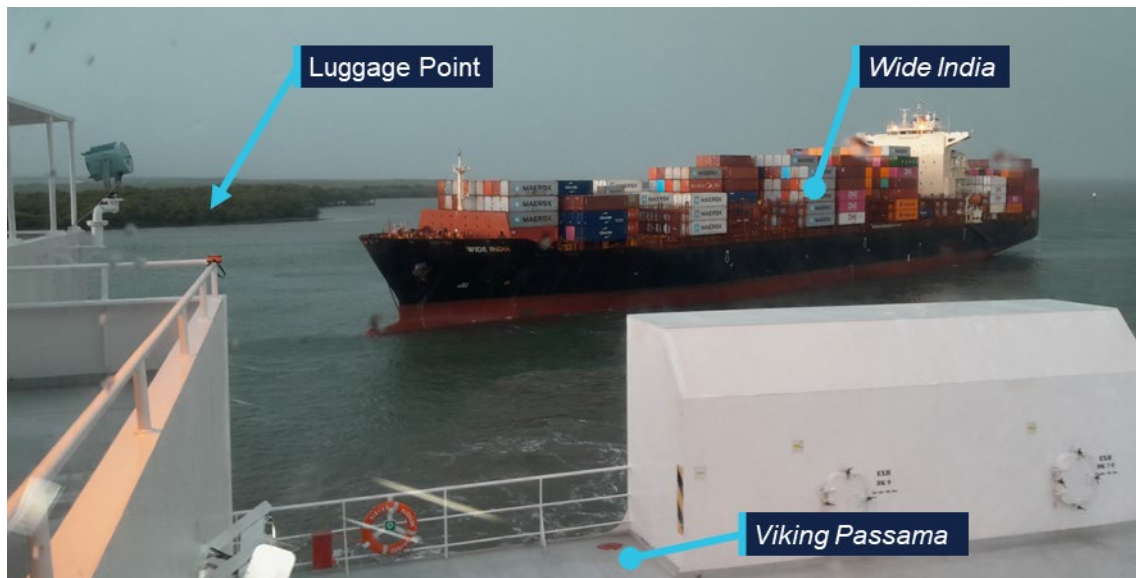
Figure 10: 1554 *Wide India* approaching *Viking Passama*

Meanwhile, *Wide India* had slowly made its way upriver to the end of the Fisherman Islands berths, approaching *Viking Passama* (Figure 10) before coming to a stop and backing away. As *Wide India* could not turn unassisted in the narrow channel its master kept it underway at slow speed, against the south-easterly wind and ebb current, to maintain steerage until a tug was available.

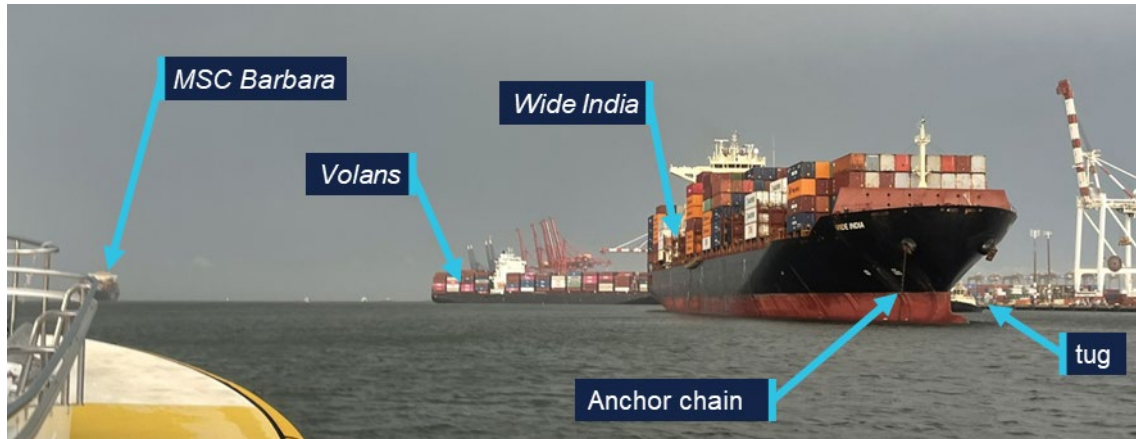
Figure 11: 1614 *Wide India* and *Volans*

The pilot boarded *Wide India*, arriving on the bridge at 1614. The pilot then coordinated with *Svitzer Newstead* to secure a tow line and assisted the ship turning in the channel (Figure 11).

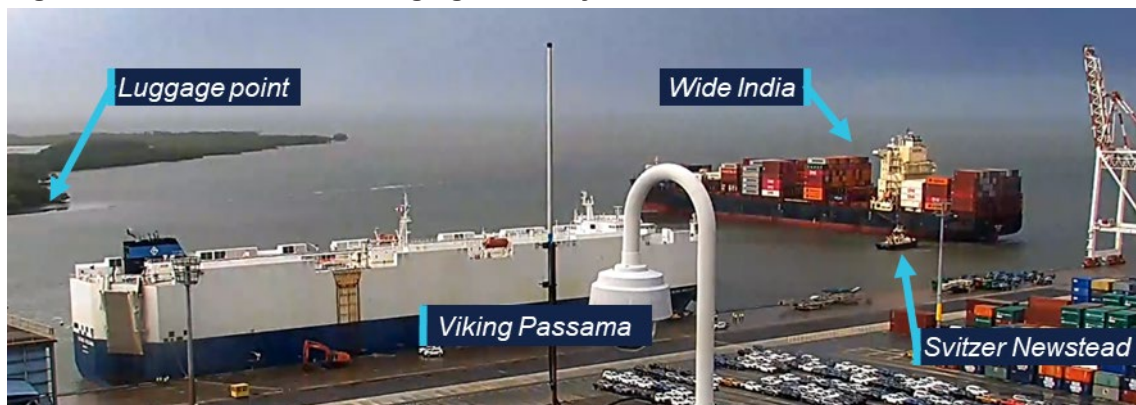
Figure 12: 1628 *Wide India* swinging in fairway

At about 1635, the ship had swung around to starboard and was heading down river (Figure 12). At 1703, the pilot reported passing the entrance beacons outbound, heading for the STS anchorage where it anchored at 1757. After inspection of the ship's mooring equipment and respooling its mooring lines at the anchorage, *Wide India* returned to its berth on 25 November to complete cargo operations and recover its hatch covers.

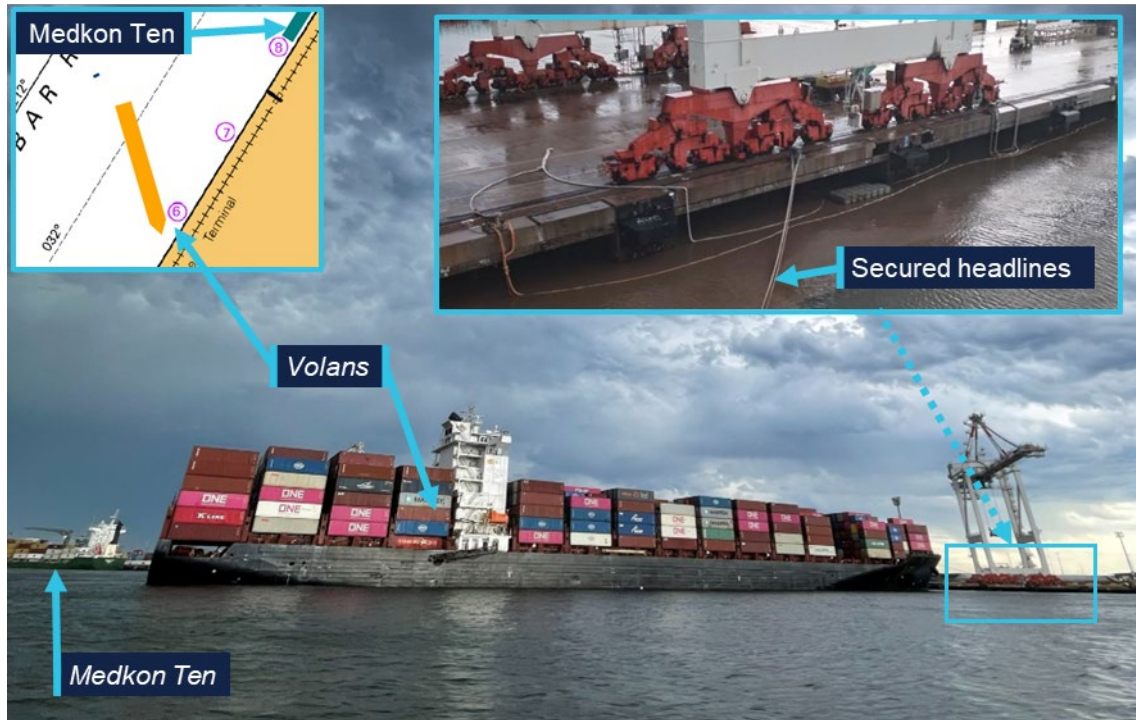
Figure 13: 1618 *Volans* secured with 2 headlines

Once the storm cleared, *Volans* was secured to the berth with its 2 remaining headlines, with additional support from both its anchors. Its exact position was determined by the wind and current, with its stern protruding into the channel. Lines from both *Volans* and *Wide India* were in the water around the ship, causing a possible navigational hazard to assisting tugs (Figure 13).

At 1620, a pilot boarded from the pilot launch, followed at 1645 by the arrival of the tug *Svitzer Olivia*. Though the ship had originally been moored on its starboard side, the pilot and master decided to use the tug to push the ship alongside on the port side first – clearing the channel for other traffic until a second tug was available to swing the ship. Meanwhile, the port tender *Moggill* assisted with recovery of the mooring lines from the water.

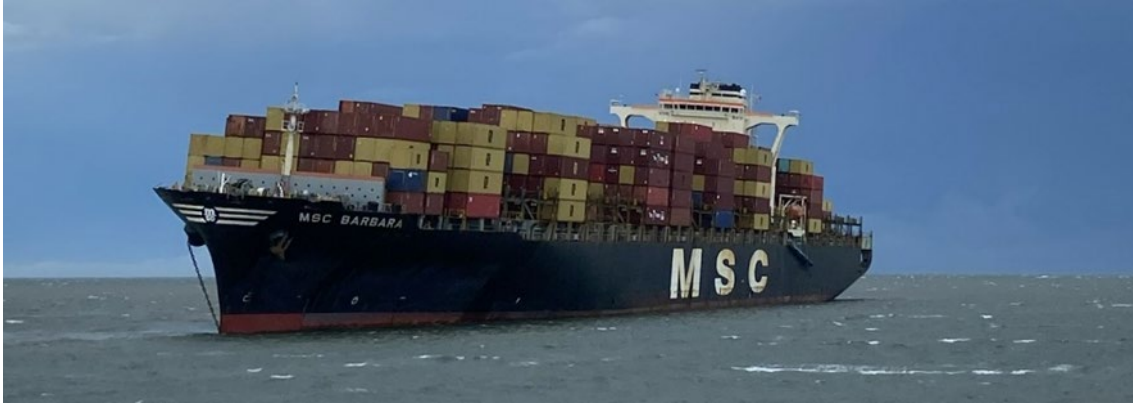
Figure 14: MSC Barbara aground

After embarking the pilot on *Volans*, the launch proceeded to *MSC Barbara*, which was grounded on the bank of the Koopa swing basin (Figure 14).

At 1713, the pilot reported to VTS that they were starting to move and, at 1716, the ship was afloat. It was then moved into the channel by the 3 tugs where its engine was tested and the anchor cable heaved in. It was found that the anchor had fouled the bulbous bow, which took some time to clear.

on a strategy to refloat the ship using the tugs assisted by heaving of the anchor. At 1645, the tug *Svitzer Newstead* arrived, followed at 1654, by *Bullara* and *SL Murrumbidgee*. Additionally, port tender *Moggill* moved the no 17 buoy away to avoid it fouling the ship's hull or propeller. Under the direction of the conning pilot, the tugs then proceeded to refloat the ship. The main engine was not used due to concerns about possible damage to the propeller.

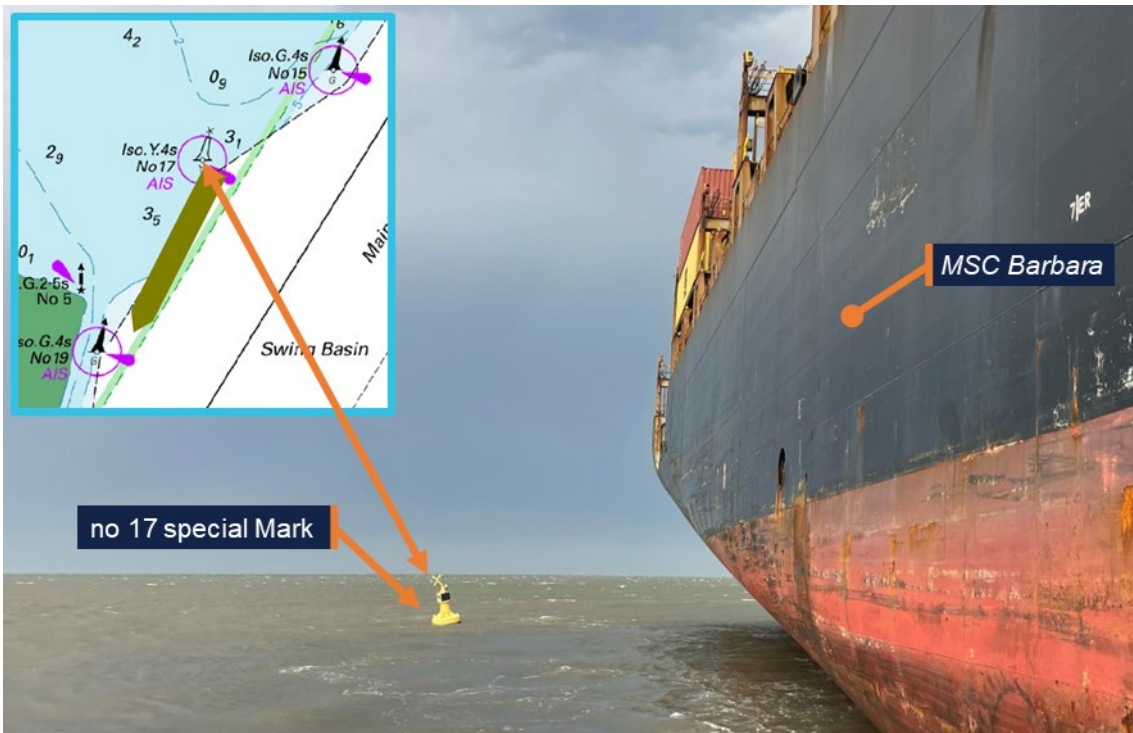
Figure 15: MSC Barbara's stern and no 17 special mark

The 2 assigned pilots first assessed the situation before boarding. They observed *MSC Barbara* heeled over slightly to port on the falling tide and at close distance from the no 17 special mark buoy (Figure 15). The ship's starboard anchor was run out to port, with the chain leading over the bulbous bow. The pilots agreed on the division of their roles, with one pilot conning the ship and controlling the tugs and the other handling communication, both on board and with parties ashore.

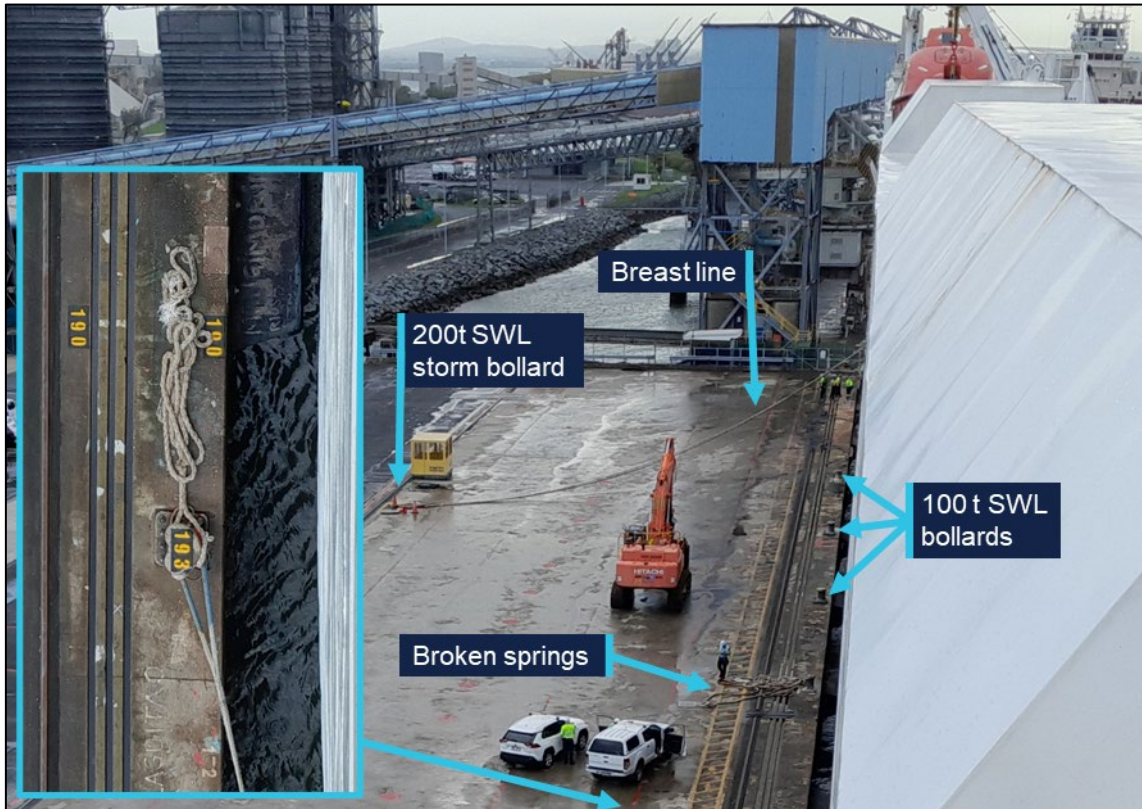
Figure 16: Berth 1 mooring arrangements

Vehicle berth 1, used by *Viking Passama*, was operated by Australian Amalgamated Terminal (AAT). Its mooring arrangements comprised 100 t safe working load (SWL) mooring bollards at intervals of 16 metres along the edge of the quay. Additionally, a limited number of 200 t SWL recessed storm bollards were located about 29 metres from the wharf face (Figure 16).

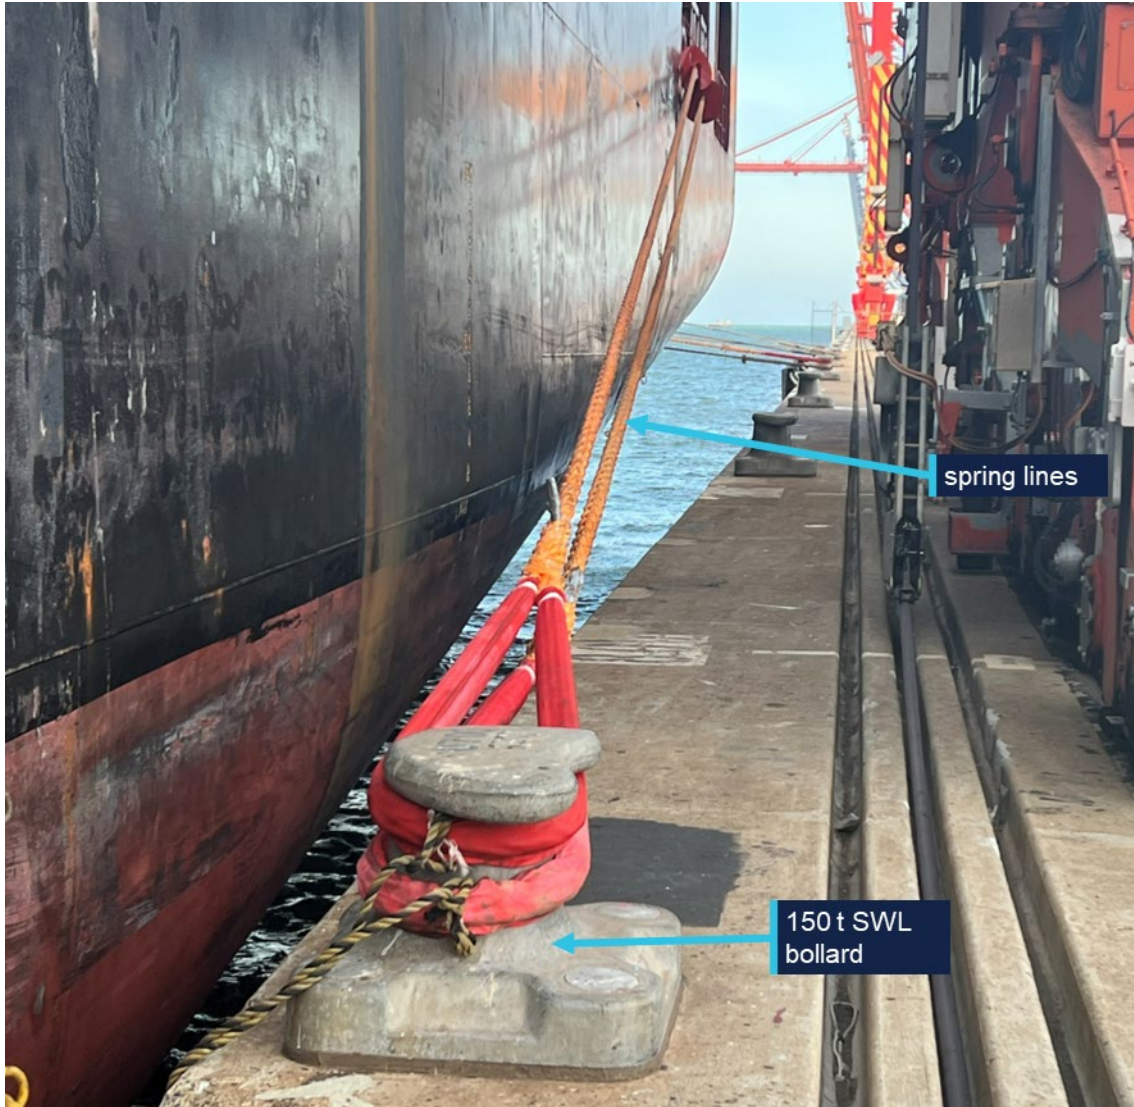
Figure 17: Mooring arrangements at Fisherman Islands berths 4 to 11

The container berths 4 to 7, used by *Volans* and *Wide India*, were operated by DP World Brisbane. *MSC Barbara* was moored at berths 9 and 10, operated by Patrick Terminals. These berths were fitted with upgraded 150 t bollards, 18 metres apart (Figure 17). Although 200 t SWL storm bollards on the far side of the quay deck were included in the original design of the berth, these were either not installed or not accessible.

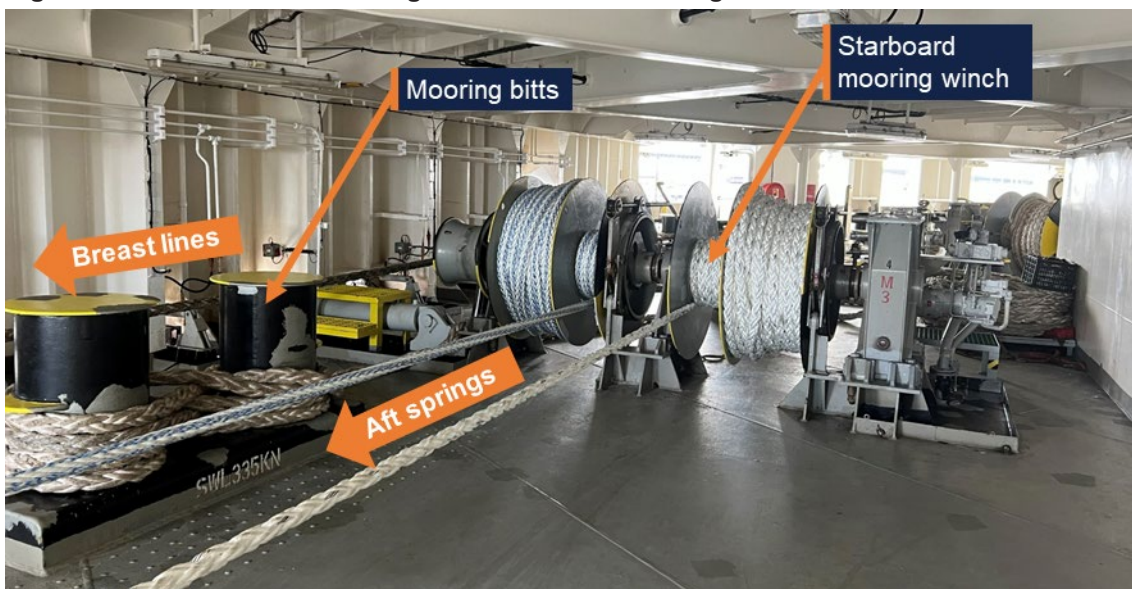
Figure 18: Starboard-aft mooring station on board *Viking Passama*

During the incident, 2 aft- and one fore-spring had been secured ashore, while the aft mooring crew were in the process of running the stern lines. The mooring plan also included 2 breast lines to be secured to the storm bollard on the quay, that were to be run from the fixed bitts on the aft mooring station.

Viking Passama's aft mooring station seen from the location of the starboard winch control (Figure 9).
Source: ATSB

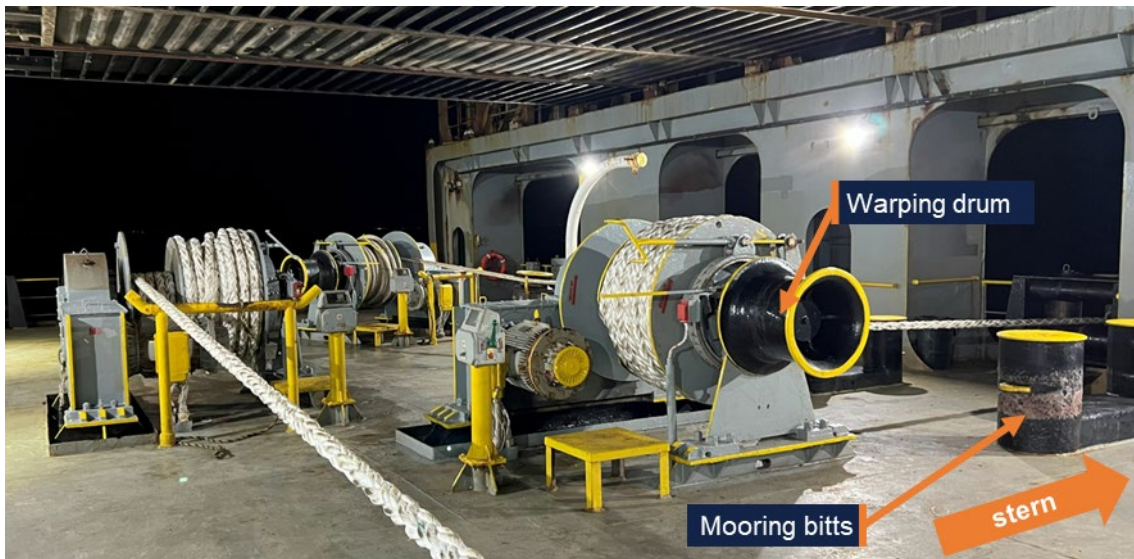
Figure 19: *MSC Barabara* aft mooring station, looking to starboard

The ship's forward mooring station was equipped with 2 windlasses, used for anchoring and each driving a single mooring drum and warping drum. Four additional single drum winches and 4 sets of 100 t SWL mooring bitts were also installed. The ship's aft mooring station was equipped with 6 winches, each equipped with a single mooring drum and a warping drum (Figure 19) and 4 sets of 100 tonne SWL mooring bitts.

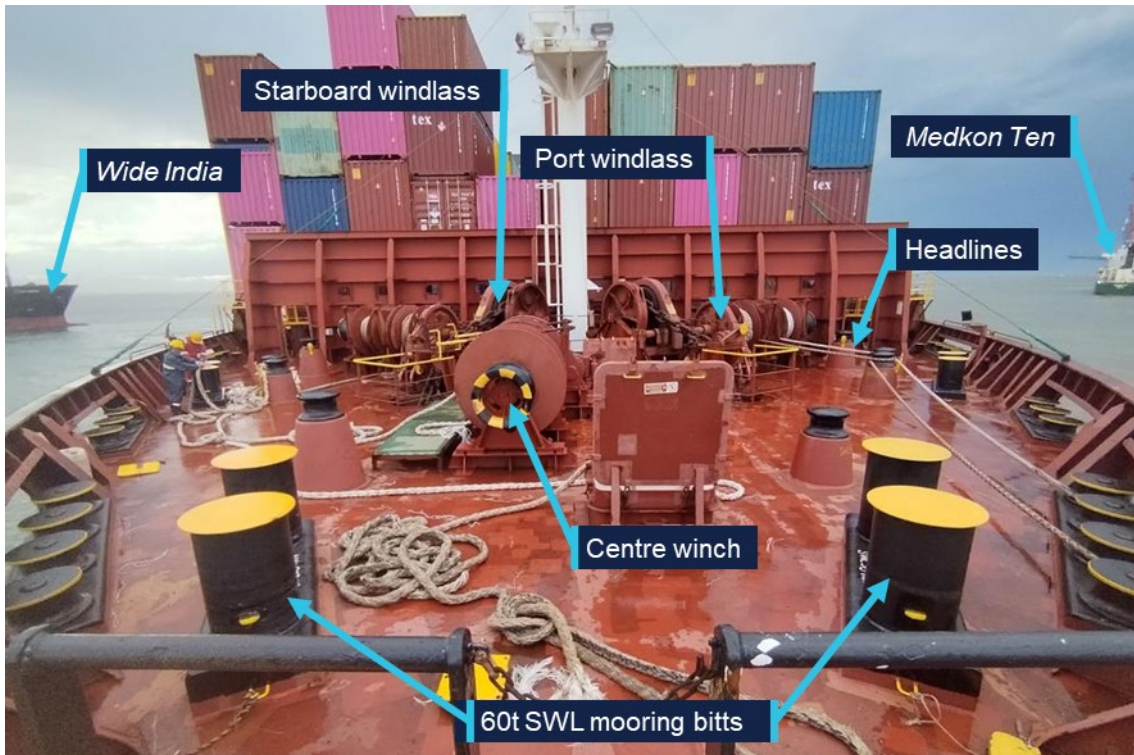
Figure 20: 1640 *Volans* forecastle looking aft

On arrival at Brisbane, the ship was moored using 4 headlines and 2 springs forward and 4 stern lines and 2 springs aft. After receiving the warning in the morning, the crew lowered the starboard anchor and secured an additional stern line aft and an additional headline and spring forward. After the storm passed the ship remained secured to the berth by 2 headlines from the port windlass mooring drums. (Figure 20)

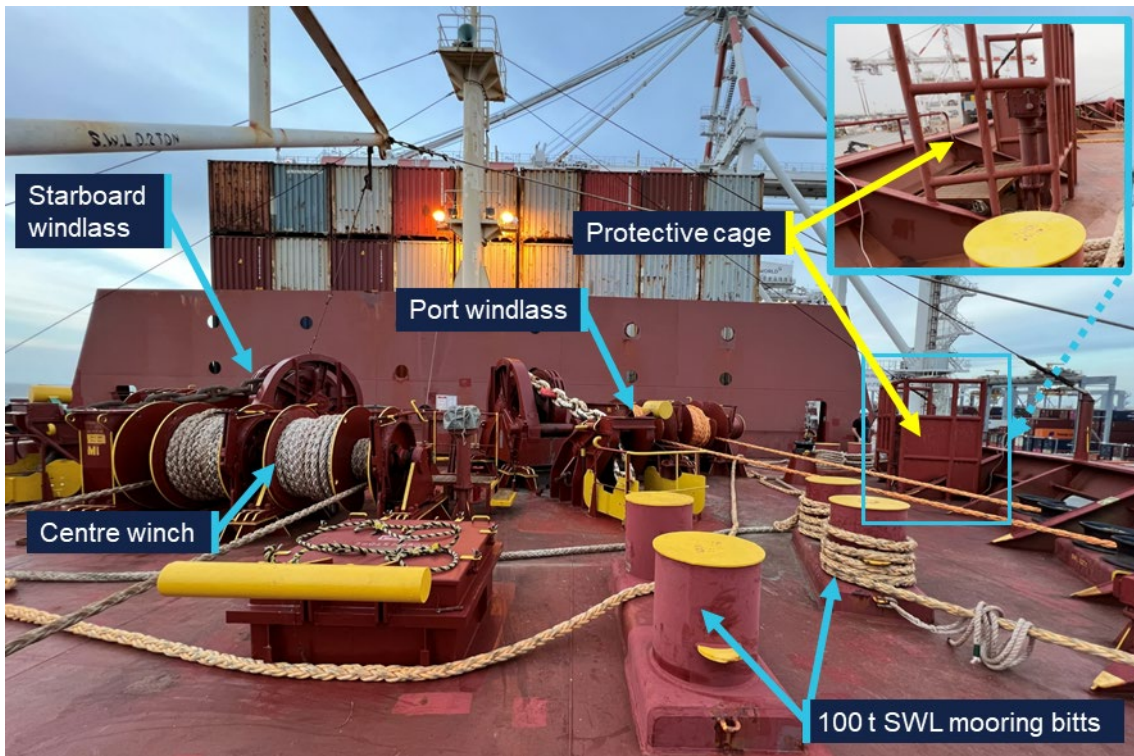
Figure 21: *Wide India* forecastle looking aft

The ship's forward mooring arrangements consisted of 2 windlasses and one centre mooring winch, fitted with 2 mooring drums each. Its aft mooring station was equipped with 3 double drum mooring winches. Both forward and aft stations were equipped with 6 sets of mooring bitts with an SWL of 100 t (Figure 21). On arrival at Brisbane, it was moored using 4 headlines and 2 springs forward and 4 stern lines and 2 springs aft. After receiving the warning from the terminal, the crew lowered the starboard anchor but did not deploy extra lines.

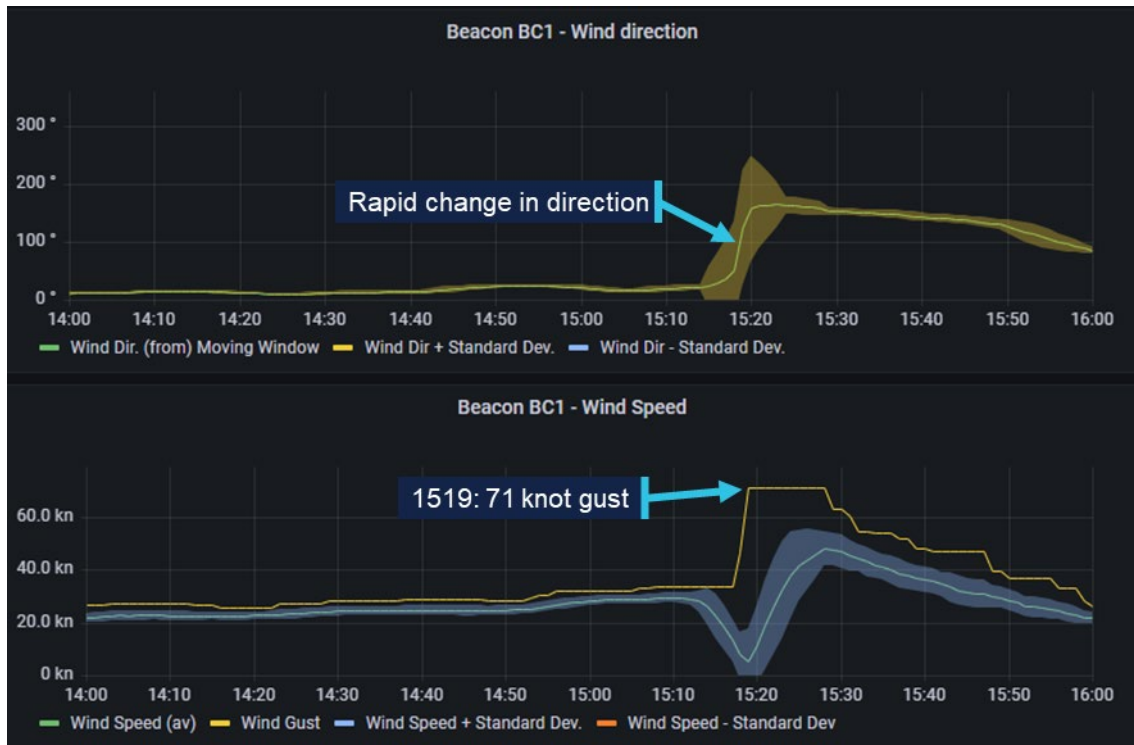
Figure 23: MSQ port weather dashboard data from beacon BC1 (1400 to 1600)

Maritime Safety Queensland also operated an online weather dashboard, called 'PortWeather'. This provided live weather, tidal and current observations for ports around Queensland. It was available to VTS, pilots and other local stakeholders for different locations in the port and its approaches. The system's meteorological instrumentation located on the port channel entrance beacon (BC1) recorded a maximum gust speed of 71 knots during the incident (Figure 23).
