Collision between Aurizon train 9M48 and Qube train 9277

Oonoomurra, Queensland, on 17 August 2022

ATSB Transport Safety Report

RO-2022-010

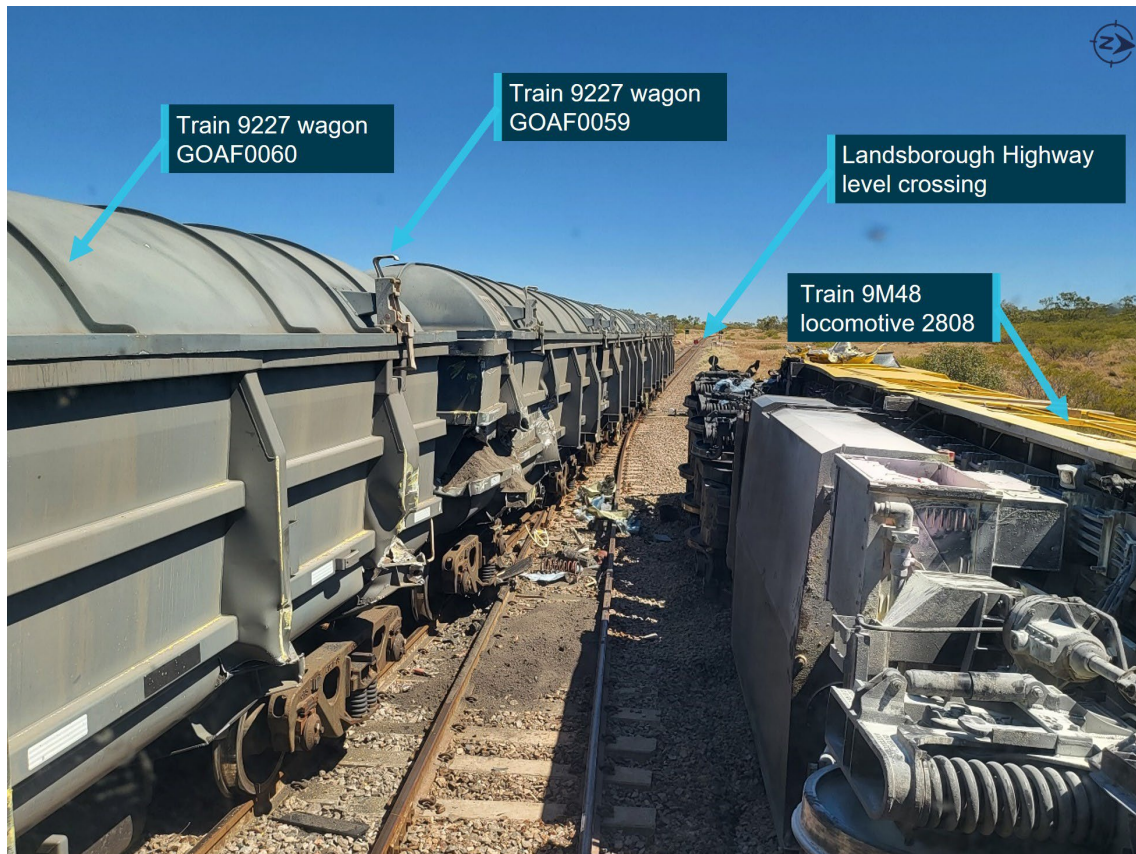
Figure 2: Collision damage to trains 9M48 and 9227

At 0637, train 9M48 was travelling at about 23 km/h when the driver, having identified wagons from train 9227 were obstructing the track, moved the automatic brake handle to the emergency position and the throttle to idle to stop the train. The braking continued for around 30 m when, at about 17 km/h, the lead locomotive (2808) collided with the side of wagons GOAF 0060 and GOAF 0059 from train 9227. Locomotive 2808 subsequently derailed, uncoupled from the trailing locomotive and rolled onto its side (Figure 2).

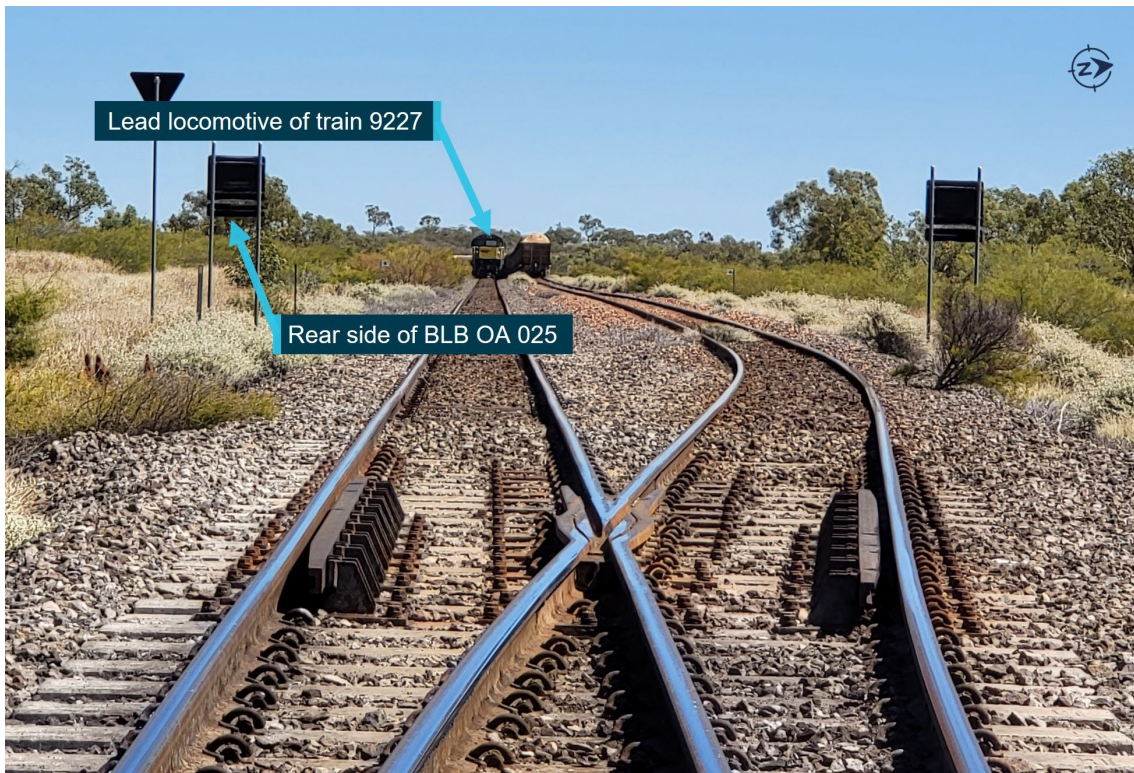
Figure 8: Stopping location of the lead locomotive from train 9227 from the limit of authority at BLB OA 25

The lead locomotive of train 9227 stopped about 317 m before the limit of authority at BLB OA 25 (Figure 8). The last 8 ore wagons of the train consist (extending approximately 86 m in length) did not clear BLB OA 16. The Cloncurry to Oonoomurra block section remained occupied and the trailable points at the western end (adjacent to the ‘trailable point indicator’ in Figure 9) of the station were fouled by the wagons from train 9227.

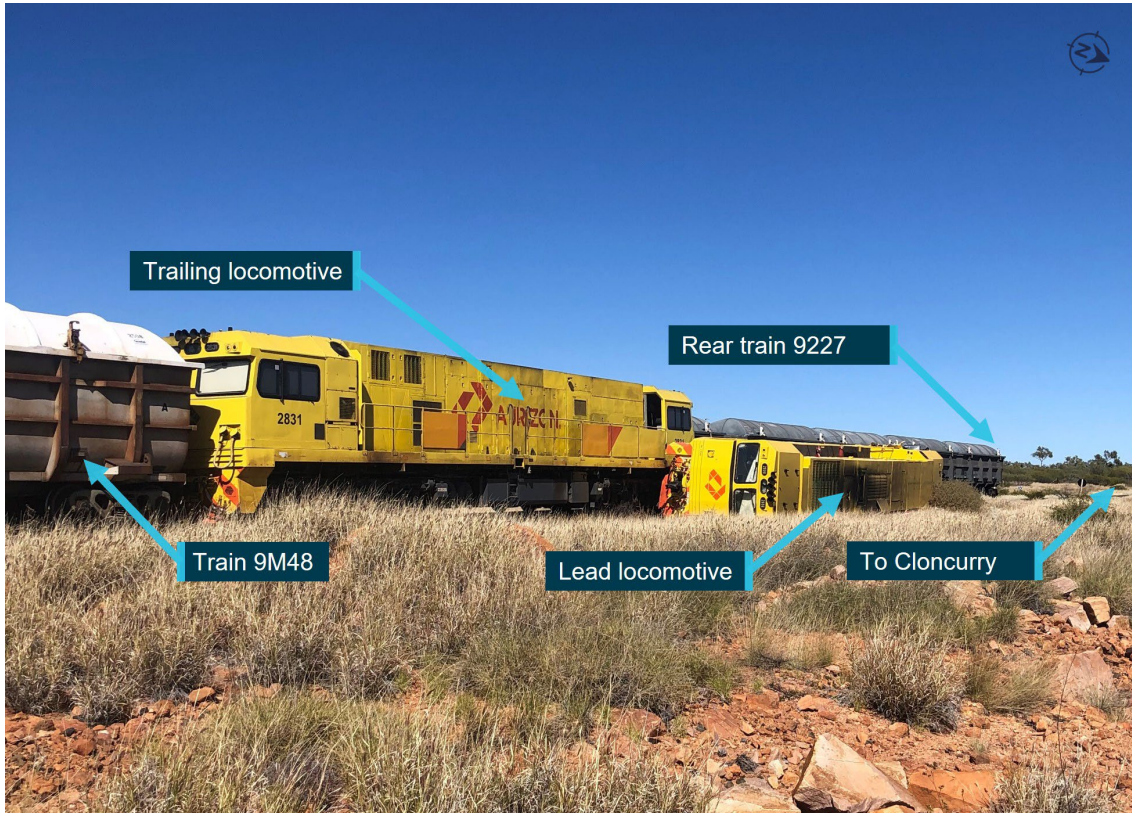
Figure 10: Derailed and overturned lead locomotive 2808 of train 9M48

During the collision, the lead locomotive (2808) of train 9M48 derailed, uncoupled from the trailing locomotive and rolled onto its 'A' side coming to a stop on the right side of the track in the direction of travel (Figure 10). The locomotive diesel fuel tank was ruptured and fuel was spilled. There was no post-impact fire.

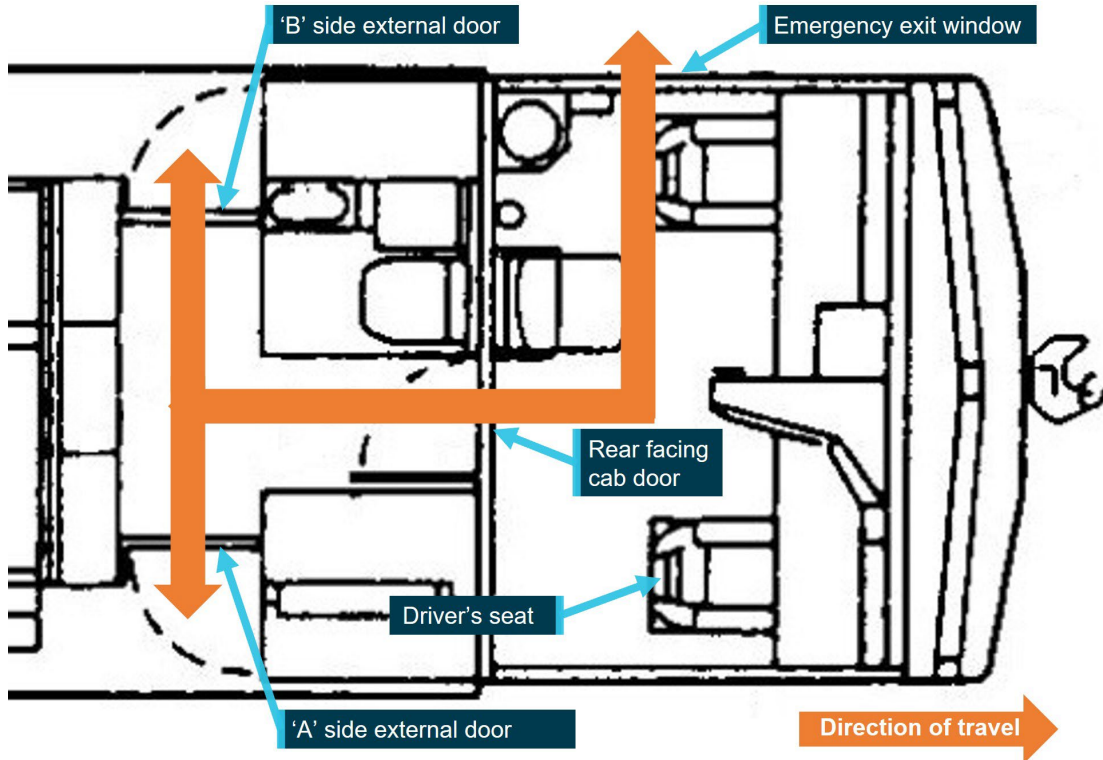
Figure 11: Locomotive 2808 emergency exit pathways

The escape paths available to the driver at the No 1 end of the locomotive were via the rear-facing internal door (the normal access and egress route) that led to the internal vestibule area, then through the external door leading to the walkway on the 'B' side of the engine hood. An alternative emergency exit was located at the assistant driver's side sliding window. The side windows were the designated emergency evacuation points from the enclosed cab of a 2800 class locomotive. An additional path may be available via the vestibule and external door on the 'A' side of the engine hood, however, this egress point was located under the overturned locomotive (Figure 11).

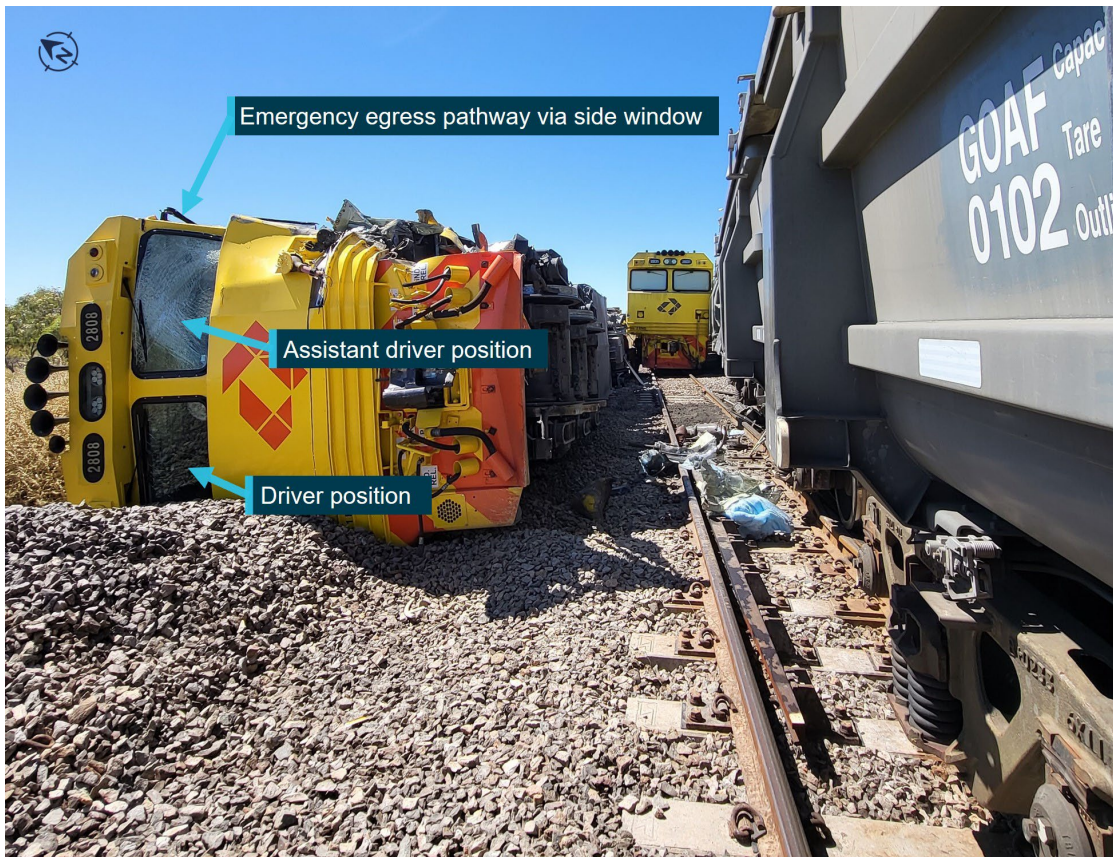
Figure 12: Overturned lead locomotive of train 9M48

The driver reported they did not attempt to egress via the rear facing door into the vestibule area but initially attempted unsuccessfully to kick out the windscreen. They then considered egress via the assistant driver's side window (alternative pathway) that was situated on the high side of the overturned locomotive cab. However, they were unable to reach the alternative pathway. Following the arrival of bystanders, the driver was able to egress via the side window with their assistance. The driver and bystanders then jumped from the side of the locomotive onto a ballast mount located at the front of the locomotive (Figure 12).
