# **Derailment of freight train 82P7 and subsequent collision with coal train 9F02**

3 km east of Marmor, Queensland, on 29 January 2023

Rail Occurrence Investigation (Systemic)

RO-2023-001

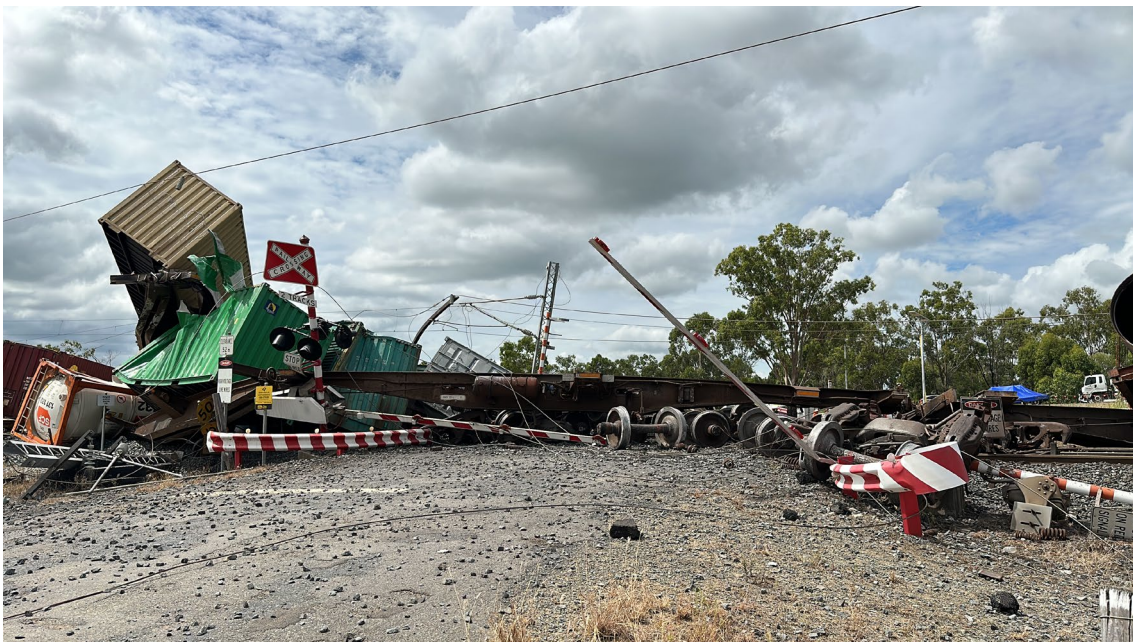
**Figure 1: Main wreckage site of train 82P7 at Bills Road level crossing**

On 29 January 2023, at about 1910 local time, Pacific National Pty Ltd freight train 82P7 was travelling west on the Aurizon Network Pty Ltd network at about 100 km/h on the down line near Marmor, Queensland. At 1910:05, as the train approached the Bills Road level crossing, the rear 8 wagons separated from the train, which disconnected the brake pipe, resulting in application of the brakes. At around the same time, the driver, unaware of the separation, reported that the train did not respond as expected when the throttle was applied and they noted a slight drag. The driver stated they checked the locomotive mirrors, noticed sparks coming from the train, and made a brake application. The brake application by the driver was recorded 5 seconds after the brake pipe pressure started to drop following its disconnection. At 1910:29, as the train was slowing, the driver broadcast an emergency call over the ultra-high frequency radio. After stopping at 1911:03, it was determined that the 8 rear wagons from train 82P7 had derailed, significantly damaging points, crossings, level crossing equipment, and overhead wiring stanchions (Figure 1).

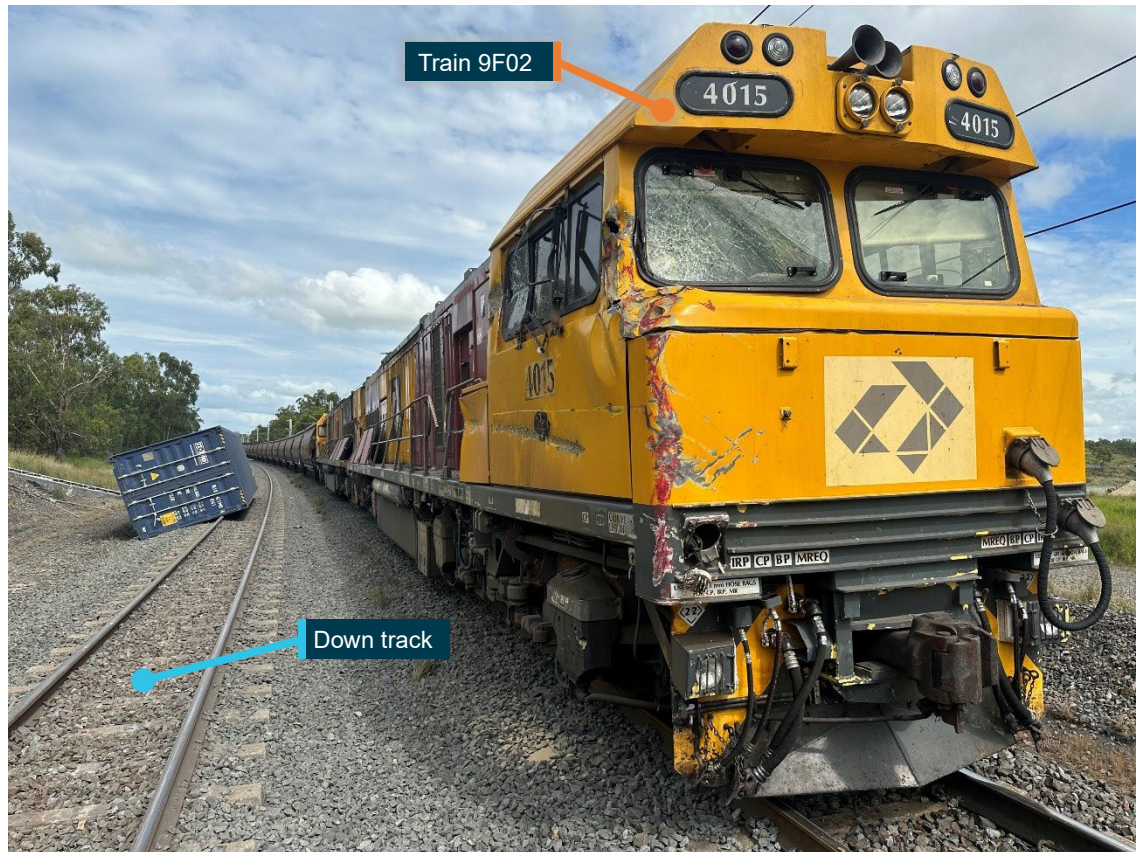
**Figure 2: Damage to leading locomotive of train 9F02**

82P7, which was fouling the up line. Train 9F02 stopped adjacent to a different container (Figure 2). It did not reach the main wreckage of train 82P7, located near the Bills Road level crossing (Figure 3). Train 9F02 sustained significant impact damage to the driver's side of the cab on the lead locomotive and along the side of the train.

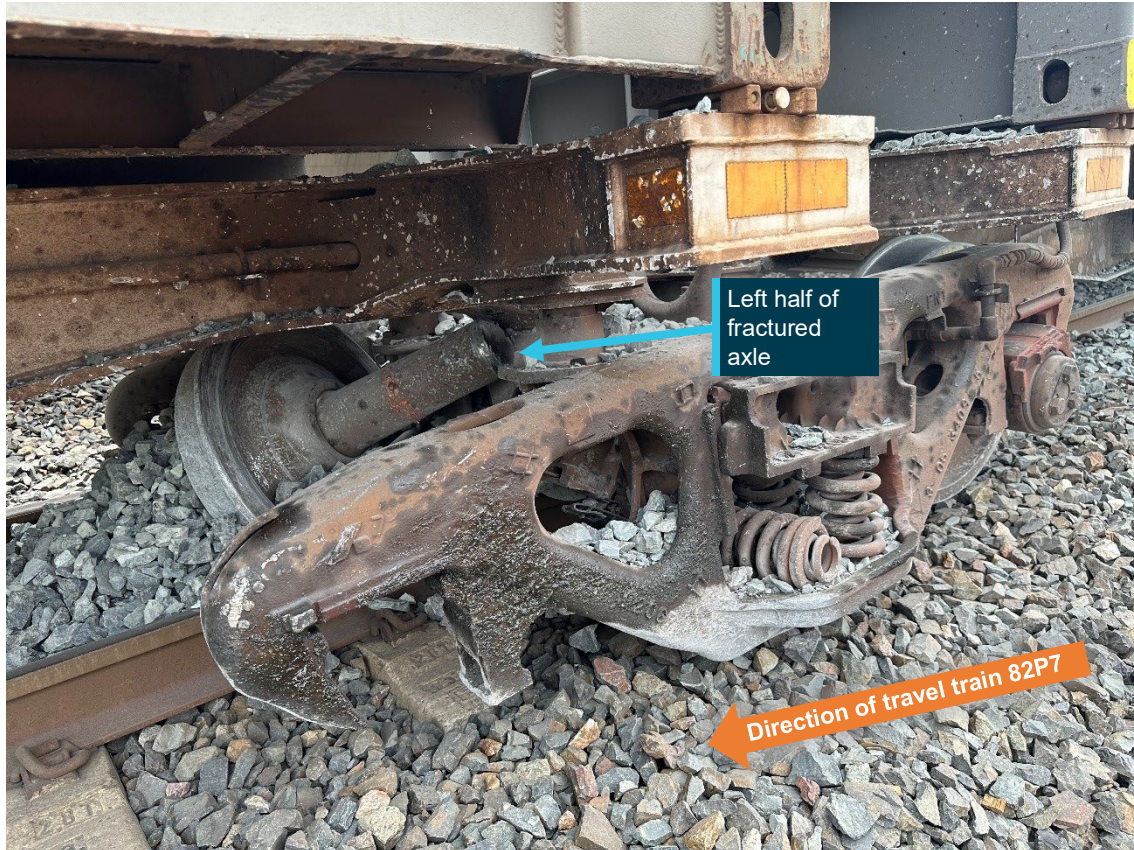
**Figure 4: Damaged bogie of RNCY137-T showing half of the fractured axle**

During onsite inspections, the ATSB found an axle from the sixth wagon (RNCY137-T) on train 82P7 had fractured (Figure 4). This evidence correlated with rail-wheel field-side<sup>1</sup> marks found on the rail head (Figure 5), identified as a point of derailment, situated before the signalling infrastructure and the points (Figure 3). The marks commenced on the field-side of the rail head and ran inwards towards the rail gauge face between both rails. There was no other evidence of derailment found on the approach to the point of derailment.

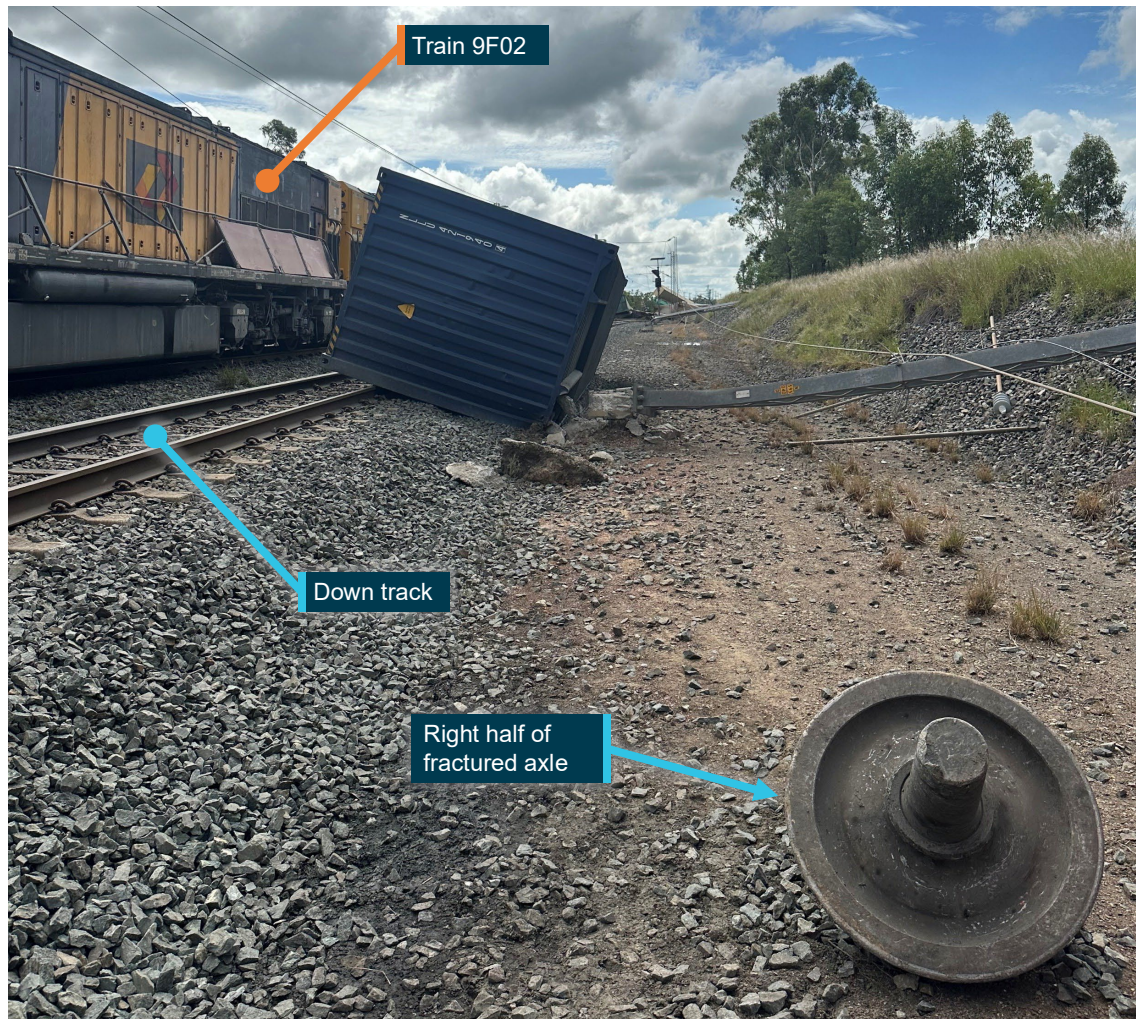
**Figure 10: Location of right half of fractured axle from train 82P7**

Train 9F02 came to a stop at 594.995 track km, shortly beyond a stationary container fouling the down line (Figure 2). Damage was sustained by both leading locomotives and the first 29 wagons of train 9F02. Also located in this area, off the tracks, was the right<sup>10</sup> half of the fractured axle from train 82P7 (Figure 10).

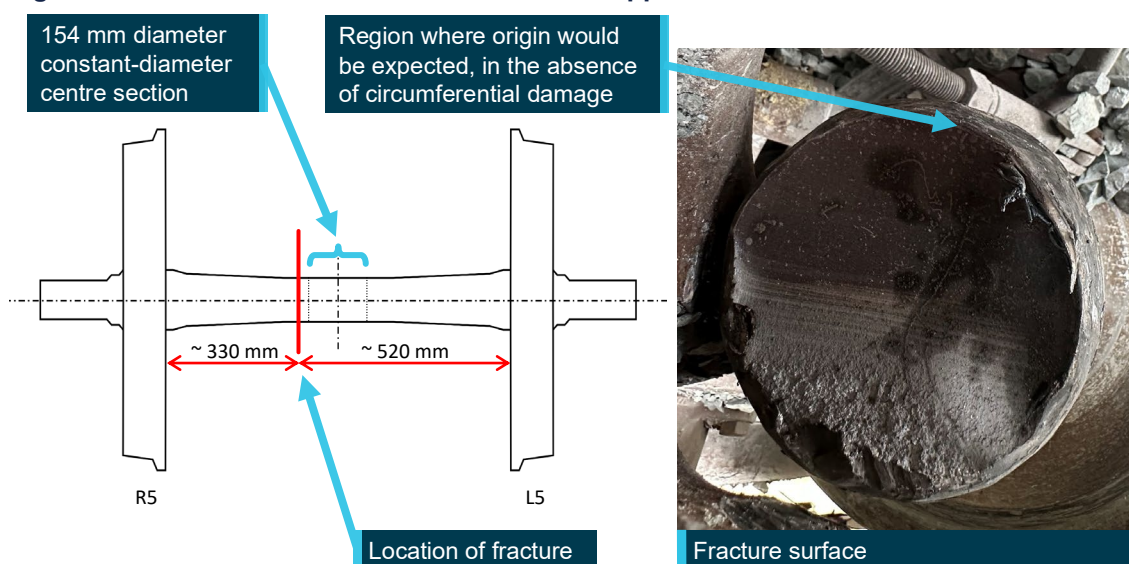
**Figure 11: Failure location and fracture surface appearance of fractured axle**

The axle had fractured around 95 mm to the right of the centreline (Figure 11). About 200 mm of axle material, including both sides of the fracture surface, was sectioned from

the axle and examined at the ATSB technical facility in Canberra, Australian Capital Territory. The fracture surface exhibited progression marks,<sup>11</sup> originating at a location on the circumference of the axle, consistent with fatigue fracture resulting from rotational bending. The indications of fatigue crack growth extended over around 60% of the axle cross-section, with a relatively small area of overstress failure, indicating low nominal stresses.<sup>12</sup> Around 50% of the fracture surface exhibited surface oxidation producing a darker appearance. The circumference of the fracture surface was extensively damaged, such that it was not possible to identify a crack initiating feature.

The surface condition of the retained axle sections exhibited derailment damage in the form of scuffs and surface damage. The barrel surface was inspected for additional surface breaking cracks using magnetic particle inspection<sup>13</sup> at the ATSB facility. There were no indications of additional cracks on the retained sections of the axle. Analysis of the axle material microstructure, hardness, and elemental composition found that the material was consistent with specification.

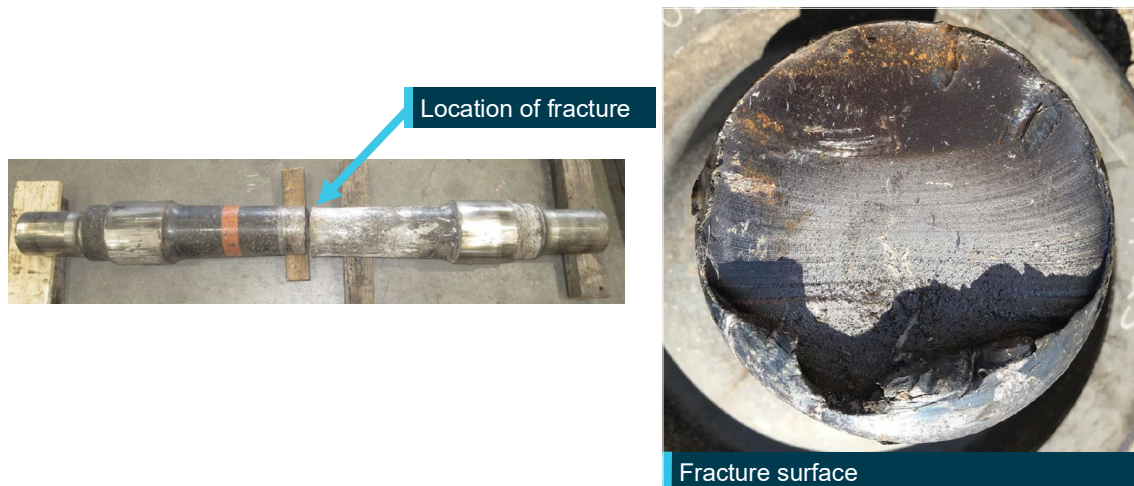
**Figure 13: Fracture location and surface appearance of Mingela axle fracture**

An NB axle, referred to as the Mingela axle, fitted to one of the derailed wagons was found to have fractured near the centre section of the barrel (Figure 13). Pacific National had never before experienced an in-service failure of a 7L7N or NB axle. The fracture surfaces exhibited progression marks followed by overstress fracture. The progression marks were estimated to extend across around 70% of the axle cross-section.

Pacific National commissioned an examination of the fractured Mingela axle, which stated that, while it was suspected that the fatigue crack may have been initiated by ‘a

small indentation caused by being struck by a piece of ballast', examination could not confirm the presence of such an indentation. Magnetic particle inspection performed on the fractured axle did not detect additional indications of cracking on the barrel. The axle was found to meet the compositional and mechanical requirements of the specified material. The report also noted that the axle had been involved in a stationary immersion and derailment event in January 2019 (around 11 months prior to the failure) where floodwaters lifted the stationary train off the tracks.

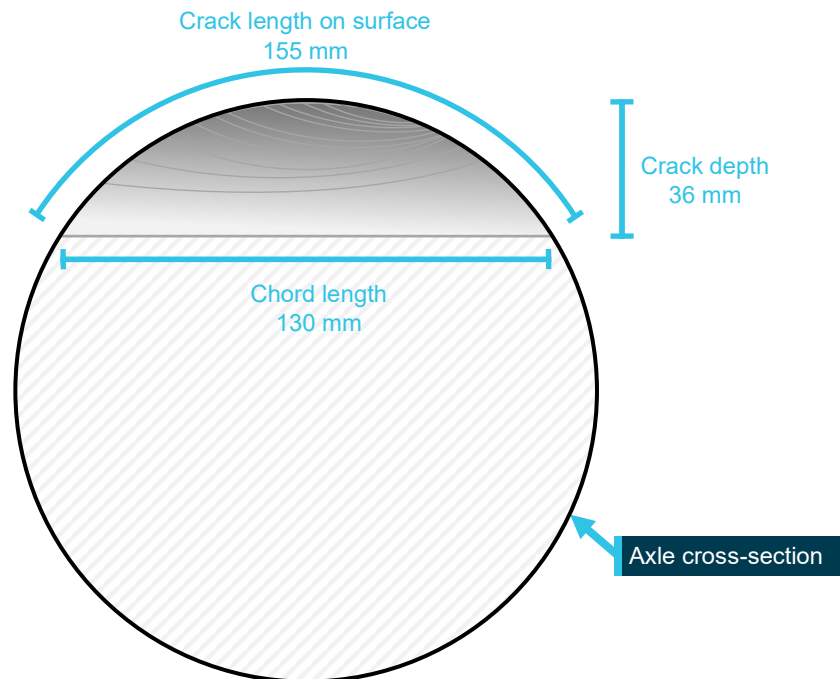
**Figure 14: Representation of a critical-depth fatigue crack in an NB axle**

The engineering evaluation stated that the fatigue life of the NB axle ‘was found to exceed 30 years of operation in the undamaged or as manufactured condition’. The critical crack depth<sup>25</sup> was stated to be 36 mm for the constant-diameter centre section of the NB axle design (Figure 14). A crack that had progressed to this depth would correspond to a crack length of 155 mm on the curved surface of the axle and a chord length of around 130 mm.
