# **Level crossing collision between passenger train DB09 and a B-double truck**

Runcorn, Queensland, on 14 August 2025

Rail Occurrence Investigation (Short)

RO-2025-006

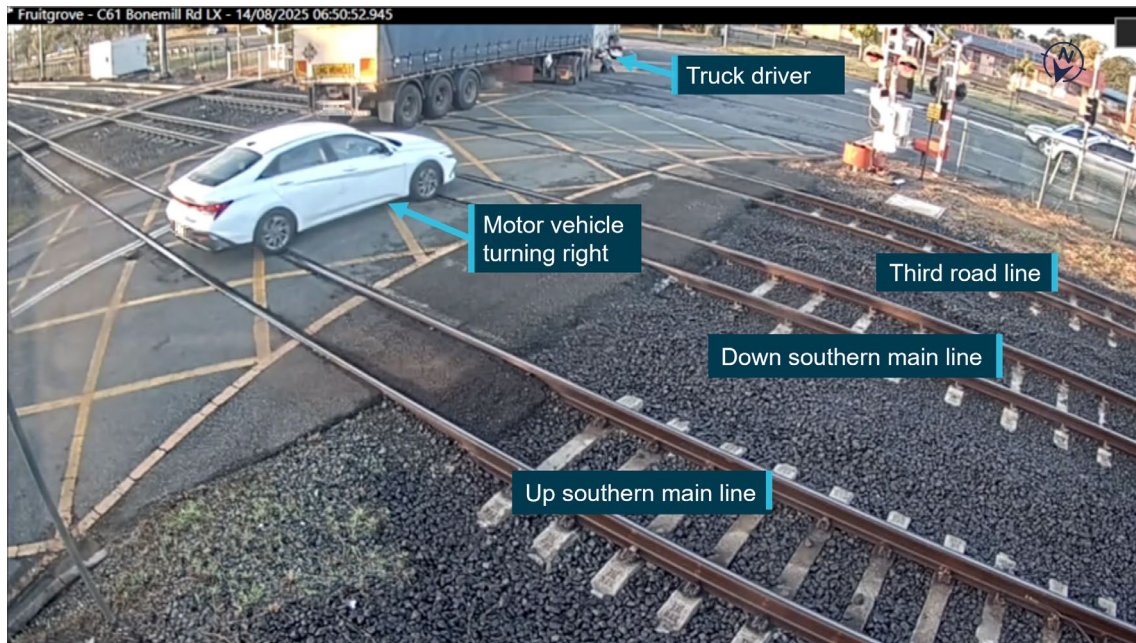
**Figure 2: Bonemill Road level crossing CCTV at 0650:53**

The B-trailer obstructed the Third road line and the Down southern main line.<sup>3</sup> The prime mover and A-trailer (first trailer) had cleared the rail corridor but were obstructing road traffic on Beenleigh Road heading east (Figure 1). The CCTV recorded the truck lurching, as the truck driver attempted to move the vehicle. The driver then exited the truck and went to inspect the area between the A- and B-trailer (Figure 2). There were other motor vehicles overtaking the truck, and some pedestrians in the area at that time.

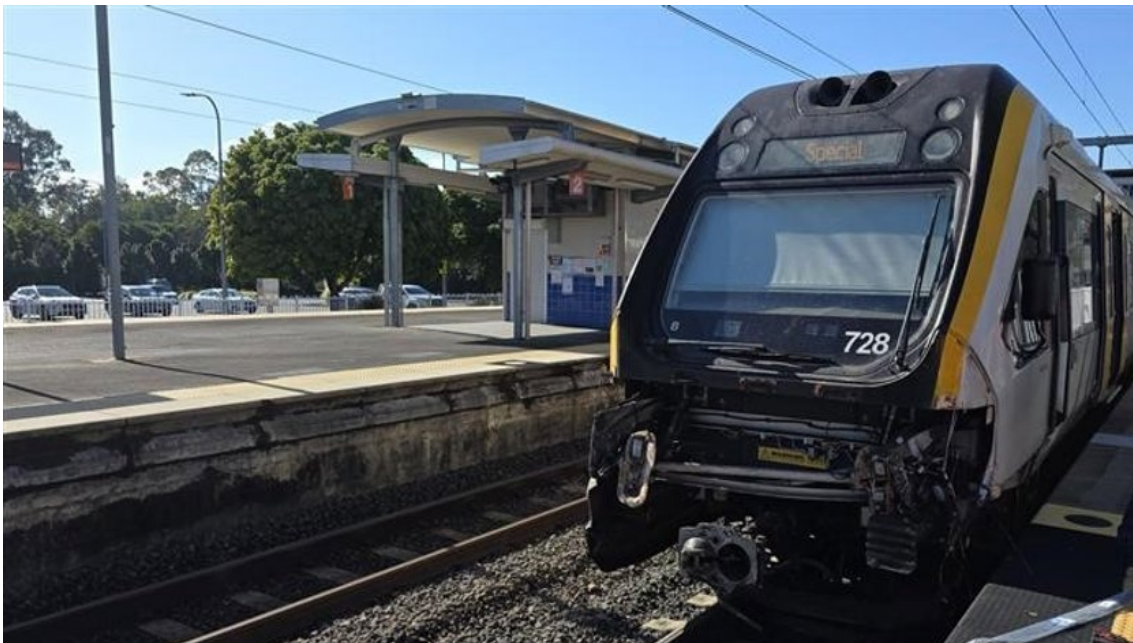
**Figure 3: Impact damage to Queensland new generation rollingstock DMB 729**

Train DB09 was a Queensland new generation rollingstock 6-car consist electrical multiple unit number 728. The train length was 146.7 m, and tare weight was about 438 t. The front motoring unit was DMB 728, which had substantial damage to the nose cone, coupler and air lines from the collision (Figure 3).

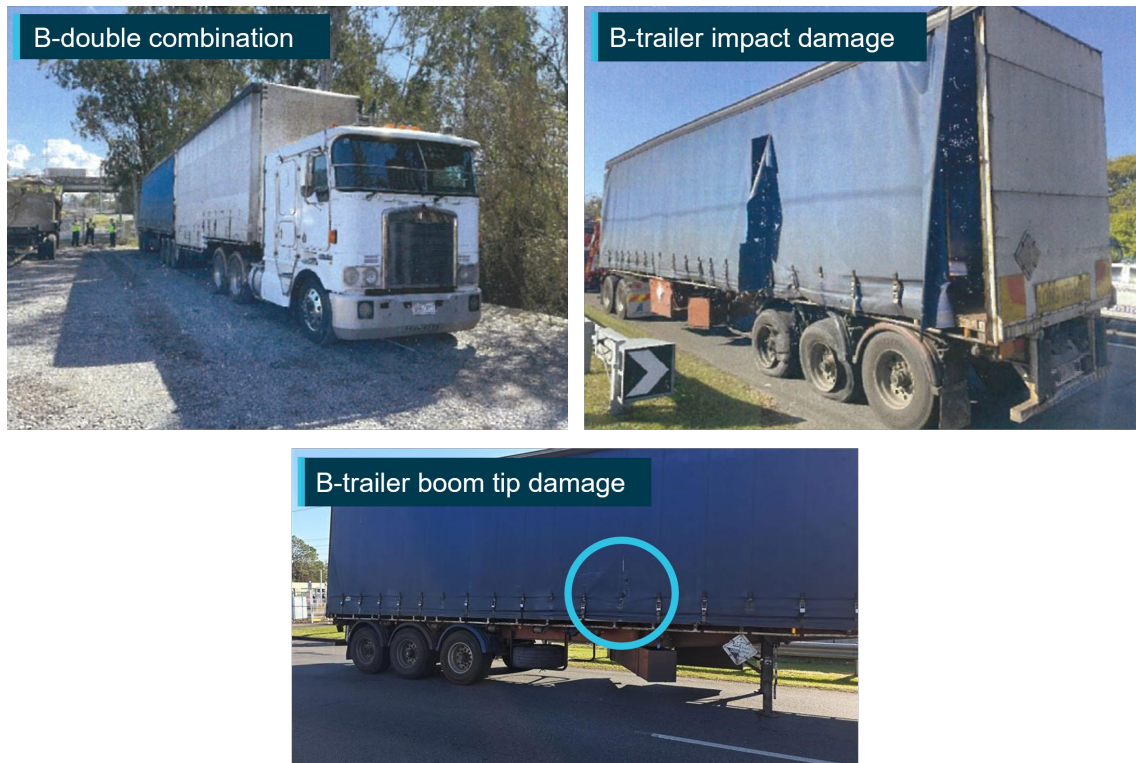
**Figure 4: B-double truck configuration and damage**

The truck driver stated that the truck was in good condition, and they had performed a daily check before departing Glass House Mountains. They did not identify any defects with the truck during this check. After becoming immobilised on the level crossing, the truck driver stated that they had found an air hose<sup>6</sup> fractured between the trailers, locking the brakes on. They did not recall seeing an air pressure warning when the truck became immobilised. The operator reported that the sudden air line failure was not attributed to inadequate maintenance or inspection practices.

After the collision, a compliance inspector from the National Heavy Vehicle Regulator (NHVR) conducted an inspection of the B-trailer and noted 'severe' impact damage (Figure 4).

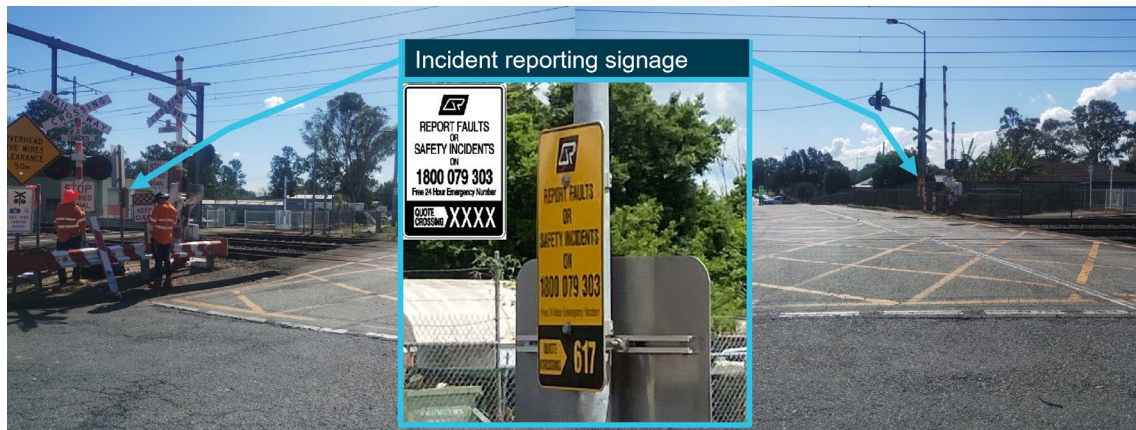
**Figure 6: Bonemill Road level crossing incident reporting signage**

On the north-east and south-west side of the level crossing, incident reporting signage was installed near the mast assembly, facing inwards to the yellow crosshatch pavement markings (Figure 6). The incident reporting signage included a 24-hour emergency phone number (1800 079 303) for anyone to report a safety incident, such as a track obstruction. This number connected directly to the QR Rail Management Centre. The truck driver recalled they had probably seen the incident reporting numbers before but had not taken any notice.

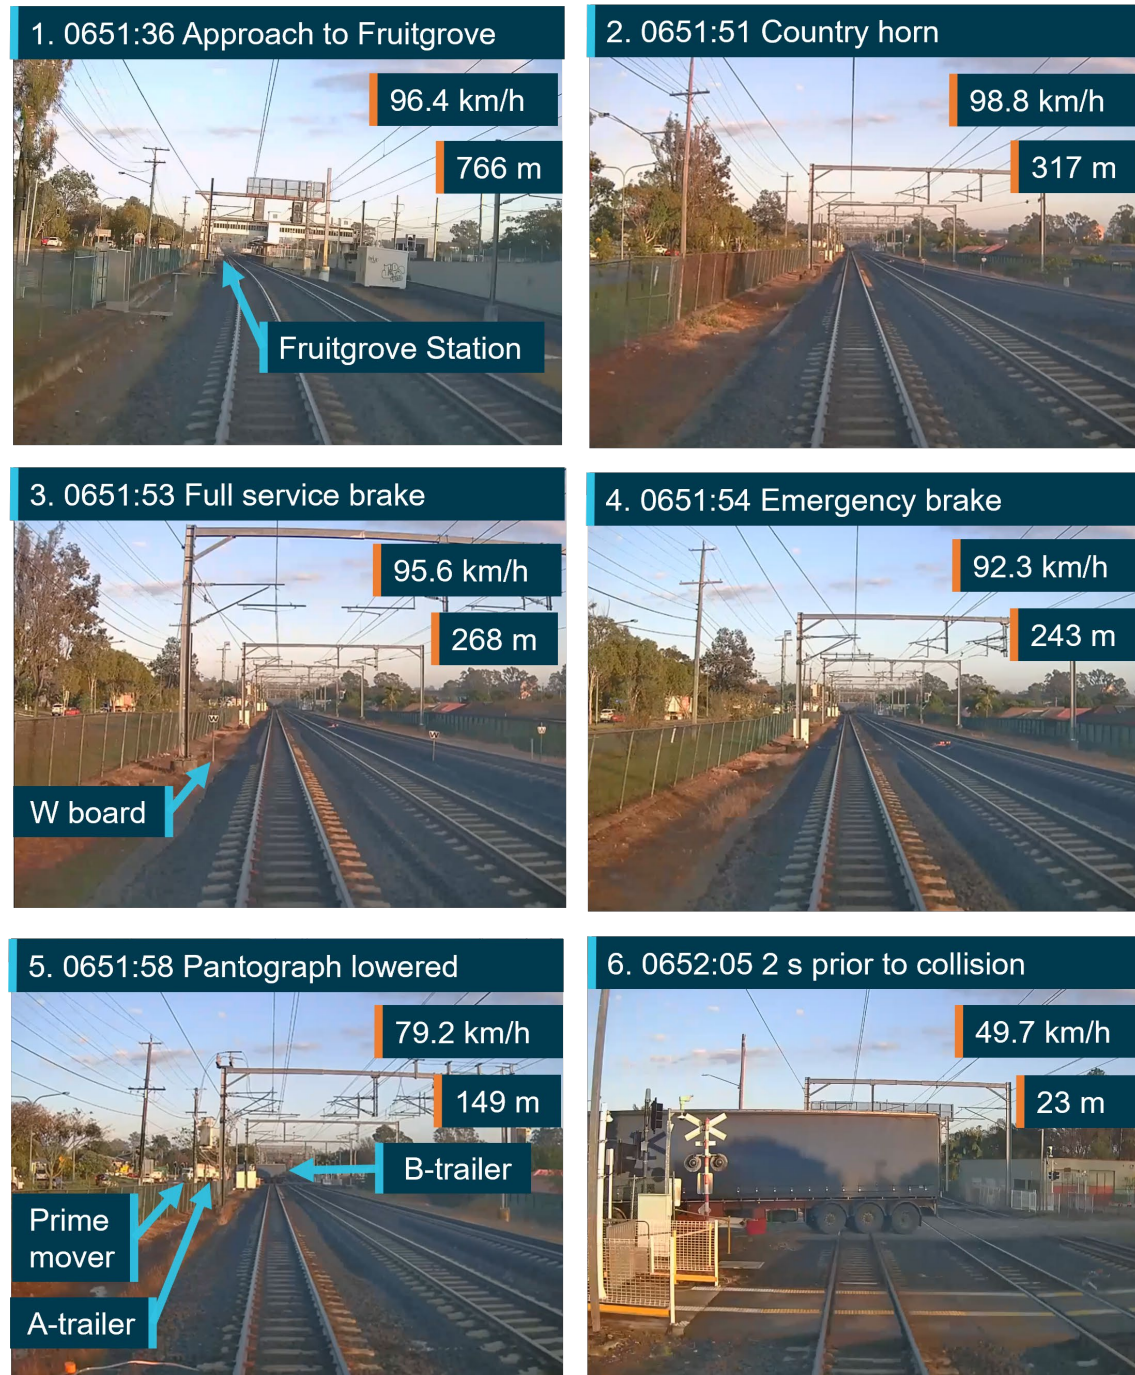
**Figure 7: Comparison of train speeds, train driver actions and DMB 728 FFCCTV**

Figure 7 compares the event recorder train speeds and train driver actions to what was visible to the train driver leading up to the collision. The train driver recalled that, when they first noticed a shadow ahead, it was very difficult to distinguish from the surrounds.

At the point of the collision at 0652:07, train DB09 was travelling at 41.0 km/h.
