# Collision between a road vehicle and train 6PM9

Reddies Road level crossing, Cressy, Victoria, on 20 January 2026

## ATSB Transport Safety Report

RO-2026-001

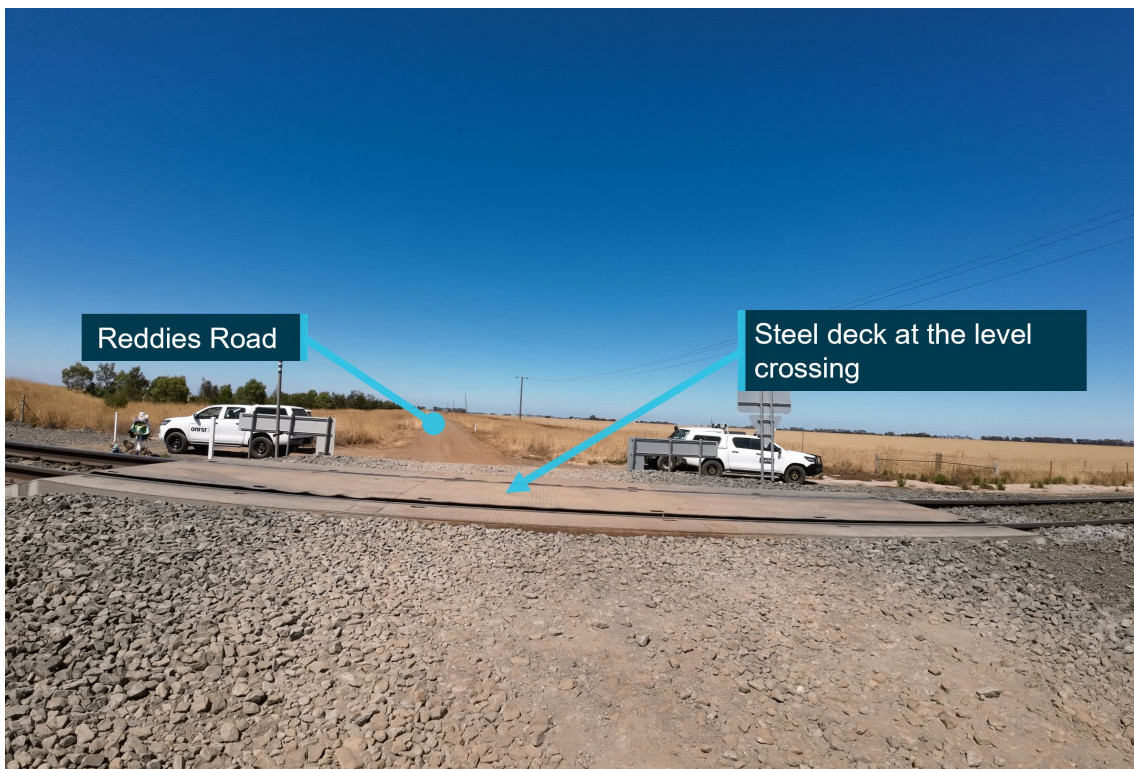
**Figure 2: Steel deck installed to align the road surface with the top of the rail heads**

To accommodate the track interface with an unsealed road, a steel deck had been installed to align the road crossing surface with the top of the rail heads (Figure 2). The purpose of the deck was to avoid rails protruding above the road surface (which can occur as unsealed roads wear) and therefore minimise the risk of vehicles catching on the rails. Post-incident inspection identified reasonable alignment of the unsealed road surface with the entry and exits of the steel deck although in places, the road surface was about 50 mm below the deck surface. During the post-site inspections, vehicles could transit the steel plated surface without difficulty.

The survey also noted that the crossing panels (the steel deck) adjacent to the rails were in poor condition due to low infill. This finding was addressed in September of 2024 when the material at the level crossing was replenished to ensure that the road surface and level crossing surfaces were flush.

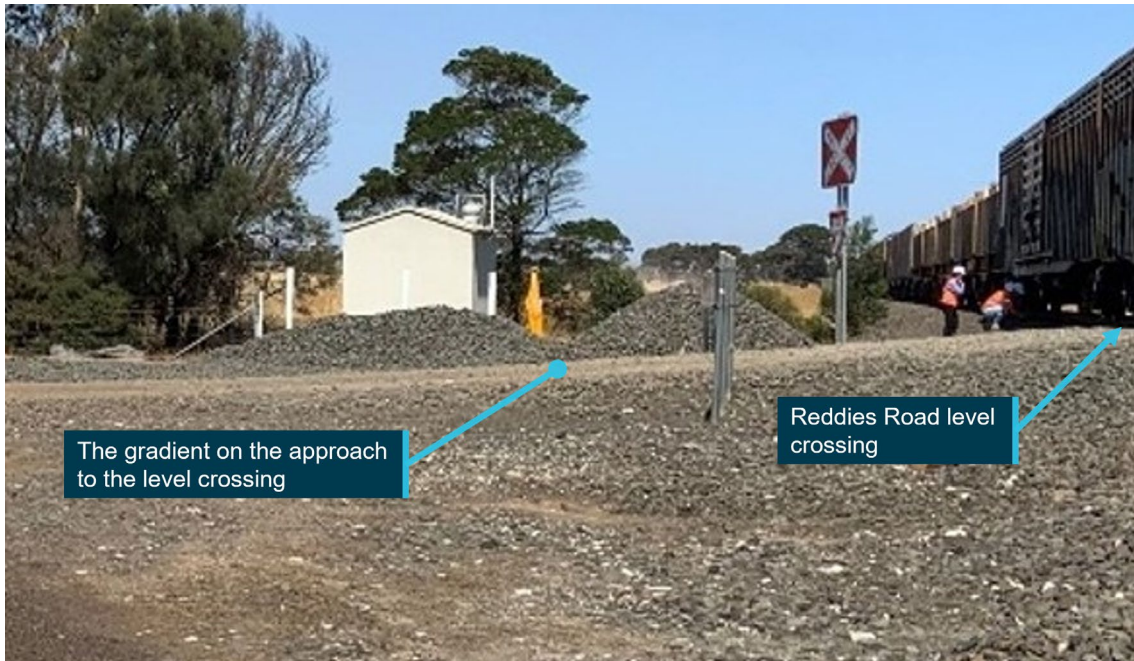
**Figure 3: The gradient on approach to the level crossing from the north**

On the approach to the level crossing from the north, the gradient over a distance of 10 m from the closest rail head was measured to be about 7%<sup>5</sup> (Figure 3).

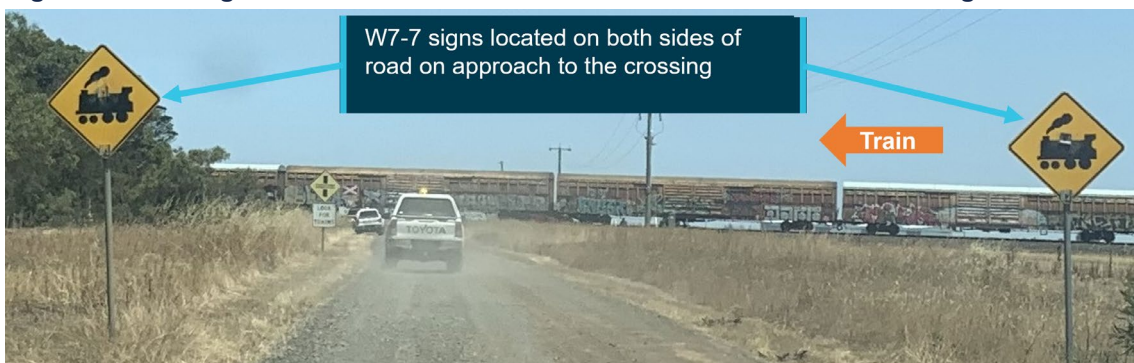
**Figure 4: W7-7 signs on each side of the road about 207 m from the crossing**

For road traffic coming from the north, the direction the vehicle approached the crossing, several signs warning of the approaching crossing were located along Reddies Road. A train warning sign W7-7 was located on each side of Reddies Road about 207 m from the northern rail head (Figure 4).

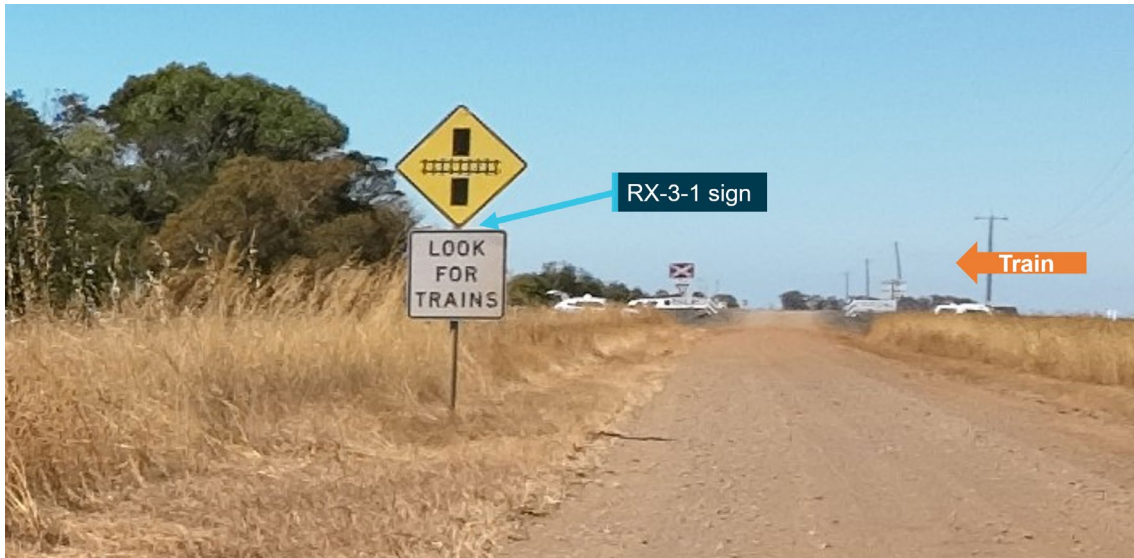
**Figure 5: RX-3-1 sign about 148 m from the crossing**

Closer to the crossing, a 'Look for trains' sign (RX-3-1) was located about 148 m from the northern rail head (Figure 5).<sup>6</sup>

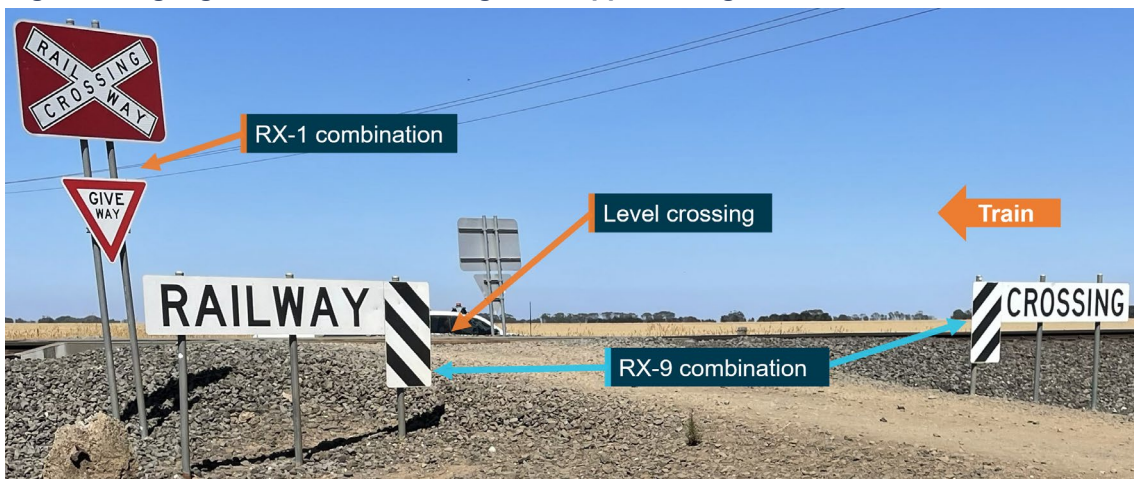
**Figure 6: Signage at the level crossing when approaching from the north**

Protection at the level crossing included railway crossing identification and give way signs (Figure 6). A railway crossing sign combined with a give way sign (RX-1 combination) was located about 3.8 m from the northern rail head.

Signs stating 'Railway' on the left and 'Crossing' on the right (RX-9 combination) were located on the sides of the road about 5.4 m from the northern rail head (Figure 6).

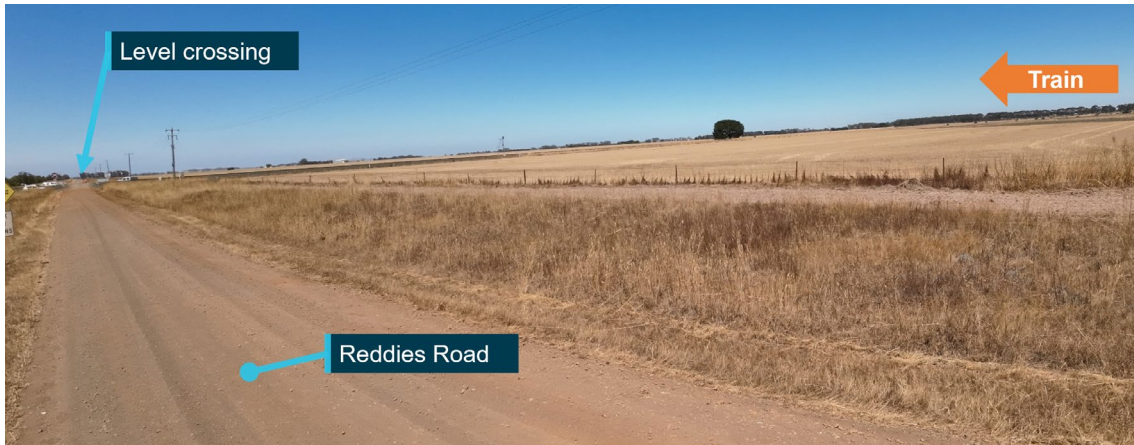
**Figure 8: Sighting to the west on approach to the level crossing from the north**

On approach to the level crossing from the north on Reddies Road (the direction the road vehicle was travelling) visibility of the rail track to the west, (the direction the train approached) at all  $S_1$  positions and at both eye levels, was unimpeded (Figure 8) and adhered to the standard.

The Reddies Road level crossing was protected by passive controls utilising give way signs. Post-incident site observations confirmed that available sighting distances from the road vehicle to the rail line to the west (towards the approaching train) was unimpeded for this combination of train and road approach. The installed signage was consistent with the relevant standard for level crossing protection. The driver of the road vehicle had the opportunity to observe the approaching train.

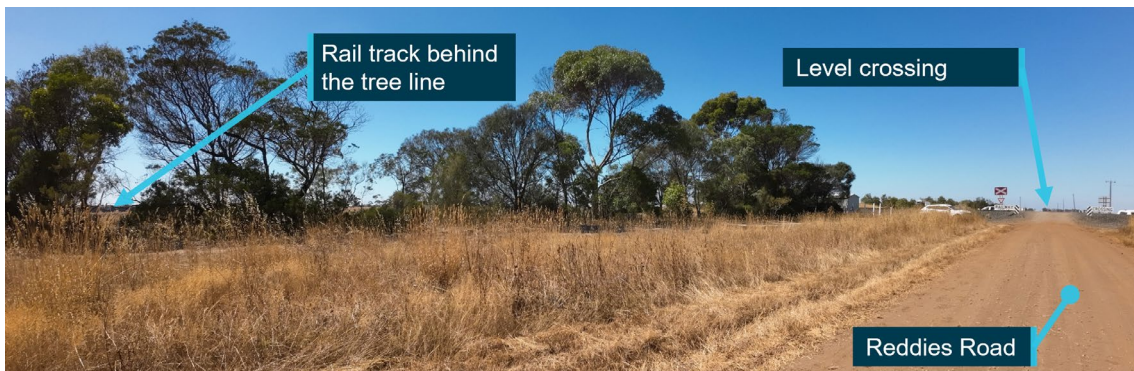
**Figure 9: Sighting to the east on approach to the level crossing from the north**

On approach to the level crossing from the north, at all  $S_1$  positions and at both eye levels, visibility of the rail track to the east of Reddies Road, was impeded by vegetation. The  $S_2$  target point was hidden behind the row of trees to the east of Reddies Road (Figure 9).

This compromised easterly view for vehicles approaching the crossing along Reddies Road from the north, meant the use of give way signage at the level crossing was inconsistent with signage recommended in the AS 1742 standard.

Post-incident site observations identified that for a road vehicle approaching along Reddies Road from the north, the sighting of the track to the east was restricted due to vegetation and a small infrastructure hut. Although not impacting the potential to sight train 6PM9, this restriction meant that the use of give way signage at this level crossing was inconsistent with AS 1742.7, the national standard for level crossing protection.

These post-incident site observations were consistent with findings of a survey of the level crossing undertaken about 23 months before this incident. An ALCAM survey in February 2024 noted that, when approaching from the north, vegetation to the east of Reddies Road restricted a road driver's view towards the rail line until just before the give way sign.

- The vegetation lining the east side of Reddies Road north of the crossing has been removed.
- ARTC has been in contact with the Colac Otway Shire Council to progress the change to the signage at the Reddies Road level crossing from 'give way' to 'stop'.

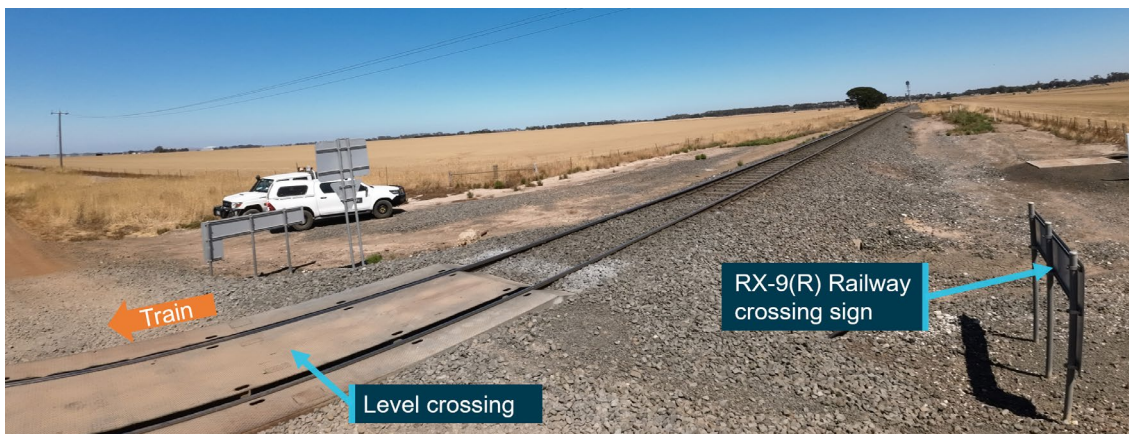
**Figure 10: Sighting to the west along the rail from about the give way sign at the level crossing**

Sighting from a vehicle closer to the rail track was also assessed, as evidence suggested that the road vehicle stopped, or almost stopped, at or about the give way sign. Sighting along the rail track to the west from about the give way sign on the north side of the crossing provided the driver with a clear view along the rail track to the west (Figure 10).

Visibility to the east from the middle of the give way line was impeded by a small self-seeding tree and a rail infrastructure hut on the northern side of the rail about 50 m along the track.
