Descent below glideslope involving Boeing 767, VH-XQU

near Sydney Airport, New South Wales, on 10 September 2025

ATSB Transport Safety Report
Aviation Occurrence Investigation (Defined)
AO-2025-055
Final – 10 July 2026

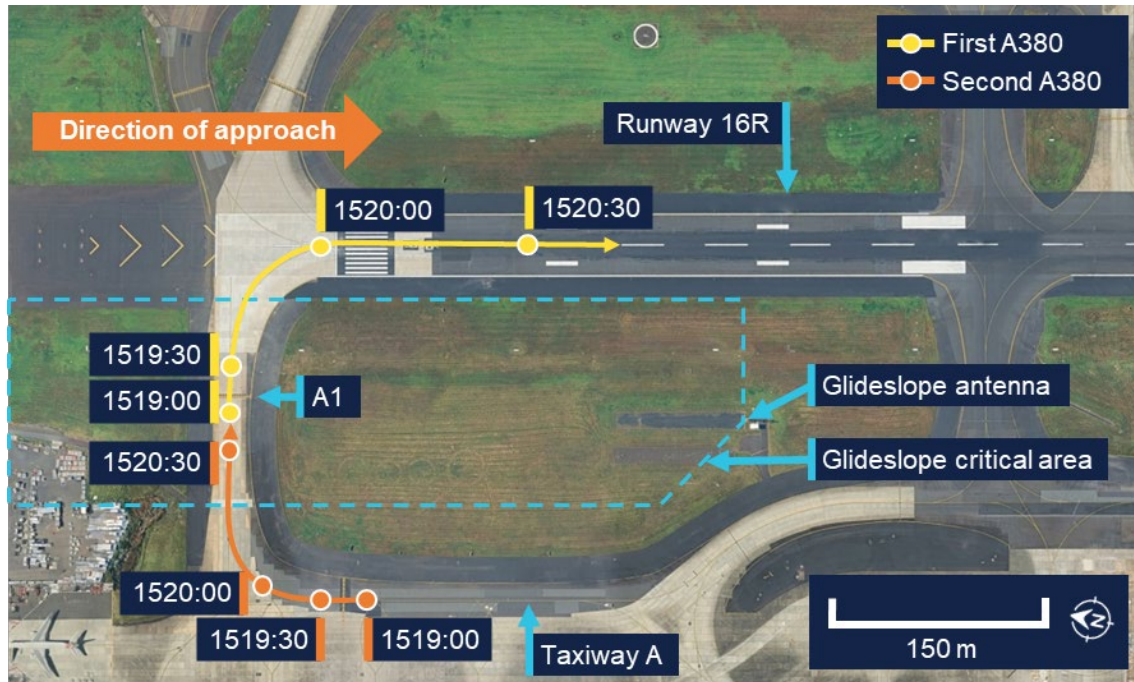
Figure 1: Ground movement of A380s

The ATSB found that 2 Airbus A380s on the ground at Sydney Airport taxied through the instrument landing system critical area and in front of the glideslope antenna, causing interference to the glideslope signal. As a result, after detecting the interference, the Boeing 767's autopilot established the aircraft on a flight path that deviated away from the glideslope, before alerting the crew that it was operating in a degraded mode.

As the aircraft was intercepting the glideslope prior to the commencement of a practice autoland approach, an A380 aircraft holding at A1, within the ILS critical area, began moving onto the runway. A second A380 then entered the critical area as the first vacated. The movements of both aircraft coincided with anomalies observed in the glideslope signal received by the aircraft.

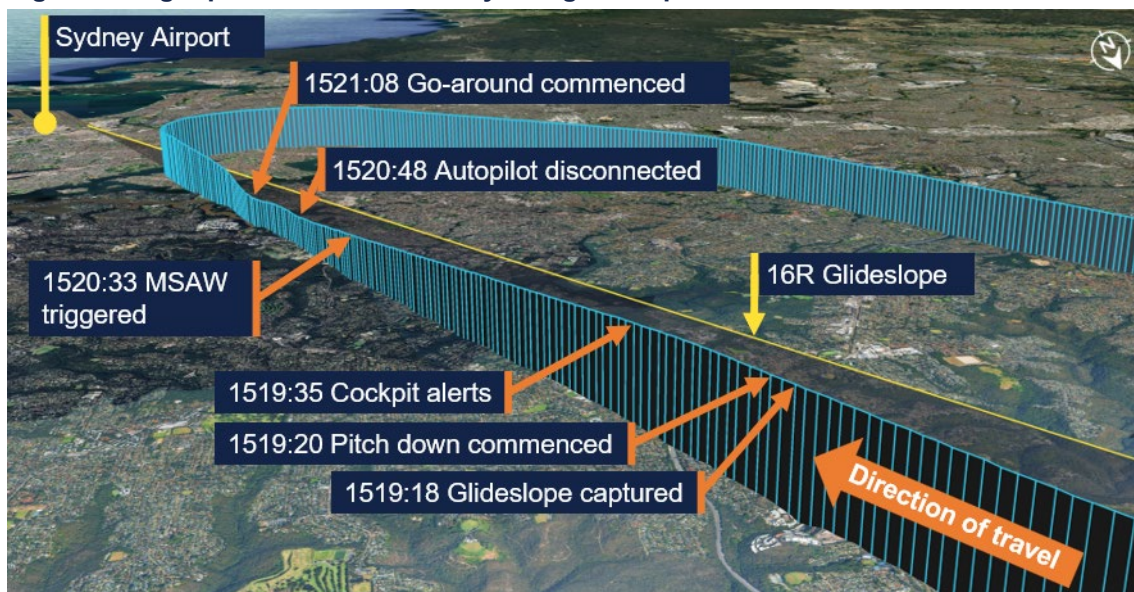
Figure 2: Flight path relative to runway 16R glideslope

At 1519:18, when slightly below and flying to intercept the glideslope, the crew of VH-XQU selected approach mode on the mode control panel and the autoflight system indicated that it had captured the glideslope (Figure 2). Two seconds later, the aircraft pitched down, adopting a nose down pitch of approximately 2°. As a result, the aircraft's descent rate increased, and it began to diverge below the glideslope. At 1519:35, 15 seconds after the commencement of the pitch down and when the aircraft was descending through 3,730 ft, the crew were presented with several alerts in the cockpit:

- a line through the pitch (G/S) flight mode annunciation (FMA)
- removal of the flight director pitch bar from the primary flight display
- an autopilot caution message.

After initially attempting to capture the glideslope from below, the aircraft's descent rate increased away from the flight director pitch guidance, and it began deviating away from the glideslope. As described in the flight crew operations manual (FCOM) bulletin for ILS signal interference, when the autopilot flight director system (AFDS) detected an unstable glideslope signal it changed to an attitude stabilising mode. Cockpit alerts were subsequently displayed to alert the flight crew to the degraded performance of the autopilot. These alerts were consistent with those expected when the AFDS had been in attitude stabilising mode for 15 seconds. Therefore, the movement of the first A380 through the ILS critical area caused an interference to the glideslope signal, which was subsequently detected by the AFDS. As a result, after attempting to capture the glideslope prematurely, the AFDS entered and remained in an attitude stabilising mode before alerting the crew.

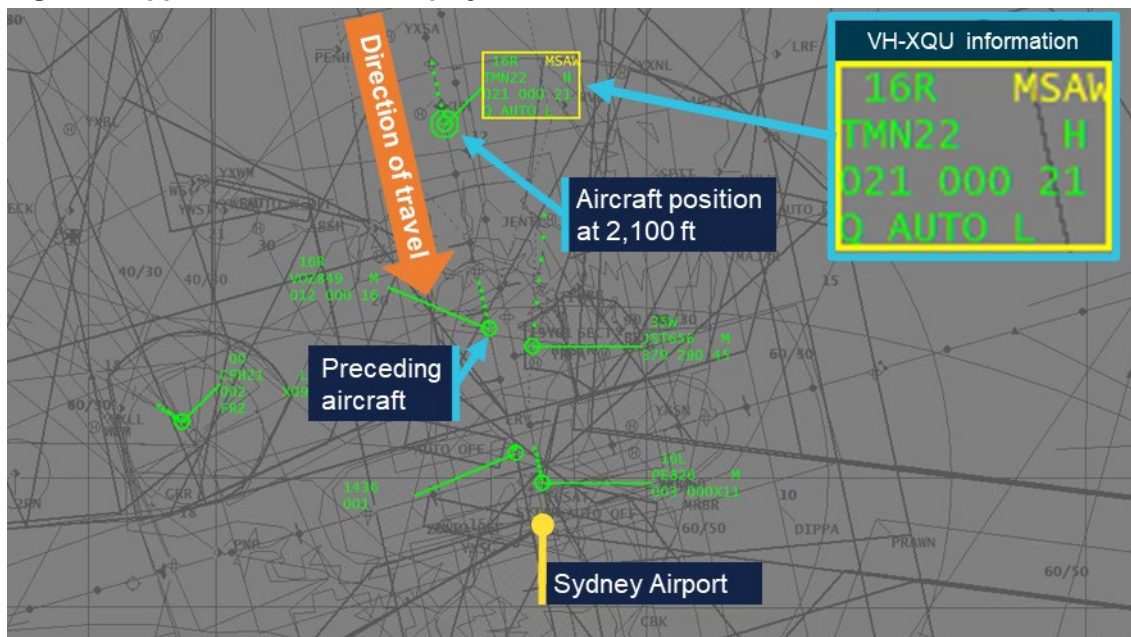
Figure 3: Approach controller display at 1520:39

altitude triggered an ATC minimum safe altitude warning (MSAW),⁴ which was presented on the approach controller’s display (Figure 3). The approach controller had just instructed the flight crew to change radio frequency and contact the tower controller, therefore they asked the tower controller to issue a safety alert to the crew. Given the frequency change instruction had just been issued, the approach controller also attempted to contact the flight crew directly on the approach frequency. The crew responded they were still on that frequency. The approach controller gave the crew a low altitude alert, advising them to check their altitude and the crew responded that they were going around.

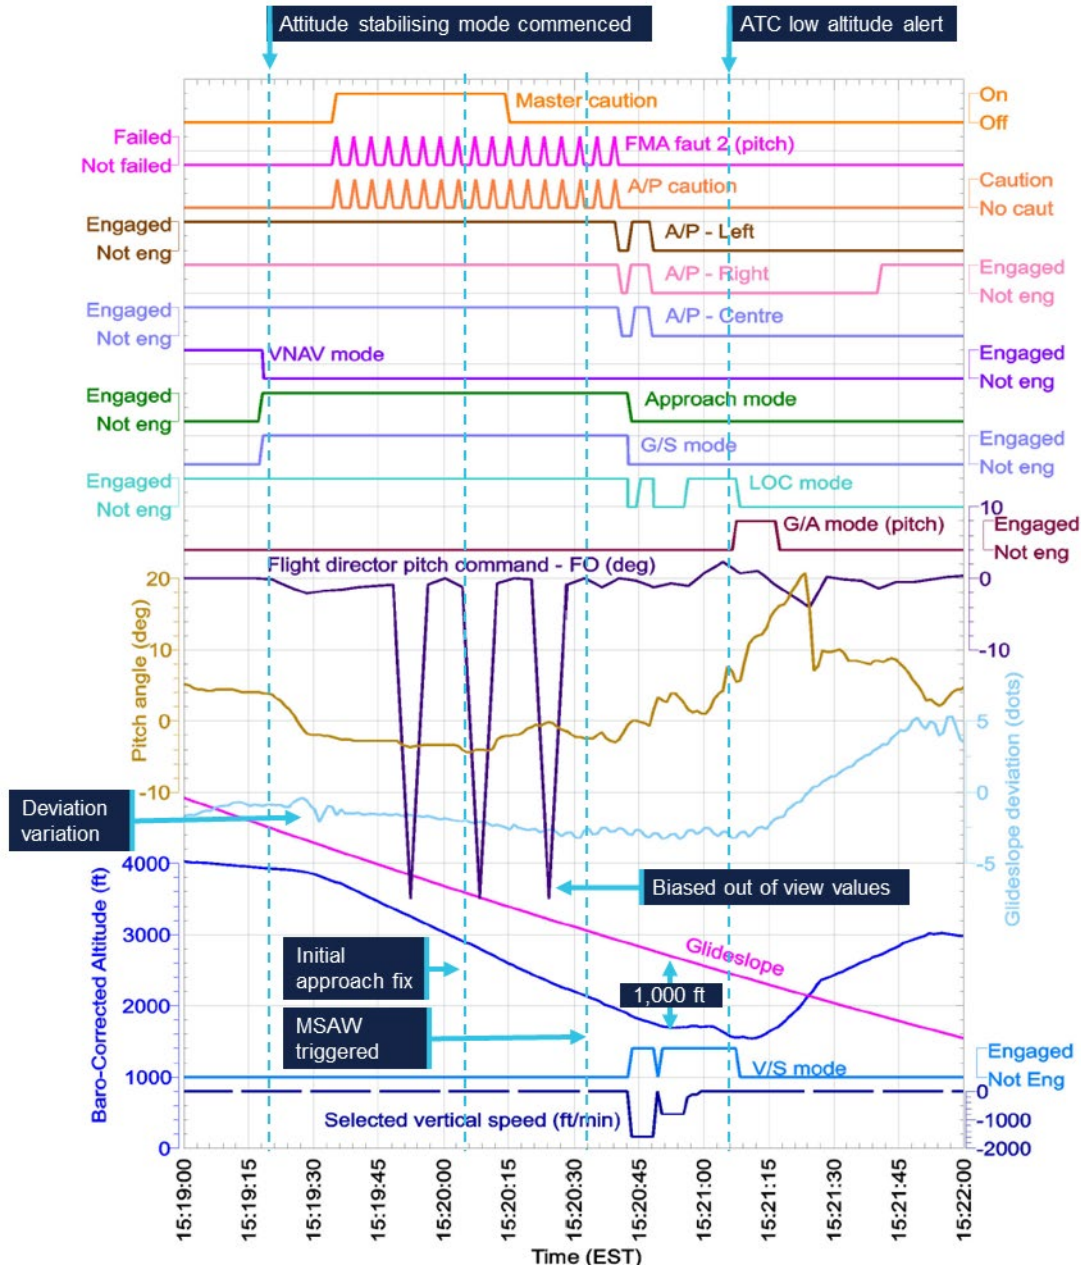
Figure 5: Graphical representation of recorded flight modes and alerts

Two seconds later, the aircraft pitch lowered from 4° nose up to approximately 2° nose down, and away from the flight director pitch command bar. The glideslope deviation then recorded a period of variations inconsistent with the aircraft's position relative to the glideslope. The aircraft's descent rate subsequently increased, and it began descending away from the glideslope.

The data recorded the activation of a pitch fault FMA, an autopilot caution, and a master caution light at 1519:35. Approximately 15 seconds later, the flight director pitch command bar began showing values alternating between 0° and 45°, which the

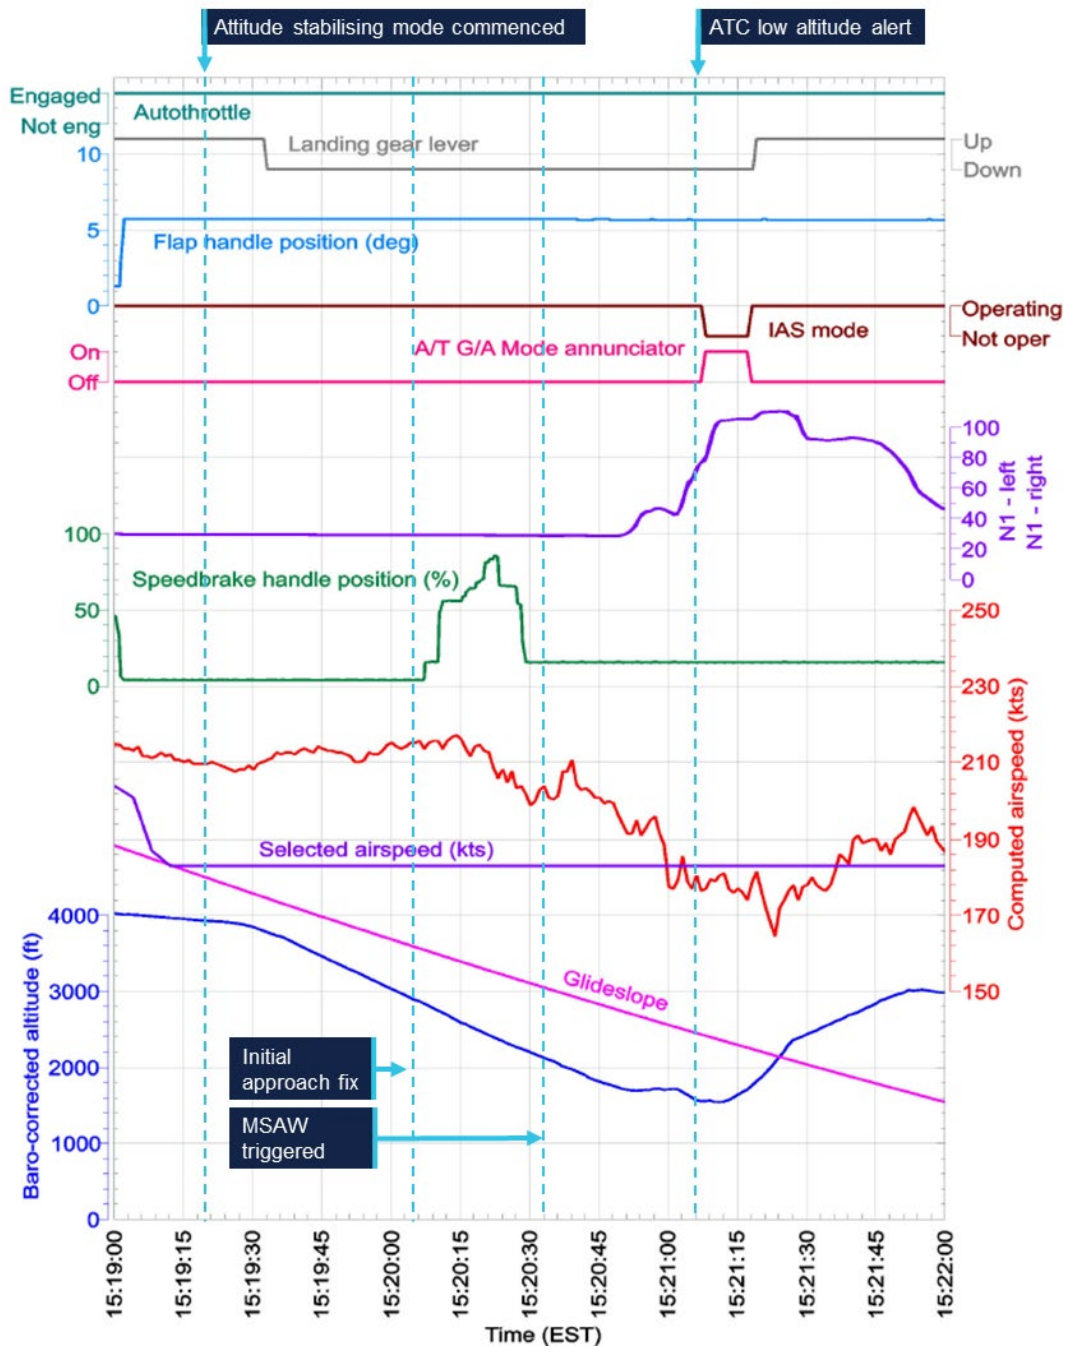
Figure 6: Graphical representation of recorded airspeed and configuration

Over the next minute, the aircraft maintained a descent rate of approximately 1,650 ft/min. During this time, the 3 autopilots remained engaged. Also during this time, the aircraft's airspeed remained above the selected airspeed (Figure 6) while the engines remained at idle thrust. At 1520:05 the aircraft passed the initial approach fix at an altitude of approximately 2,900 ft, with the glideslope deviation at 2 dots, or full-scale deflection. From 1520:08, the speedbrake was deployed in varying positions, before being armed for landing at 1520:29.

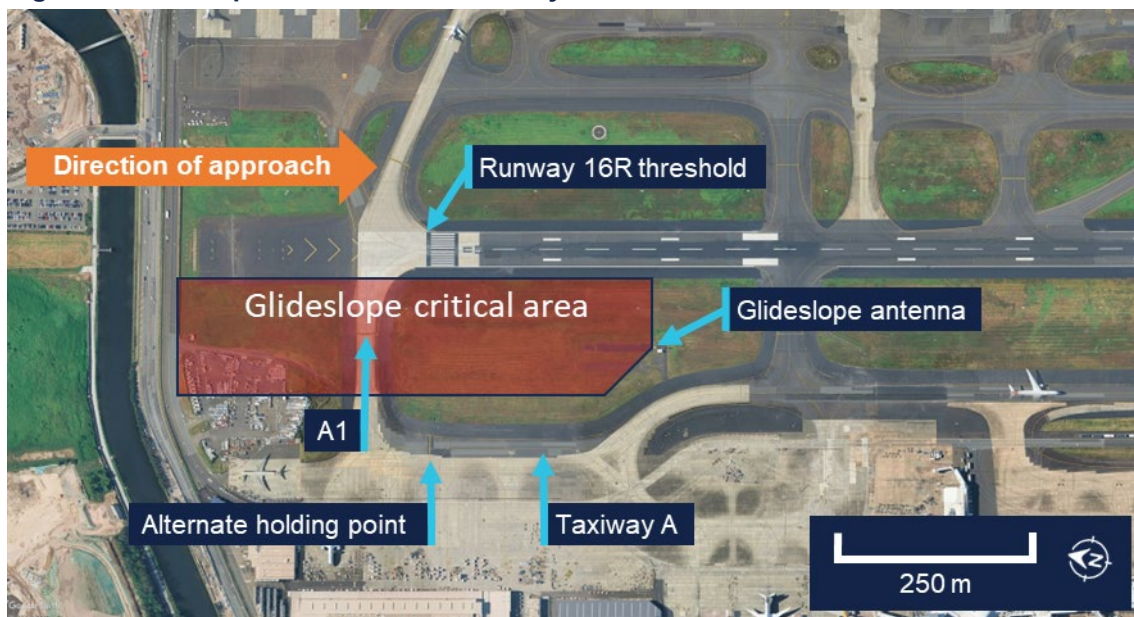
Figure 8: Glideslope critical area for runway 16R

The glideslope critical area for runway 16R at Sydney Airport was an area 600 m long and 145 m wide and included the A1 holding point (Figure 8). When protection of this critical area was required, air traffic control (ATC) directed aircraft to hold at an alternate holding point on taxiway A, instead of A1.

The weather conditions at Sydney Airport at the time were better than those for which protection of the ILS critical area was required. Therefore, ATC was not required to protect the area for a practice autoland. Furthermore, while the tower controller was required to inform the flight crew that the ILS was not being protected, the flight crew had not yet transferred to this controller. Therefore, there was no opportunity for the flight crew to be given this advice.

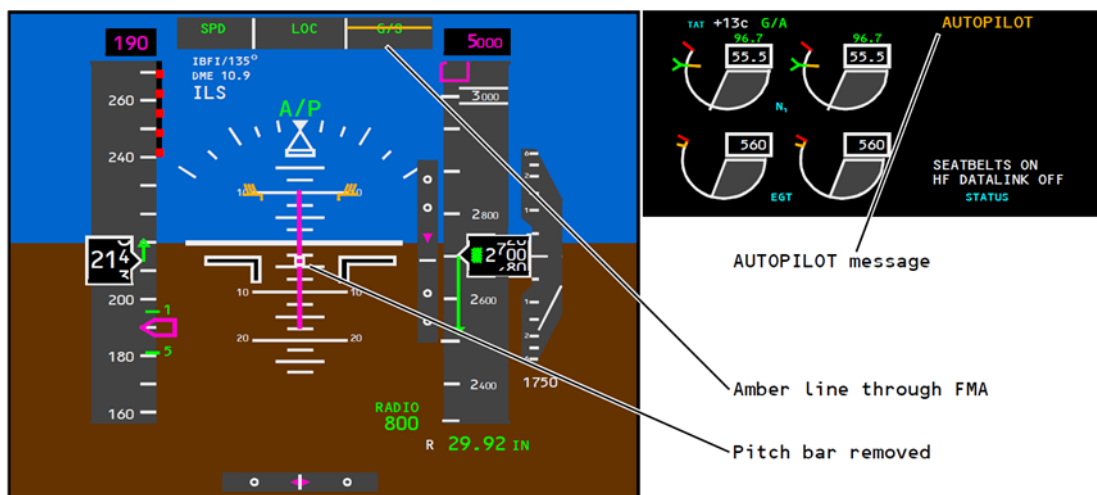
Figure 9: Indications following extended time in attitude stabilising mode

- the AUTOPILOT message shows (if autopilot is engaged) (Figure 9) and
- the flight director roll or pitch bar is removed (if flight director is on) and
- an amber line shows through the affected flight mode annunciation (FMA)
