# **Rotor drive belt failures resulting in collisions with terrain involving Robinson R22s, VH-8H8 and VH-HFQ**

Near Argadargada Aerodrome, Northern Territory, and Chillagoe Aerodrome,  
Queensland, on 15 and 23 November 2025

**ATSB Transport Safety Report**

AO-2025-069

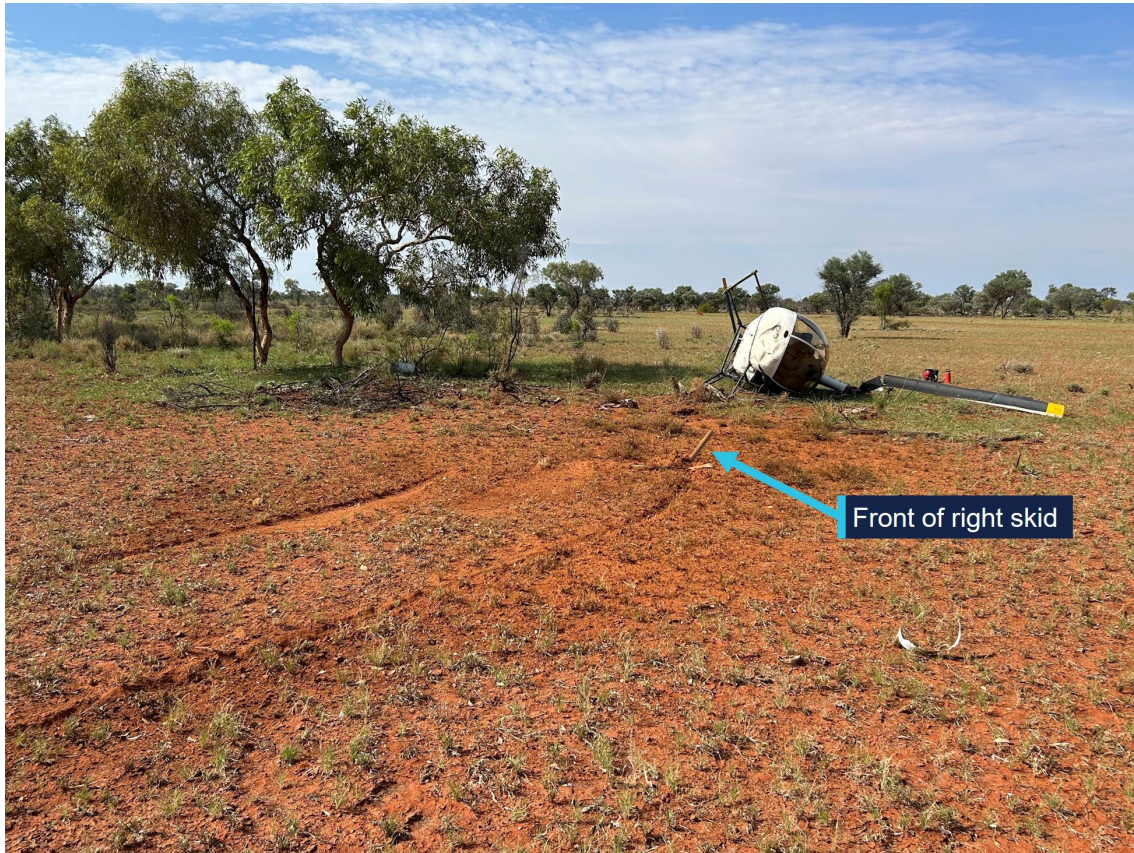
caused the helicopter to roll over before coming to a stop (Figure 1). There was no post-impact fire.

**Figure 1: VH-8H8 accident site**

The pilot shut down the engine before extracting themselves and assisting the passenger from the wreckage. The pilot then radioed for assistance, before turning off the emergency locator beacon, which had activated during the accident. The pilot observed that the skids had spread significantly from the ground impact and that the passenger's seat base had compressed. Additionally, the pilot noted that one drive belt had snapped and the other was separated into several pieces.

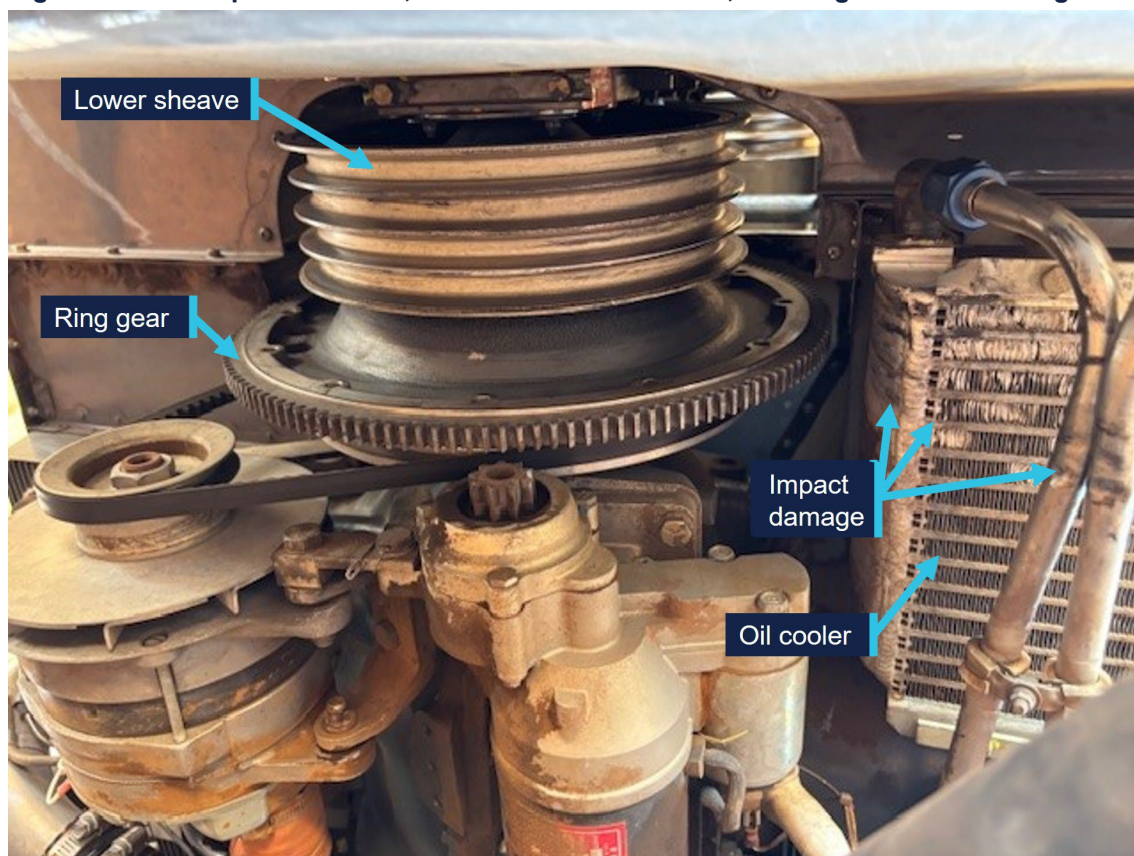
Subsequent examination of the helicopter by the operator showed additional evidence of in-flight drive belt failure, including an accumulation of black dust on the engine starter ring gear support (to which the lower drive sheave is connected), and rubber marks and impact damage to the oil cooler and feed lines adjacent to the belt drive (Figure 2).

**Figure 2: VH-8H8 post-accident, viewed from underneath, showing oil cooler damage**

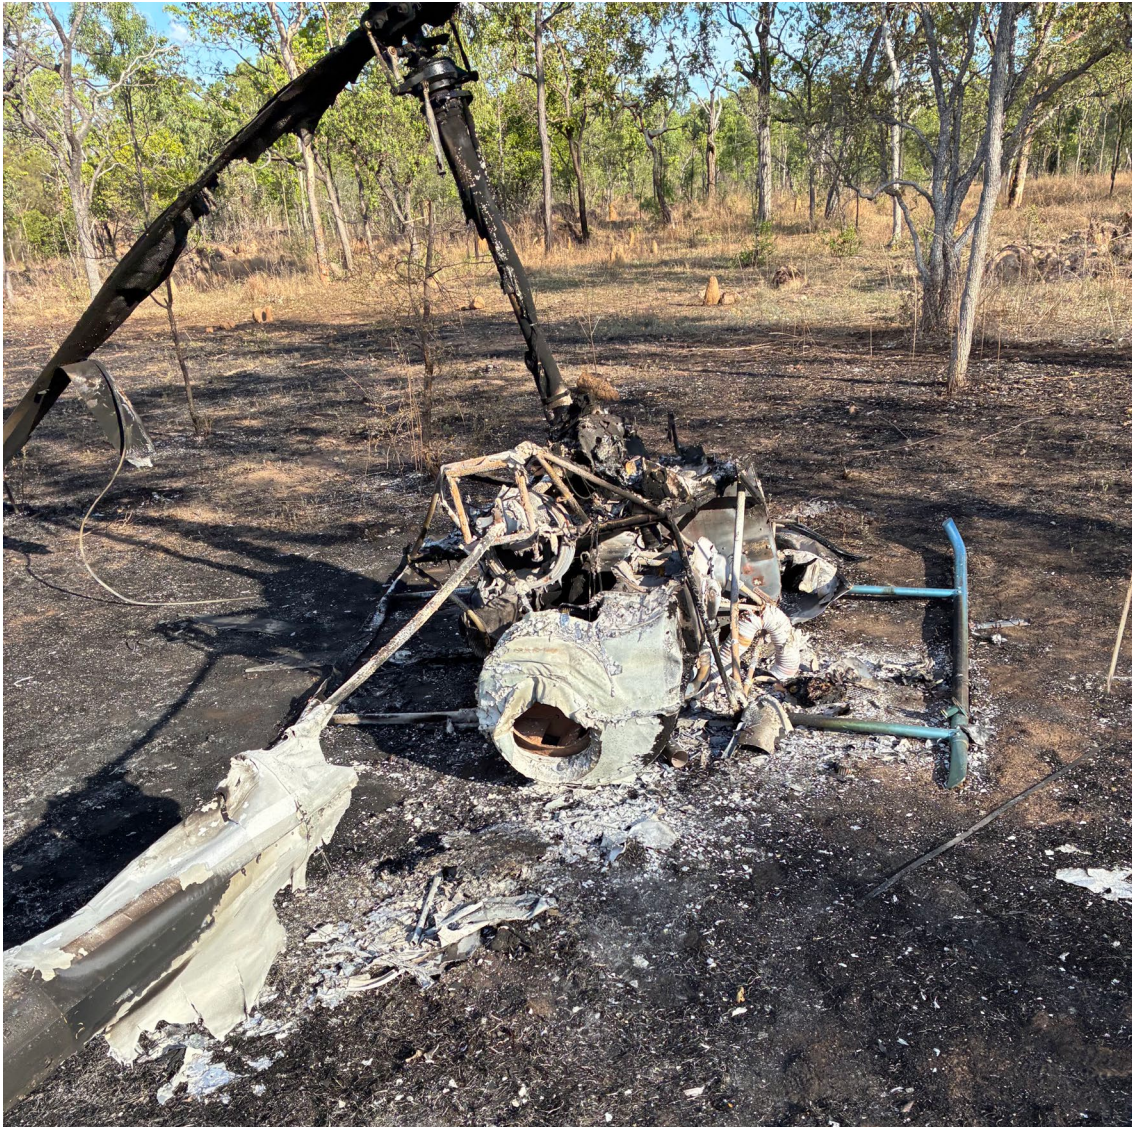
Shortly afterwards, a fire ignited in long, dry grass around the engine and exhaust. The fire subsequently destroyed the helicopter (Figure 3).

**Figure 3: VH-HFQ post-accident**

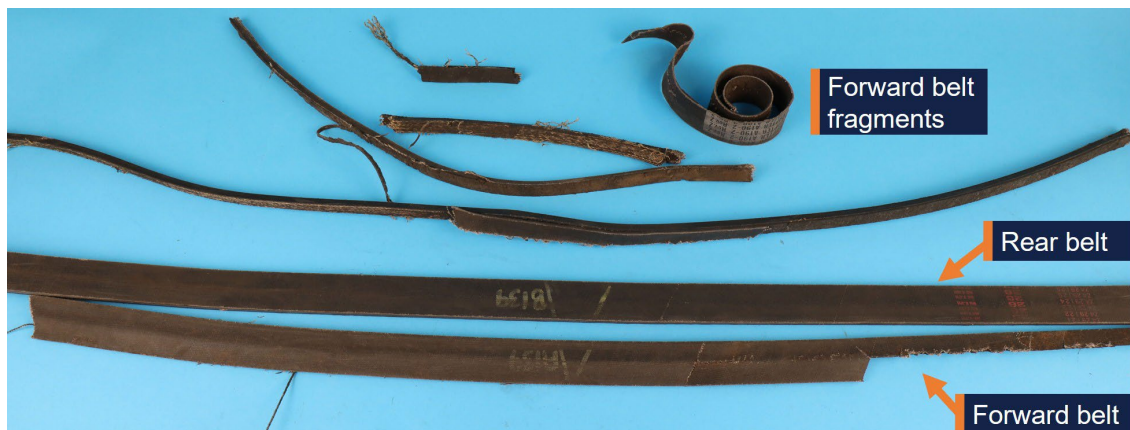
**Figure 6: VH-8H8 drive belts as-recovered**

The rear belt had a single tensile break through both vees in the same location and showed no abnormal wear or defect.

The forward belt was separated into multiple pieces. The front vee of the forward belt had entirely delaminated from the backing strap and was fractured at several places. The rear vee was still largely attached to the backing but was also separated in more than one location along the length.

The VH-8H8 pilot report of a burning rubber smell, followed shortly afterwards by the 'bang', the significant reduction in main rotor RPM and sudden increase in engine RPM, was all consistent with failure of the helicopter's drive belts. The short (10 to 15 minute) duration of flight, rubber smell, and uneven belt wear, was consistent with the forward belt not being correctly seated in the drive sheave grooves. This belt misalignment most likely occurred during startup, as the flight duration was consistent with RHC's experience of belt longevity when operated in this configuration. The abnormal wear indicated that the forward belt most likely failed first and, noting the very brief time interval between the 'bang' and the main rotor RPM decay, the forward belt probably interfered with the rear belt, which then fractured, resulting in the complete drive train disconnect.

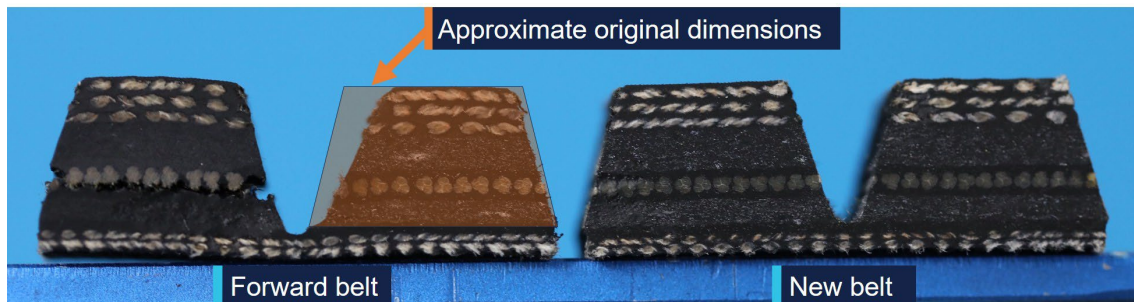
backing strap (between the vees) had deformation consistent with running on the crest of a sheave groove. A cross-section through the belt showed significant wear of the rear vee (Figure 7).

The abnormal, non-uniform wear and stretching was consistent with the belt running while misaligned, with the belt having pushed forward and one of the vees not running in the drive sheaves. RHC advised that in this configuration, the belts might last 10–20 minutes before failure. RHC also advised that the belts would have to be very loose for this to occur, particularly as the outer sheave groove is raised to reduce the likelihood of such an event.

**Figure 7: VH-8H8 forward belt cross-section (left) and new rev-Z belt (right)**
