# Misaligned take-off involving Beechcraft B200C King Air, VH-FDI

Brisbane West Wellcamp Airport, Queensland, on 24 February 2026

Aviation Occurrence Investigation (Short)

AO-2026-062

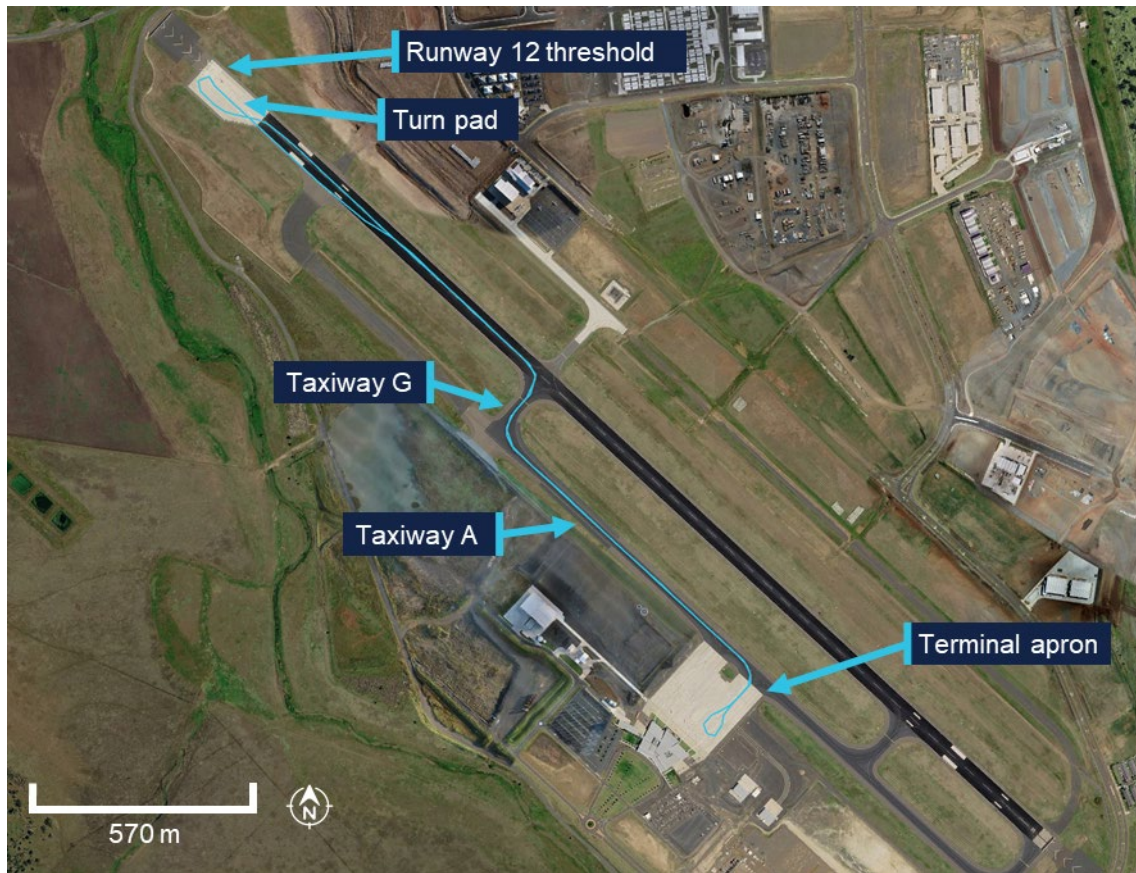
**Figure 1: Aircraft movement overview**

The aircraft taxied from the terminal apron at 2355 (23 February) on taxiway A, before entering and backtracking<sup>1</sup> runway 12 at taxiway G. The pilot then taxied along the runway centreline towards the runway 12 threshold (Figure 1).

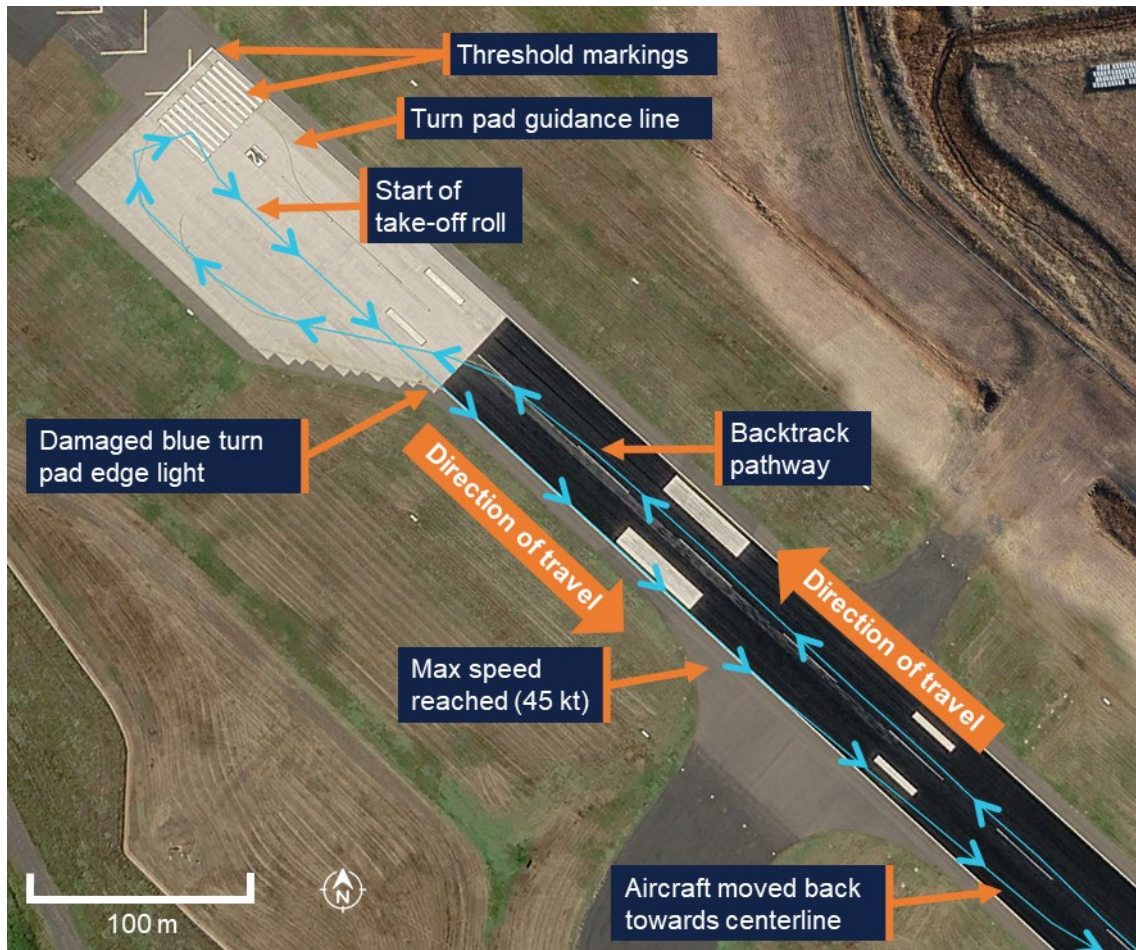
**Figure 2: Aircraft movement details**

At the end of the runway, the pilot conducted a 180° right turn. When entering the turn pad, the pilot initially turned left to allow room for the right turn, then part-way through the turn identified the right runway edge lights and anchored their alignment with these lights. Although recorded data indicated the aircraft initially followed the turn pad guidance line, the pilot reported that they did not recall seeing the turn pad guidance line or the threshold markings,<sup>3</sup> and did not use the markings to orient the aircraft during the turn (Figure 2).

The aircraft was now in the centre of the concrete turn pad but misaligned with the white lights of the right runway edge for take-off. The pilot reported mistaking the right runway edge lights for centreline lights, however, no centreline lights were present at Wellcamp Airport.

While taxiing on the turn pad at the end of runway 12, the pilot initiated a tighter right turn than the guidance line to line up for take-off. The pilot reported that this tight turn was an accepted operational practice as no specified operational procedure was provided for turn pads. The pilot also reported that they could not recall seeing the threshold markings, or the guidance line in the dark conditions, and stated that they were not intentionally using these features to guide the turn. As they progressed through the turn, they noticed the right runway edge lights and aligned the aircraft with these.

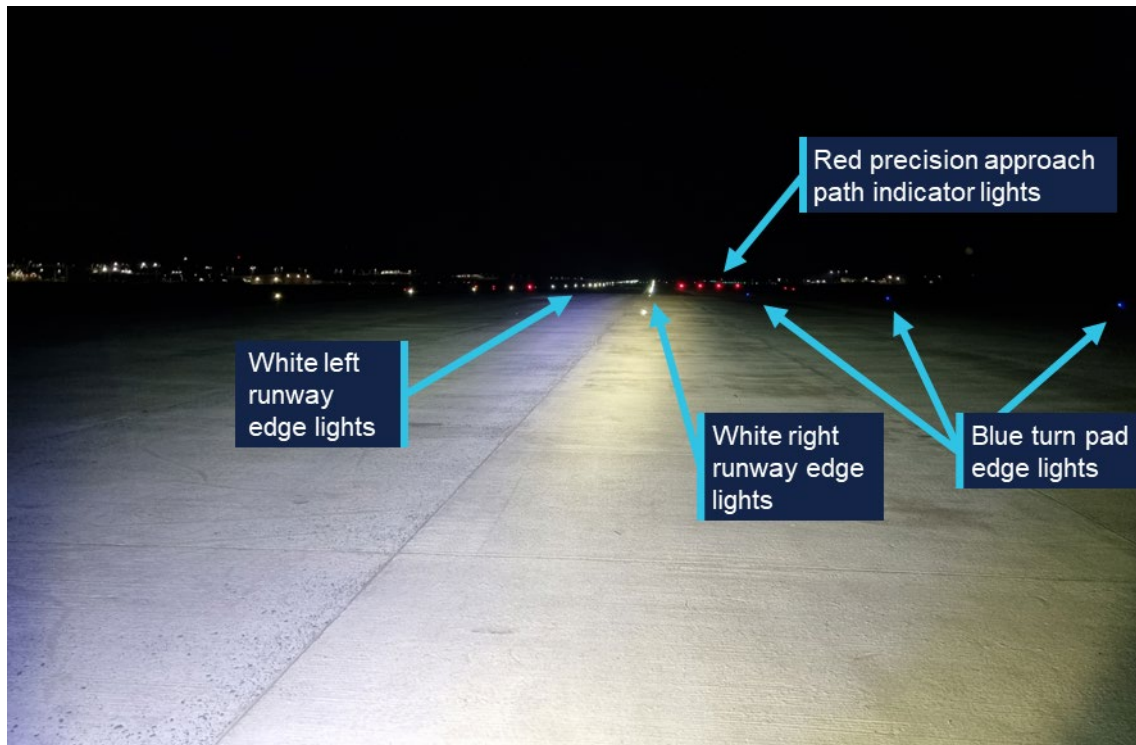
**Figure 3: Reconstructed view of the runway 12 lighting when lined up with the right edge**

The pilot did not recall seeing the left runway edge lights which were about 45 m to the left of their lined-up position, nor did they recall seeing the blue turn pad node lights spaced in a diagonal direction along the start of the right turn node edge. They also did not identify the red precision approach path indicator (PAPI) lights close to the right runway edge lights (Figure 3).

The pilot then missed several conflicting cues to alert them of the aircraft's misalignment. Before completing the turn, the threshold markings were not identified by the pilot. Furthermore, the pilot did not identify the left runway edge lights 45 m away from the aircraft position on the turn pad. This would have contradicted their perception that the right edge lights were centreline lights, because only 2, rather than 3, parallel lines of lights were present.

Other available cues included the blue turn pad node lights spaced in a diagonal direction along the start of the right diagonal turn node edge. If perceived, the angle of the lights had the potential to alert the pilot to their alignment with the turn pad edge. Lastly, the pilot was unaware of the red precision approach path indicator (PAPI) lights visible to the right of the runway edge lights which indicated the area to the right of the aircraft was outside the runway surface.

None of the above cues sufficiently alerted the pilot to their misalignment with the right runway edge, and the pilot misperceived the right runway edge lights as the centreline lighting. The pilot then started the take-off roll from the turn pad, resulting in the aircraft accelerating faster than taxi speed by the time the edge of the runway was reached.

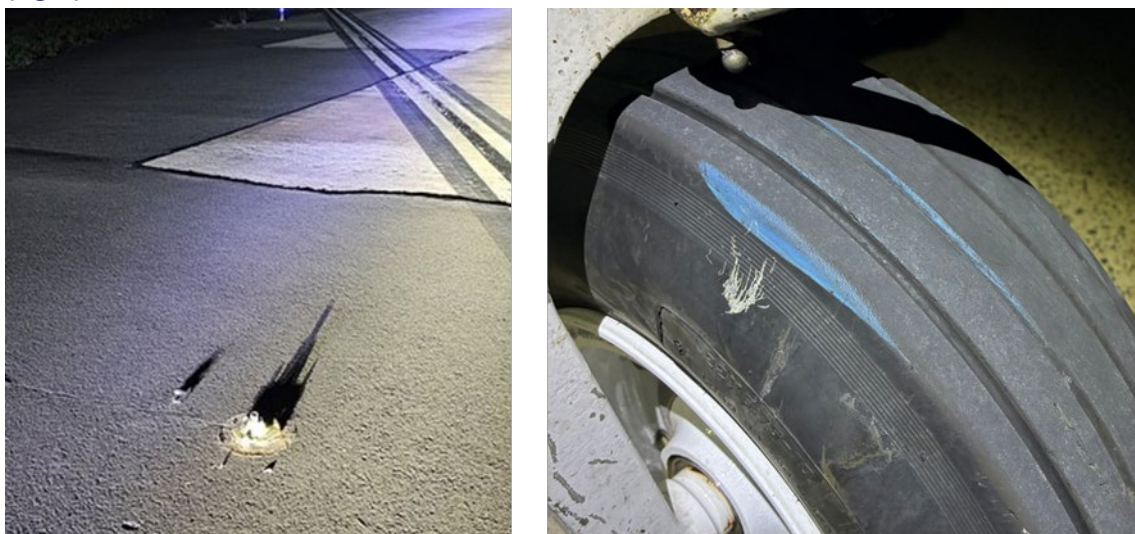
The pilot commenced the take-off roll and at 0003 (24 February), the aircraft's front wheel struck an elevated blue turn node light, leaving blue marks on the wheel tyre (Figure 4, right).

The pilot heard a bang during the take-off roll, detected the misaligned position, rejected the take-off and steered left towards the runway centreline. They then cancelled their flight plan, returned to the terminal apron and notified the aerodrome reporting officer (ARO), who subsequently conducted a runway inspection and identified the runway light damage (Figure 4, left).

**Figure 4: Damaged blue turn node light (left) and blue marks on the aircraft front wheel (right)**

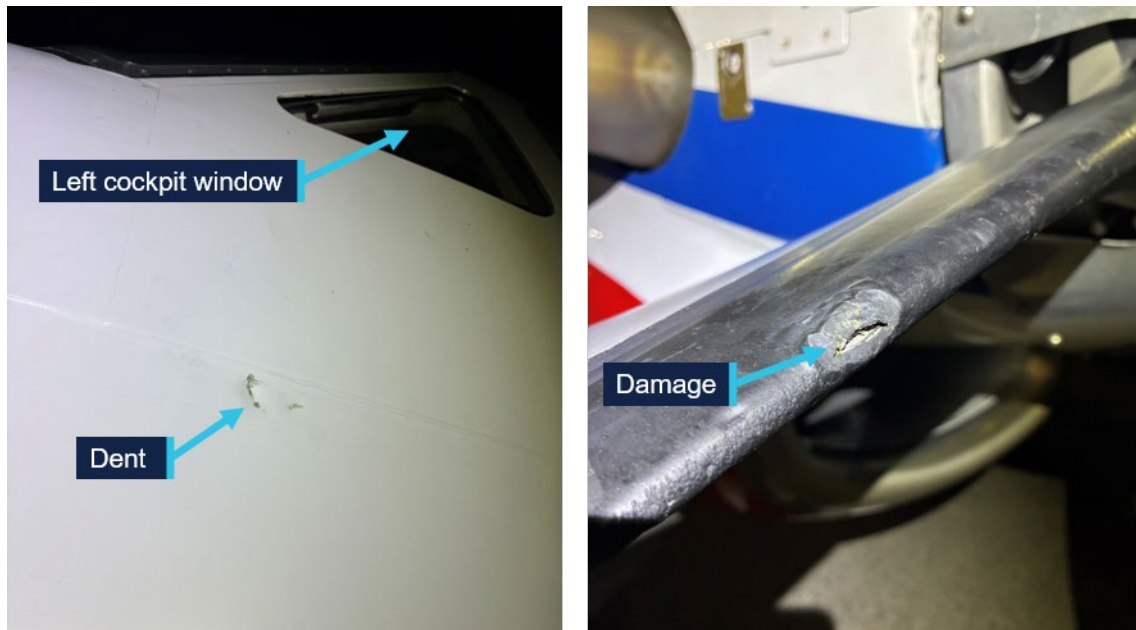
On impact with the front wheel, debris from the frangible<sup>4</sup> blue turning node light caused minor damage to both aircraft propellers, and a dent to the aircraft fuselage below the left cockpit window (Figure 5).

**Figure 5: Dent on aircraft fuselage (left) and damage to one of the left propeller blades (right)**

The aircraft sustained minor damage which prevented further flight until repaired.
