# **Fuel starvation involving Piper PA-32R-301, VH-LPW**

9 km south of Bacchus Marsh Aerodrome, Victoria, on 1 May 2026

## **ATSB Transport Safety Report**

AO-2026-076

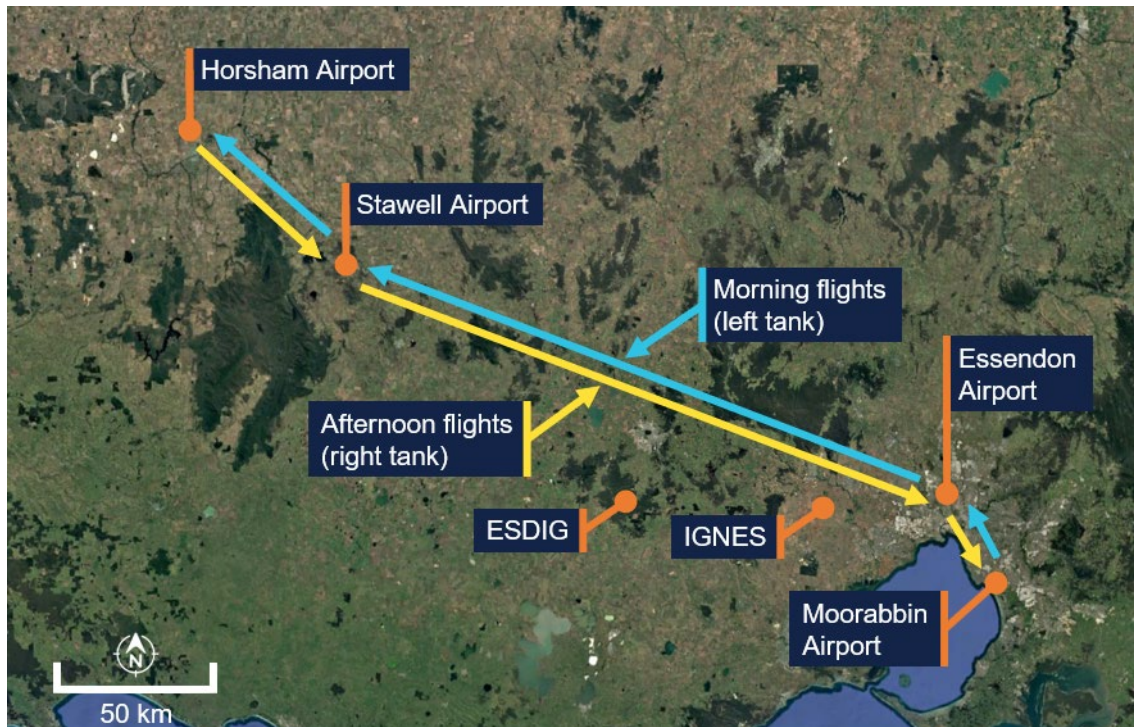
**Figure 1: Planned flights**

The flights were operated as private flights (see the section titled *Operation*) under the instrument flight rules.<sup>1</sup> The pilot intended to operate the flights to Horsham using the fuel contained in the left tank and then change to the right tank to operate the return flights (Figure 1).

After completing the morning's flights, the aircraft landed at Horsham at 0913 with about 74 L in the left tank and 130 L in the right. In the afternoon, the pilot prepared for the return flight to Stawell but inadvertently omitted to select the right tank and, at 1429, the aircraft departed Horsham with the left tank still selected.

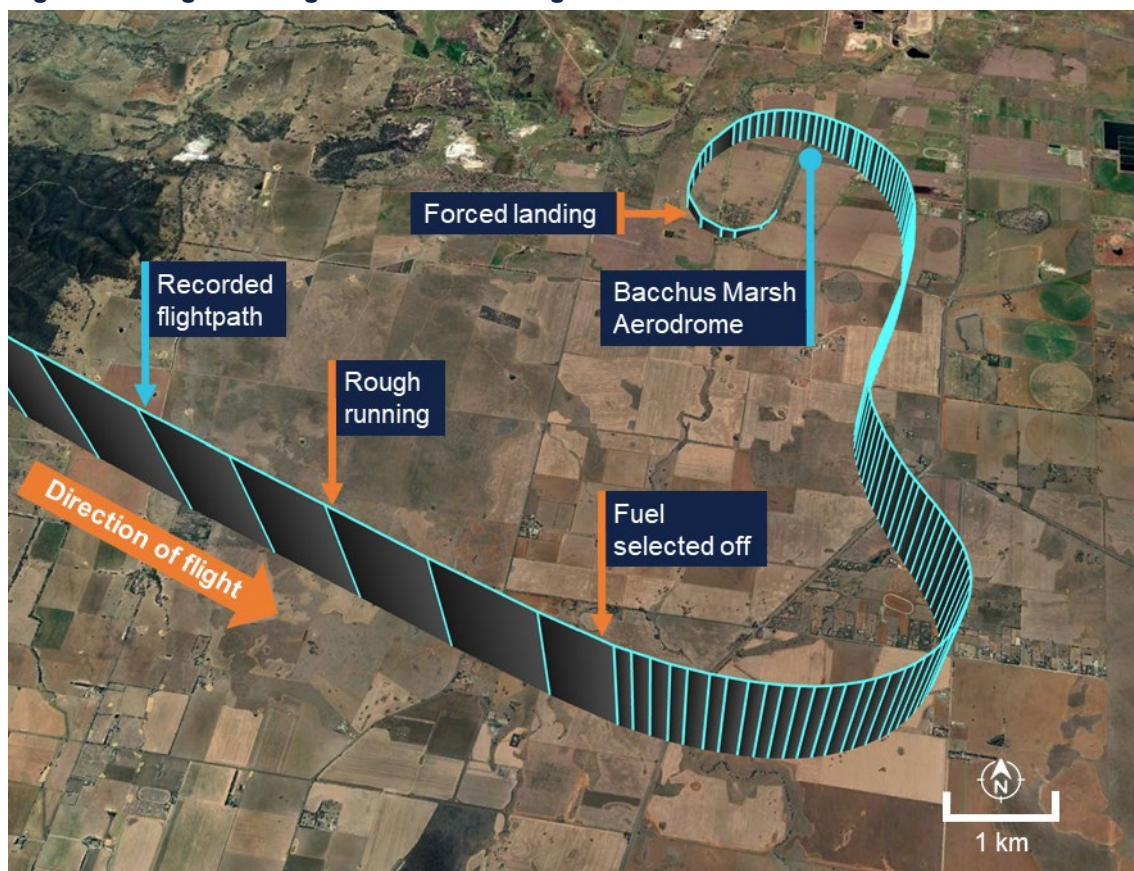
**Figure 2: Rough running and forced landing**

At 1616, the aircraft was continuing toward IGNES at 7,000 ft above mean sea level and passed through a patch of cloud. At that time, the engine began to run rough. Before commencing emergency procedures (see the section titled *Emergency procedures*) the pilot visually identified Bacchus Marsh Aerodrome, which was about 4 NM (7.4 km) north of the aircraft, as a suitable location for a forced landing (Figure 2). The engine continued to run rough and, in response, the pilot commenced the engine power loss in flight actions and selected the right fuel tank.

After switching fuel tanks, normal engine power did not immediately return, and the pilot assessed that the rough running was not fuel-related. The pilot then shut the engine down by moving the mixture control to the idle cut-off position and the fuel selector to the off position.

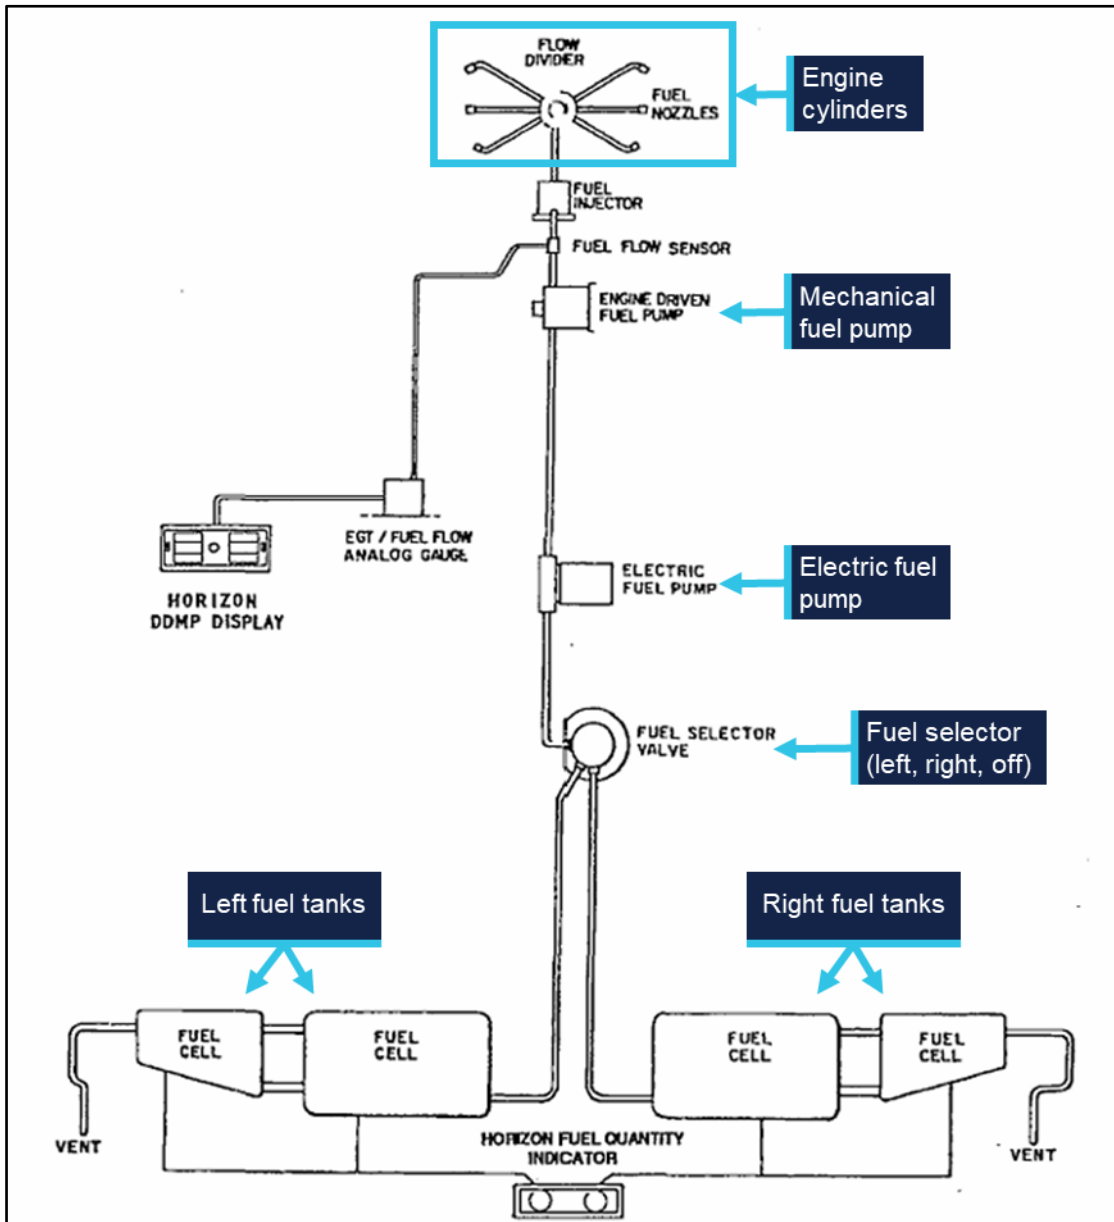
Figure 4: Fuel system schematic

The Saratoga was fitted with 2 fuel tanks in each wing. The total fuel capacity was 405 L, of which 386 L was usable (193 L in each wing). The 2 fuel tanks in each wing were interconnected and acted as one tank and the fuel selector had 3 positions: left, right and off. Fuel was fed to the engine cylinders via a mechanical fuel pump and a pilot-selectable electric fuel pump (Figure 4).
